**AGENDA
HISTORIC DISTRICT COMMISSION
OCTOBER 5, 2022**

Petition Concerning the Chestertown Armory
Chestertown Historic District Commission
October 5, 2022

Re: Chestertown Armory, 509 S Cross Street, Chestertown, Maryland
Asbestos & Lead Survey; Mold and Moisture Evaluation

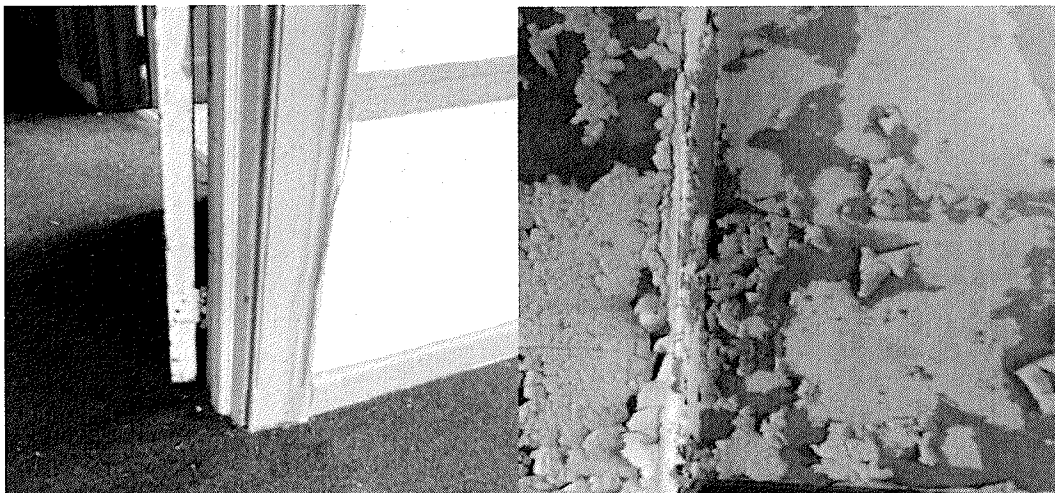
- Doors, baseboard, trim, door casings 1.1 mg/cm^2

Lead paint on door casing, base and doors

Peeling paint due to moisture

The lead painted materials must be addressed as lead if sanded or paint is disturbed. The contractor addressing lead painted surfaces must meet requirements for EPA's Lead Renovation, Repair and Painting Rule (RRP Rule). This rule requires that firms performing renovation, repair, and painting projects that disturb lead-based paint in homes, child care facilities and pre-schools built before 1978 have their firm certified by EPA (or an EPA authorized state), use certified renovators who are trained by EPA-approved training providers and follow lead-safe work practices.

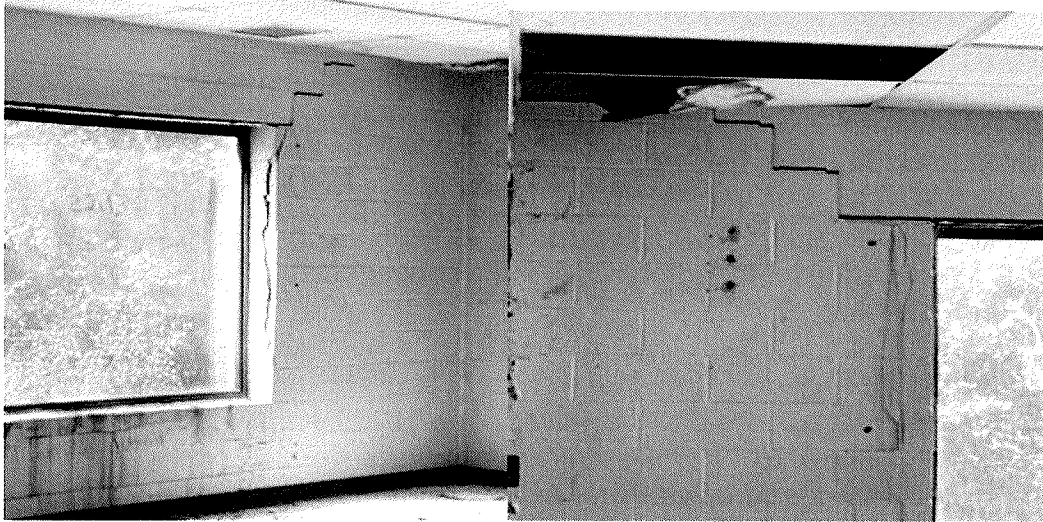
Block walls separating in several areas

It is recommended a structural engineer assess the building to determine current condition due to foundation and wall cracks and suspect structural concerns. The roof was not yet addressed but will be as schedule permits for use of ladder or lift access.

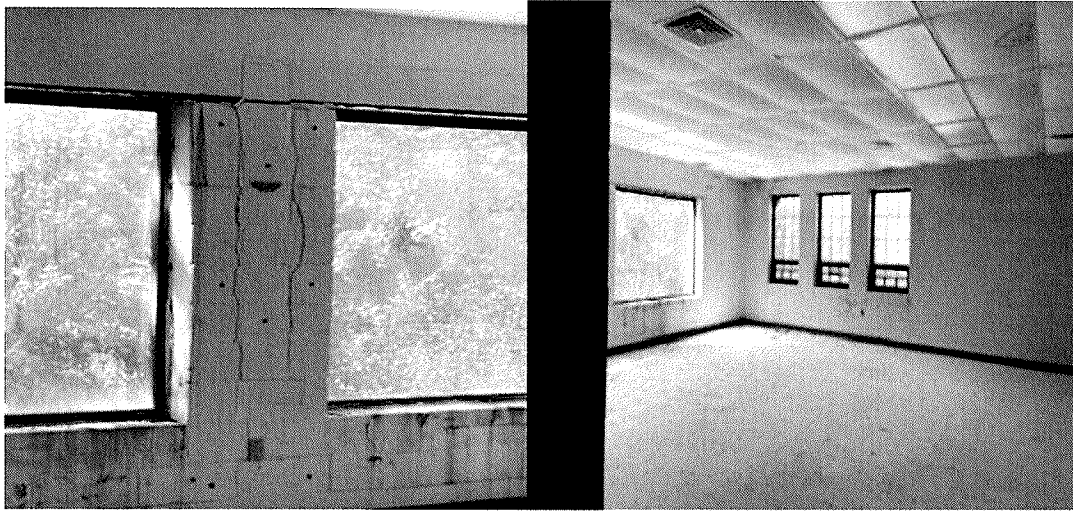
It also appears that some windows may be leaking which will require replacing.

Cracks in block; windows leaking

Extensive moisture issues; bowed ceiling tiles
