**Earth Data**  
INCORPORATED

GROUNDWATER AND ENVIRONMENTAL CONSULTANTS  
CENTREVILLE, MARYLAND

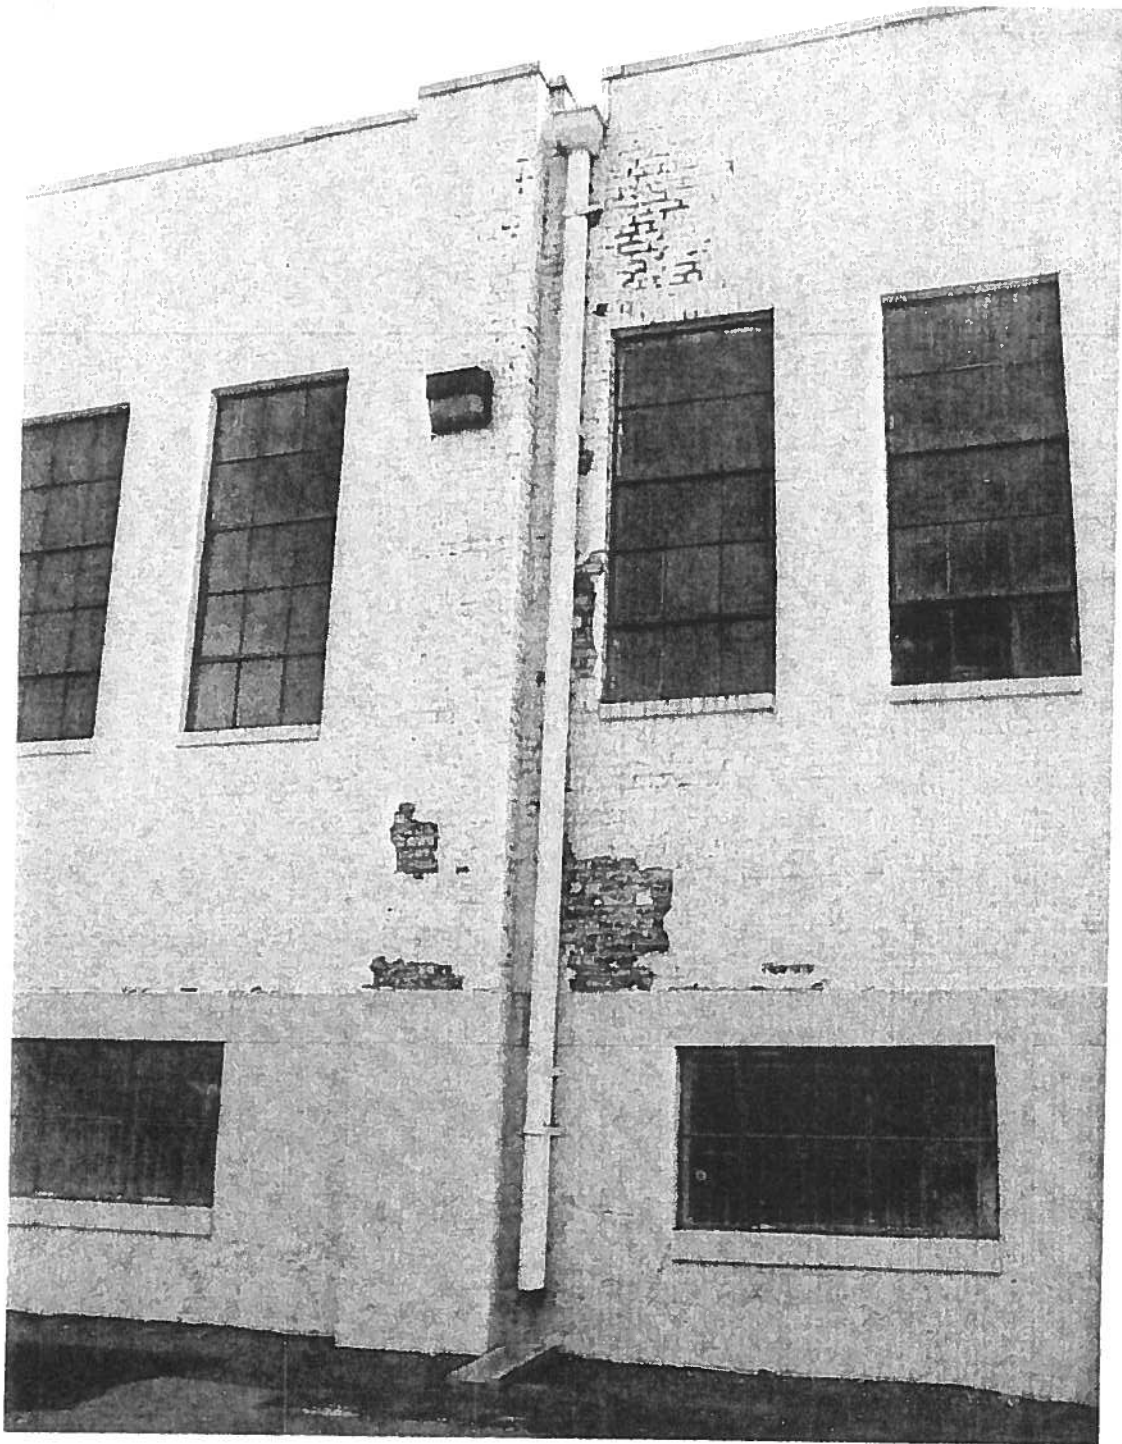
Deteriorated condition of the down spouts on the armory brick painted face.

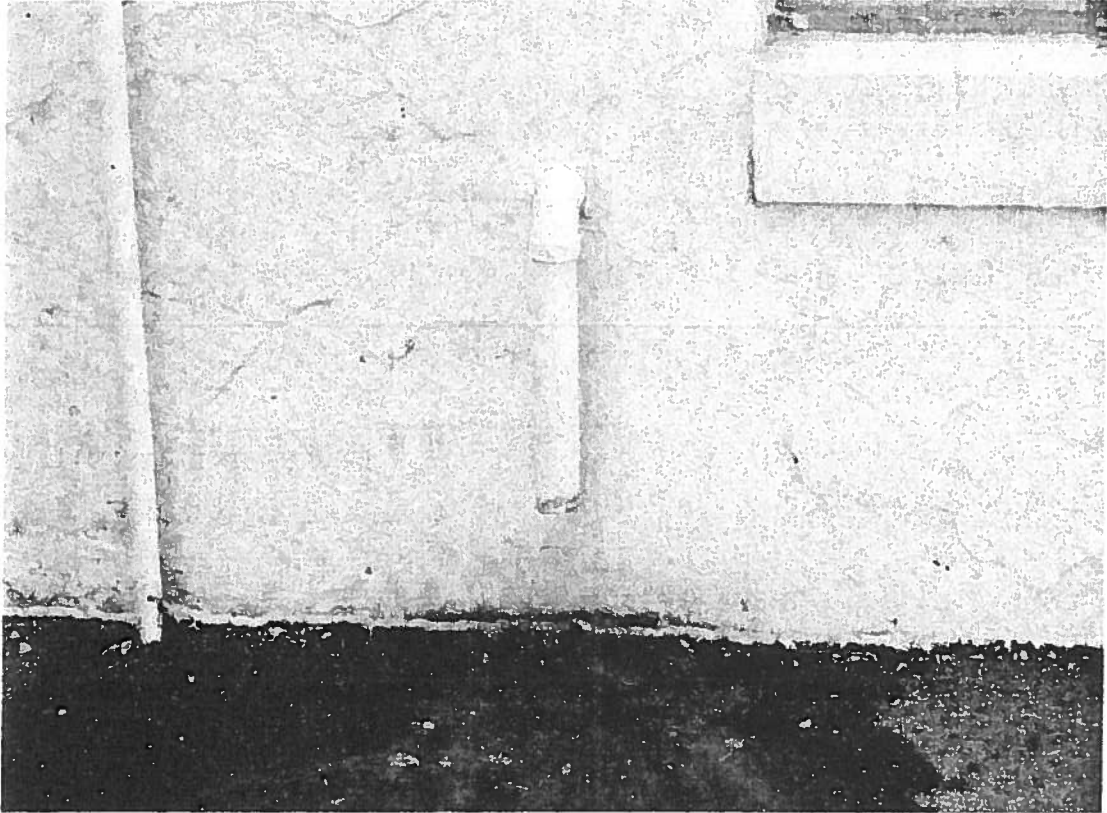
Air-conditioning condensate drain for upper floor units to the compound for

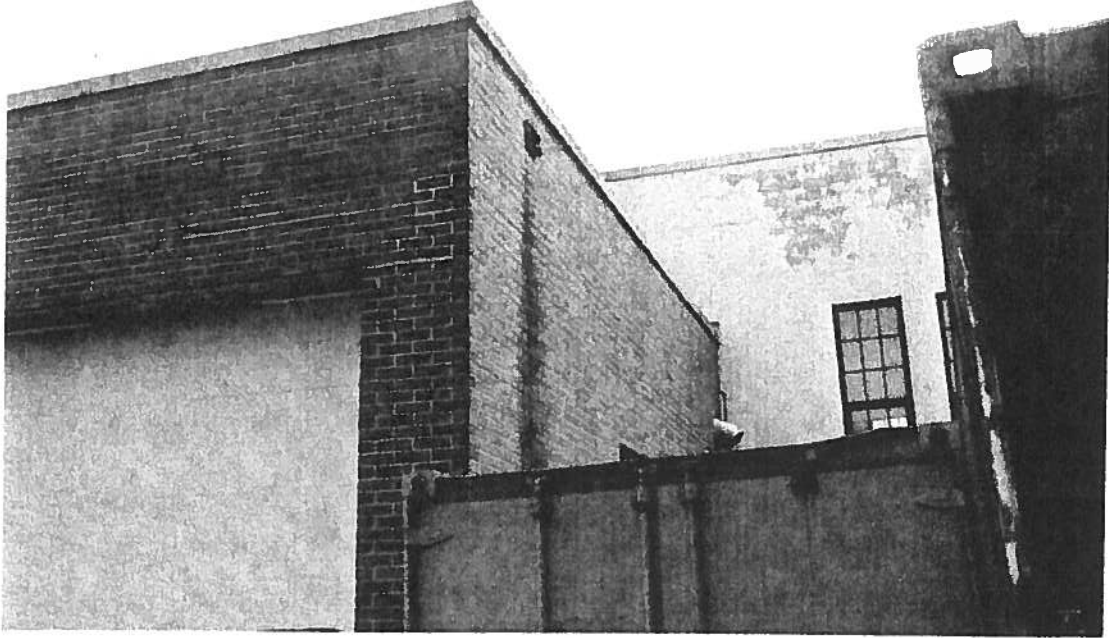
West rear of the armory roof drain direct drain down the face of the brick and deteriorated paint above.

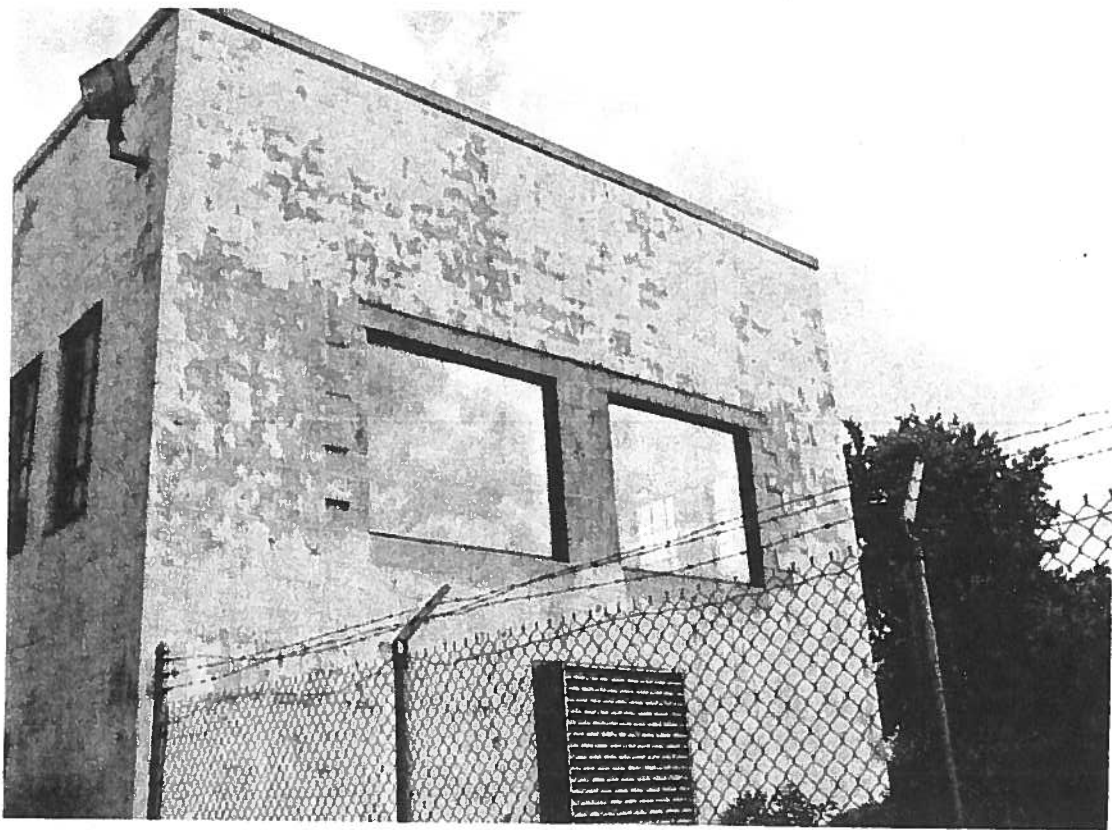
Picture window improperly installed and deteriorating.

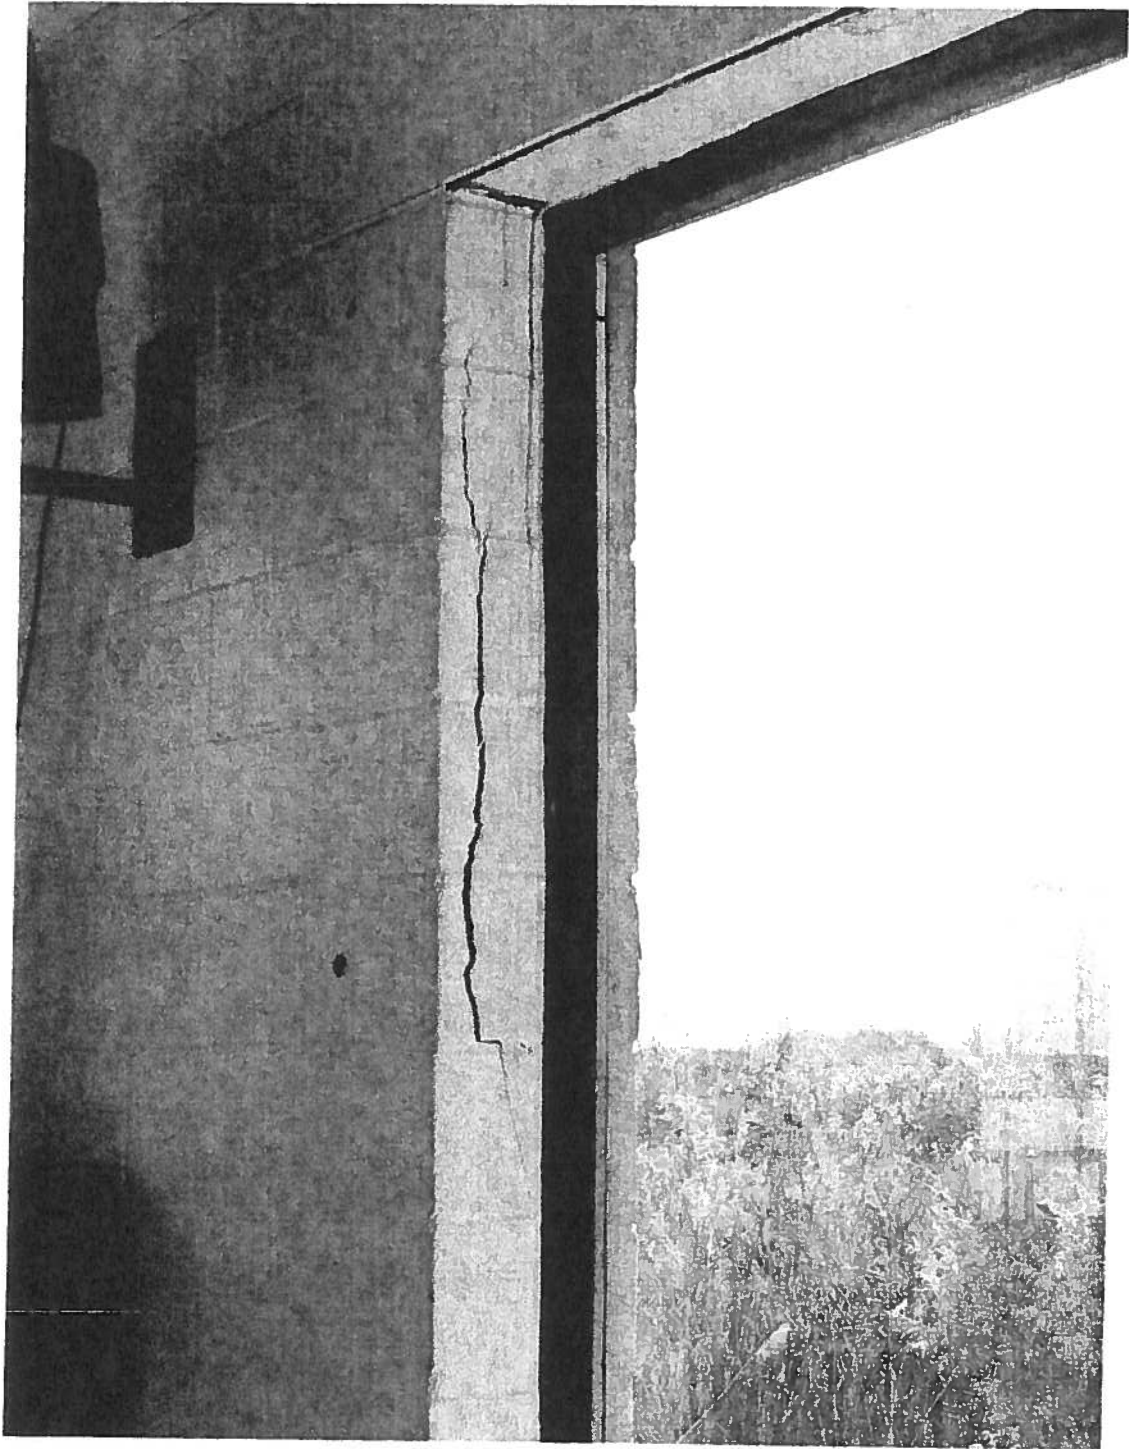
Structural crack in block surrounding the window that includes the middle and sides of the windows

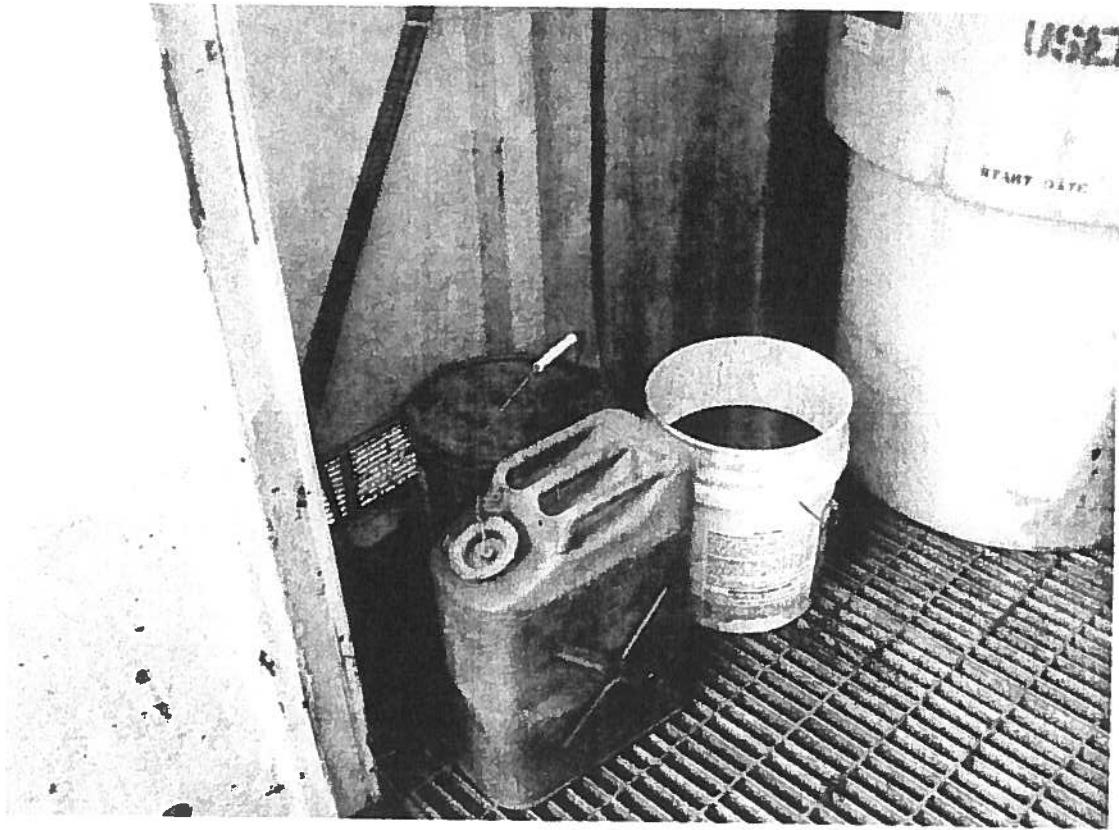
HAZMAT Building potential spill from Hurricane Isabel. Contents appear to be antifreeze fluid, oil and unknown substance in red can. Needs to be evaluated for T/I and /or clean-up.

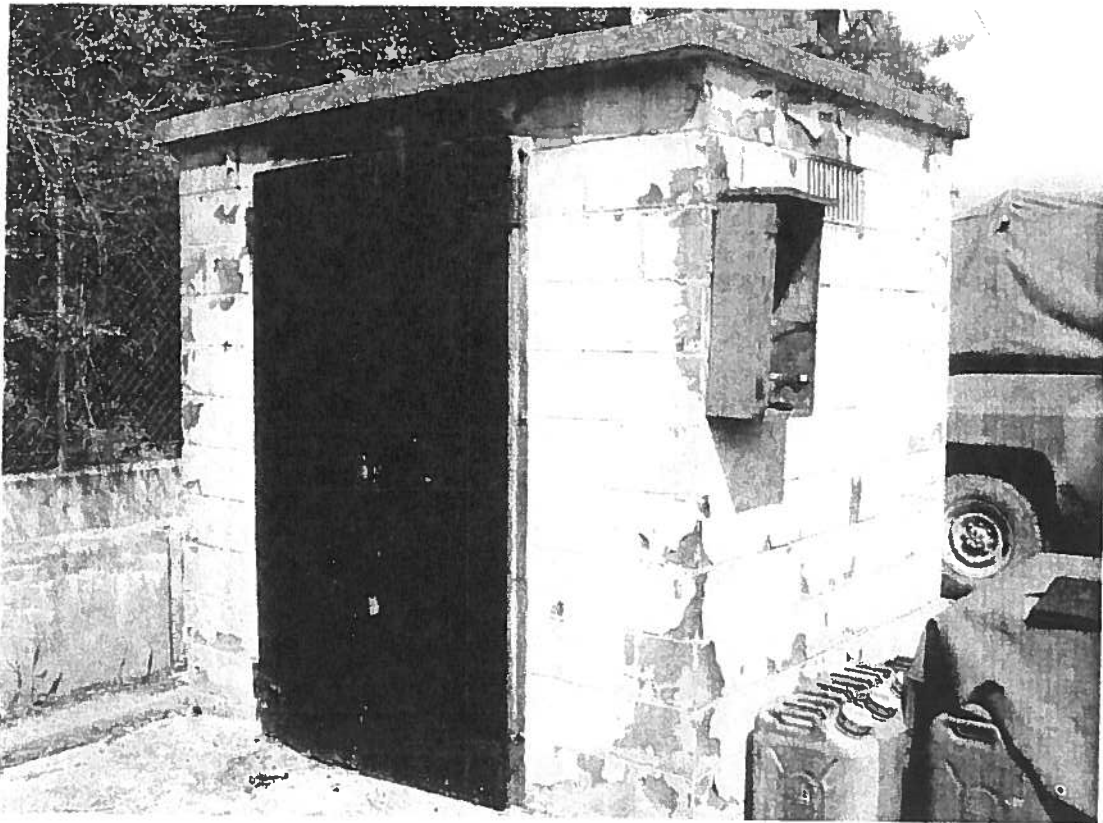
POL building missing fire extinguisher, contents need to be cleaned out and store diesel cans within, out of the weather.

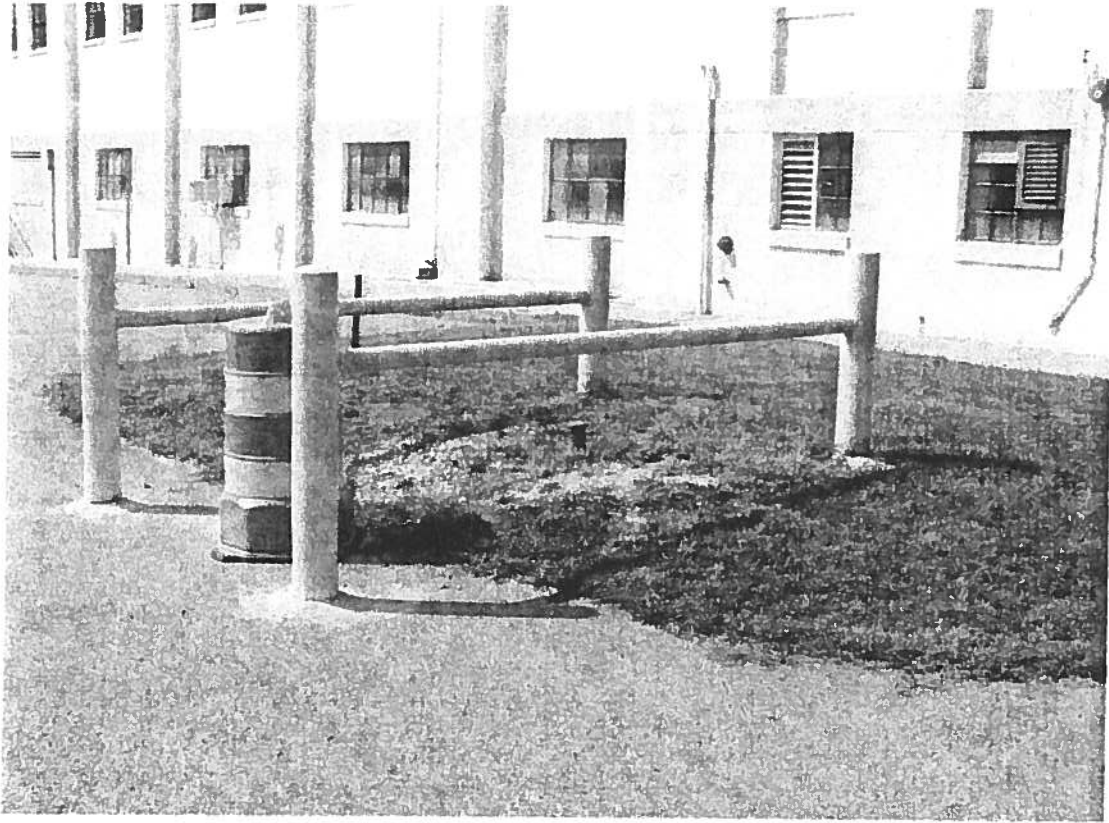
6000gallon under ground storage tank for heating oil that is under contract for replacement by an above ground storage tank this FY.

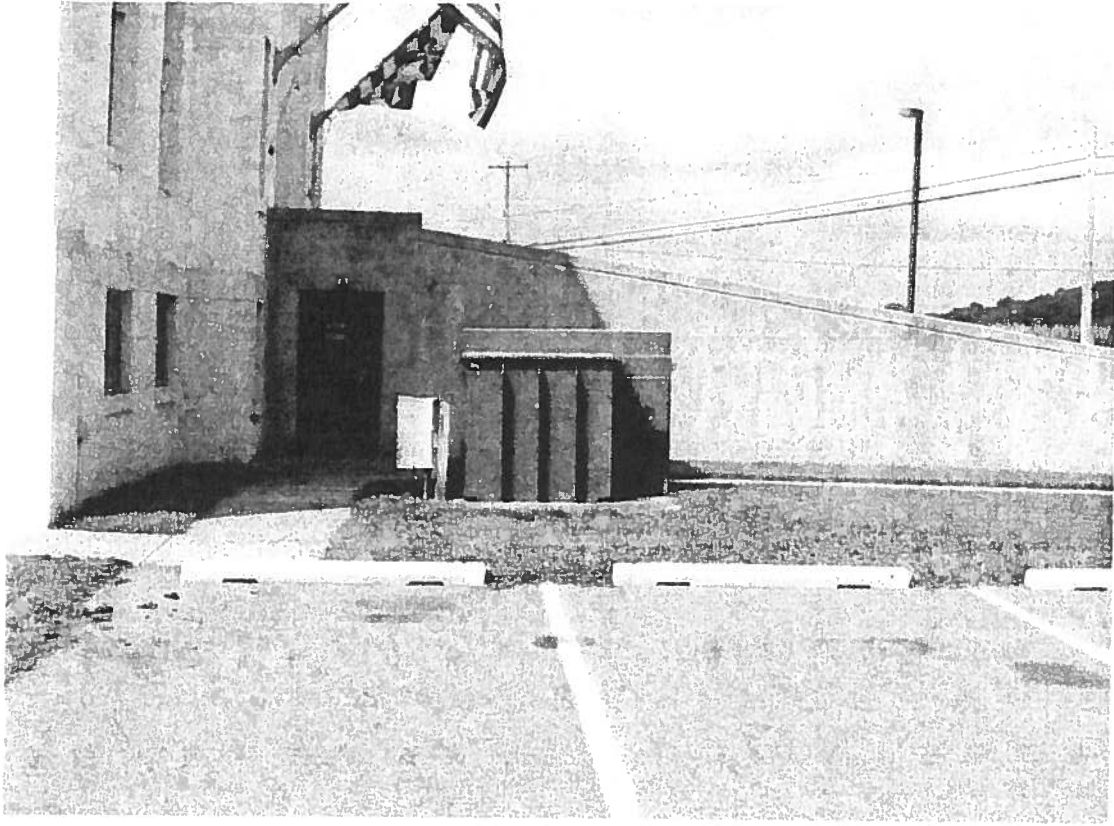
Armory power transformer located on front east side of the building.

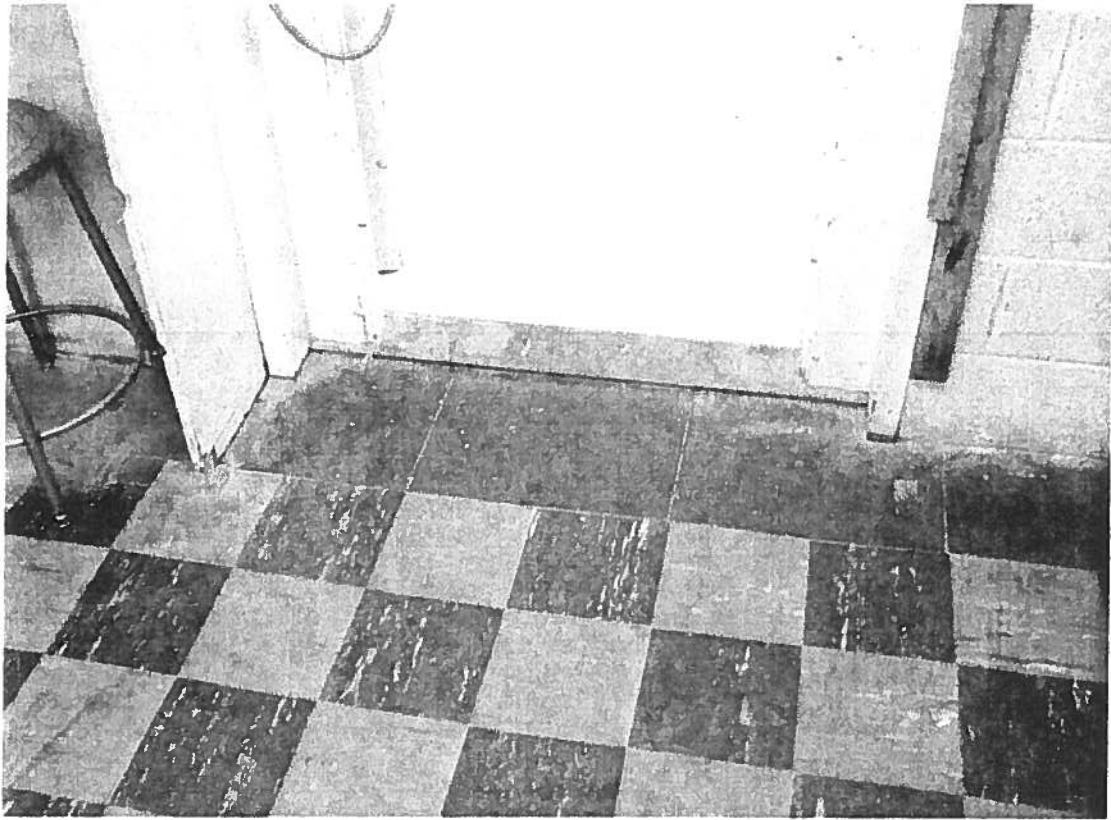
Asbestos tile not replaced as part of Isabel clean-up, note the new tiles in hallway

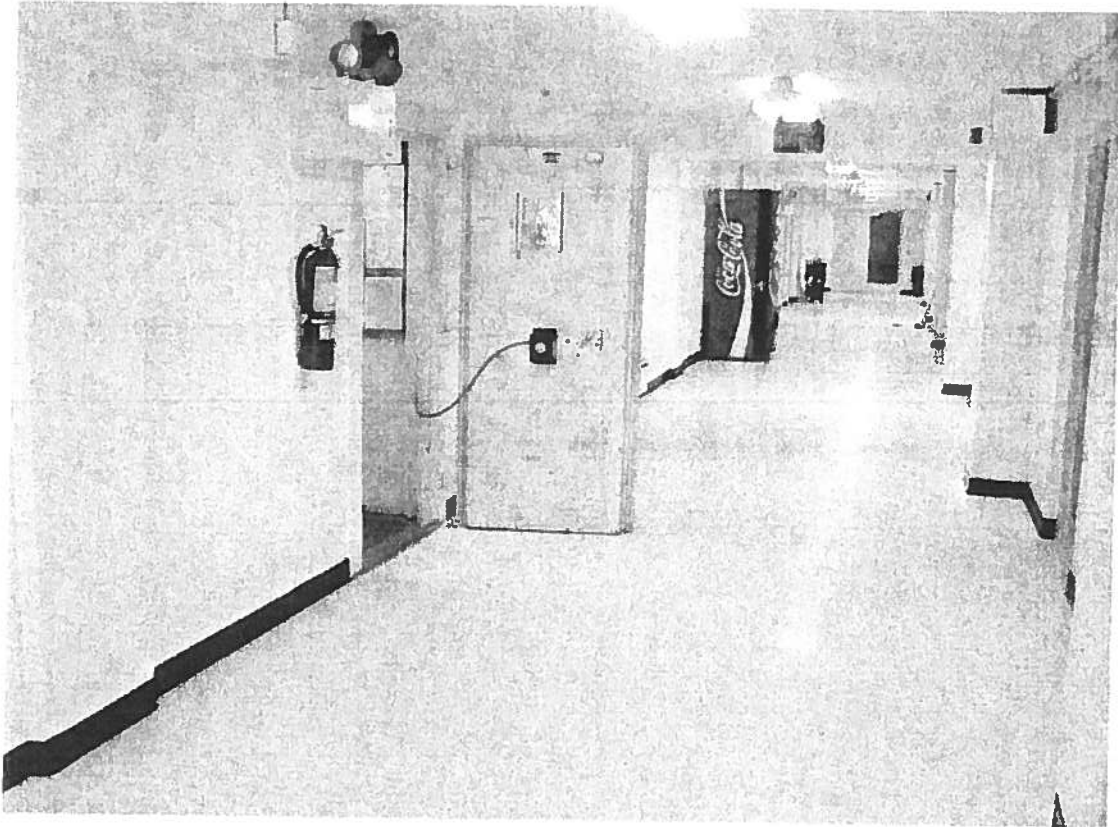
This is the main hallway and it has been retiled and repainted throughout, except as noted above.

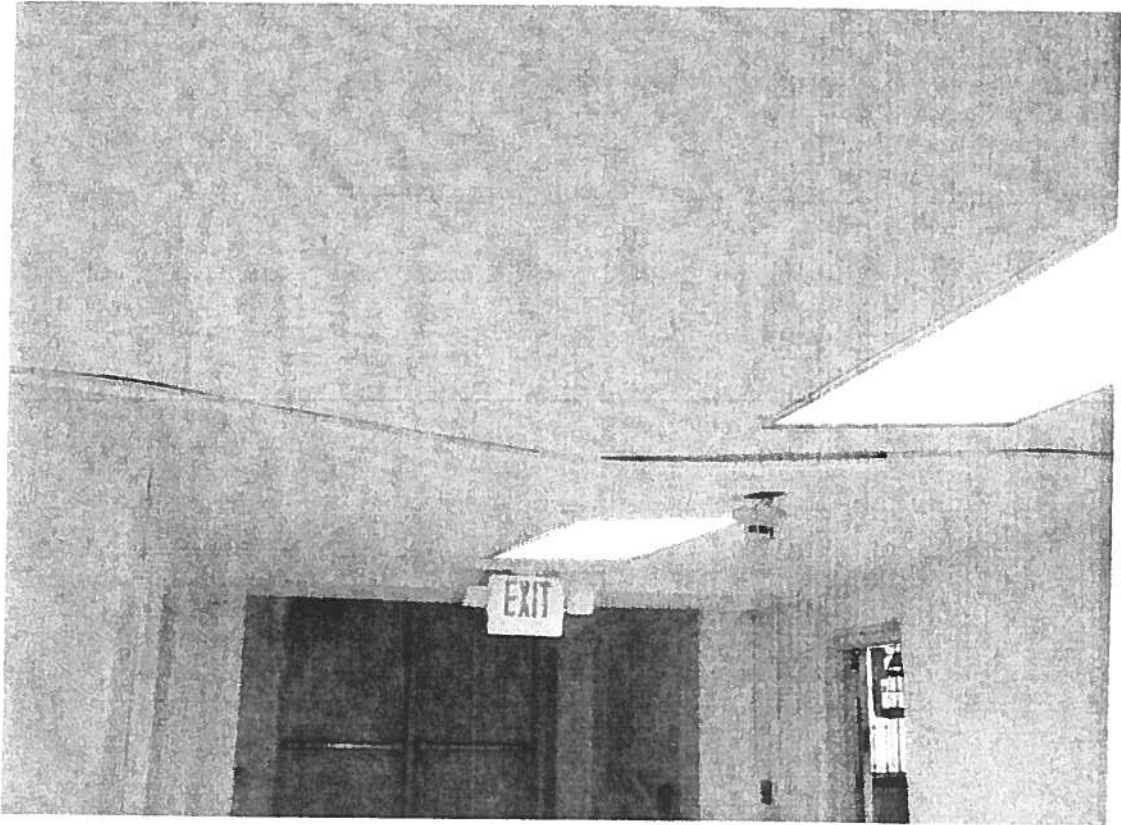
Sagging ceiling in 1<sup>st</sup> floor foyer, T! line running in the middle of the sag.
