Home Inspection Report

4 Main Street, Anytown, NC 28173

Thursday, April 11, 2019

0411191

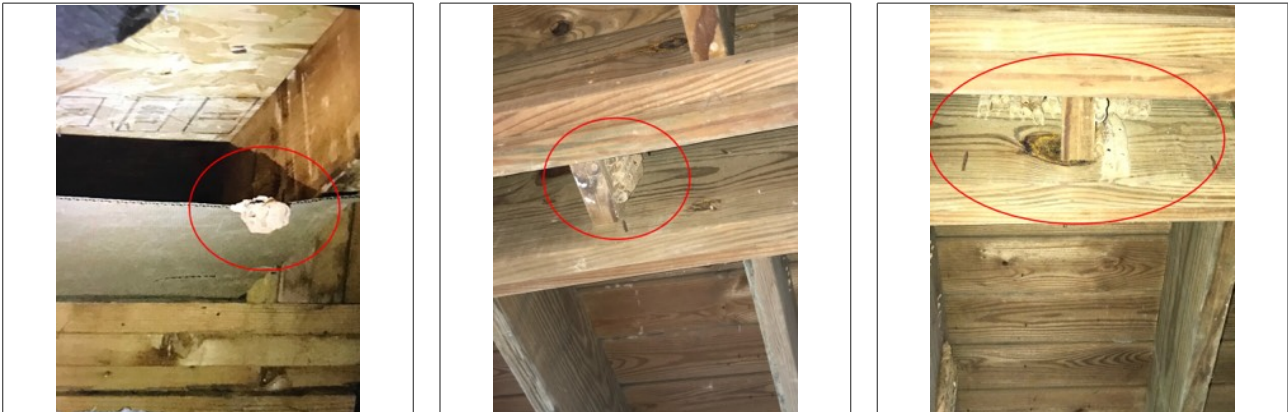
Observations	
Crawl spaces	<ul style="list-style-type: none">•The Debris and Stored items in the Crawlspace of this home should ideally be removed to prevent insect activity.
Wood boring insects	<ul style="list-style-type: none">•Evidence of wasp (mud daubers) activity was observed in the attic and on the exterior of this home. If the property has not already been treated, a licensed pest control specialist should be engaged to treat the property.

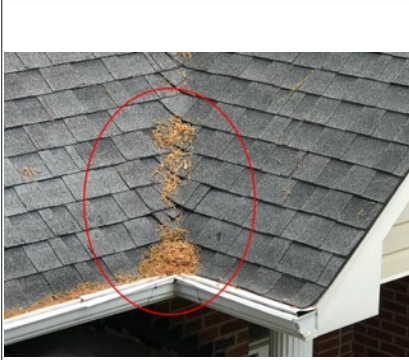
Sloped •Debris should be removed from the roofing to reduce risk of leaks and early roof wear.

Debris.

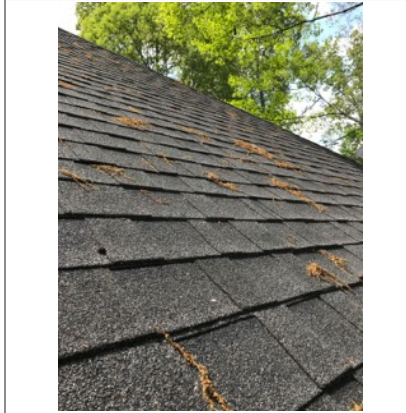
Debris.

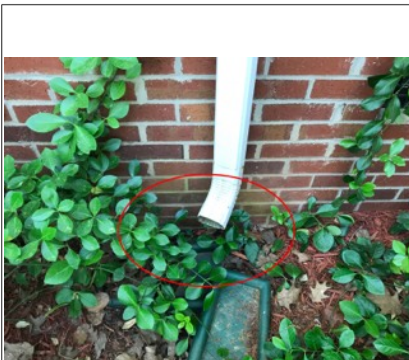
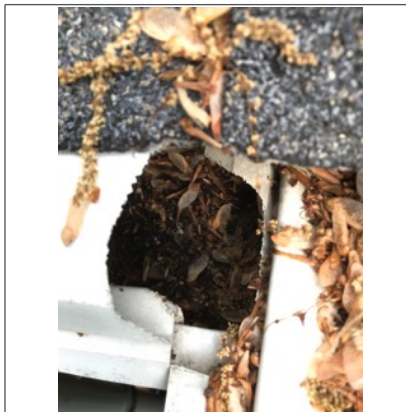
- The downspout(s) should discharge water at least five (5) feet from the house. Storm water should be encouraged to flow away from the building at the point of discharge.
- The gutters require cleaning to avoid spilling roof runoff around the building - a potential source of water entry or water damage. The gutter guards should ideally be removed from the gutters of this home as they may restrict the function of the roof water management during heavy rains.
- The downspouts that discharge below grade level should be monitored. If they are ever suspected to be clogged or disconnected below grade, they should be redirected to discharge at least five (5) feet from the building. Foundation leakage adjacent to a downspout is an indication of a problem below grade.

Gutter cleaning is recommended.

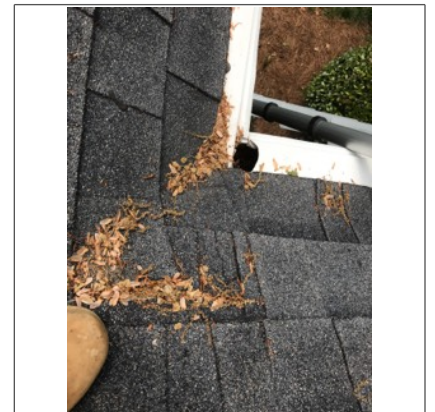
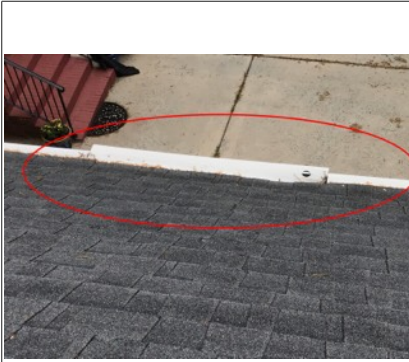
Gutter guards can sometimes discourage the flow of roof water management into the gutters and cause the water to spill on the ground below.

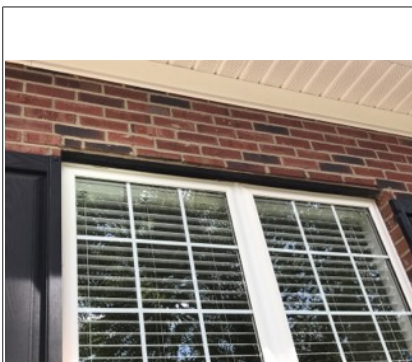
- Ext. walls**
 - Localized moisture staining of the front porch overhang were evident and there is extra risk of hidden damage in such areas caused by previous or present leaks that should be sealed. The areas were dry at the time of the inspection. Current owners should ideally be consulted regarding these stains.
 - The lentils should be painted to preserve the building.

The lentils of this home exhibit signs of corrosion and should be painted.

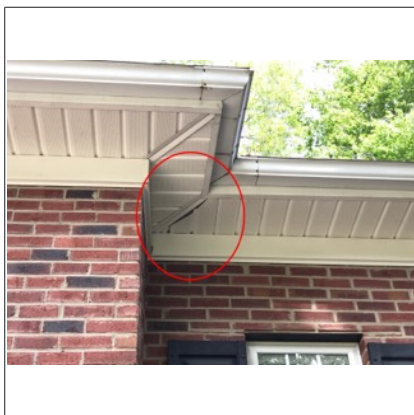
- Eaves**
 - Openings in the eaves should be sealed to prevent moisture, wind, insect and vermin damages.

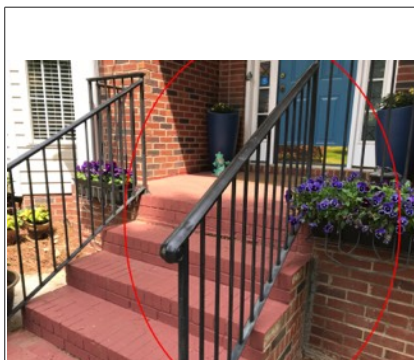
•The right side front porch railing is loose. It is recommended that this be repaired for improved safety.
 •The porch masonry is deteriorating noticeably. Repairs or rebuilding may eventually be needed here and may involve significant expense.

Loose right side porch railing.

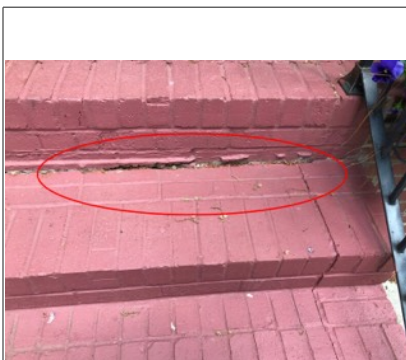
Spalling masonry.

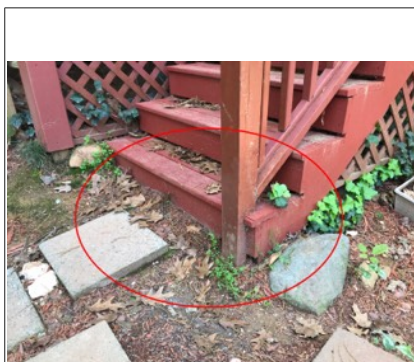
•Wood to soil contact should be avoided on the steps of the rear deck of this home.

Wood to soil contact should be avoided on the rear deck steps.

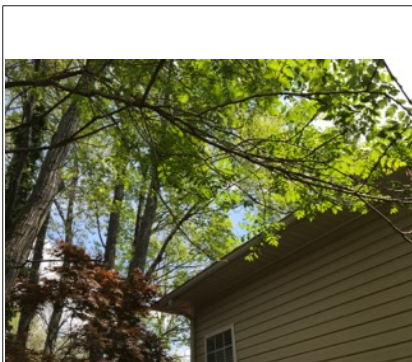
Landscaping •The proximity of the trees located on the left side of this home could disrupt drainage pipes, cause mechanical damage to the exterior of the house, or influence the foundation over time. You should consider removal of the trees.
•Vegetation and tree branches growing on or near exterior walls should be kept trimmed away from siding, window trims, and the eaves to reduce risk of insect and water damage.

Tree branches on the left side of this home are in contact with the home and roof.

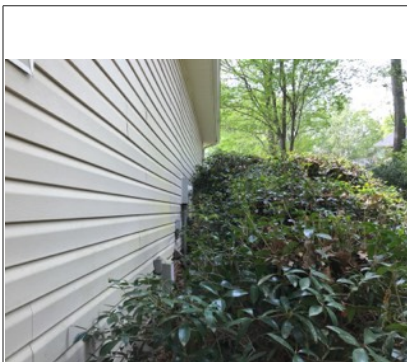
Vegetation on the left side of this home should ideally be trimmed back at least 8-10 inches.

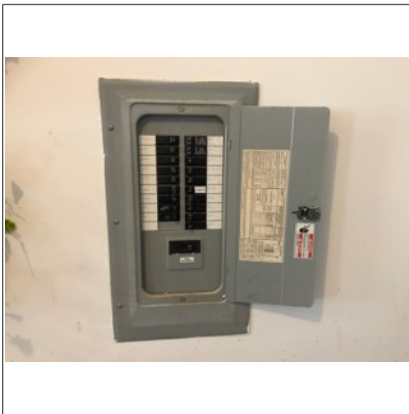
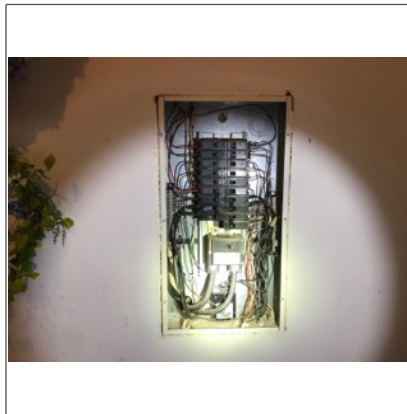
Distribution wires •Extension cords, such as the extension cord used to power the exterior outlet on the front of this home, plugged into the outlet in the center of the crawlspace of this home, should not be used as permanent wiring. This wiring should be removed.

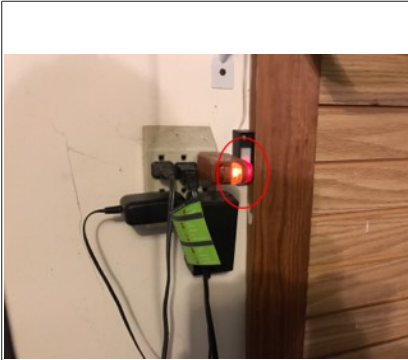
Outlet •Outlets in the garage, but not limited to, have reversed polarity (they are wired backwards). These outlets and their circuits should be investigated and repaired as necessary. GFCI outlets on reversed polarity wiring will not protect the circuit.
•Ungrounded 3-prong outlets (lack of an equipment ground) such as the outlet located under the front porch of this home should be repaired. In some cases a ground wire may be present in the electrical box and simply needs to be connected. If no ground is present "repair" can be as simple as filling the ground slot with epoxy. Better, since having a ground increases safety, a grounded circuit could be strung to this outlet, or a separate ground wire could be connected. Some electrical codes allow the installation of a ground fault circuit interrupter (GFCI) type outlet where grounding is not provided. In this case the GFCI may work but can't be tested by normal means.

Reversed polarity outlet located on the left wall of the garage.

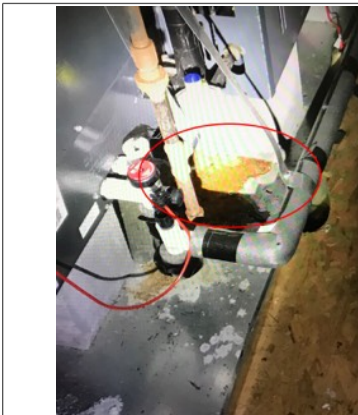
Furnace • The heating system requires service. This should be a regular maintenance item to assure safe, reliable heat.
 • The condensate drip pan showed signs of historic puddles of water under the furnace and or air handler or also known as inside AC coil accumulating under the furnace or AC coil. Excessive water inside and or outside a furnace or coil should be repaired immediately to avoid moisture issues. An qualified HVAC technician is recommended for further review. Also, leading from the furnace drip pan should be a drain line. This should also be installed during the next service of this HVAC system to prevent water damage to this home.

Signs of historic water pooling under the furnace or air handler. This condition should be maintained as mentioned above.

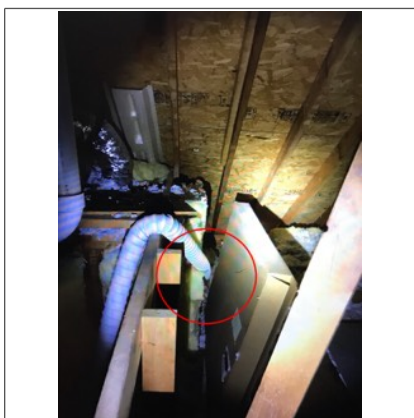
- Attic / roof**
- Exhaust vent pipes from the bathroom(s) should ideally be vented to the building exterior via roof (can) vents.
 - For improved energy savings, the attic access door should be insulated to help prevent loss of efficiency and the encouragement of moisture following the heat loss as discussed.

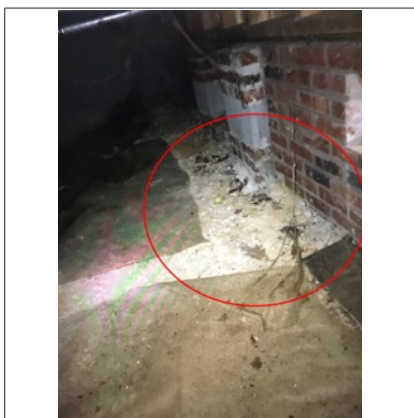
- Crawl space improvement**
- The moisture (vapor) barrier in the crawl space floor should be adjusted to cover all areas of exposed soil.

Exposed soil should ideally be covered up by moisture barriers adjustment is needed.

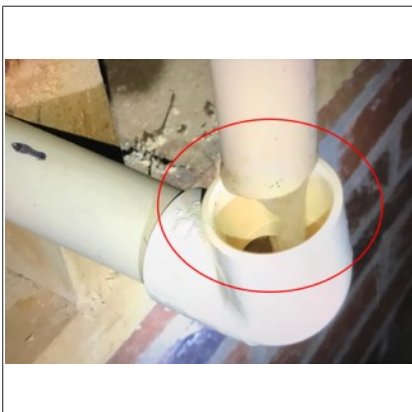
Water heater unit	<ul style="list-style-type: none"> •Water heaters have a typical life expectancy of 7 to 12 years. The existing unit is approaching the middle of this age range. One cannot predict with certainty when replacement will become necessary. •The Temperature and Pressure Relief (TPR) Valve serving the water heater is leaking slightly. Minor repairs or cleaning can usually rectify this condition.
--------------------------	--

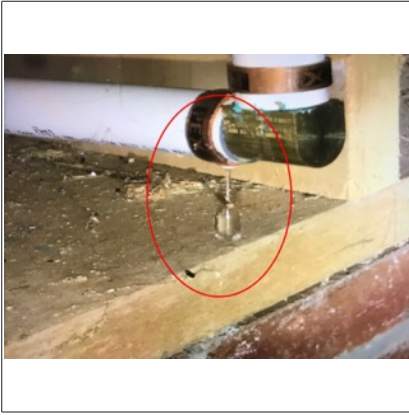
Supply •The supply piping is leaking under the tankless water heater of this home.

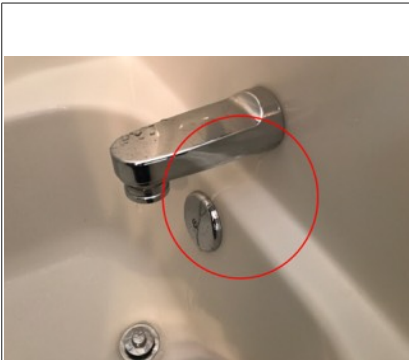
- The tub spout is leaky in the right wing main bath of this home.

Tub spout leak.

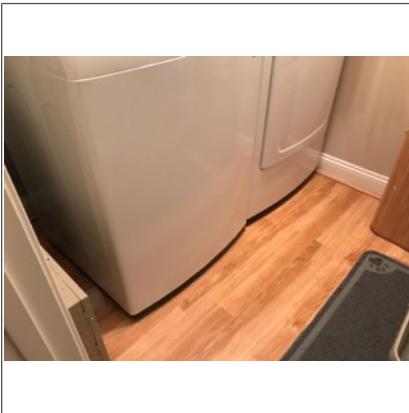
- The use of an overflow pan is recommended on the washing machine of this home to protect against overflow or hose failures.

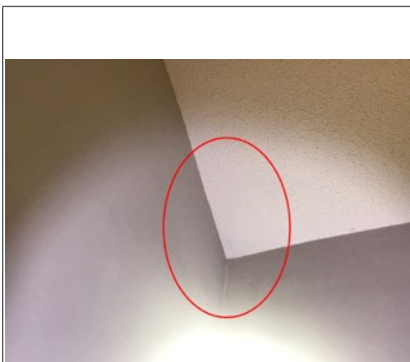
Typical or expected ceiling damage above the master bath shower.

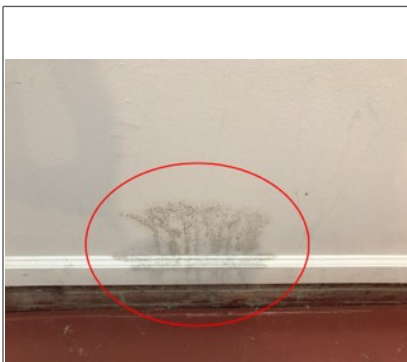
Surface mold staining on the front garage wall should ideally be cleaned.

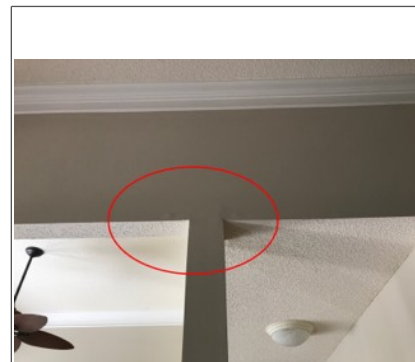
Nail pops and cracks on the walls in the foyer area of the this home.

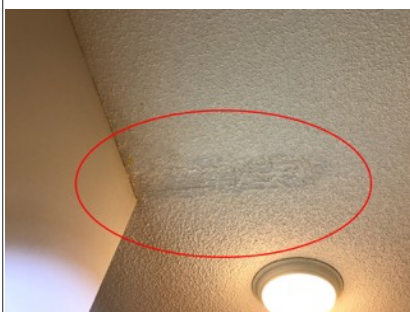
Wall / ceiling finishes •Typical or expected damage to the interior finish was observed above the master bath shower of this home.
 •Apparent water staining was noted on the ceiling between the master bedroom and the laundry room of this home. The areas were dry at the time of the inspection, but due to the lack of recent rain we are unable to determine if the stains are still active. Recommend consulting with the current owners for additional information prior to closing. If the leaks are still active, we recommend repair/replace as needed to remedy the leaks.

Moisture staining observed on the ceiling between the laundry room and the master bedroom of this home. This area was dry at the time of the inspection.

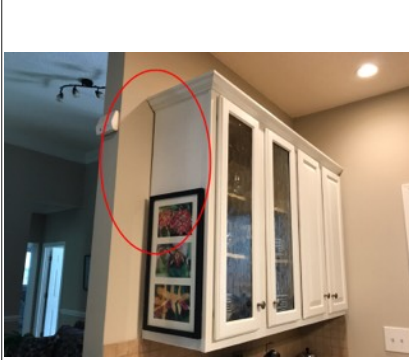
Kitchen cabinets •The installation of the kitchen cabinets is relatively low quality, improved hardware appropriate for kitchen cabinet installation should had been used. Improvement may ultimately be desirable as two of the cabinets exhibit slight signs of movement from the wall.

The kitchen cabinets should ideally be re mounted with appropriate hardware as they exhibit signs of movement from the walls.

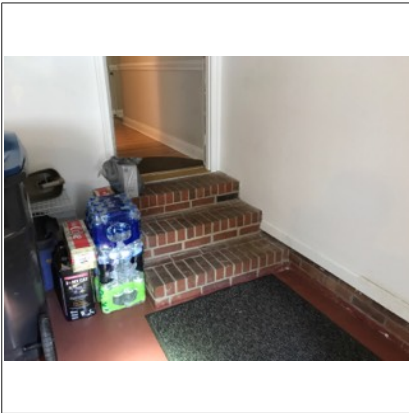
Stairways •For improved safety, it is recommended that a graspable hand rail be provided for the garage steps.

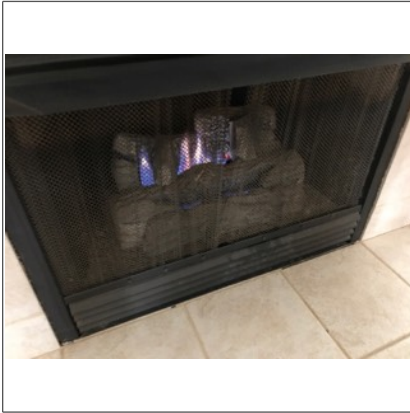
Fireplace •The fireplace chimney should be inspected and cleaned prior to operation.
