Concrete Cloth™

Knox County
Culvert Lining

CASE STUDY:

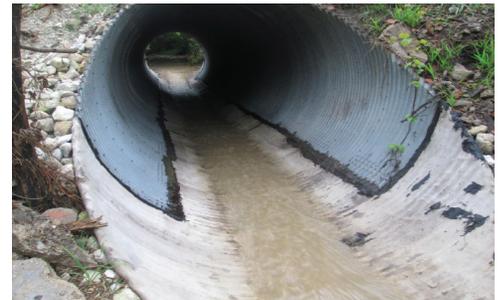
Rehabilitated CMP invert.

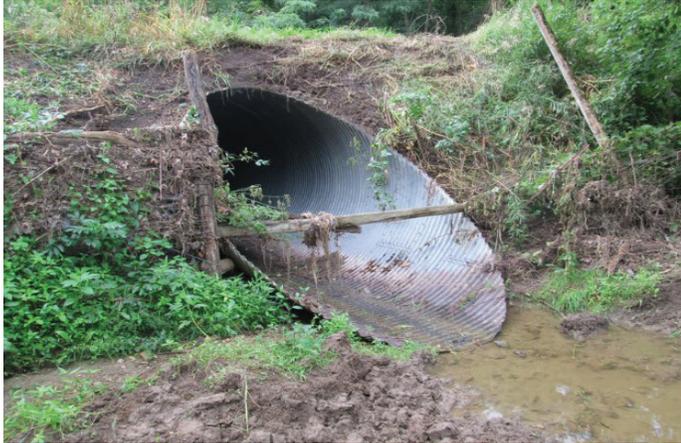
This existing 9-foot diameter corrugated metal pipe (CMP) was corroding or rusting through the invert or base of the pipe. At some points, water was just beginning to undermine the culvert, forcing the township to take some action or risk affecting the roadway embankment and potentially forcing an unscheduled replacement of the culvert. Stormwater runoff in this agricultural area magnifies the corrosion rate of the metal culvert, either as a result of the areas soils or fertilizers used, or both. In addition, there was beginning to be some significant erosion at the inlet and outlet of the culvert, which needed to be addressed.

State of culvert before repair.

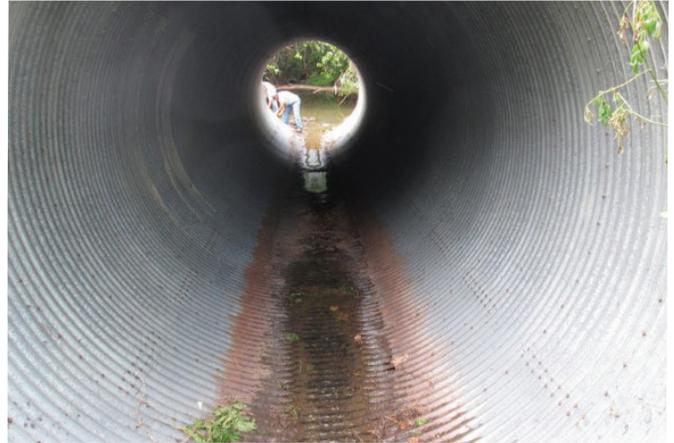
Signs of corrosion on invert.

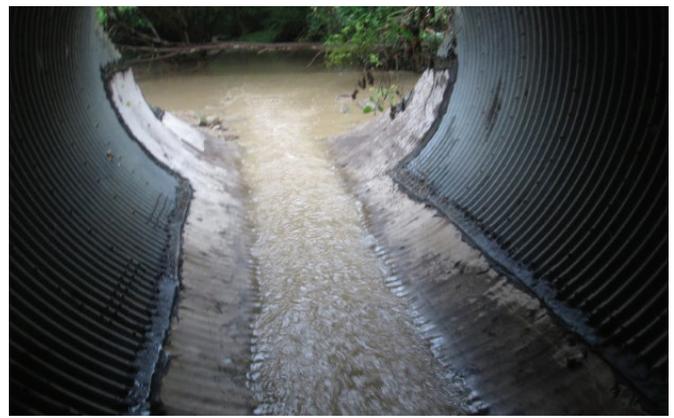
Internal view of completed installation with flow.
