Inspection report for the property at
6543 Sample Townhome Report, Bainbridge Island, WA
98110

This report is prepared exclusively for **Nick Savage**
On: **2021-09-22**

Orca Inspection Services, LLC
(206) 713-5715

Inspected by: Dylan Chalk
WA State Pest License #: 65540
WA State Inspector #: 365

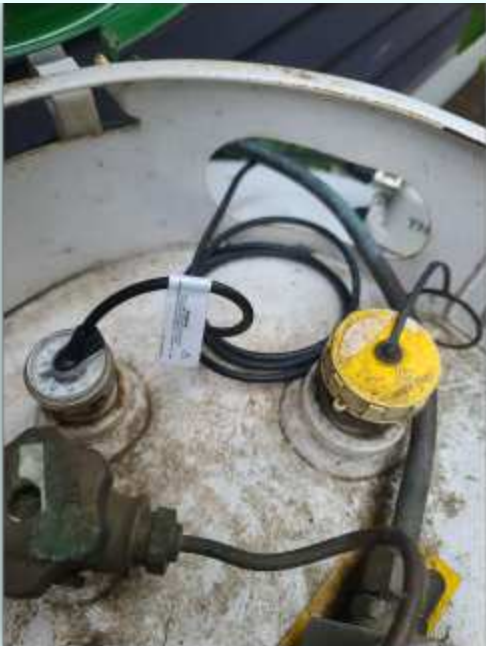
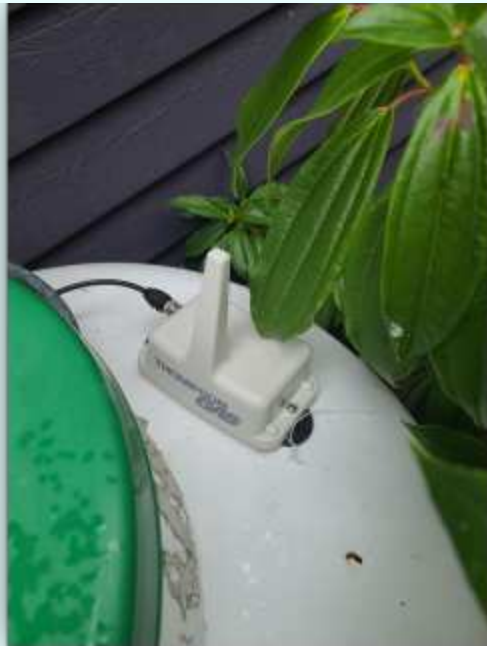
📷 (FSD-1) Recommended Disclosure Items: There seems to be a fill sensor on the propane tank that can alert the propane provider to the need for refilling. Disclose any additional information about this.

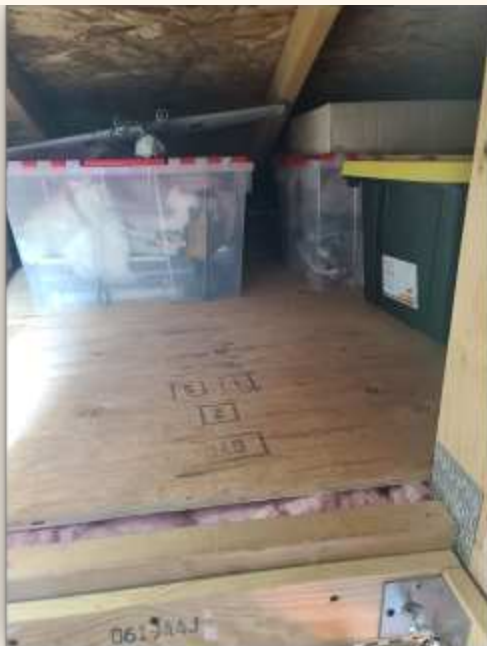
✂️ **(G2-1) Repair:** The pulldown ladder in the garage does not appear to be a fire rated model. This can be tricky to repair without replacing the pulldown ladder with a fire rated model - see [LINK](#) as an example. You can try sheet rocking the ladder cover, but this often compromises proper operation of the ladder, causing the ladder to sag and leaving a gap in the fire wall. You can also try making a fire rated sheetrock separation between the garage and the house in the attic above the garage, but this too can be complicated. Hire a qualified contractor to further evaluate and repair.

🛠️ **G2-1 Garage:** The pulldown ladder in the garage does not appear to be a fire rated model. This can be tricky to repair without replacing the pulldown ladder with a fire rated model - see [LINK](#) as an example. You can try sheet rocking the ladder cover, but this often compromises proper operation of the ladder, causing the ladder to sag and leaving a gap in the fire wall. You can also try making a fire rated sheetrock separation between the garage and the house in the attic above the garage, but this too can be complicated. Hire a qualified contractor to further evaluate and repair.

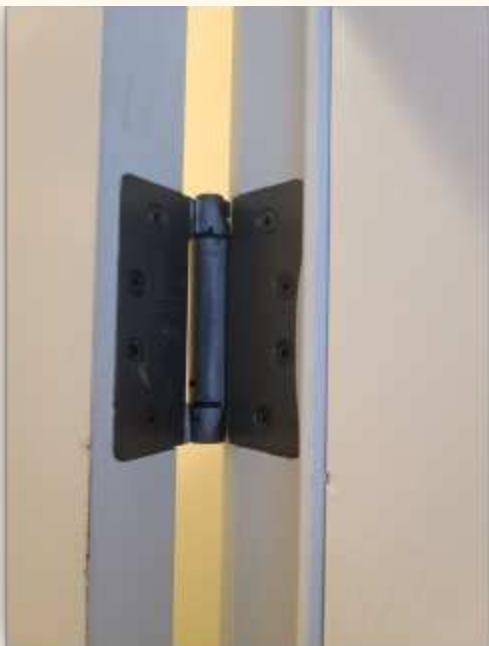
**(G2-2) Repair:** The auto-close hinges on the garage occupant-door have been disabled. This safety device is recommended to ensure the door is closed to keep pollutants and even fire from spreading into the house. Repair as needed.

🛠️ **G2-2 Garage:** The auto-close hinges on the garage occupant-door have been disabled. This safety device is recommended to ensure the door is closed to keep pollutants and even fire from spreading into the house. Repair as needed.

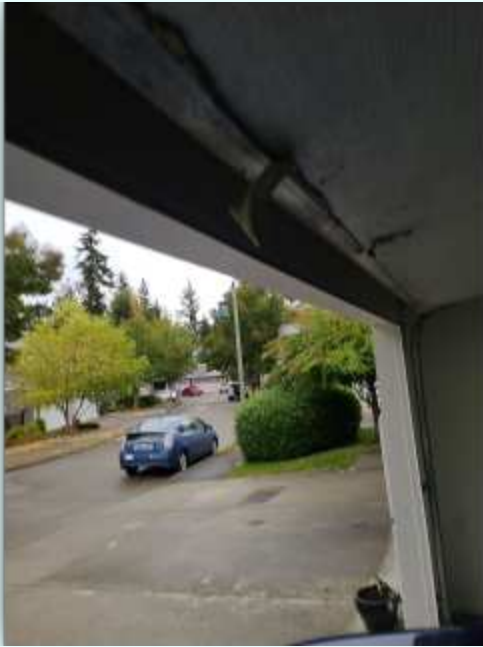
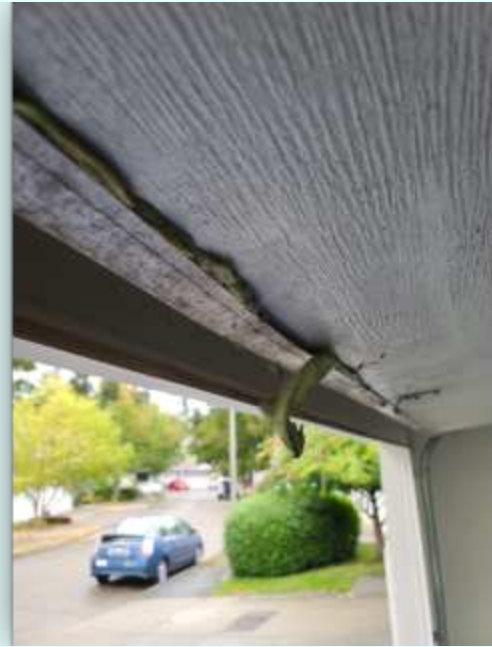
📷 (G2-3) Recommended Disclosure Items: For some reason, a few rags were stuffed into the base of the overhead door. It is not clear that a repair is needed. Disclose any additional information about this.

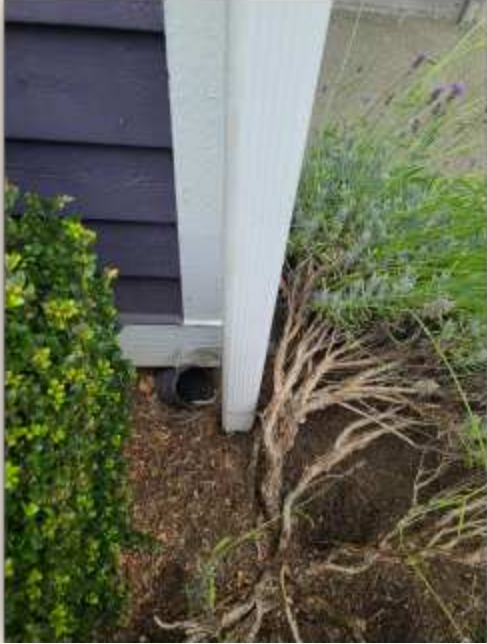
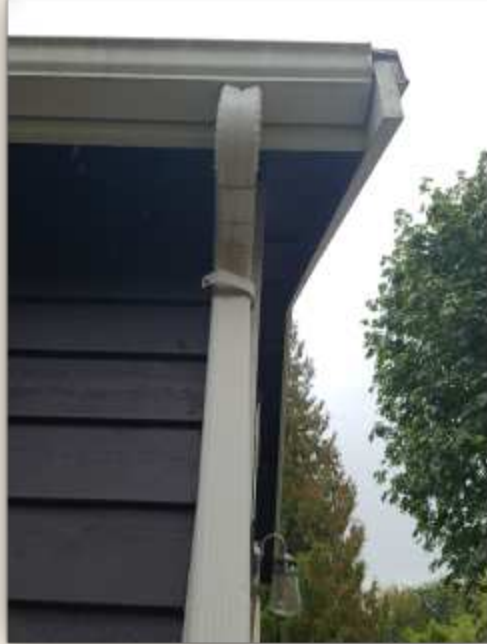
🔧 **(RCG-2) Repair:** The downspout at the southwest corner is not properly secured to the house and is not connected to the storm drain. Repair as needed.

The downspout at the southwest corner is not properly secured to the house and is not connected to the storm drain. Repair as needed.

🛠️ **RCG-2 Roof, Chimney and Gutters:** The downspout at the southwest corner is not properly secured to the house and is not connected to the storm drain. Repair as needed.

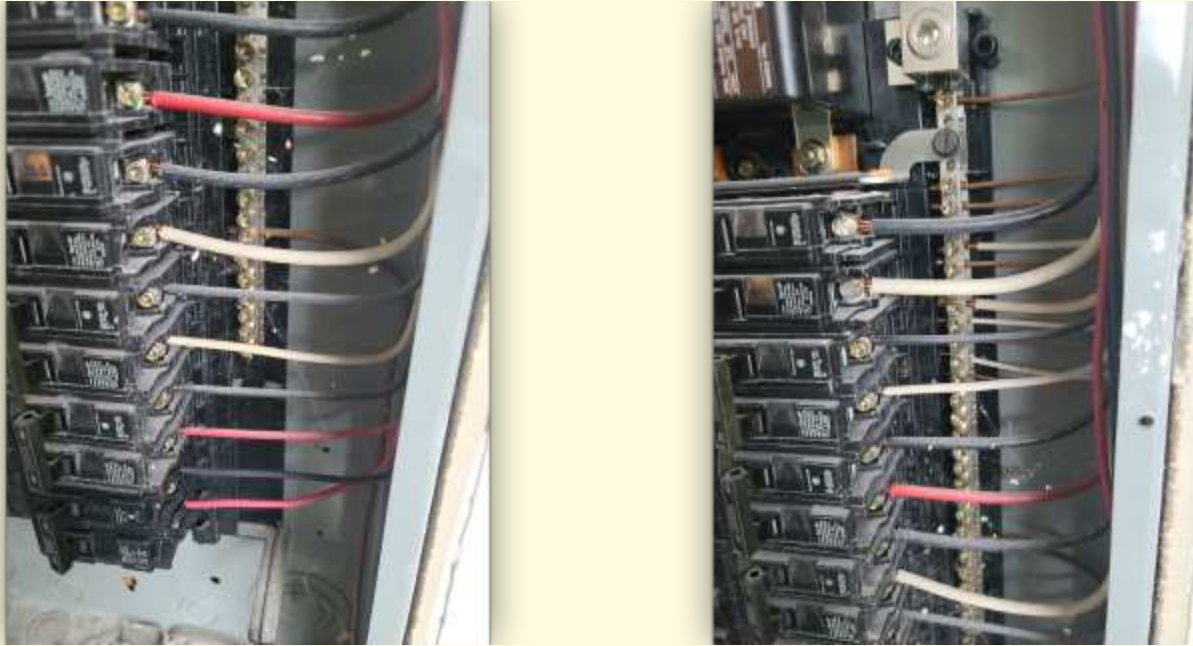
**(ES1-2) Improve or Upgrade:** The white conductors inside the electric panel at the breakers are not correctly identified as hot or ungrounded conductors - these should be painted in black or red ink for correct identification and improved safety. I would do this in the context of other electrical repairs.

**ES1-2 Electric Service:** The white conductors inside the electric panel at the breakers are not correctly identified as hot or ungrounded conductors - these should be painted in black or red ink for correct identification and improved safety. I would do this in the context of other electrical repairs.

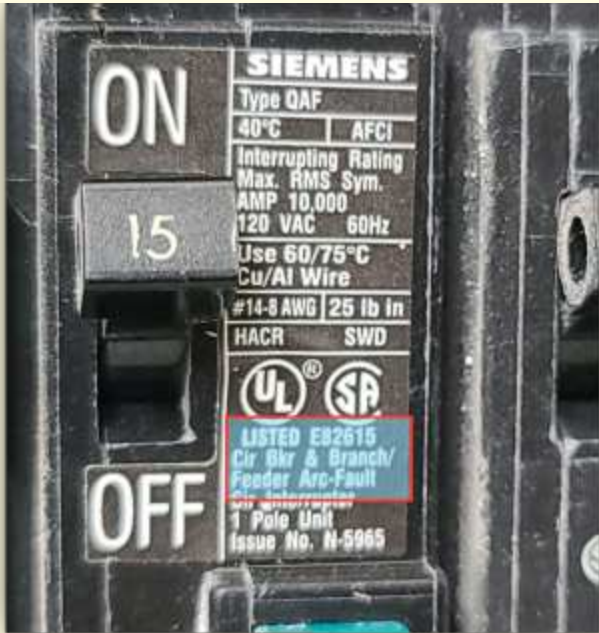
**(ES1-5) Improve or Upgrade:** The AFCI breakers inside the electric panel are an older Branch Feeder type breaker. These are a first generation technology and many of them had troubles with nuisance tripping and they are not capable of detecting series arcing conditions. Modern AFCIs are called Combination AFCIs and they can detect both series and parallel arcing conditions. Updating these old branch feeder AFCIs with modern combination type AFCI protection is recommended.

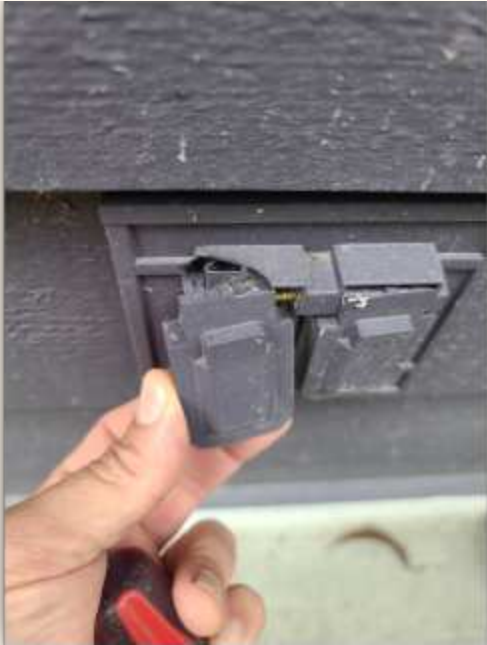
🔧 (EDFW-1) **Repair:** Repair the broken exterior electric receptacle cover - backyard. The modern "[in-use covers](#)" are recommended to protect this receptacle.

🛠️ **EDFW-1 Electric Distribution and Finish Wiring:** Repair the broken exterior electric receptacle cover - backyard. The modern "[in-use covers](#)" are recommended to protect this receptacle.

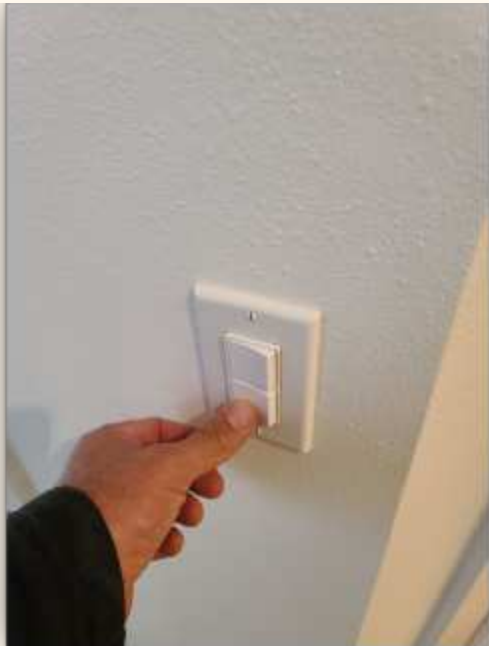
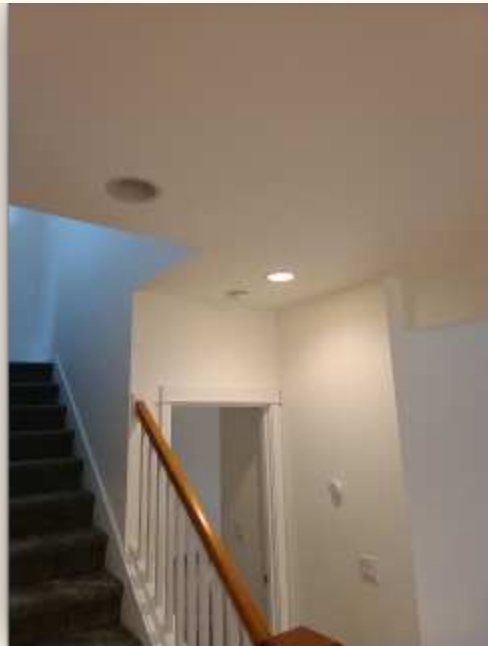
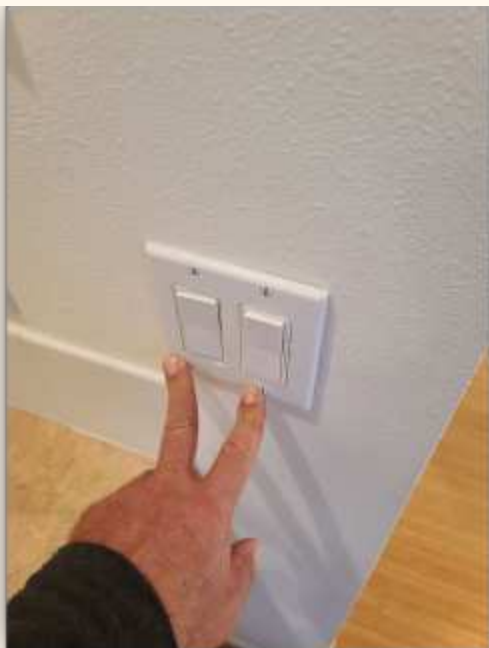
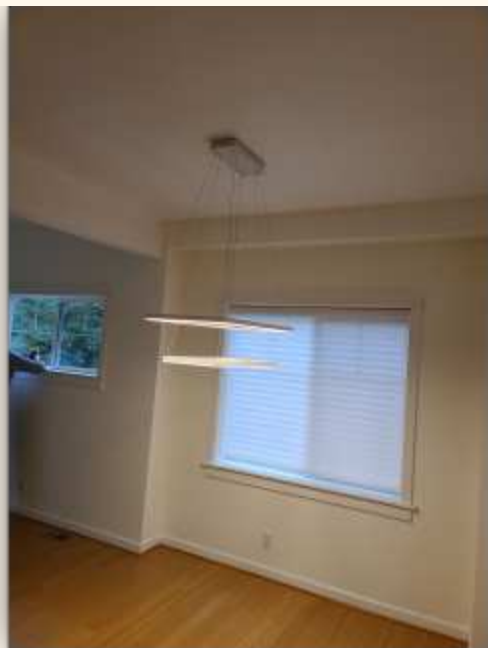
🔧 (EDFW-2) **Repair:** I recommend additional inspection of some of the light switches in the entry / stairway area. It is confusing operating the lights and one of the switches by the door seems to shut off the fireplace fan, which is odd. Also, it takes a unique sequence of switches to get the stairwell light to come on. Adjust / repair as needed/desired.

🛠️ **EDFW-2 Electric Distribution and Finish Wiring:** I recommend additional inspection of some of the light switches in the entry / stairway area. It is confusing operating the lights and one of the switches by the door seems to shut off the fireplace fan, which is odd. Also, it takes a unique sequence of switches to get the stairwell light to come on. Adjust / repair as needed/ desired.

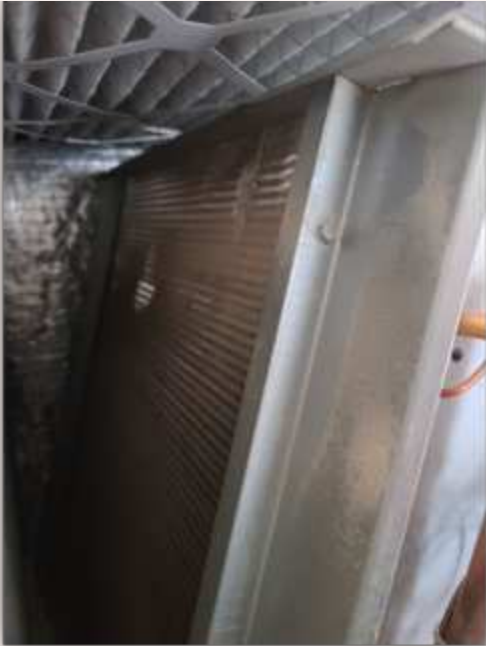
⚠ (HCFV-1) Recommended Maintenance: Annual servicing of the electric forced air furnace is recommended for safe and reliable heat. I could not find recent service records on the furnace, so a servicing is recommended. The furnace was tested during inspection and was operational. Examples of observations noted during inspection include:

The furnace is dirty inside at the air handler evaporator coil - note this coil is not in use currently as a heat pump was never installed.

**HCFV-1 Heating, Cooling, Fireplaces and Ventilation:** Annual servicing of the electric forced air furnace is recommended for safe and reliable heat. I could not find recent service records on the furnace, so a servicing is recommended. The furnace was tested during inspection and was operational. Examples of observations noted during inspection include:

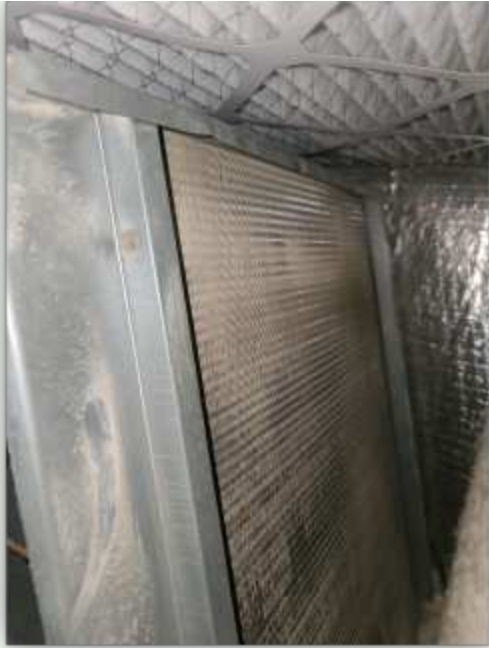
**(HCFV-3) Efficiency:** This building appears to be ready for a heat pump system - I noted wiring and refrigerant lines run. If you wish to upgrade the heating system in this building, I recommend an Energy Star heat pump as this will better pay for itself in saved heating costs.

This shows an evaporator coil that was likely never used

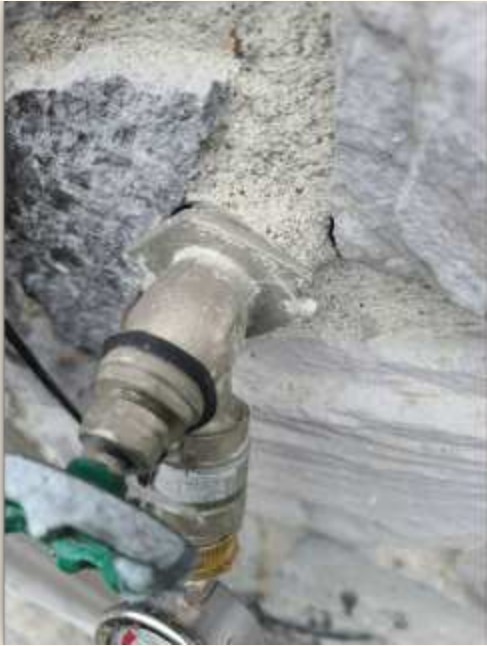
✂️ (P2-4) Repair: The hose bib at the front side of the house is poorly mounted to the siding. This could cause leaks in the siding around the hose bib and could allow the hose bib to become loose during operation. Hose bibs should be securely mounted to blocks that are lead into the siding and which are properly flashed or caulked.

siding. This could cause leaks in the siding around the hose bib and could allow the hose bib to become loose during operation. Hose bibs should be securely mounted to blocks that are lead into the siding and which are properly flashed or caulked.

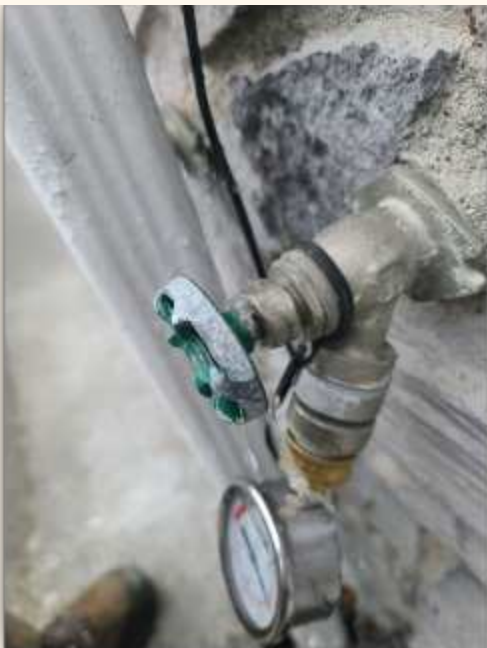
✂️ **(P2-5) Repair:** The leaky hose bib at the north side of the house requires repair or replacement - it leaked from the faucet handle when the faucet was turned on and under pressure. This often requires tightening the packing around the handle stem.

**P2-5 Plumbing:** The leaky hose bib at the north side of the house requires repair or replacement - it leaked from the faucet handle when the faucet was turned on and under pressure. This often requires tightening the packing around the handle stem.

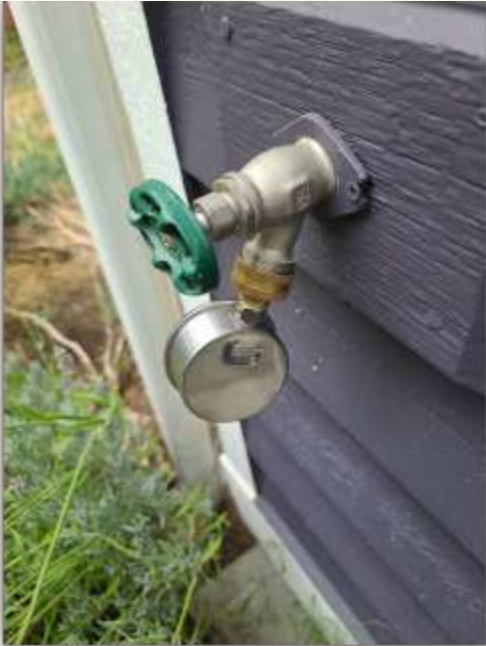
✂️ **(P2-6) Repair:** The hose bib at the south side appears to require an anti-siphon attachment - the threads available at the end of the hose bib are thin and most hoses will not attach to this. Repair as needed. Please note that anti-siphon protection is recommended to prevent stagnant water in a hose from accidentally being pulled into the house water supply.

**P2-6 Plumbing:** The hose bib at the south side appears to require an anti-siphon attachment - the threads available at the end of the hose bib are thin and most hoses will not attach to this. Repair as needed. Please note that anti-siphon protection is recommended to prevent stagnant water in a hose from accidentally being pulled into the house water supply.

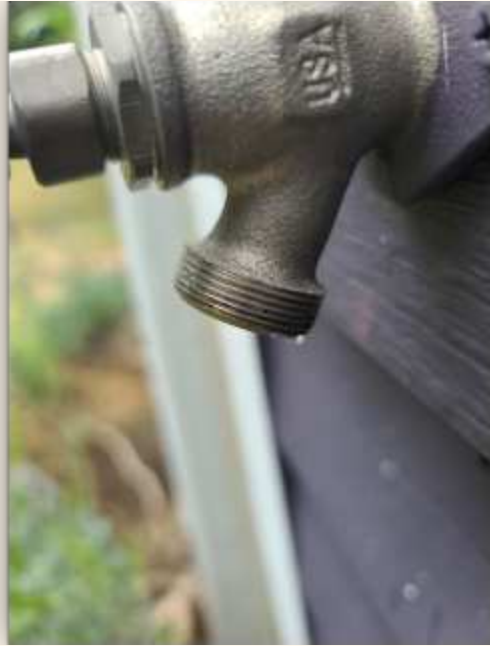
The anti-siphon device is missing for the backyard hose bib.

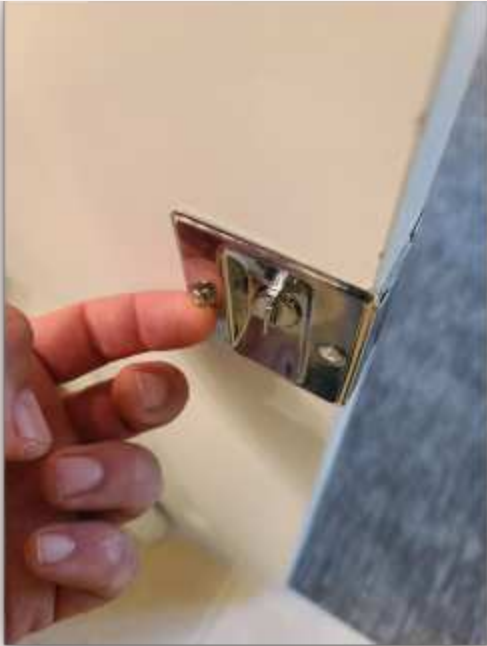
**(I-1) Recommended Maintenance:** A loose screw was noted on the pocket door to the main bathroom. Repair as needed for smooth operational pocket door

A loose screw was noted on the pocket door to the main bathroom. Repair as needed for smooth operational pocket door

**L-1 Interior:** A loose screw was noted on the pocket door to the main bathroom. Repair as needed for smooth operational pocket door

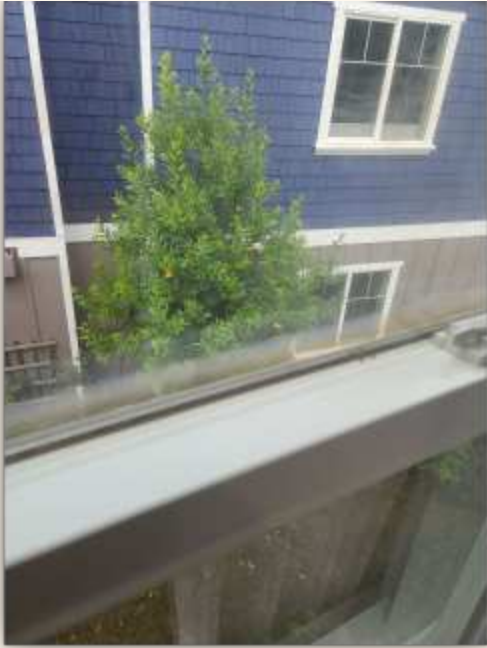
🔧 **(I-2) Repair:** The energy coating for the window seems to have failed - see the cloudy stain between the panes of glass - west, 2nd floor bedroom. This typically requires glazing replacement to repair. Hire a qualified glass replacement specialist to further evaluate and repair as needed.

A failed energy cutting noted at the second floor window on the west side.

**I-2 Interior:** The energy coating for the window seems to have failed - see the cloudy stain between the panes of glass - west, 2nd floor bedroom. This typically requires glazing replacement to repair. Hire a qualified glass replacement specialist to further evaluate and repair as needed.

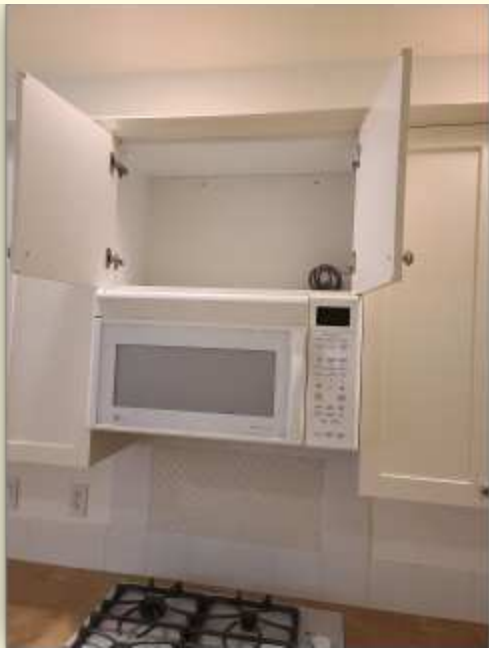
(K-2) Improve or Upgrade: A ductless exhaust fan was noted for the cook-top. Installation of a fan that ducts to the exterior is recommended to remove moist air and odors to the exterior. Please note that if you switch to a gas range or cooktop in the future, a fan that vents to the exterior is still not required, as long as there is some ventilation in the kitchen, but is more strongly recommended. Gas ovens produce carbon monoxide while running and should really have an exhaust vent to the exterior.

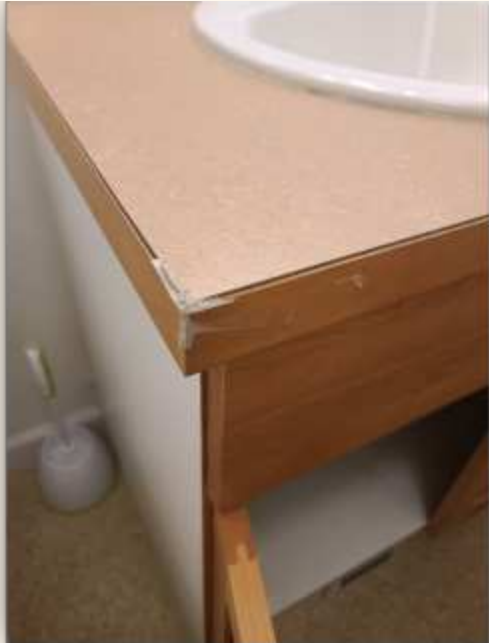
**(PB3-2) Repair:** The bullnose material is loose in the powder bathroom cabinet. Repair or update as needed.

**PB3-2 Powder Bathroom:** The bullnose material is loose in the powder bathroom cabinet. Repair or update as needed.

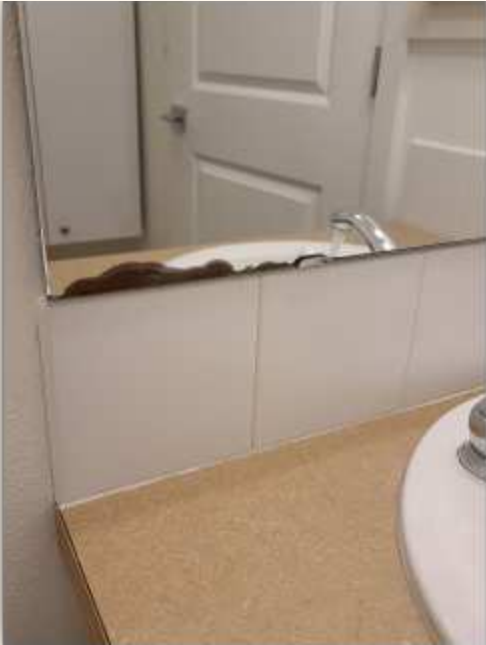
🔧 **(PB3-3) Repair:** The mirror in the powder bathroom is missing its reflective surface in places. Update the mirror as desired.

**PB3-3 Powder Bathroom:** The mirror in the powder bathroom is missing its reflective surface in places. Update the mirror as desired.

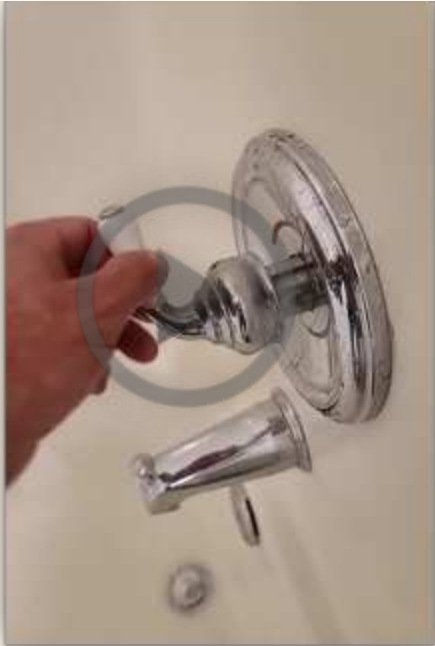
**(GB-2) Repair:** The handle for the mixing valve to the upstairs bathroom shower is loose. Secure the loose handle as needed to ensure reliable performance.

**GB-2 Upstairs Bathroom:** The handle for the mixing valve to the upstairs bathroom shower is loose. Secure the loose handle as needed to ensure reliable performance.

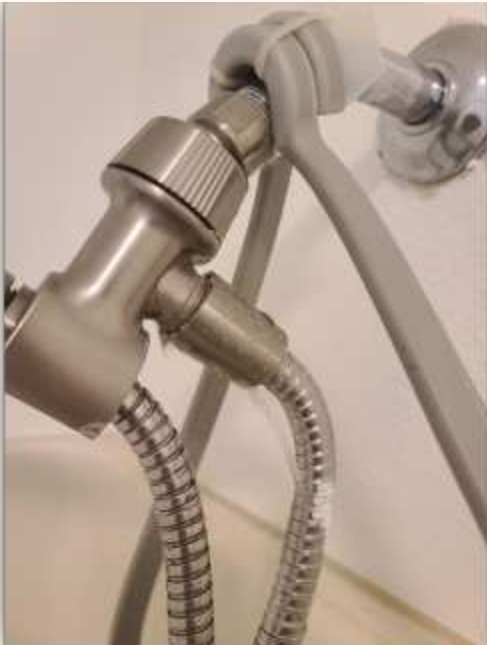
🔧 **(GB-3) Repair:** The shower head in the downstairs bath is leaking and requires repair. Leaky shower heads are common and not a significant concern. Adjust as needed to prevent leakage at the shower head.

**GB-3 Upstairs Bathroom:** The shower head in the downstairs bath is leaking and requires repair. Leaky shower heads are common and not a significant concern. Adjust as needed to prevent leakage at the shower head.

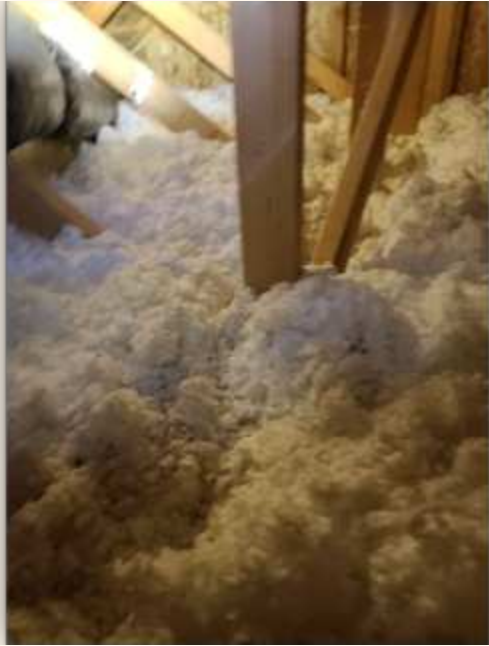
🔧 **(A-4) Repair:** The attic insulation is rodent-damaged - not bad, just a few trails in places. Remove all contaminated insulation and complete repairs to fans, wiring, ventilation.... Once repairs are complete re-insulate to modern standard or to best possible levels. Be sure to seal up all air leakage points during repairs and prior to insulating to modern standard be sure all rodent issues have been resolved and all projects like wiring and bath fans have been completed.

**A-4 Attic:** The attic insulation is rodent-damaged - not bad, just a few trails in places. Remove all contaminated insulation and complete repairs to fans, wiring, ventilation.... Once repairs are complete re-insulate to modern standard or to best possible levels. Be sure to seal up all air leakage points during repairs and prior to insulating to modern standard be sure all rodent issues have been resolved and all projects like wiring and bath fans have been completed.

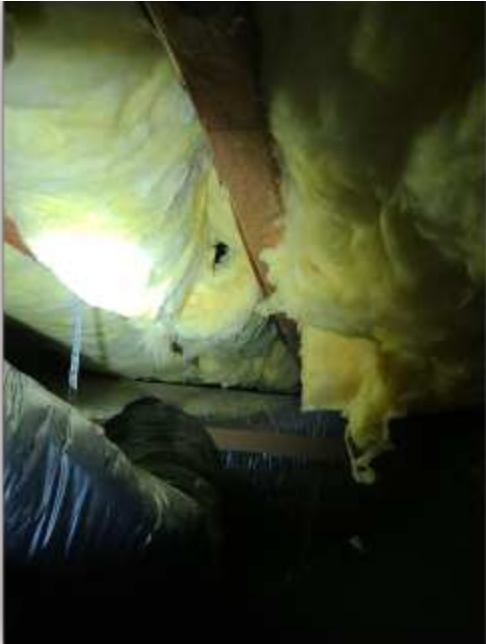
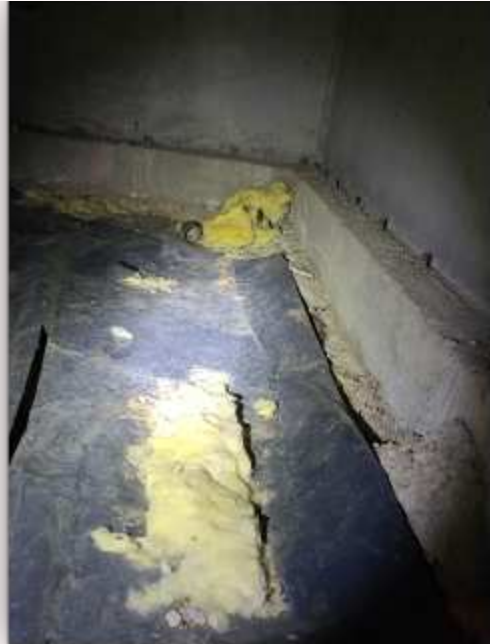
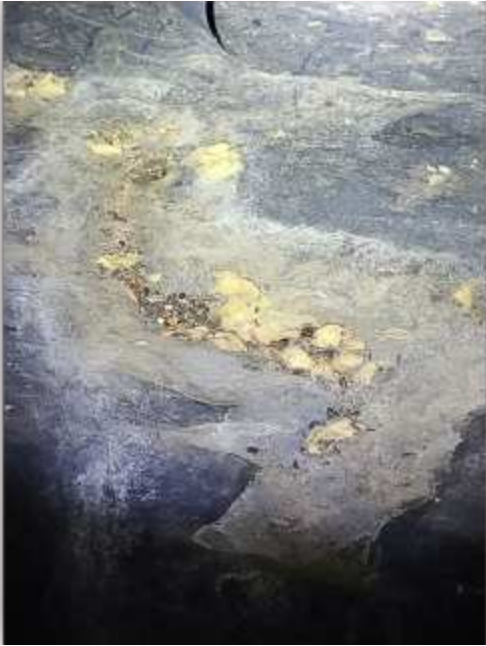
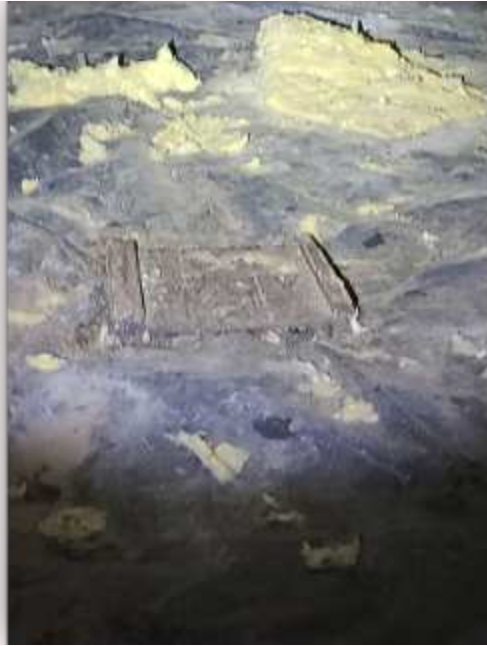
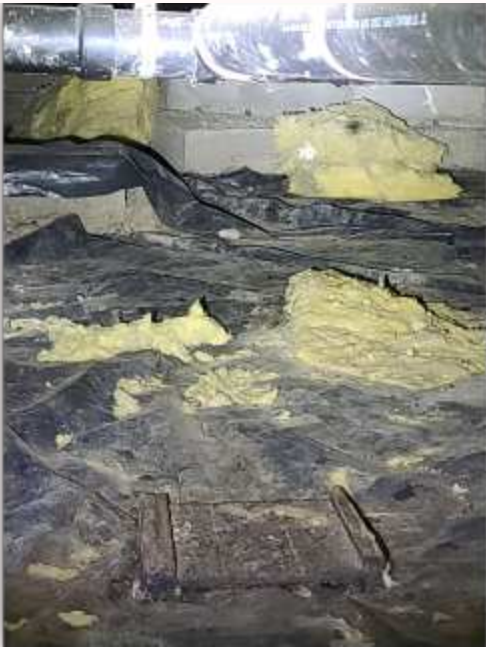
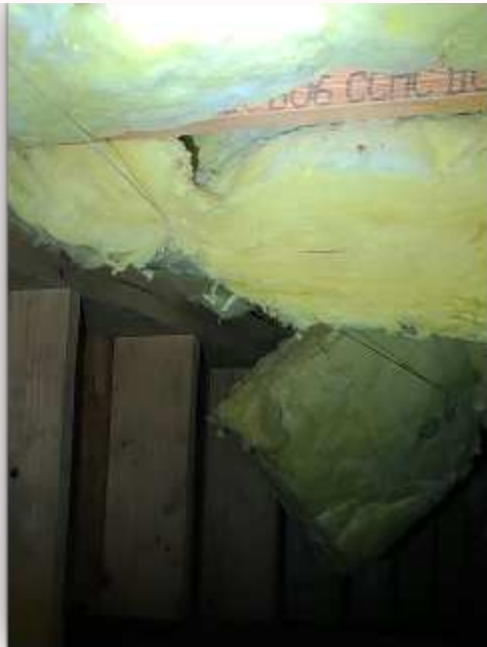
⚠️ 🛠️ **CS3-1 Crawl Space:** Overall, numerous repairs are needed to the crawl space below this house. I have made a series of detailed observations in the base of this report and below in this observations but given the extent of repairs I recommend further evaluation of this crawl space by a licensed general contractor who specializes in crawl space clean-up as additional repairs could be needed that are latent or concealed. Examples of observations noted during inspection include:

- Pipe insulation is incomplete on supply piping
- The plastic vapor barrier is rodent damaged and incomplete in places
- The sub-floor insulation is rodent-damaged and requires repair and replacement
- Wood debris should be cleaned from the floor.

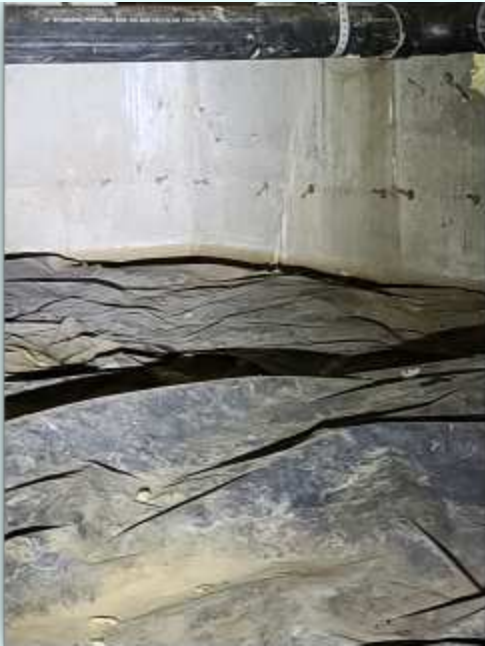
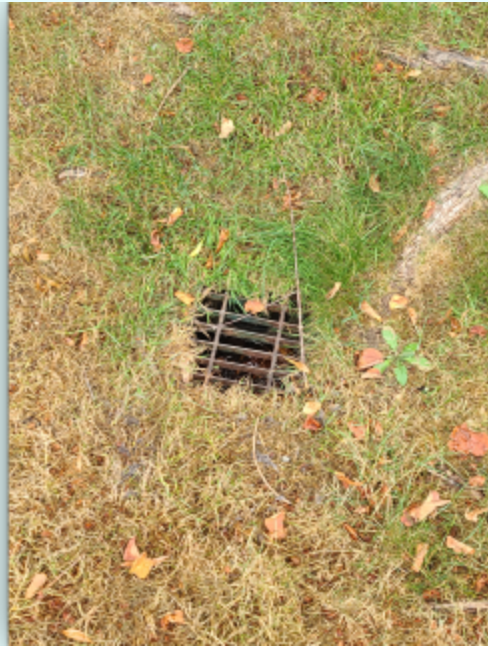
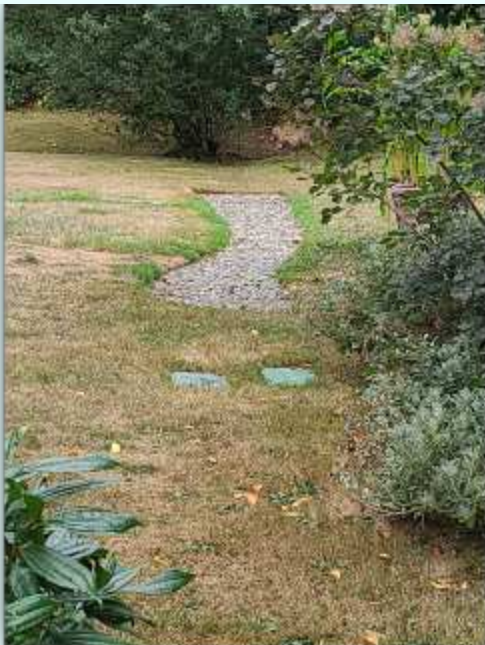
**(CS3-2) Recommended Disclosure Items:** The crawl space was dry at the time of inspection but I noted indications of prior water in the crawl space. This is difficult to understand during a one-time inspection. It could have been repaired or it could have been from construction or it could be a seasonal on-going issue. In this case, I did see signs of drainage work at the exterior. This may have been done by the HOA? Disclose any additional information.

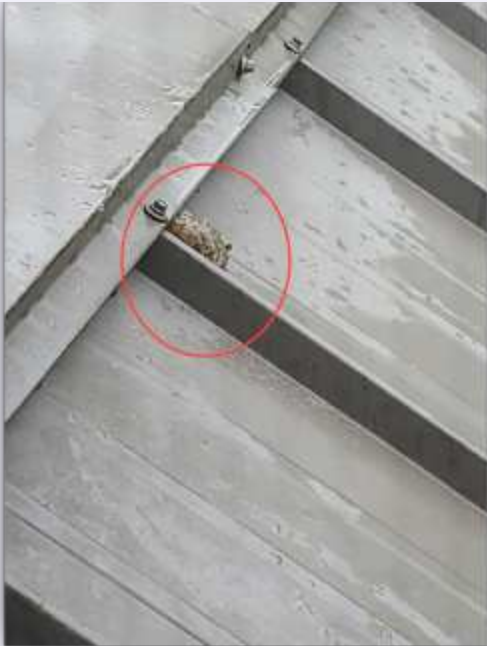
This was at the south side ridge

☒ (RPWDO-1) **Home Owners Association:** A bee or wasp nest was noted in the in the metal ridge venting. No activity was noted so it could be old or it could be seasonally inactive? Treatment and removal may be needed. This may be an HOA item.
