Manning Home Inspections

Home Inspection Report

Prepared For:

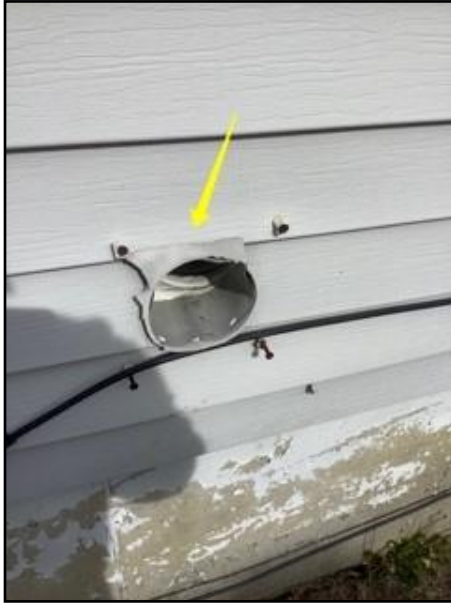
Figure 1-1

Missing dryer cover. Recommend repair to prevent pest entry into home

- 1) Missing dryer cover. Recommend repair to prevent pest entry into home
- 2) Recommend repairing vinyl soffit to prevent pest entry into home.

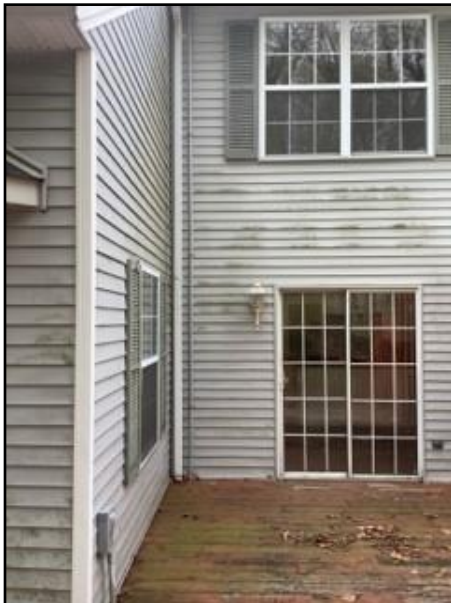
Figure 2-1

Recommend power washing siding. Cosmetic.

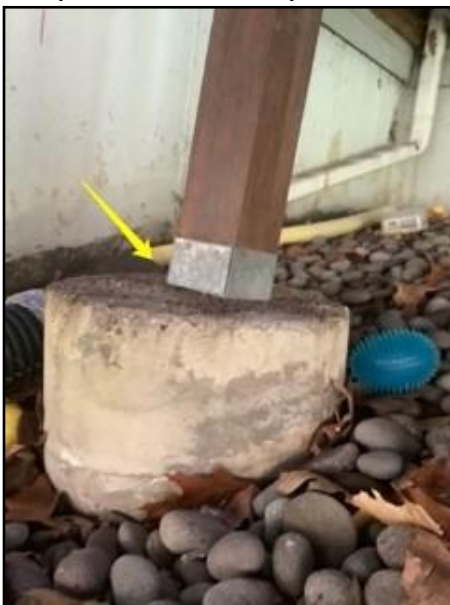
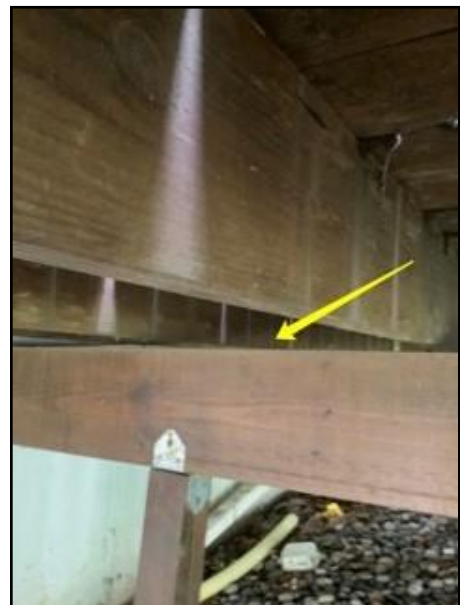
Deck has lifted due to possible snow/ice heave. Recommend having a decking contractor evaluate and repair if necessary

- 4) Deck has lifted due to possible snow/ice heave. Recommend having a decking contractor evaluate and repair if necessary
- 5) Outlet not working on deck. Recommend repair

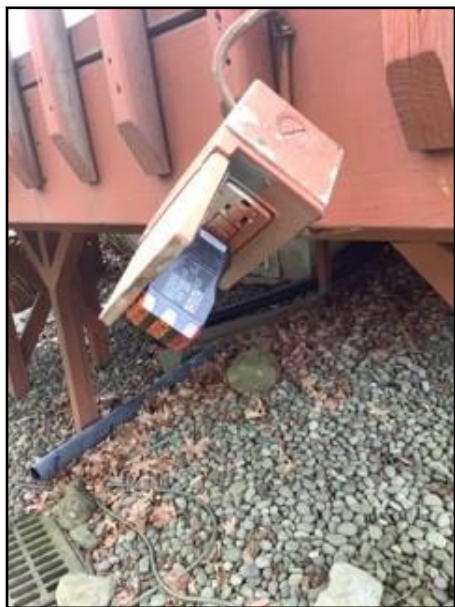
Figure 8-1

Outlet not working on deck. Recommend repair

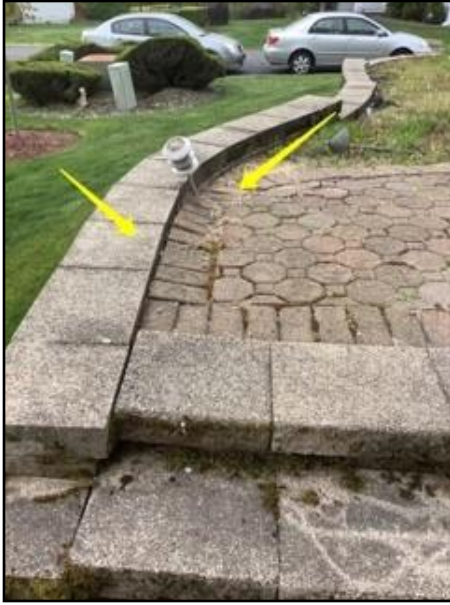
Figure 9-1

Stone has settled and sunken on walkways. Tripping hazard. Recommend repair by mason

- 6) Stone has settled and sunken on walkways. Tripping hazard. Recommend repair by mason

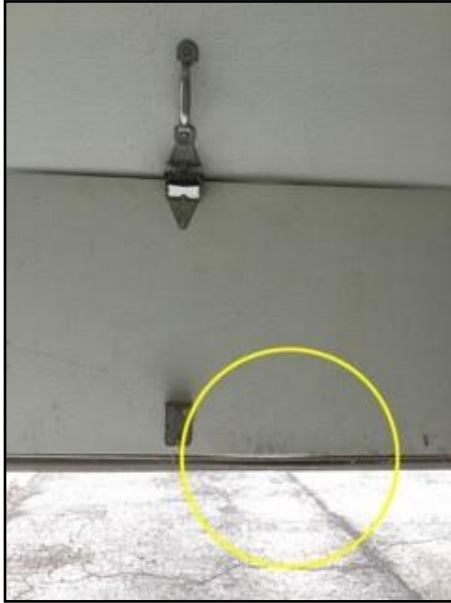
Figure 10-1

Garage door is dented .Recommend repair.

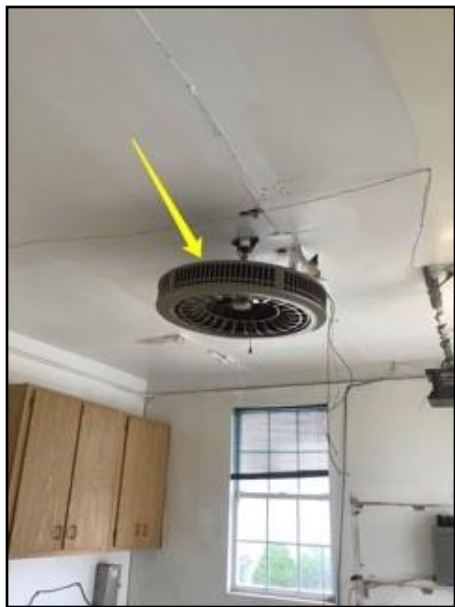
Figure 12-1

Large industrial fan in garage. Recommend removal prior to close

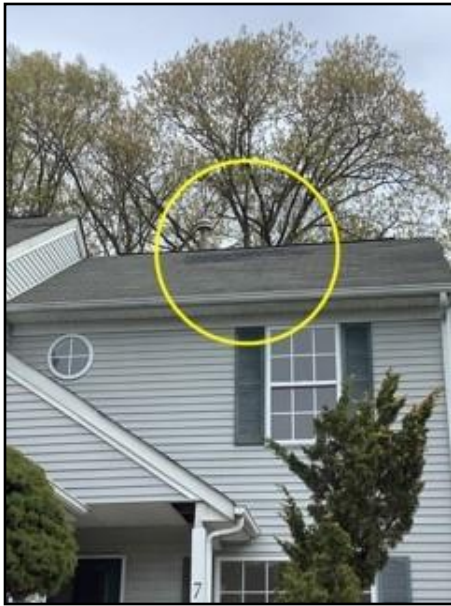
Figure 14-1

Repairs were observed on the roof. However, no indication of leaks, existing roof damage

at the time of inspection.

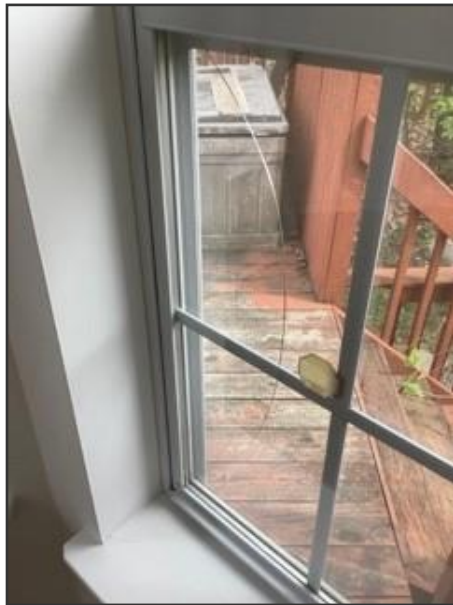
Figure 16-1

Broken window in living room. Recommend replacing

- 8) Broken window in living room. Recommend replacing

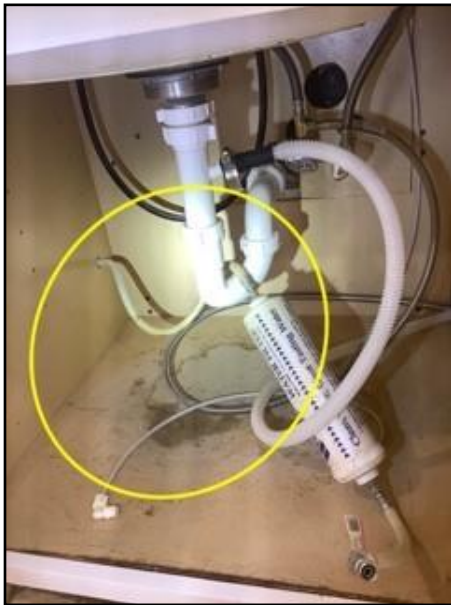
Figure 17-1

Leak observed under kitchen sink. Recommend repair

- 9) Leak observed under kitchen sink. Recommend repair
(Report Summary continued)

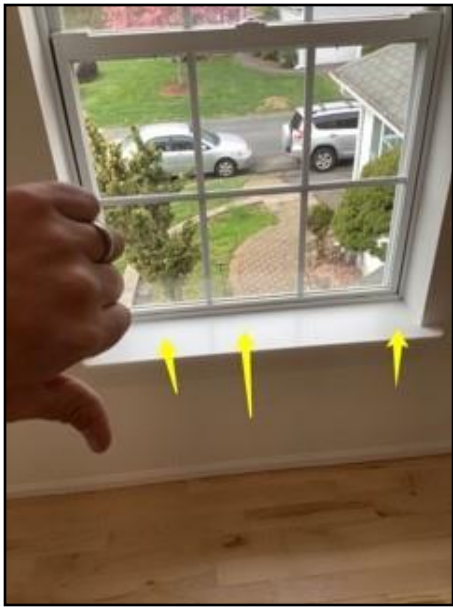
Figure 18-1

Window slams shut when attempting to open. This is a safety issue. Recommend repair

- 10) Window slams shut when attempting to open. This is a safety issue. Recommend repair

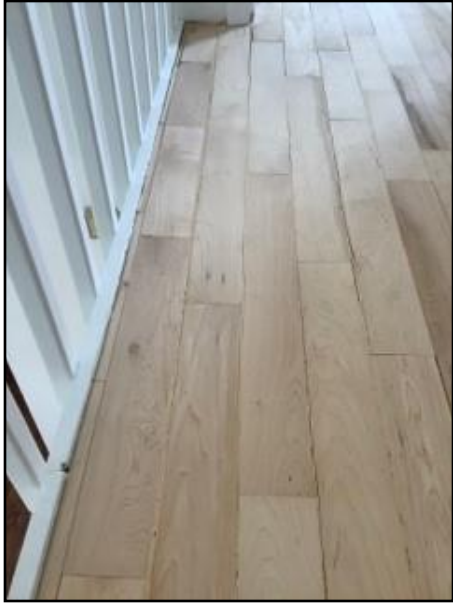
Figure 19-1

Some cracks were observed in wood floors due to improper installation. Cosmetic

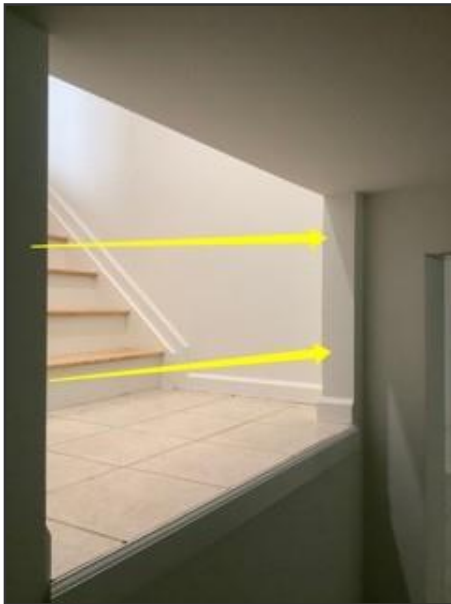
Figure 20-1

Opening in basement landing is large enough for a child/pet to fall through and injure themselves. Recommend installing safety railings/ banisters to prevent this.

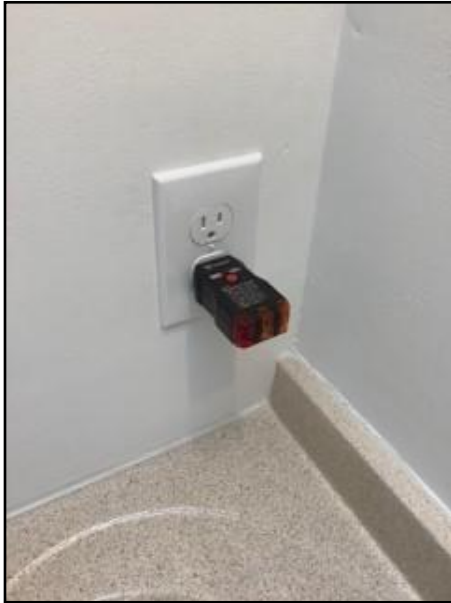
Figure 21-1

Outlet in bathroom not working. Recommend repair

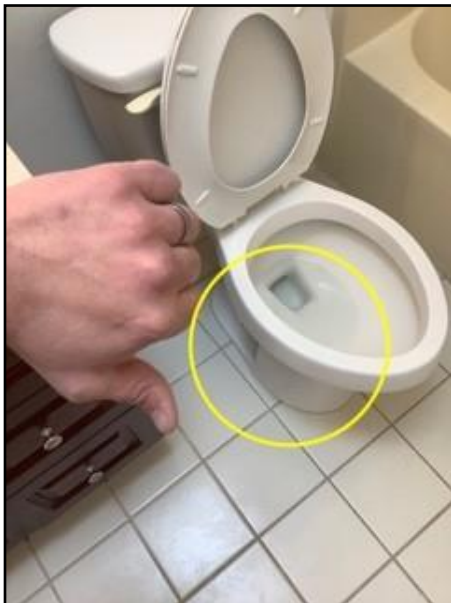
Figure 22-1

Toilet not properly secured to ground. It is loose. Recommend repair

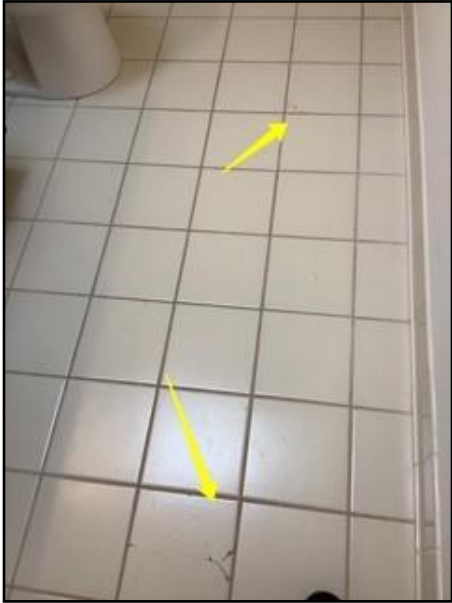
Figure 23-1

Small cracks found on bathroom tile. Cosmetic

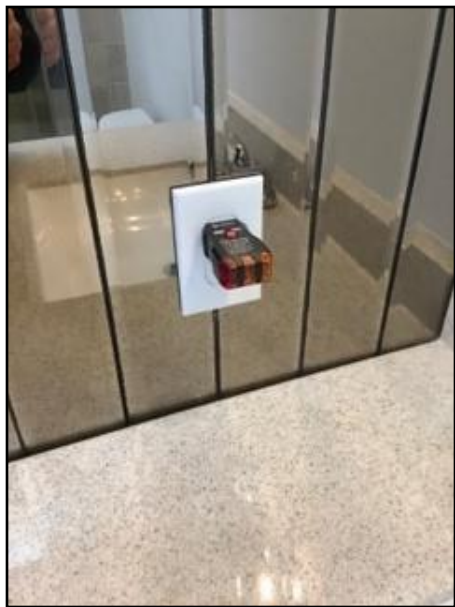
Figure 24-1

Outlet in bathroom not working. Recommend repair

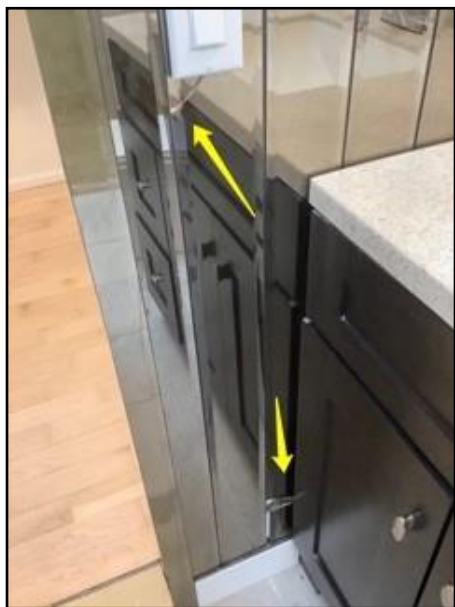
Figure 25-1

Mirror in master bathroom has cracks in it. Recommend repair.

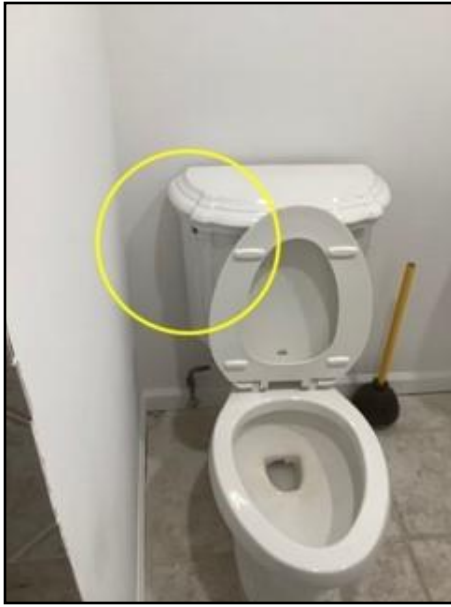
Figure 26-1

Comment 26:
Toilet hardware missing. Recommend repair

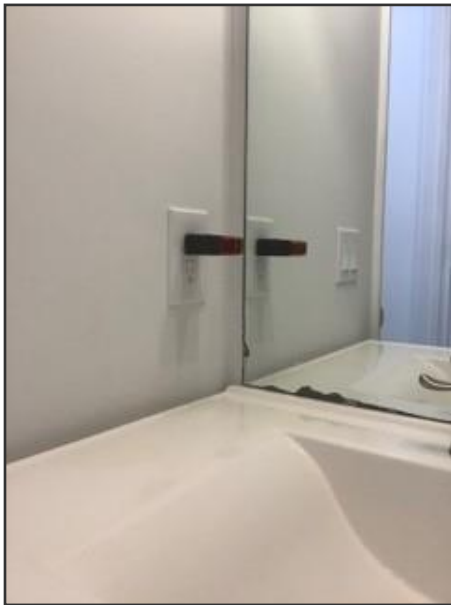
Figure 27-1

Outlet not working in bathroom. Recommend repair.

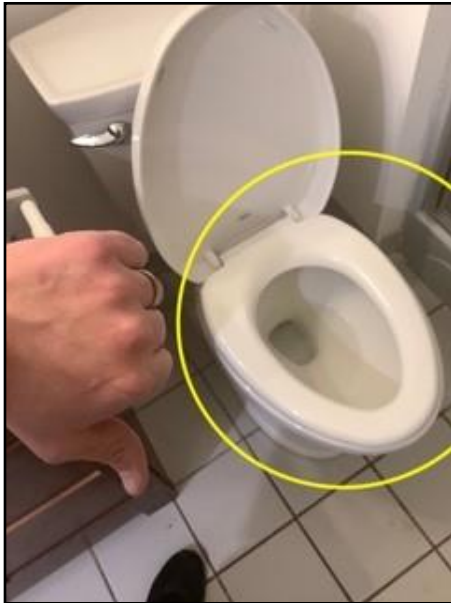
Figure 28-1

Toilet loose. Recommend repair

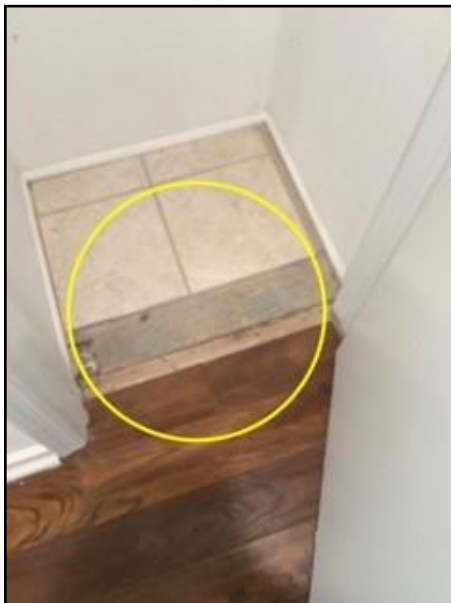
Figure 29-1

Tile missing in entryway closet. Recommend repair

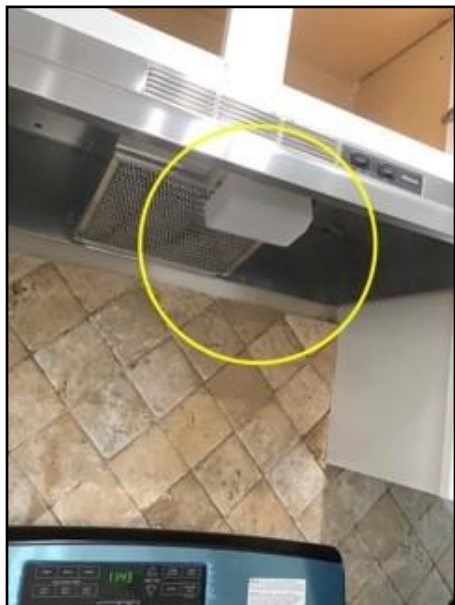
Figure 30-1

Light not working in range hood. Recommend replacing

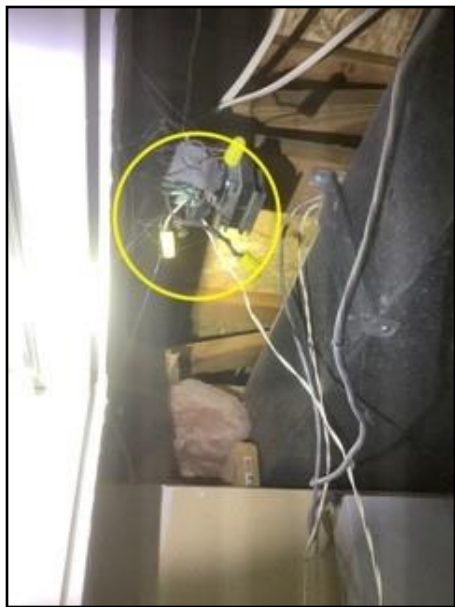
Figure 33-1

All exposed wiring should be covered with a proper junction box. This is on basement utility room. Recommend repair

- 18) All exposed wiring should be covered with a proper junction box. This is on basement utility room. Recommend repair

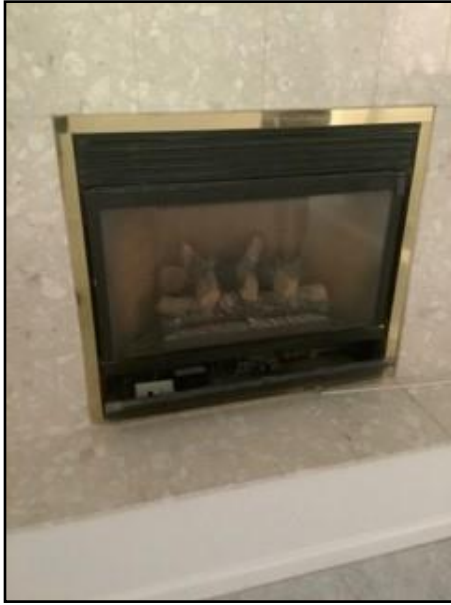
Figure 34-1

Both fireplaces were not working at time of inspection through the use of normal operating controls. This is most likely due to pilot not being lit. Recommend evaluation/repair by professional and ensuring they are working properly prior to close

- 19) Both fireplaces were not working at time of inspection through the use of normal operating controls. This is most likely due to pilot not being lit. Recommend evaluation/repair by professional and ensuring they are working properly prior to close

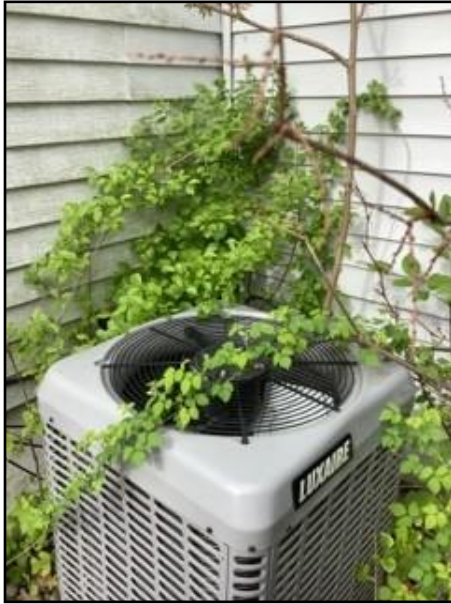
Figure 35-1

Recommend clearing vegetation away from home to ensure compressor can operate properly. We did not test AC due to outside temperature. Recommend ensuring it is working properly using normal controls (thermostat) prior to close.

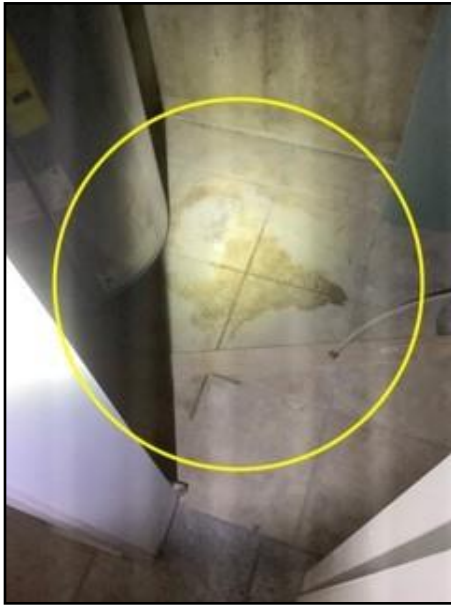
Figure 36-1

There was a leak observed in the utility room. It appears to be coming from the bathroom above. It is also in close proximity to exposed wiring. Recommend having a licensed contractor evaluate and repair

- 20) There was a leak observed in the utility room. It appears to be coming from the bathroom above. It is also in close proximity to exposed wiring. Recommend having a licensed contractor evaluate and repair

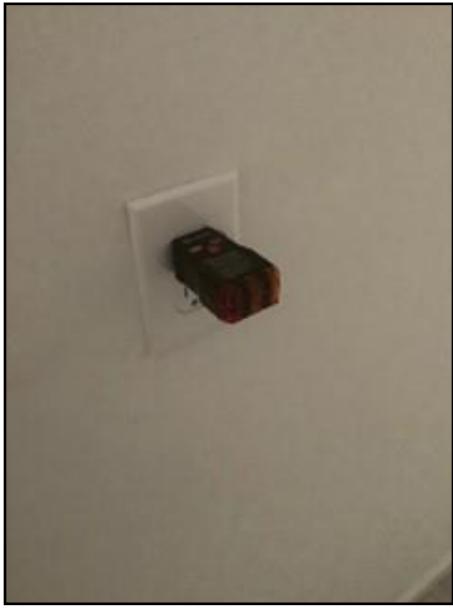
Figure 38-1

Several lights and outlets were not working in the basement. This could be from a thrown breaker. Recommend evaluation and repair.
