Neckar Valley Company

1 Sample report rd

INSPECTED ON 11/23/2025

This is a sample report to allow you to see what a report issued will look like and what to expect. The images used are collected from various properties and inspections.

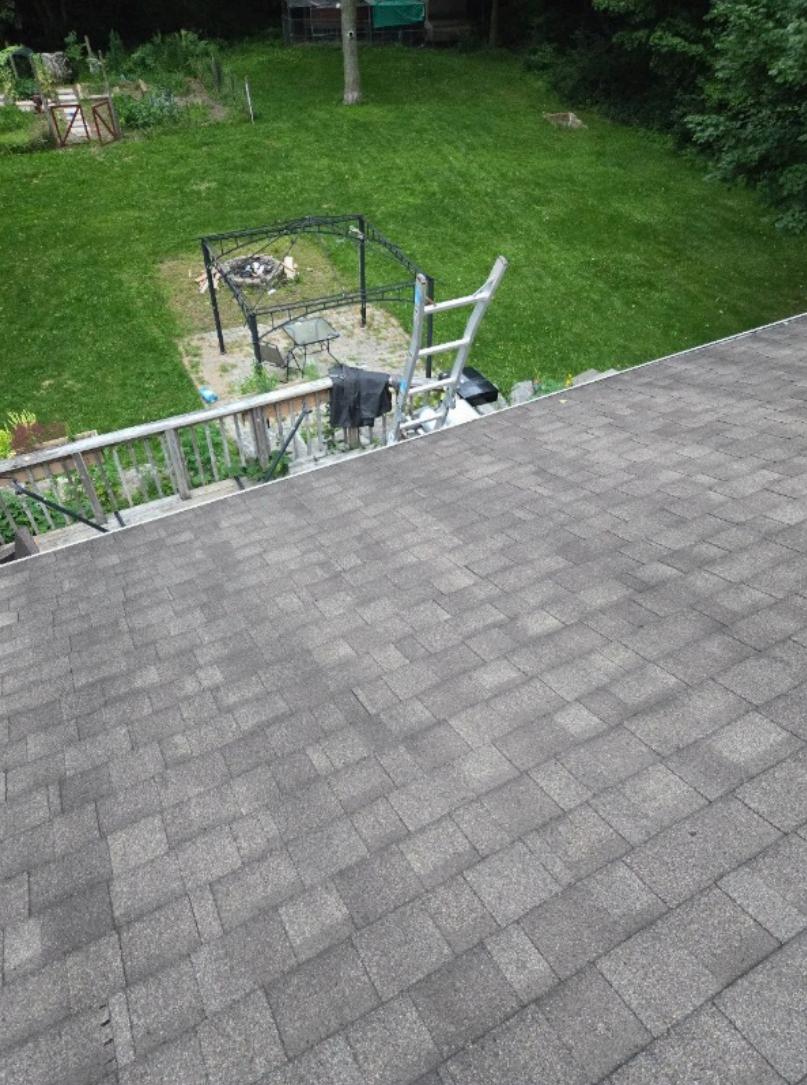
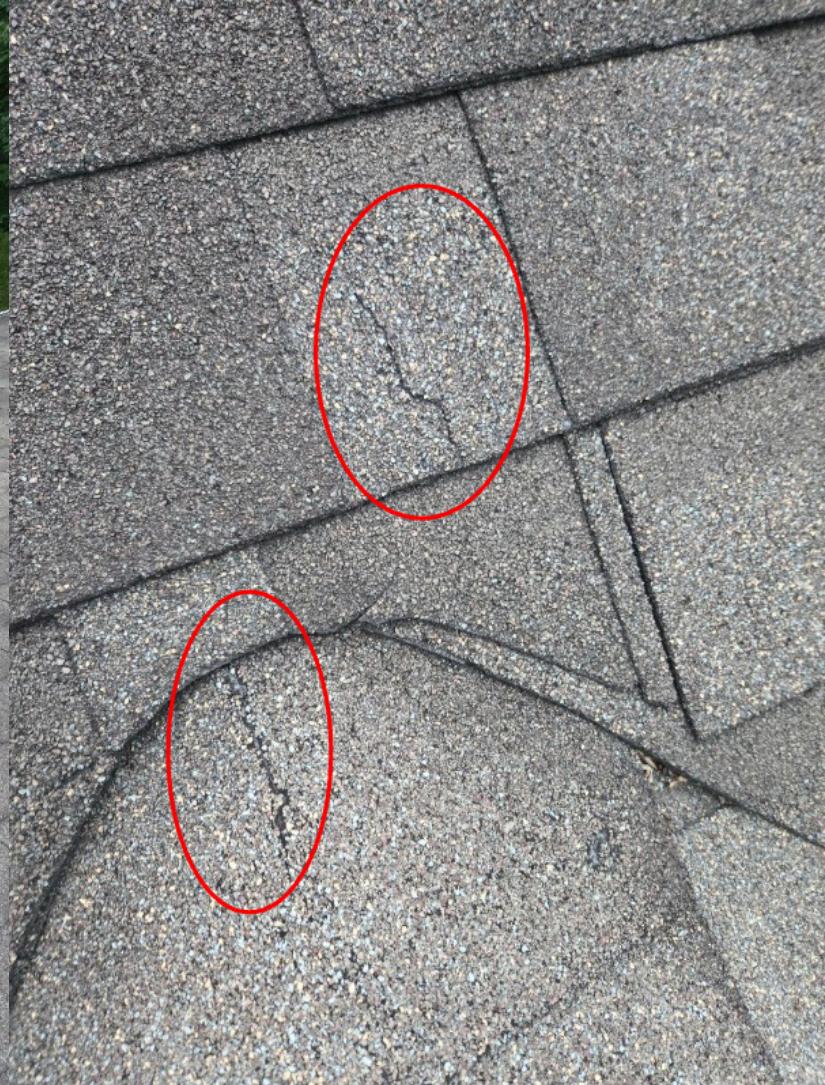
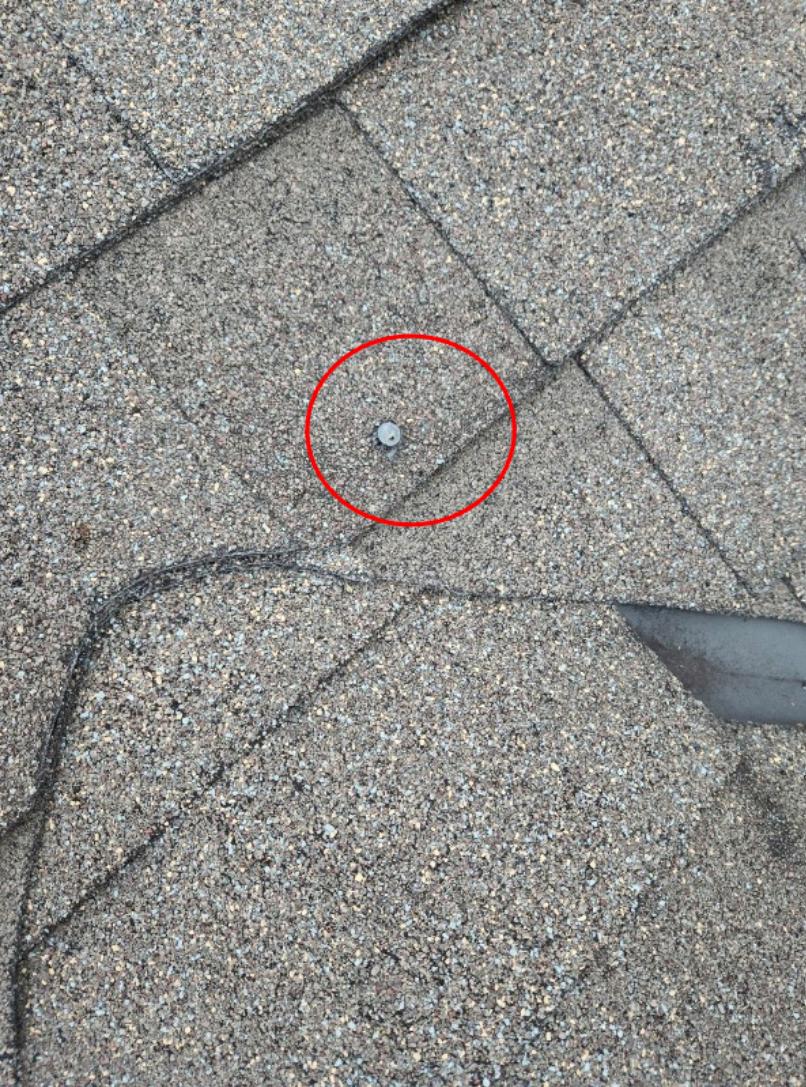
- Exposed fasteners observed
- missing kickout flashing where roof edge meets wall covering
- signs of wear and aging

Contact a roofing professional to make necessary repairs

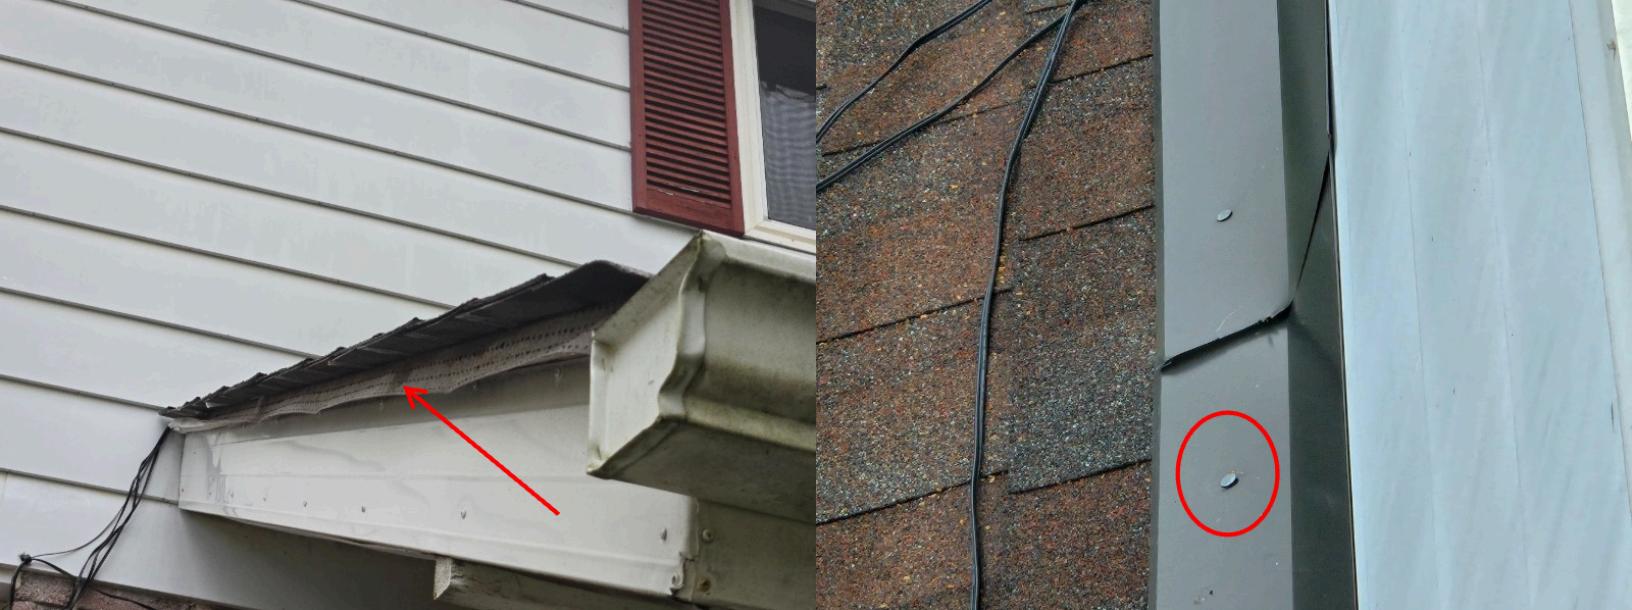
- missing drip edge flashing, too much overhang
- exposed fastners

Contact a qualified professional roofing contractor for repairs

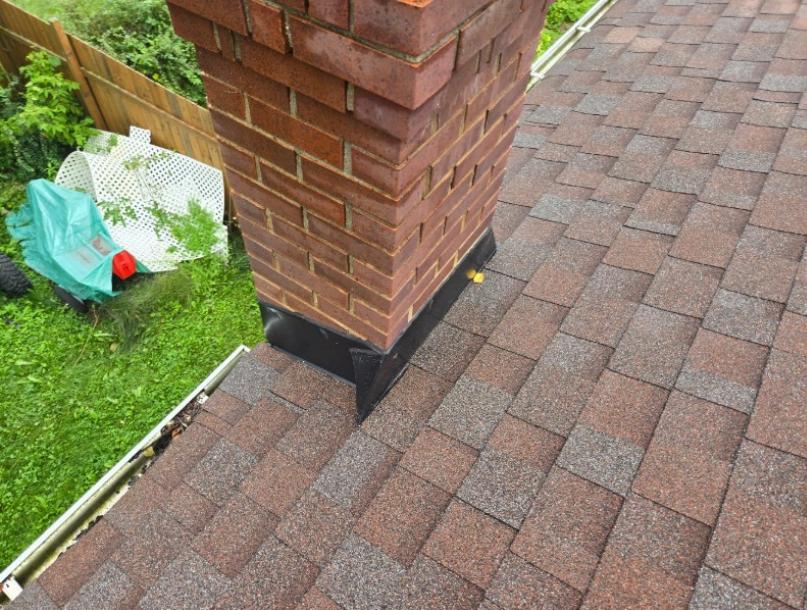
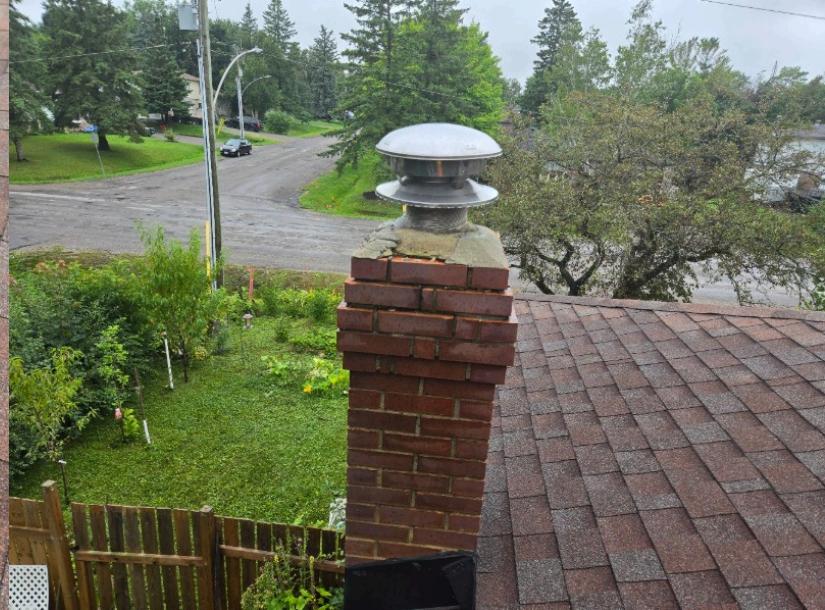
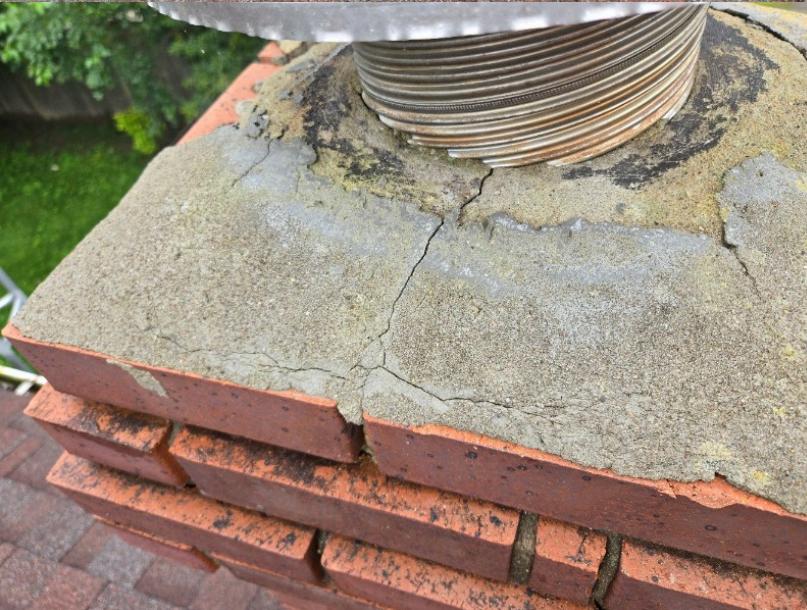
Deterioration of brick mortar

Contact a qualified masonry contractor for repair

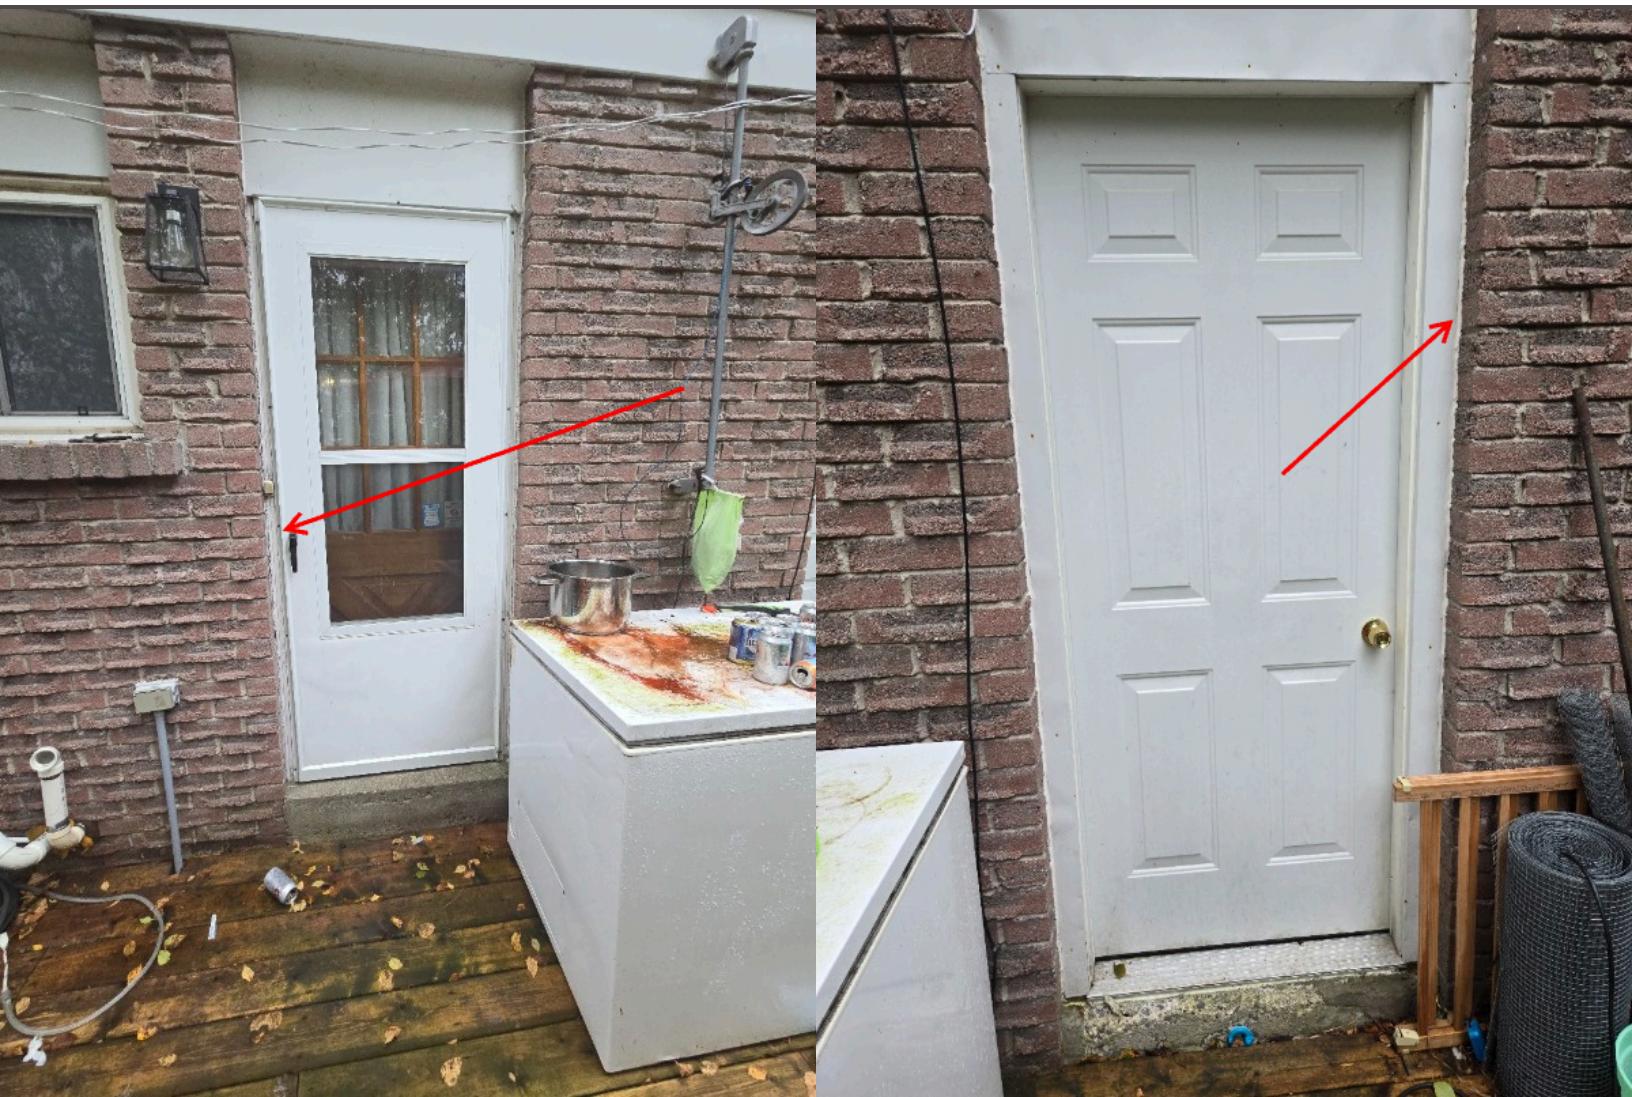
Caulking deterioration observed, regular maintenance item

Replace caulking around exterior doors

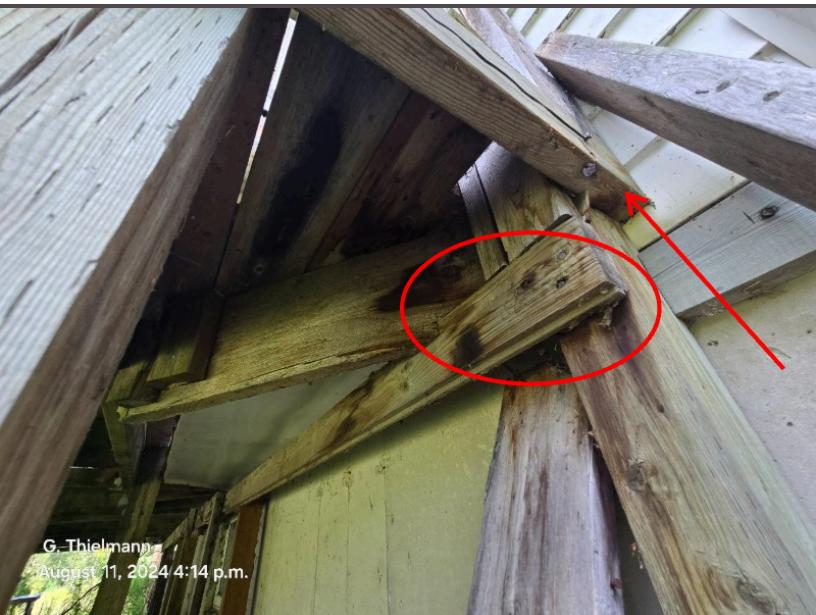
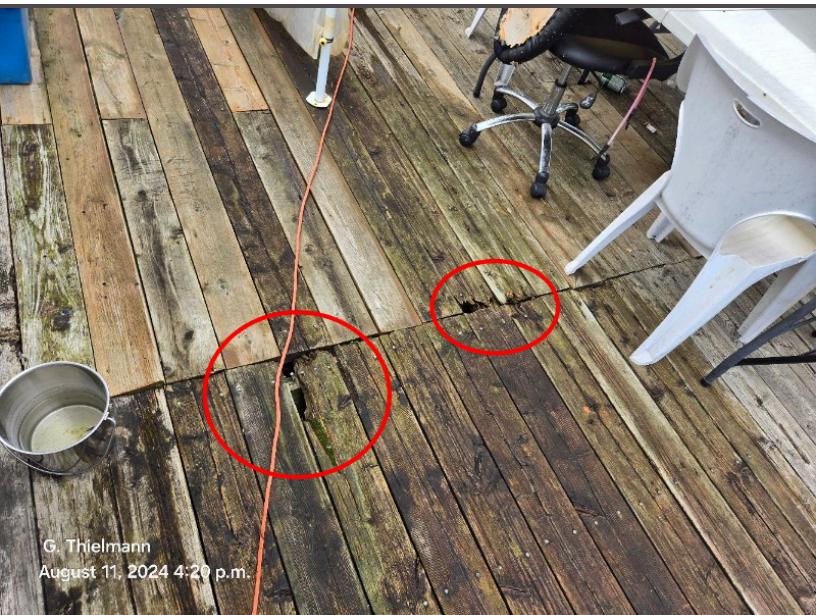
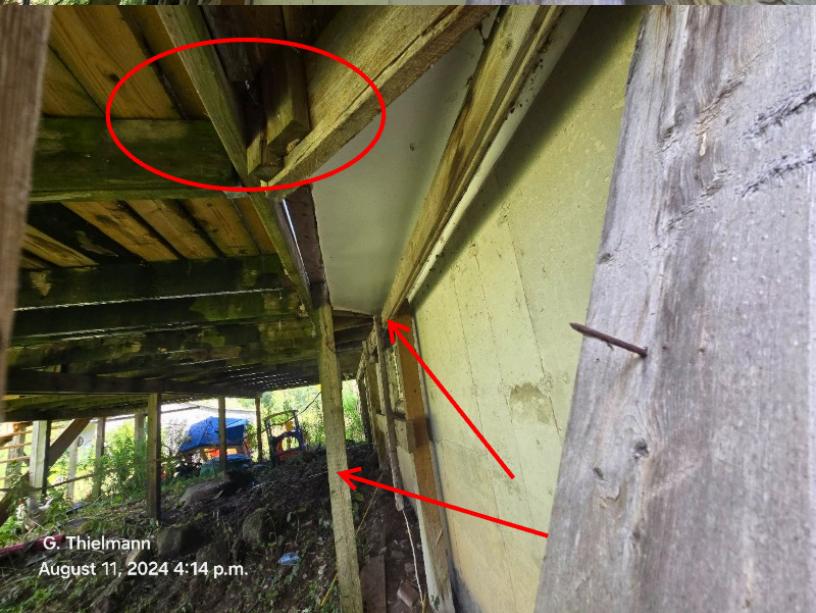
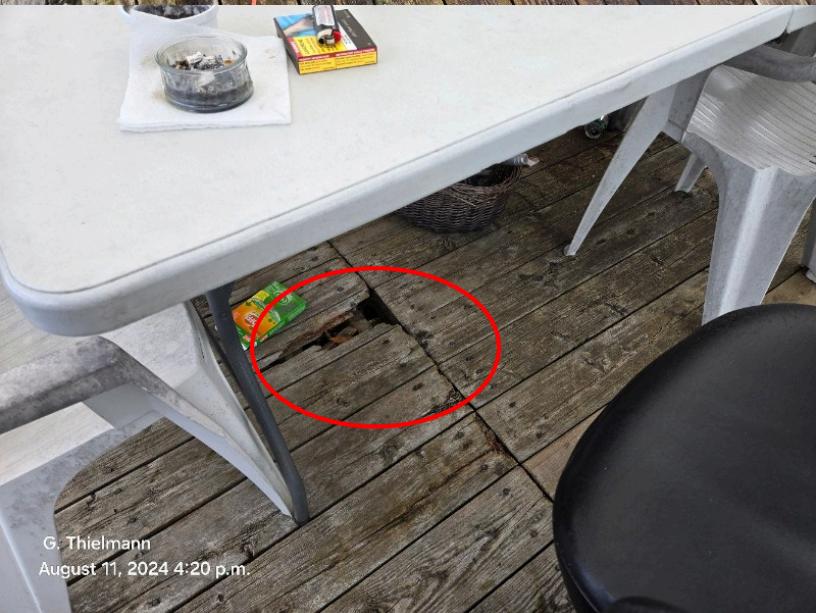
- Improper construction practices observed
- Rotten Components observed

Have repairs made by a qualified contractor. Safety hazard

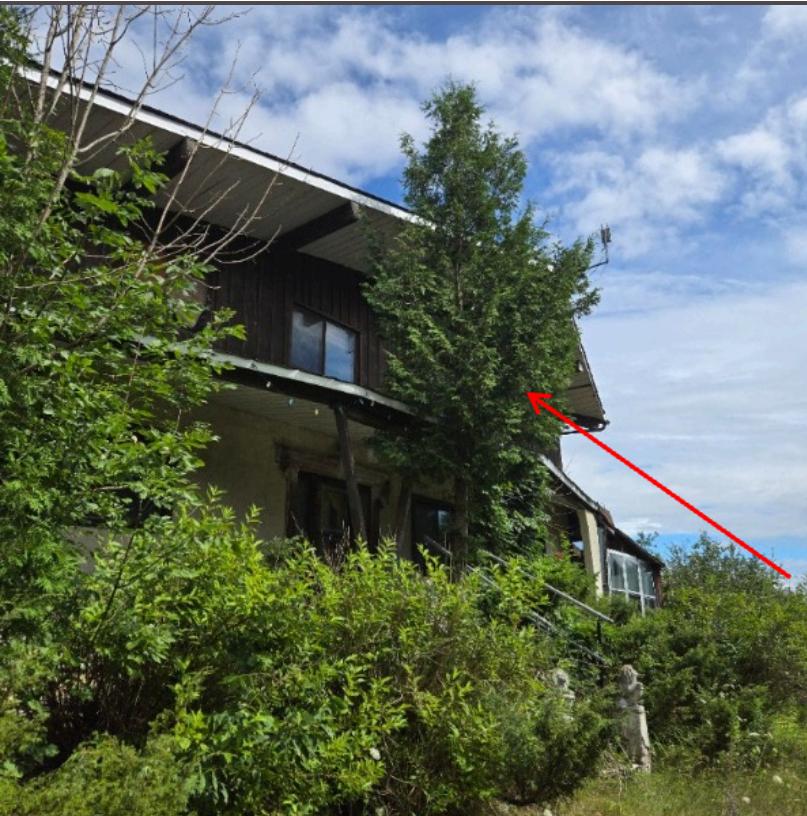
Tree is too close to structure, minimum of 10' is recommended

Remove trees that are closer than 10' to the structure

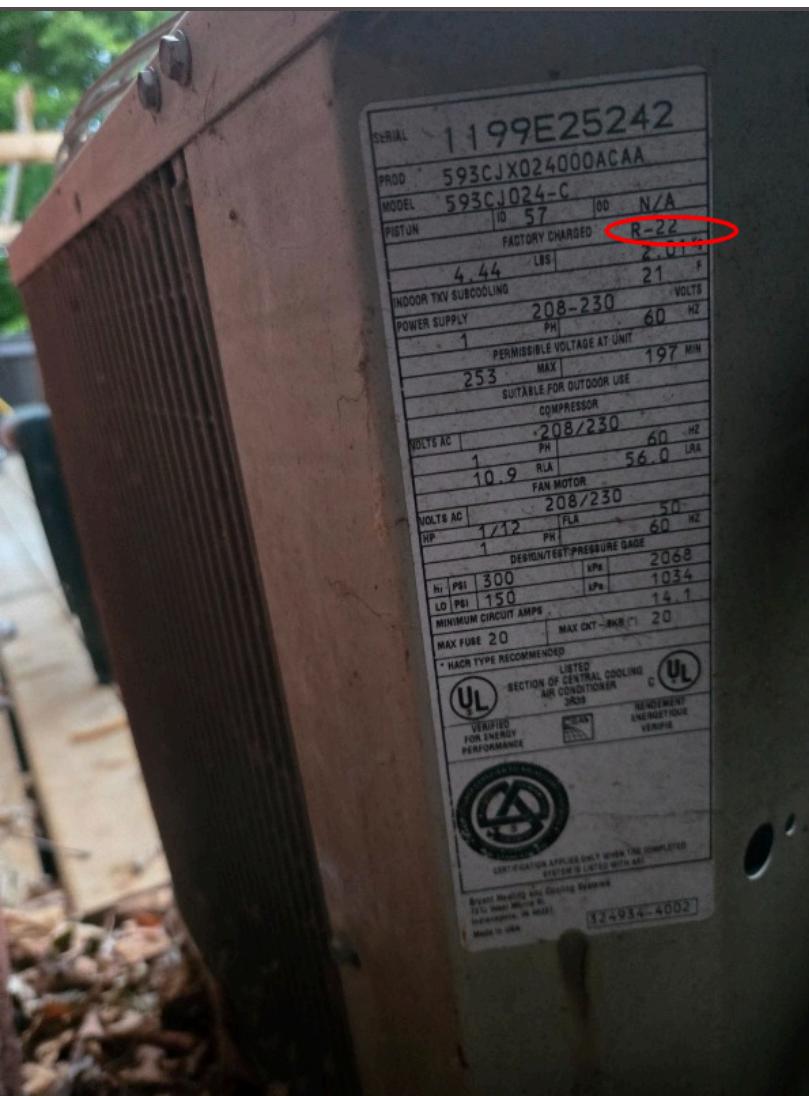
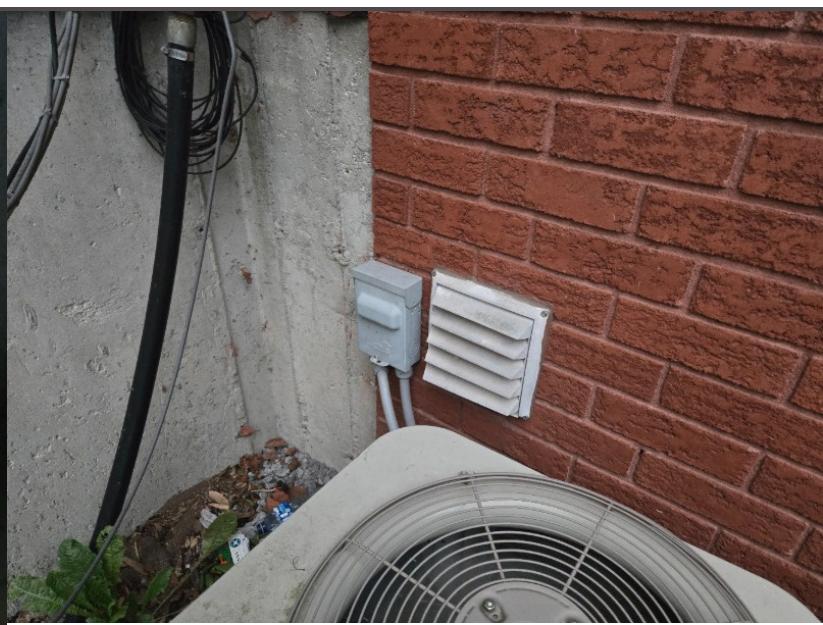
R22 while in itself is not a defect, it can be difficult to find and costly should the system need to be recharged.

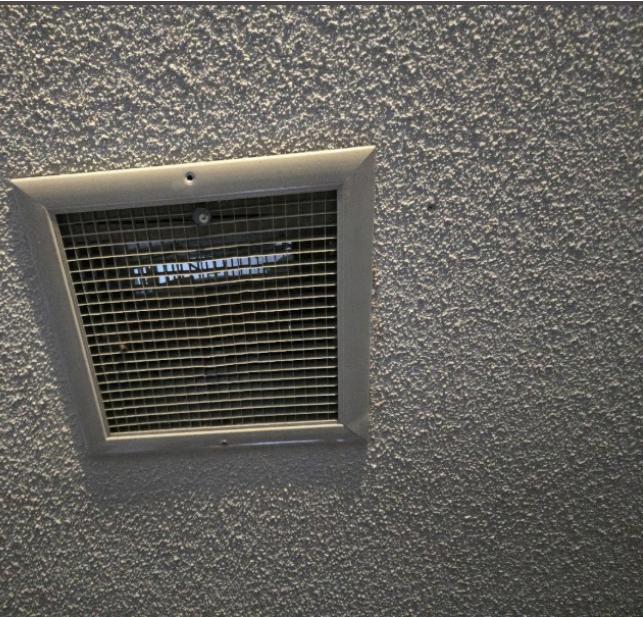
Due to the age of the home, popcorn ceiling may contain asbestos

If popcorn ceiling is to be disturbed in any way, hire a professional to test the material for asbestos before hand

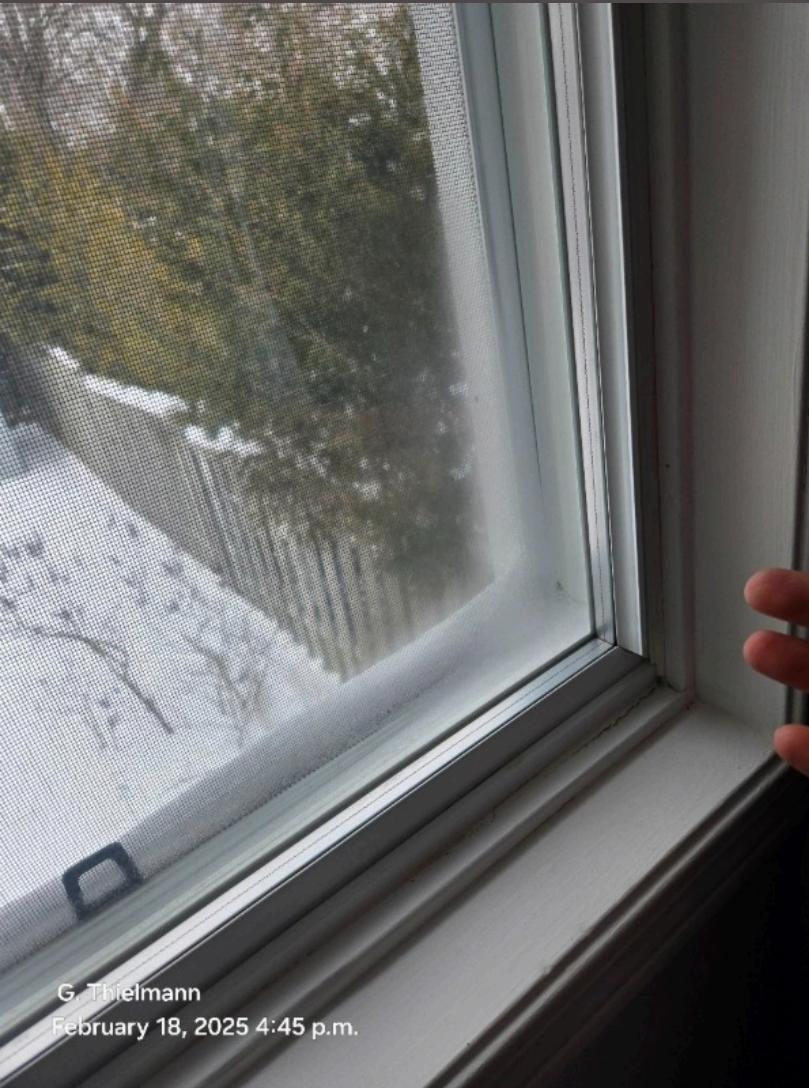
Appeared Serviceable for the most part. One window (master bedroom) showed signs of fogging

Contact a qualified contractor for repairs

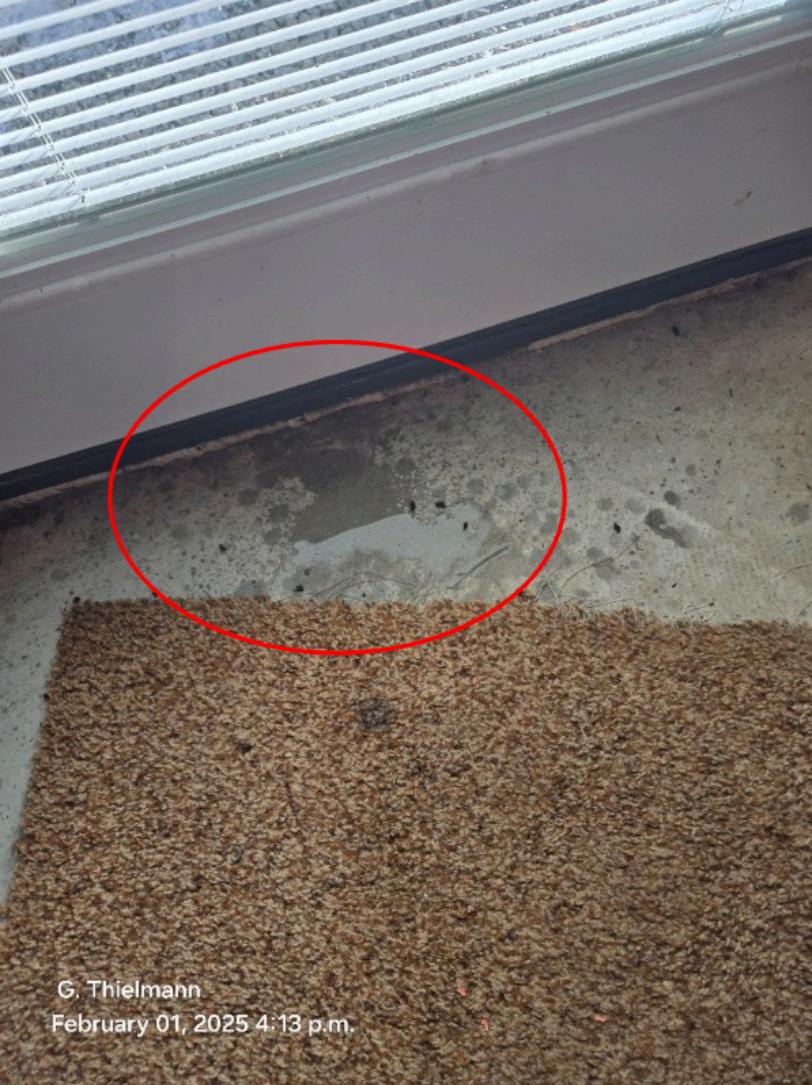
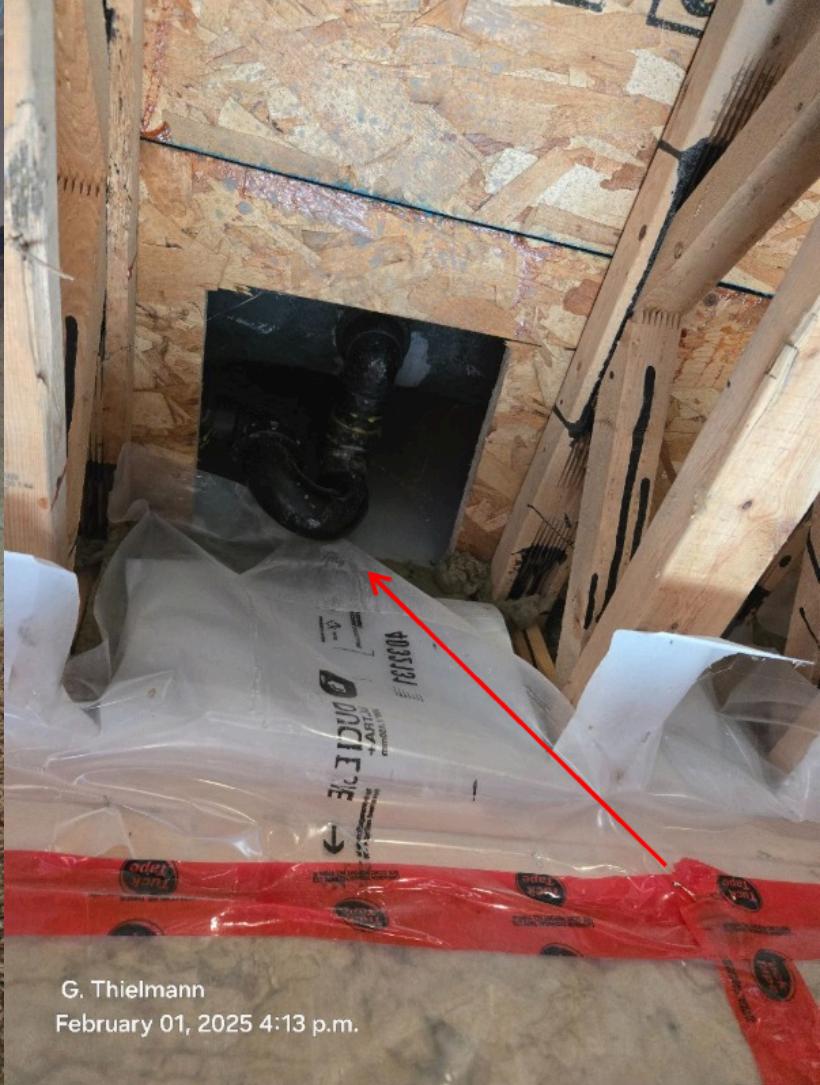
Leak observed under master bathroom tub while running faucet, with drain plug installed and closed.

Contact a qualified plumbing contractor to repair

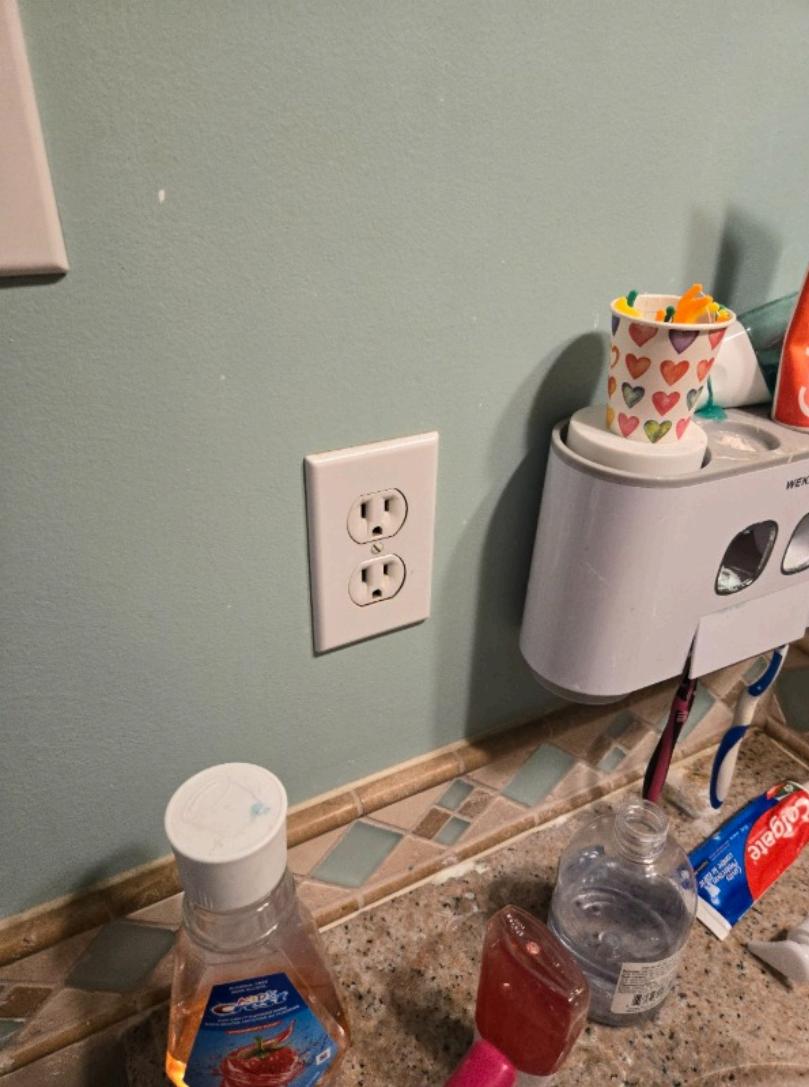
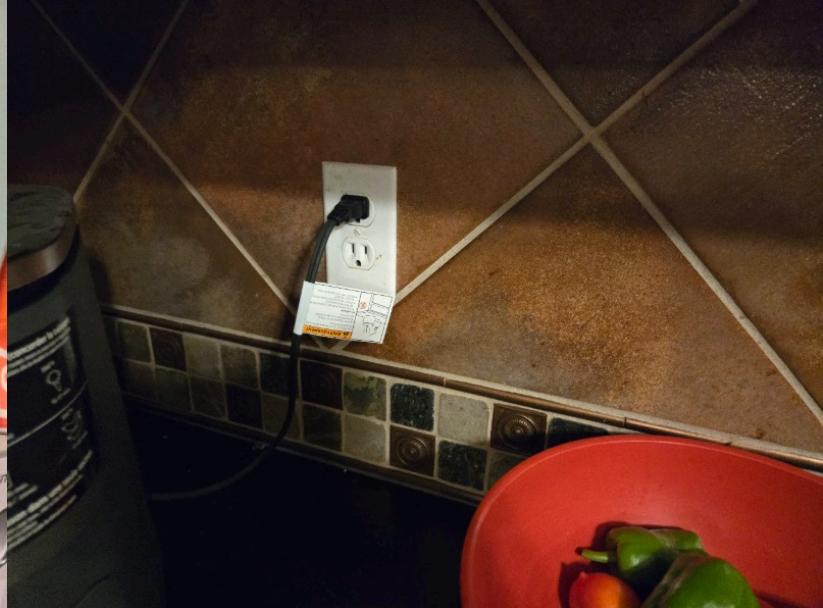
Bathroom outlet not GFCI protected

Kitchen outlet not GFCI protected

Contact a qualified electrical contractor for repairs

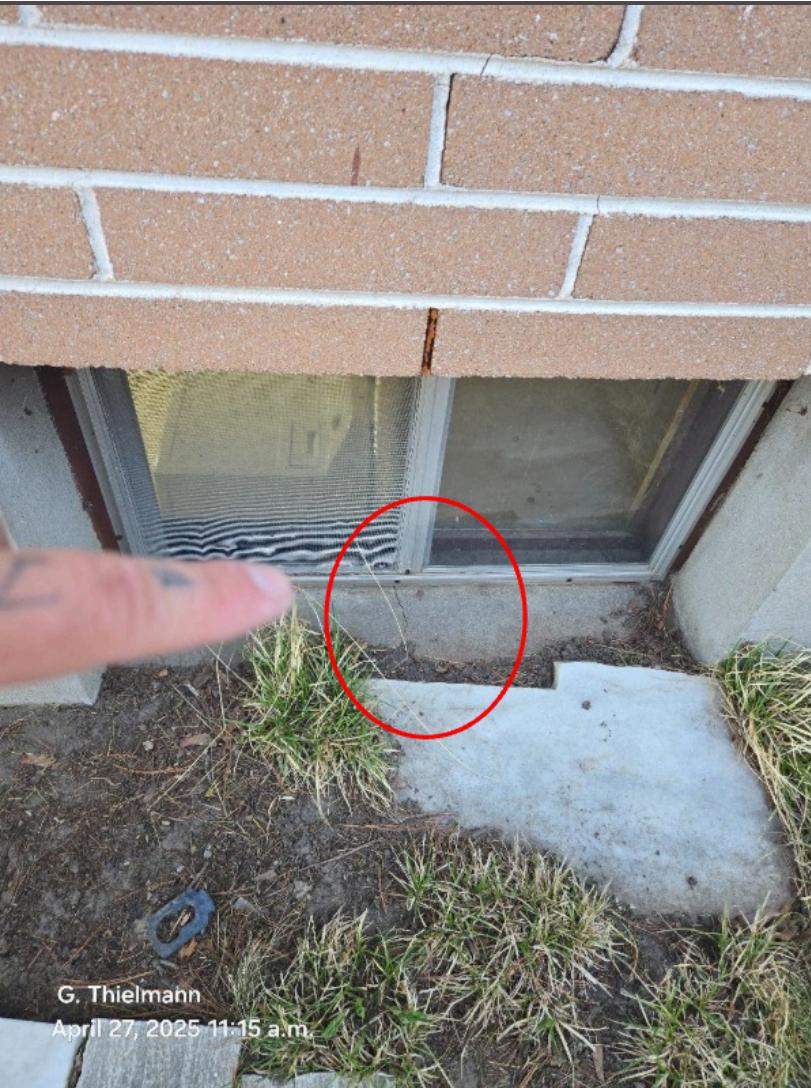
Cracks observed, less than 1/8". (Common)

Seal cracks to prevent moisture intrusion and monitor cracks for growth and expansion.
