# Todd's Home Inspection Services

## Standard Home Inspection Report

07/20/2021 @ 3:00pm

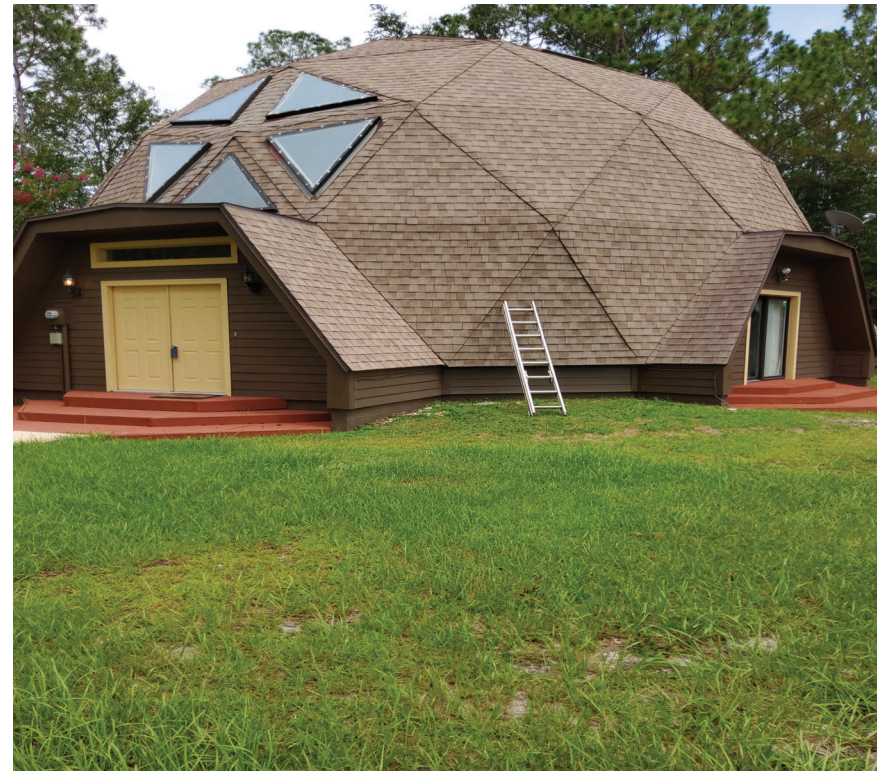
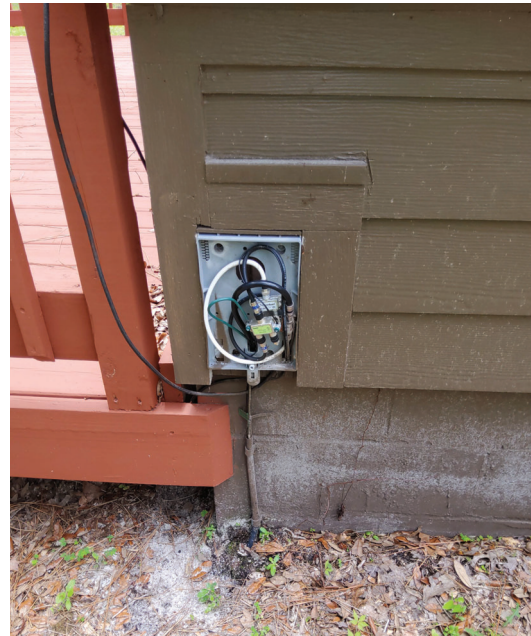
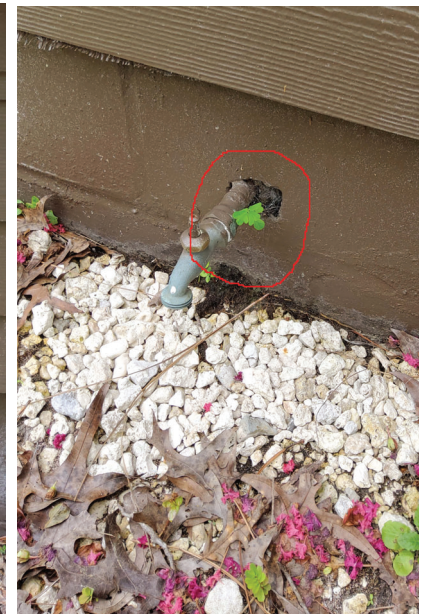
Cable box cover needs to be installed - recommend repair by homeowner/qualified handyman

Opening in slab at water spigot needs to be sealed - recommend repair by homeowner/qualified handyman

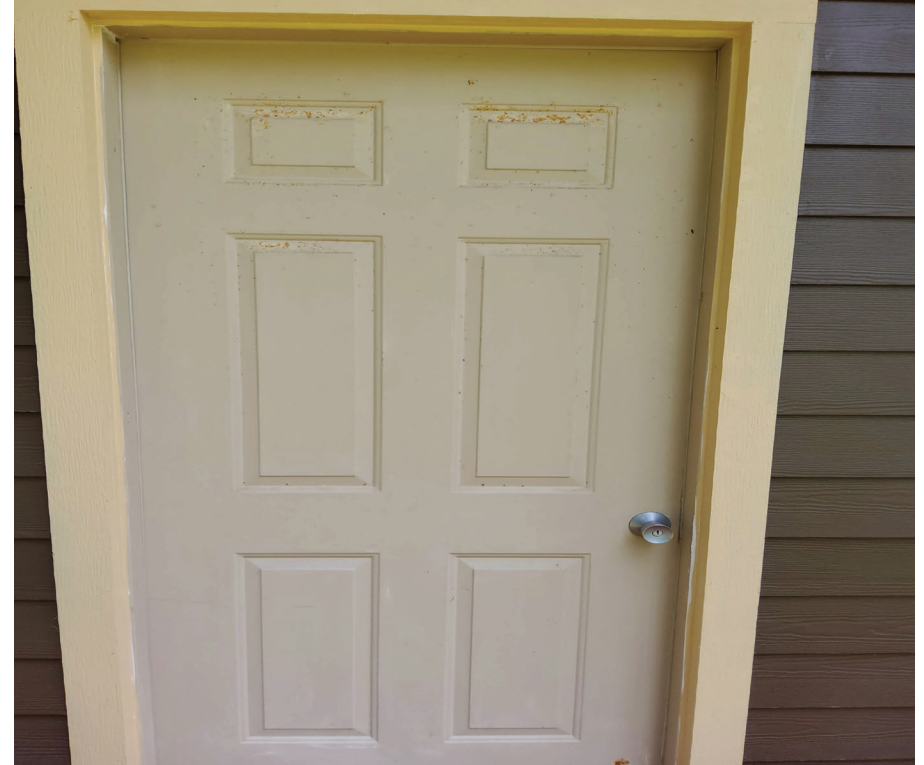
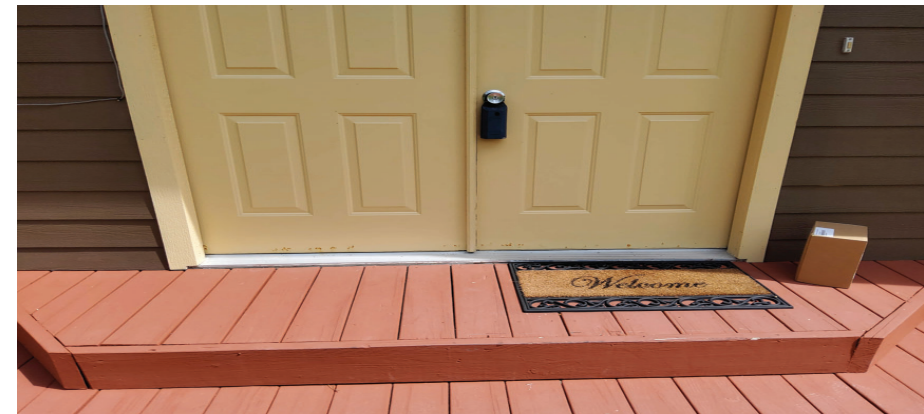
Visible rust on front and back left steel door. Need sanding and repainting - recommend repair by homeowner/qualified handyman

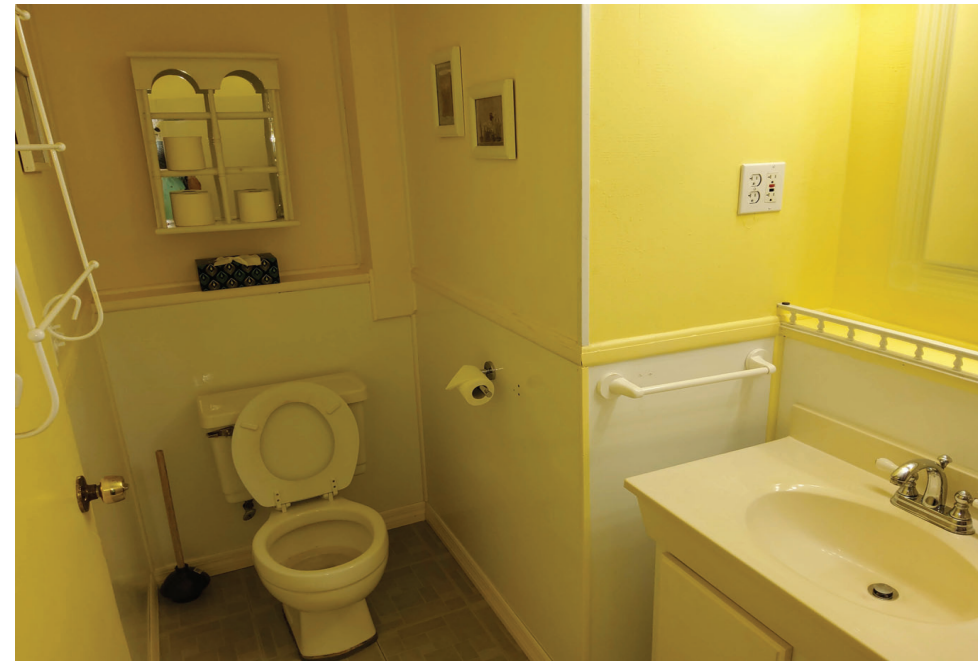
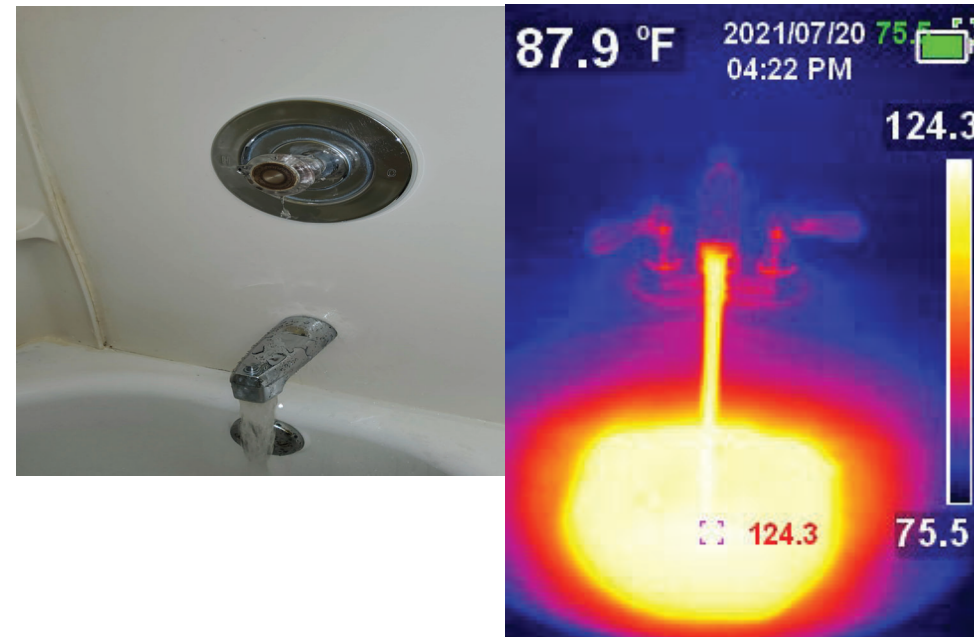
Water leaks at tub handle - recommend repair by licensed plumber

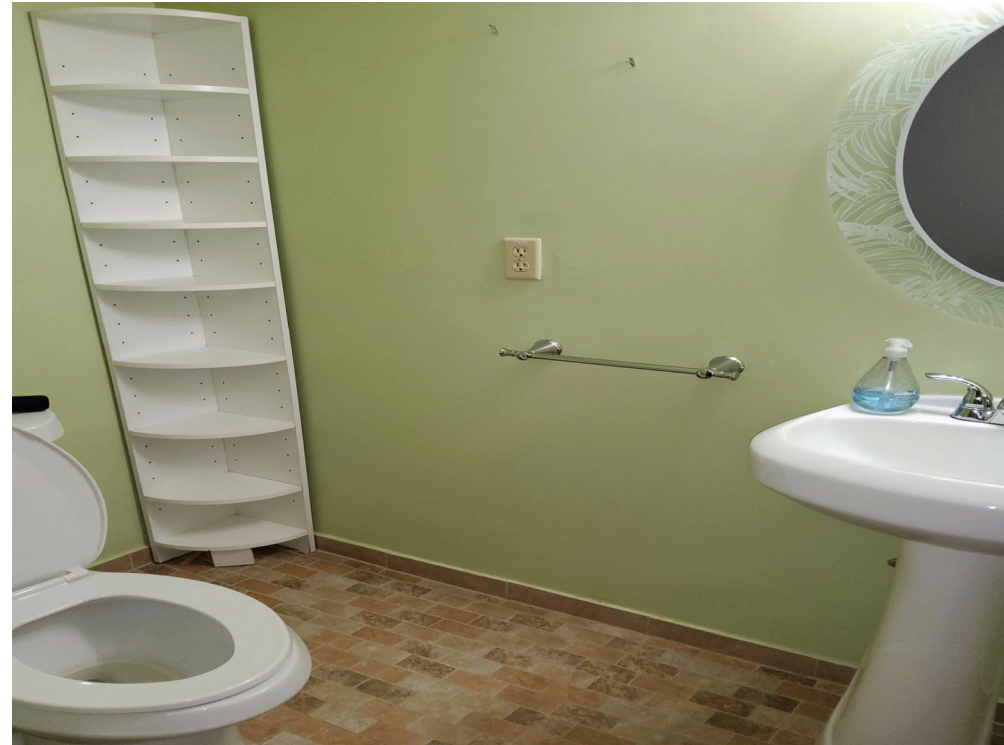
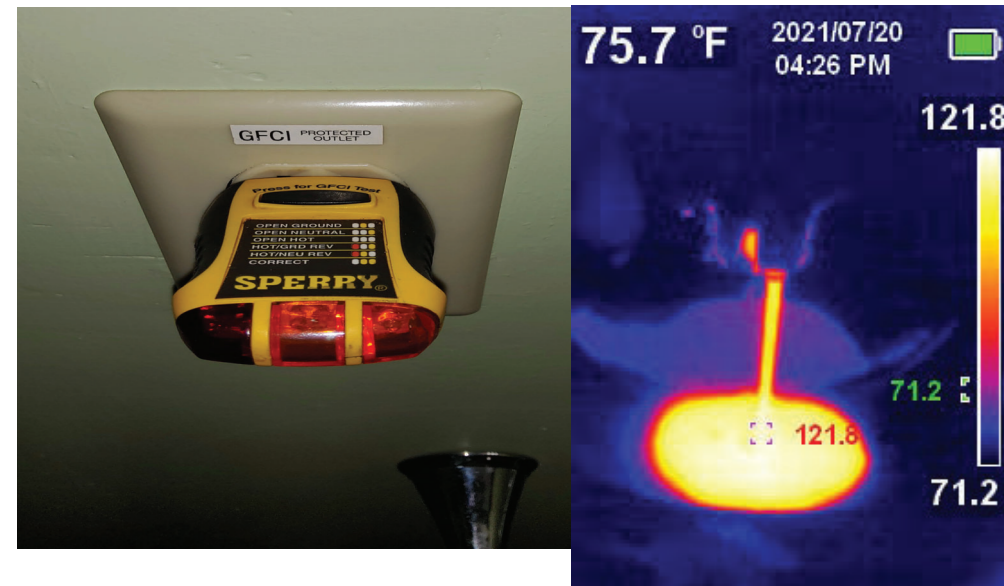
Outlet has open neutral - recommend repair by licensed electrician

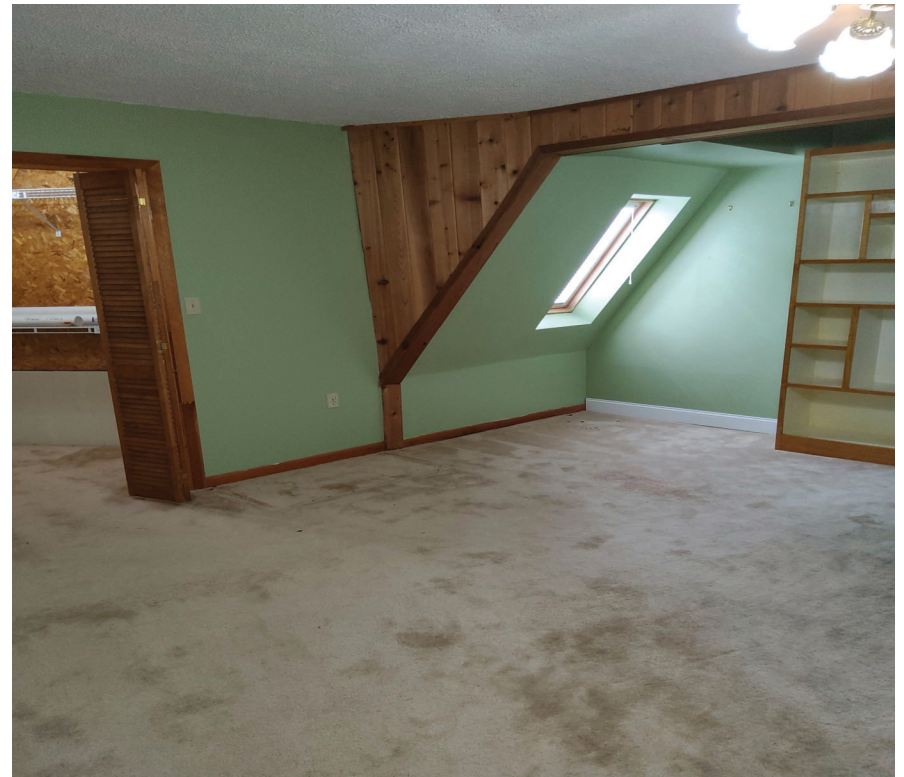
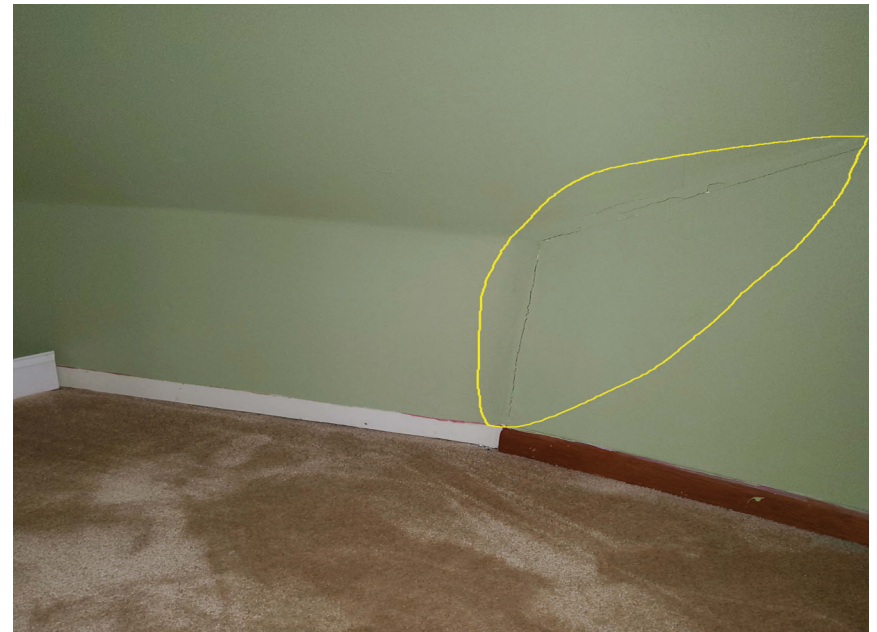
Wall cracking and missing trim, cracking not present on exterior - recommend repair of drywall by handyman

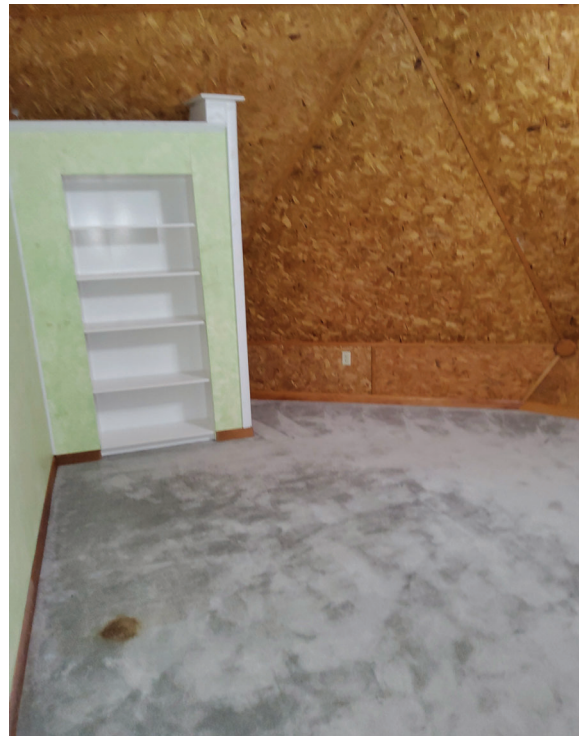
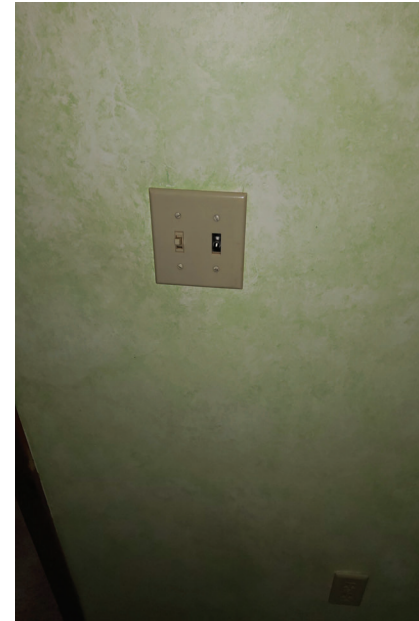
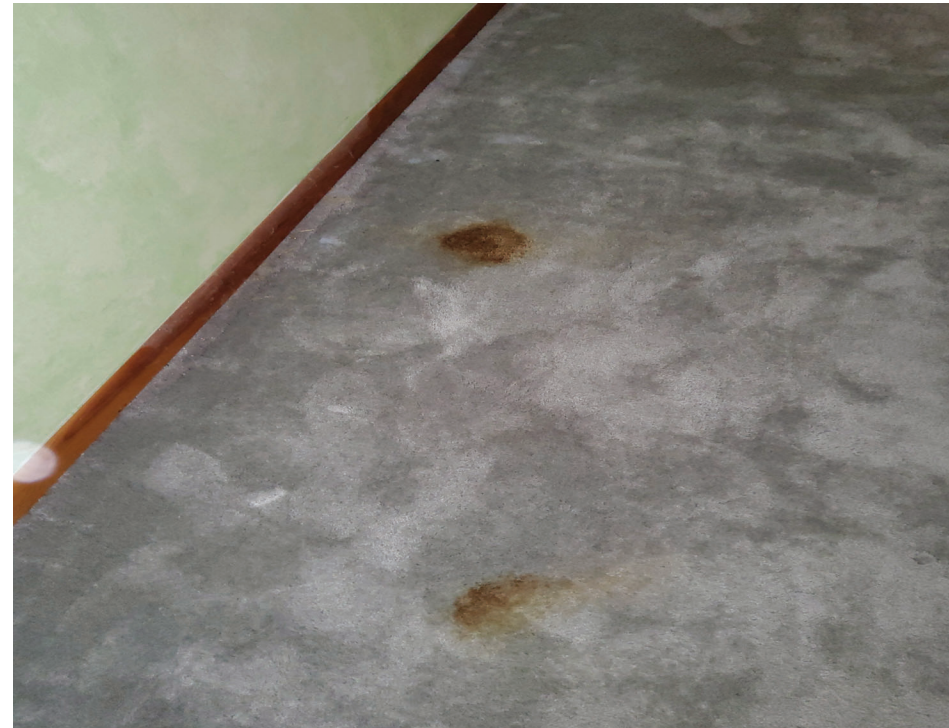
Significant sized carpet staining, cause unknown

Missing knob for lighting - recommend repair by licensed electrician

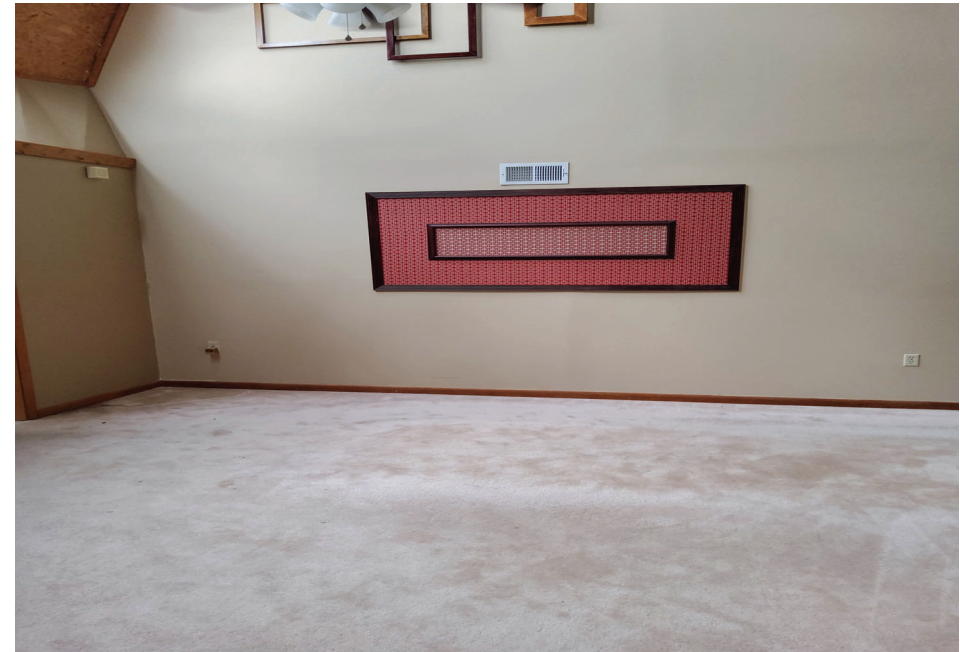
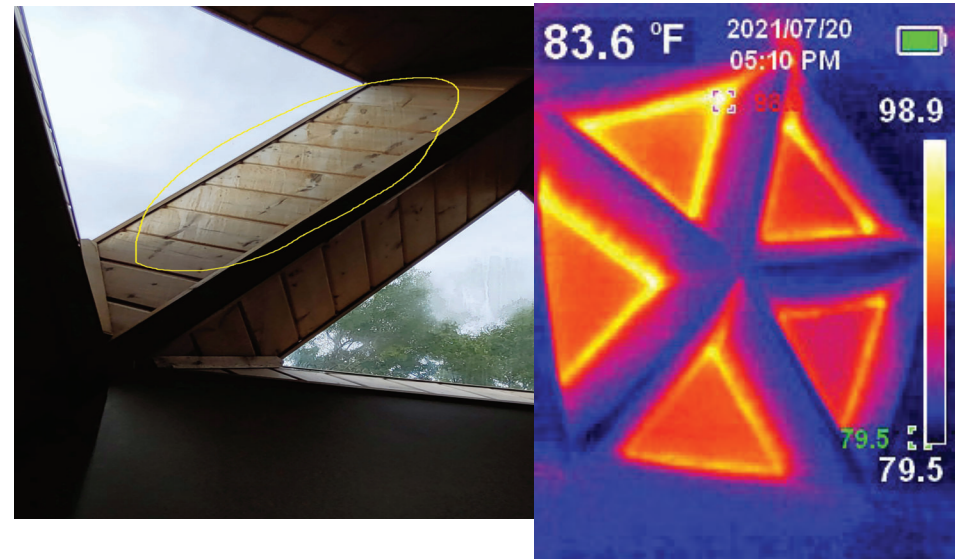
Staining around skylights, no moisture detected - recommend further evaluation by licensed roofer

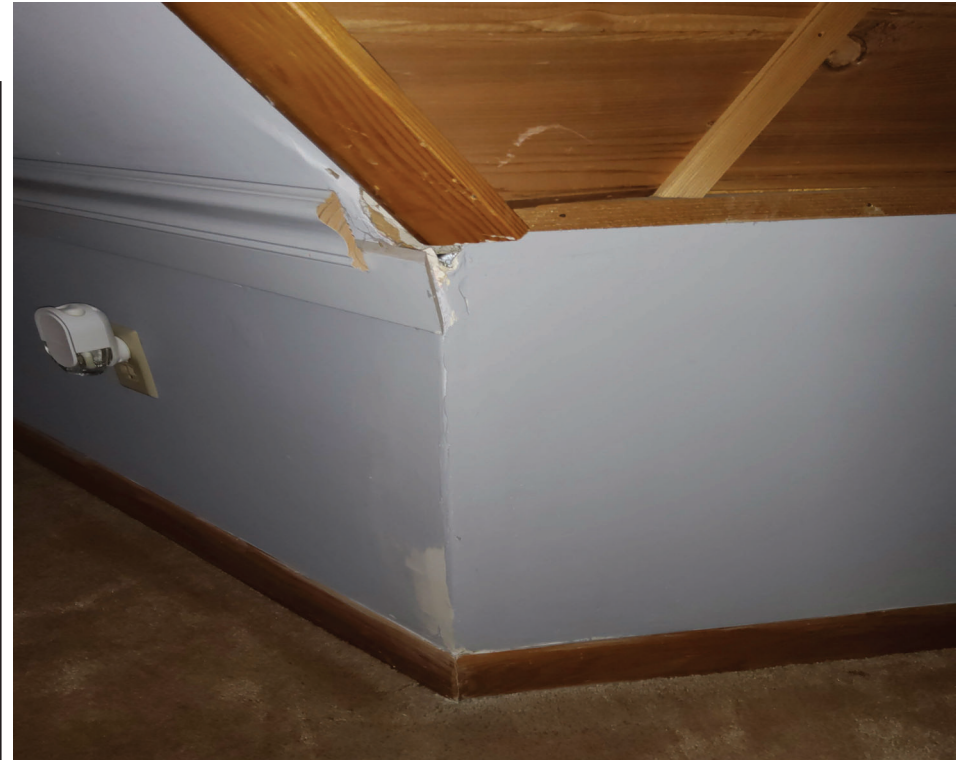
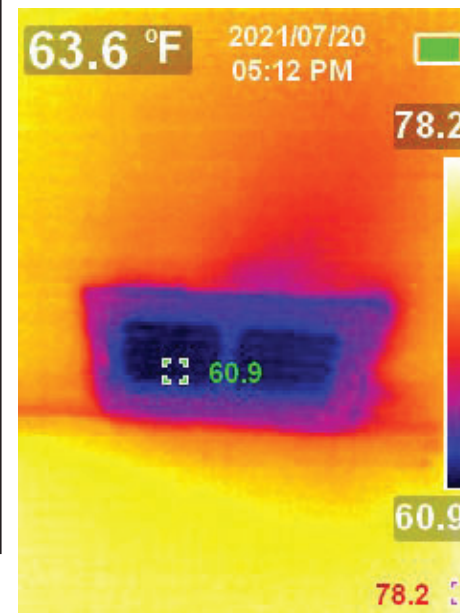
Loose trim and cracked drywall - recommend repair by handyman

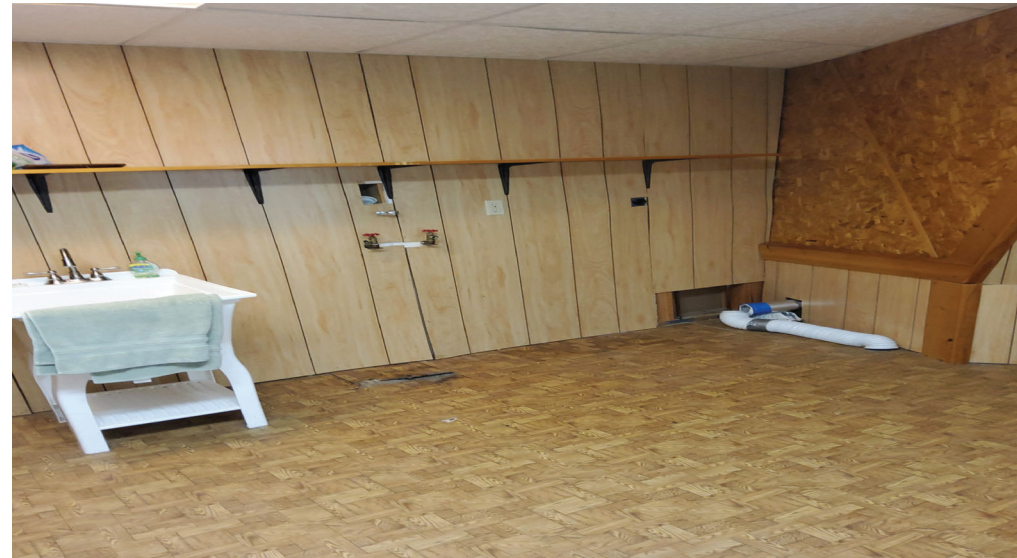
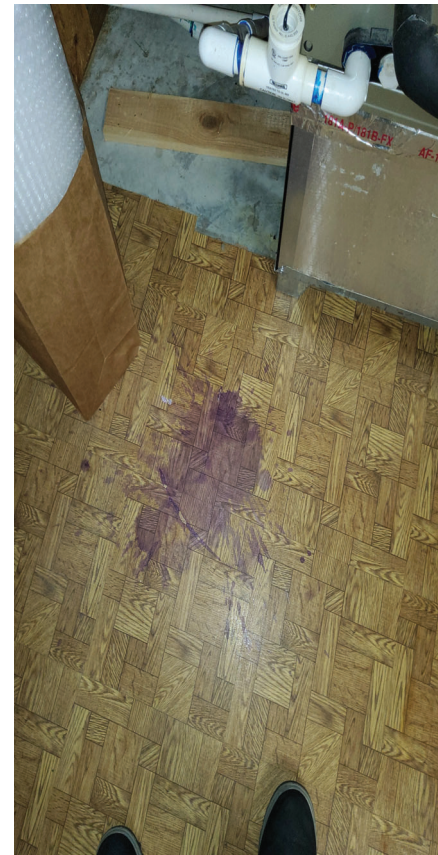
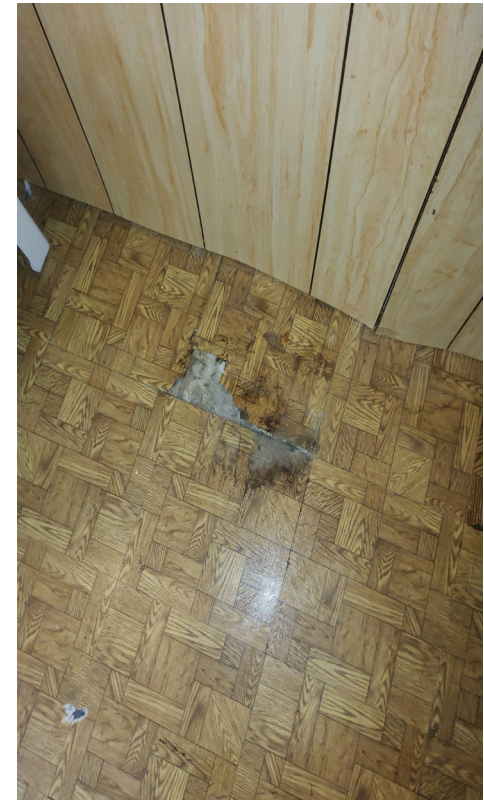
Flooring needs to be completed and repaired
