CHELMSFORD ROOD CONDITION AND LEAK SURVEY 05/05/2022, 9:05 AM

Thursday, 5 May 2022

20 Items Identified

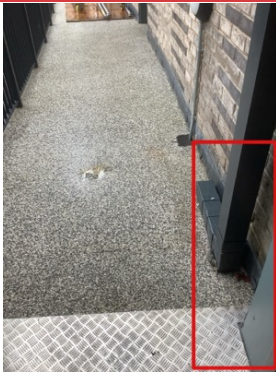
ITEM 1

Area of interest with clear discolouration to brick work.

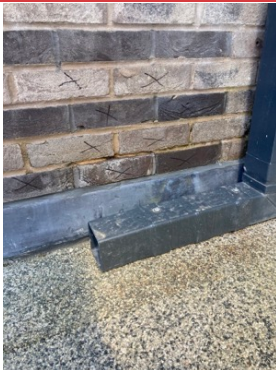
ITEM 2

Brick work marked ready for removal to inspect the behind cavity. This picture was taken on my first visit 20/4 and no action taken to explore the possibility of water getting into the cavity.

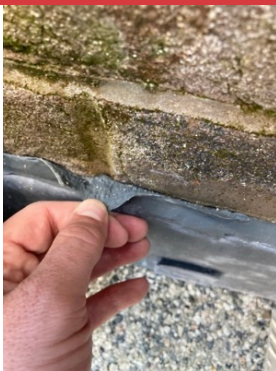
ITEM 3

Picture taken on my first visit 20/4 of mastic failing.

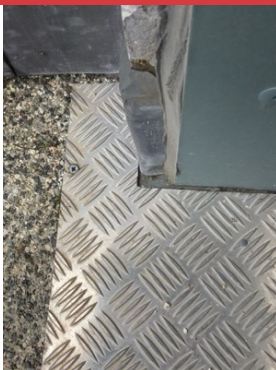
ITEM 4

Door plate needs removing to investigate in and around threshold. If resin finishes at door line, it will need removing in order to investigate the build up. Please refer to items 11 & 12 as the Up-stands don't seem to be sufficient and high enough to keep water out the building?

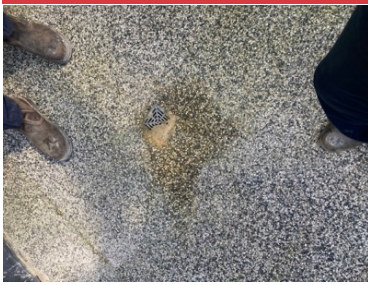
ITEM 5

Ponding evident in the discolouration of resin bond. Outlet grate half blocked by area of water ingress into flat 21.

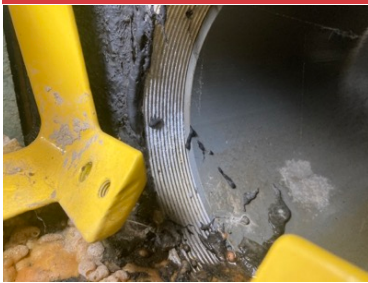
ITEM 6

First outlet inspected shows the PVC spigot not being screwed into outlet far enough? No evidence of glue or PTS tape around connection area.

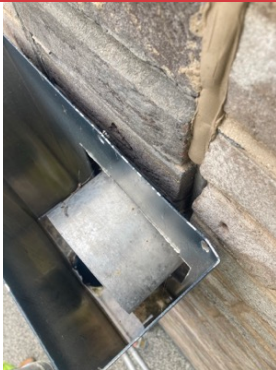
ITEM 7

Hoper side of outlet. Clear opens in brickwork and mastic evident. If capillary reaction happens, water will run under the pipe and back towards the brick and cavity.

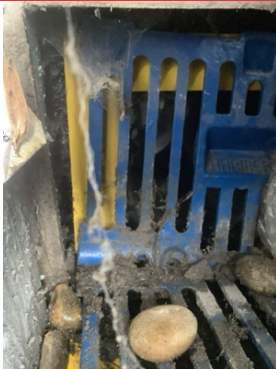
ITEM 8

Outlet of interest directly above area of leak to the inside of apartment 21. Ref items 1 & 2

Outlet grill could not be removed due to insulation.

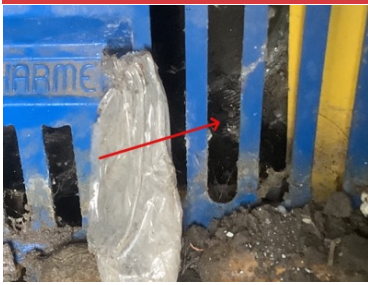
ITEM 9

Again the thread could be seen through the the leaf guard. PVC spigot not screwed into outlet far enough? No evidence of glue or PTS tape around connection area.

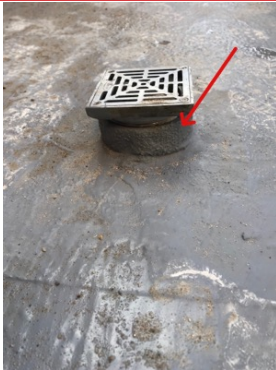
ITEM 10

After speaking with John weller, he advised that holes where penetrated in the side of the outlet to disperse water under the resin bond.

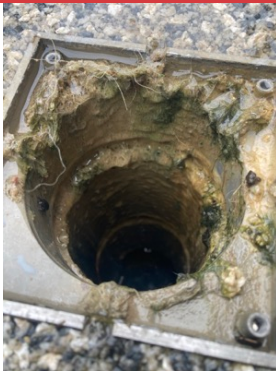
ITEM 11

The grill was removed for inspection and clearly evident that no holes penetrating the outlet for water dispersal under resin bond.

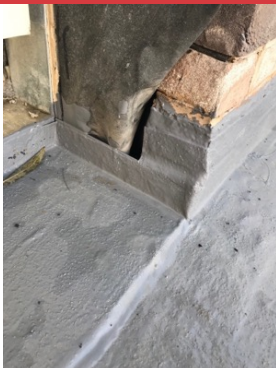
ITEM 12

Upstand to close the cavity installed at the same height if not slightly lower than FFL. Any drainage issues would mean water could potentially back up and over small upstand. I've been advised that this detail was the same to doors/entrances and in the location of the leak to flat 21

Please provide section detail/dimensions of screed and resin build up as the screed level maybe higher than the upstand highlighted in the picture so water may breach the upstand filling the cavity.

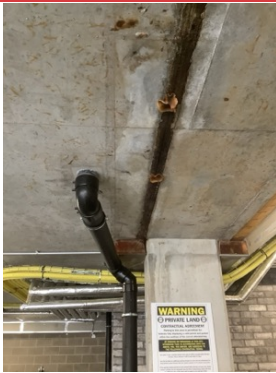
ITEM 13

Expansion joint in car park growing fungi suggesting water/damp issues.

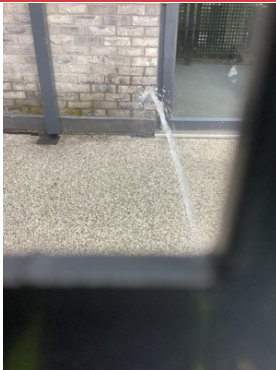
ITEM 14

Water test carried out to above expansion joint shown in item 13

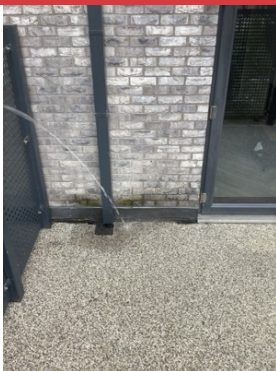
ITEM 15

Water test carried out to above expansion joint shown in item 13

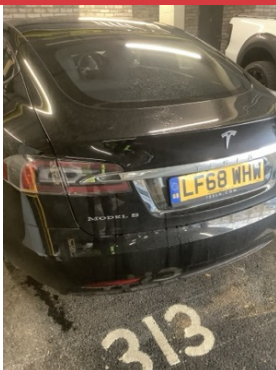
ITEM 16

After 20mins of water testing water droplets could be seen on the underside of expansion joint.

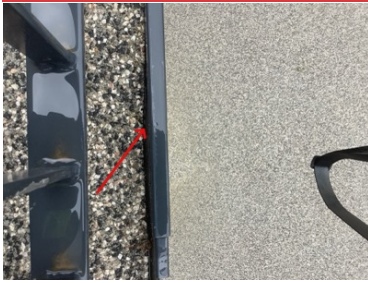
ITEM 17

Water can be seen ponding between resin bond and upstand after light rain.

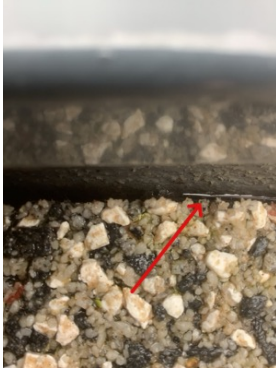
ITEM 18

Water can be seen ponding between resin bond and upstand after light rain in different location.

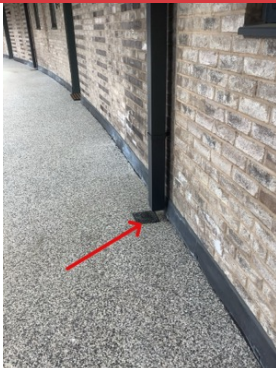
ITEM 19

Outlets to level 1 have covers which prevents water draining correctly.

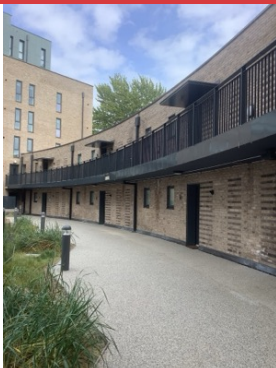
ITEM 20

With the dispersal of water from main roof to the walkway on level 2 and the water not being able to discharge under the resin bond correctly due outlet installed incorrectly. There is clear drainage issues here.

With the water discharging from all areas on to level 1 podium and the outlets being covered over, it's clear there is water drainage issues?
