LEYLAND COURT ROOF CONDITION REPORT FLAT 35 08/04/2022, 11:53 AM

Friday, 8 April 2022

18 Items Identified

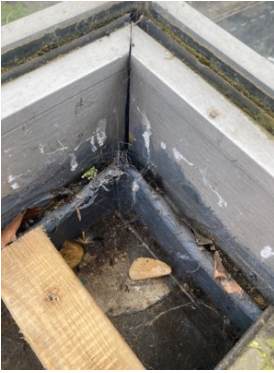
ITEM 1

Upstand waterproofing failing and has started sagging in between the upstand and balustrade.

90 degree angle balustrade needs mastic.

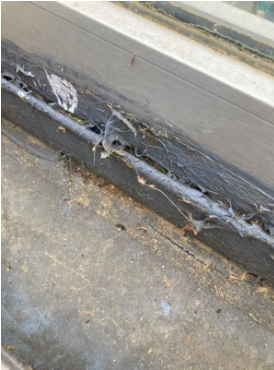
ITEM 2

Upstand waterproofing failing and has started sagging in between the upstand and balustrade.

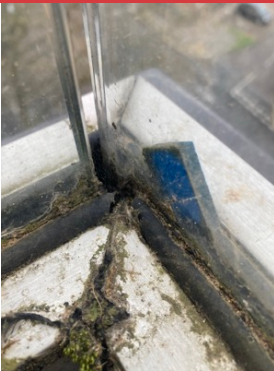
ITEM 3

90 degree angle balustrade needs mastic. Gap in glass clearly visible and open to the elements.

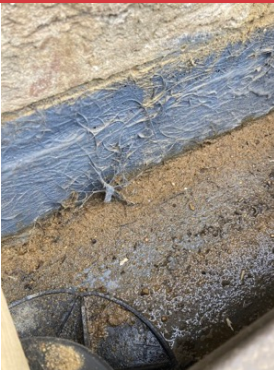
ITEM 4

Fibres in upstand waterproofing clearly visible. This leaves the waterproofing system vulnerable and could potentially let water soak up through the fibres and beyond?

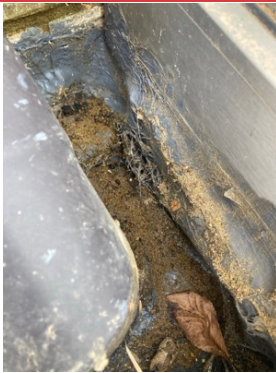
ITEM 5

Fibres in upstand waterproofing clearly visible. This leaves the waterproofing system vulnerable and could potentially let water soak up through the fibres and beyond?

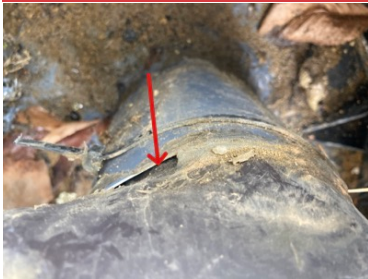
ITEM 6

Short of mastic to top of waterproofing detail on the rain water down pipe as marked in Red.

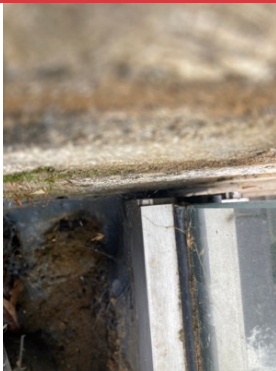
ITEM 7

Balustrade ends at the building line has no mastic and is open to the elements.

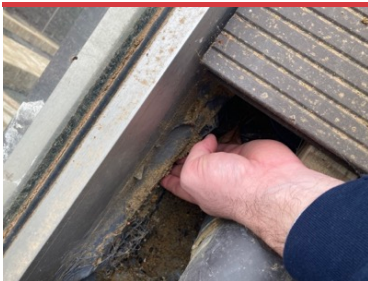
ITEM 8

Waterproofing to upstand not bonded correctly and is soft and spring at touch.

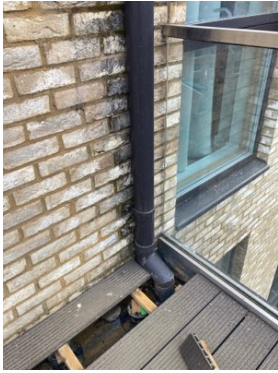
ITEM 9

Wall stained behind rain water down pipe.

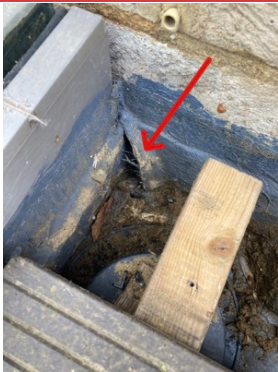
ITEM 10

Failing in waterproofing clearly visible.

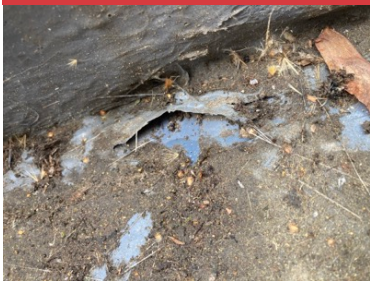
ITEM 11

Cold applied waterproofing that laps from the upstand and onto the single ply membrane is starting to delaminate.

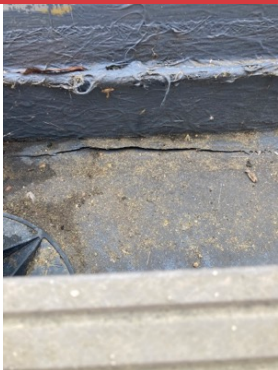
ITEM 12

Cold applied waterproofing that laps from the upstand and onto the single ply membrane is starting to delaminate.

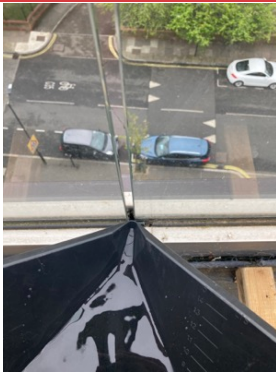
ITEM 13

Water test carried out to all joins in glass to balustrade.

Item 15 & 16 was the outcome.

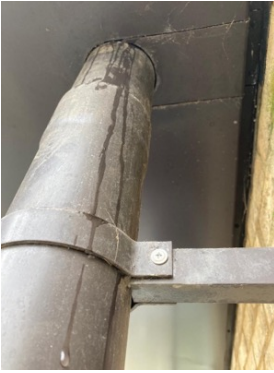
ITEM 17

Item 17 is the outcome and suggests a connection problem to outlet and down pipe.

Water can be seen coming down the rain water down pipe. I believe this from the testing carried out to outlet in item 14.

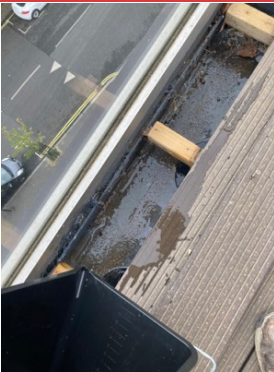
ITEM 18

Water test was carried out to flat single ply area but nothing stood out as there being any failings?
