Developer, Development, House Type, Plot Number

Saturday, 01 April 2023

102 Identified

Boiler Commissioning

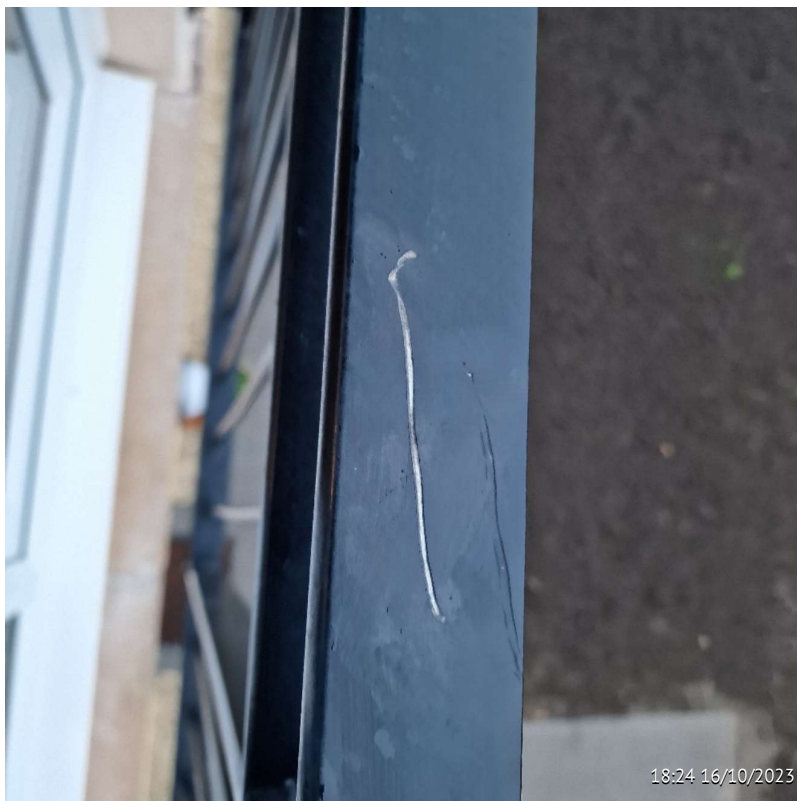
Location: Bed 1

External guardrail various areas of damage to paintwork

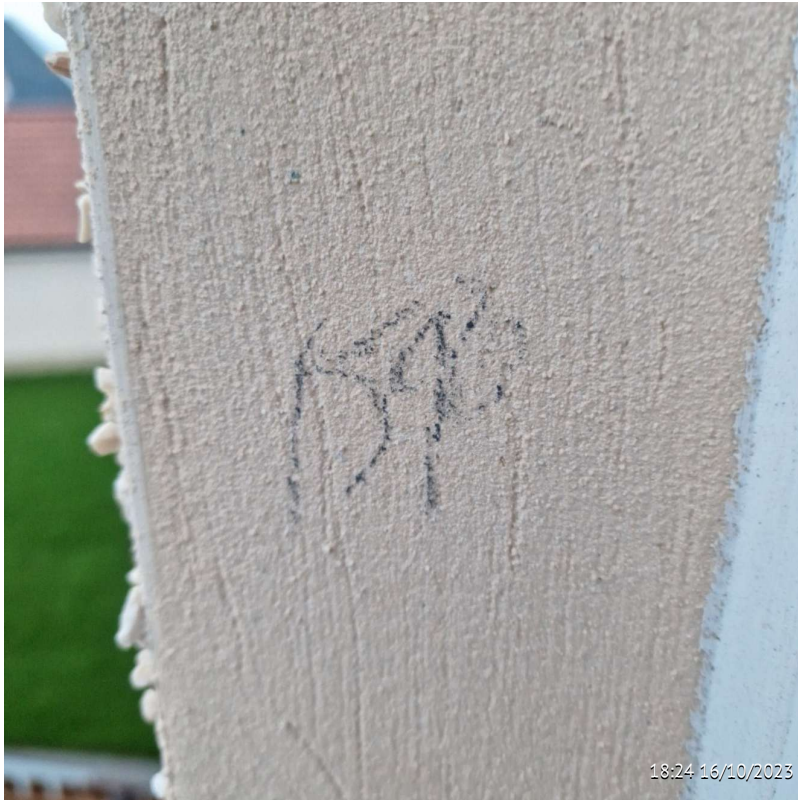
Location: Bed 1

Damage to external rendered reveal

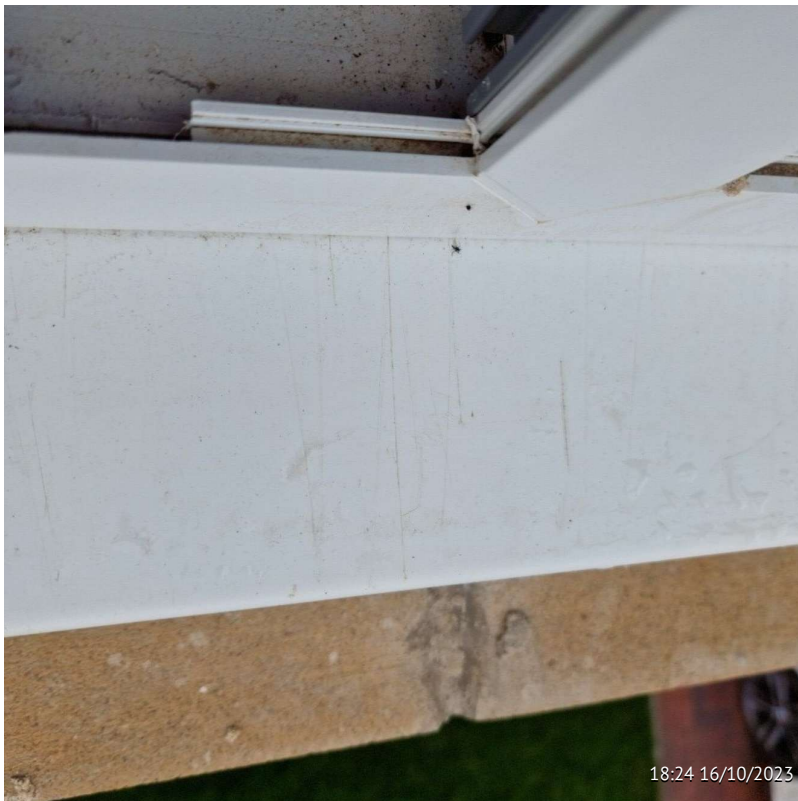
Location: Bed 3

External PVC sill excessive scratches

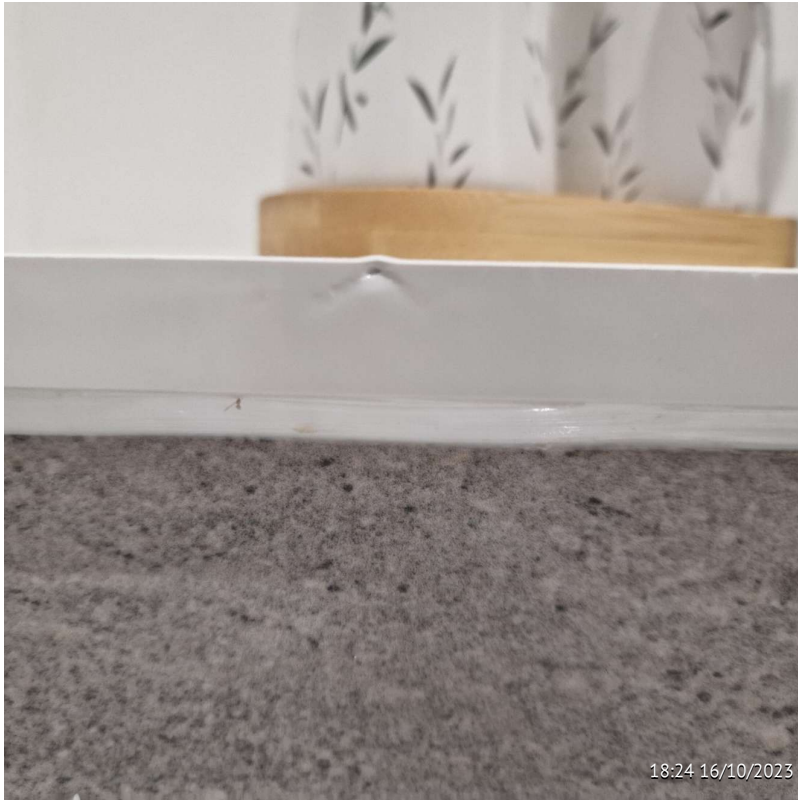
Location: Master Bathroom

Damage to bulkhead sill lip

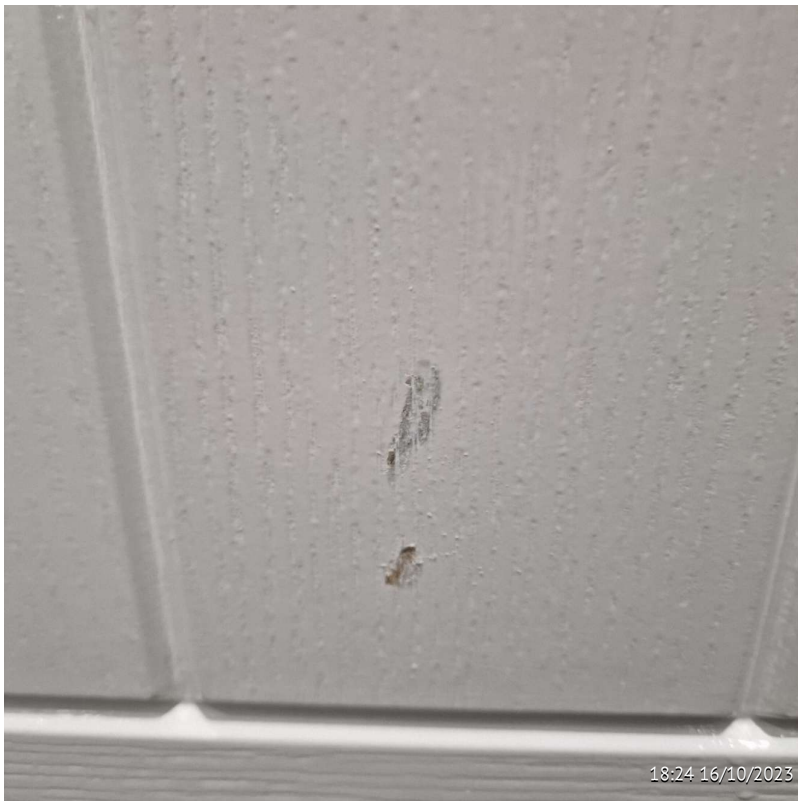
Location: Master Bathroom

Damage to door slab, bathroom face

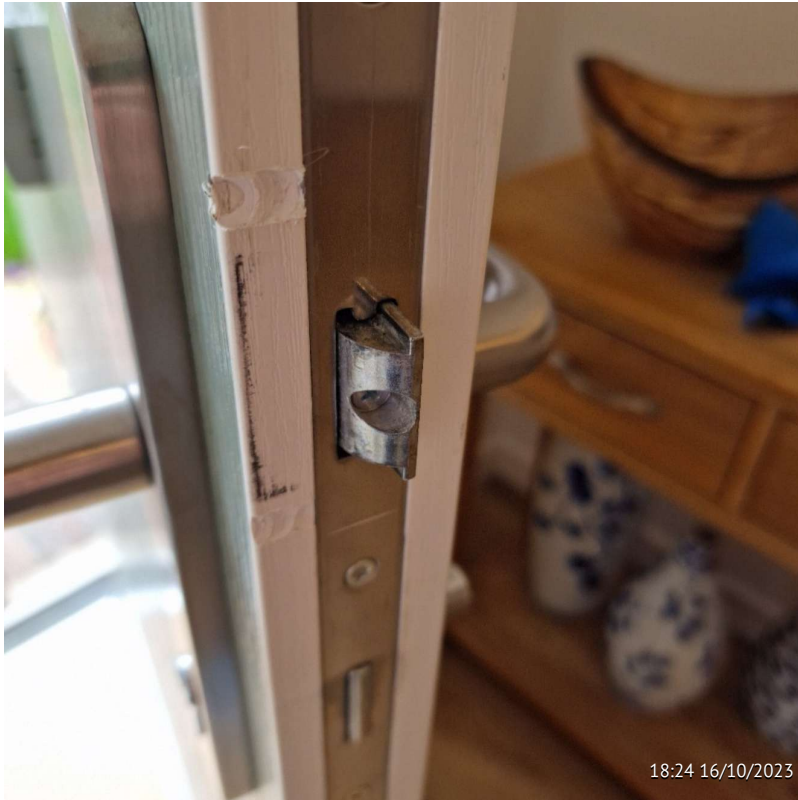
Location: Front Door

Damage to leading edge of slab

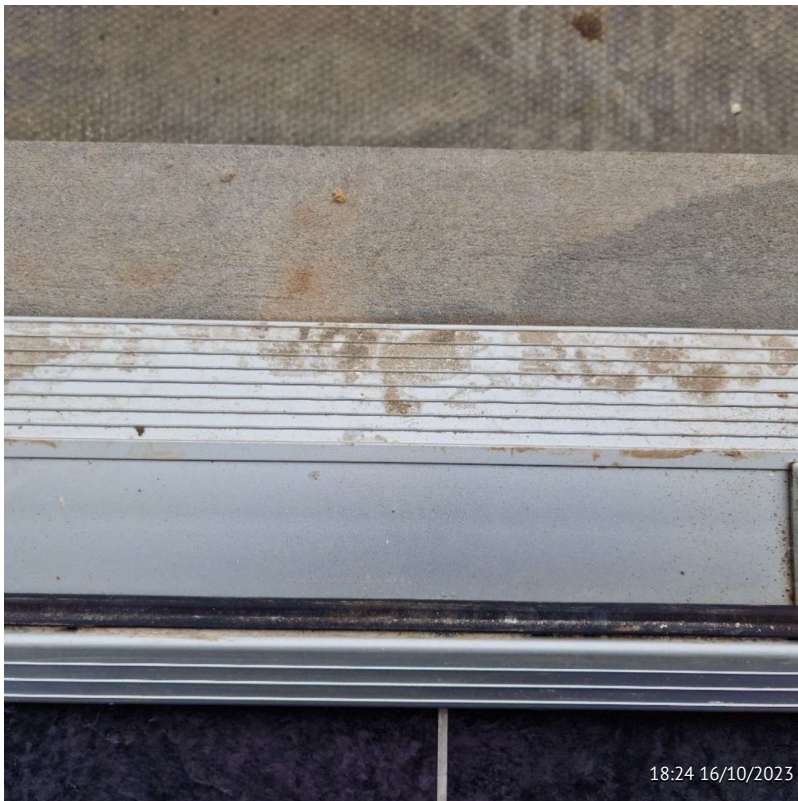
Location: French Doors

Tarnished threshold

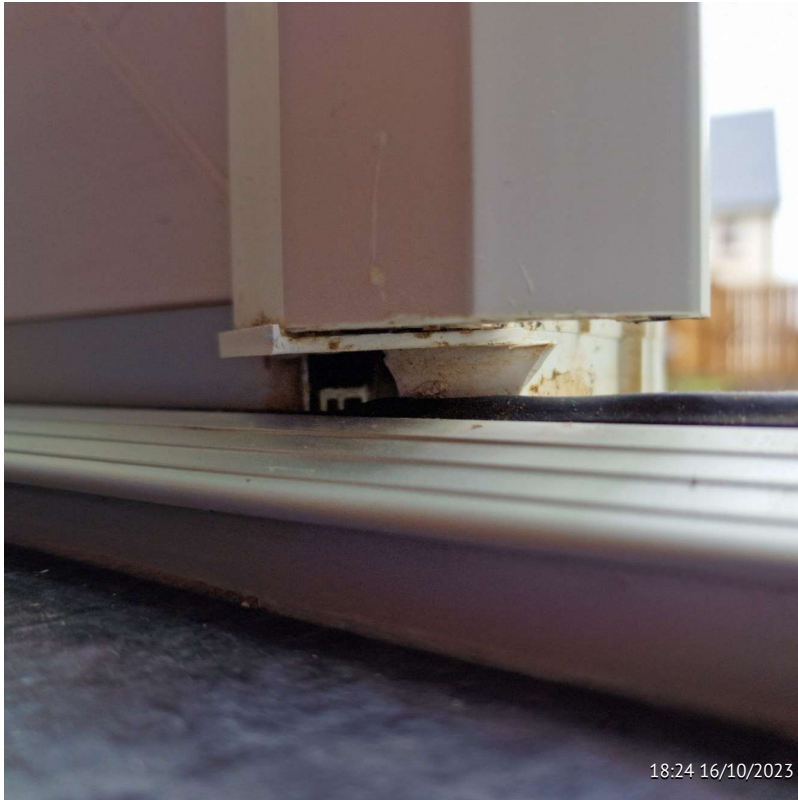
Location: French Doors

Damage to bottom of centre mullion cap

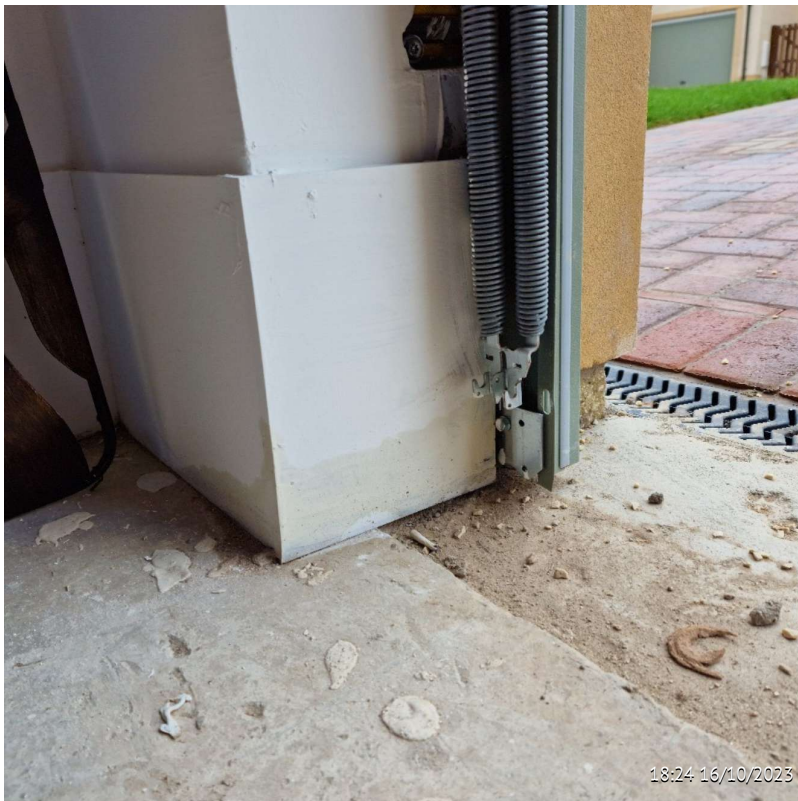
Location: Garage

Garage skirting water damaged.
Skirtings touching floorslab

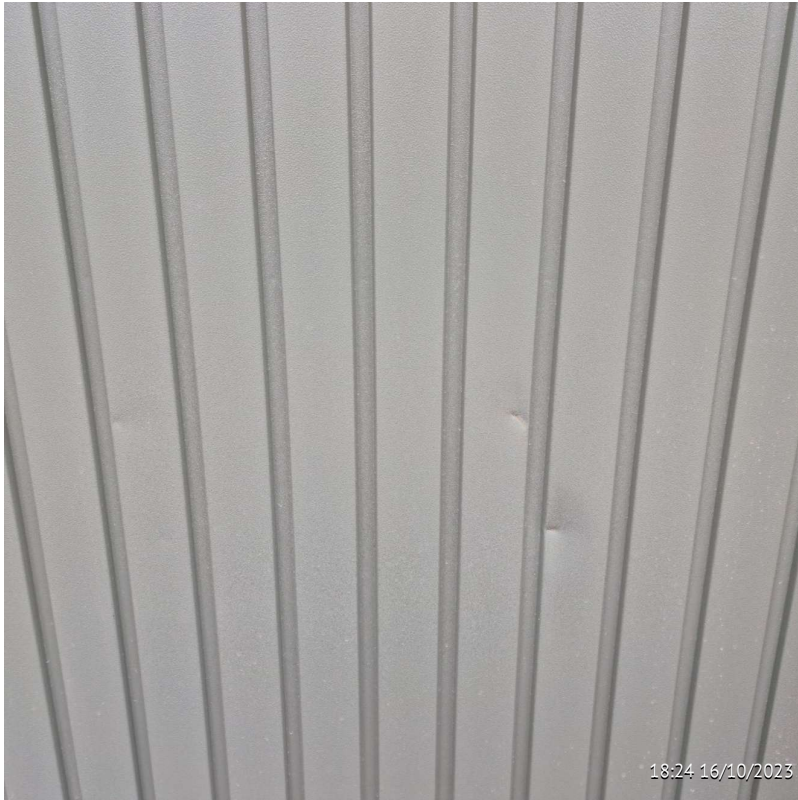
Location: Garage Door

Damages to face

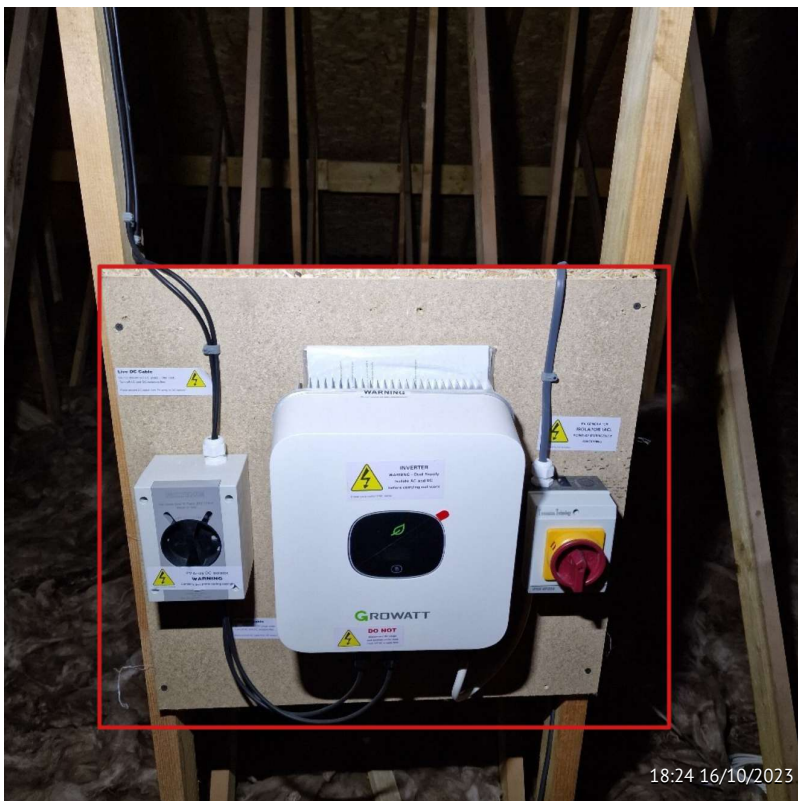
Location: Loft Space, Solar Inverter

Incorrect use of materials.
Mounting material to be non heat conductive

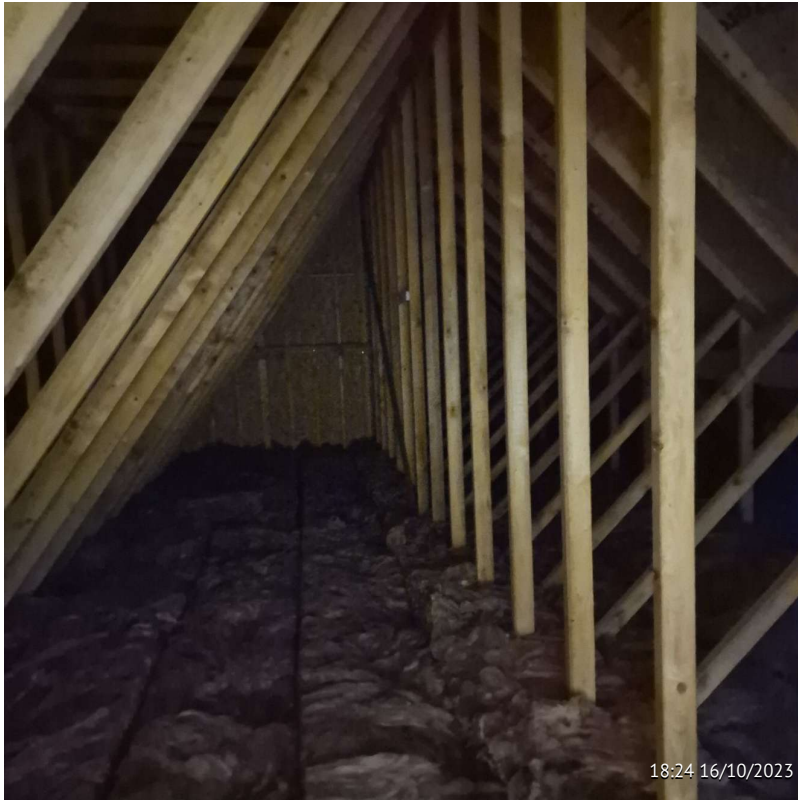
Location: Loft Space

Loft space spanning 5m or greater requirement for hard wired interlinked for smoke detection

Loft space spans 9.592m

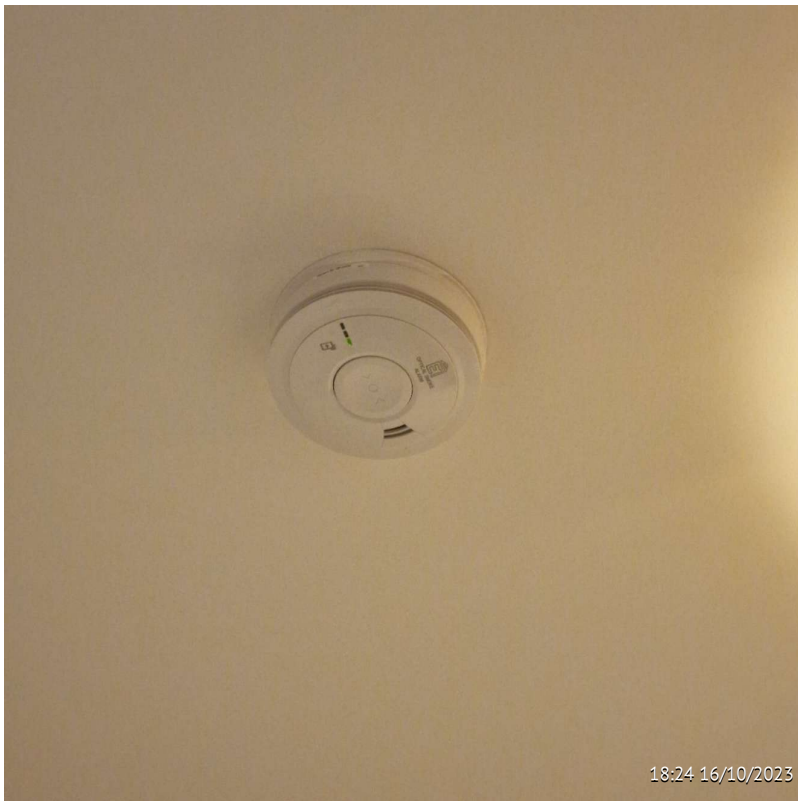
Location: Throughout Property

Smoke and heat alarms must either be interlinked by cable or by wireless radio-frequency interlink. Carbon monoxide alarms do not have to interlink with the smoke and heat alarms.

Smoke and heat alarms not sounding throughout property simultaneously, alarms not operating interlinked

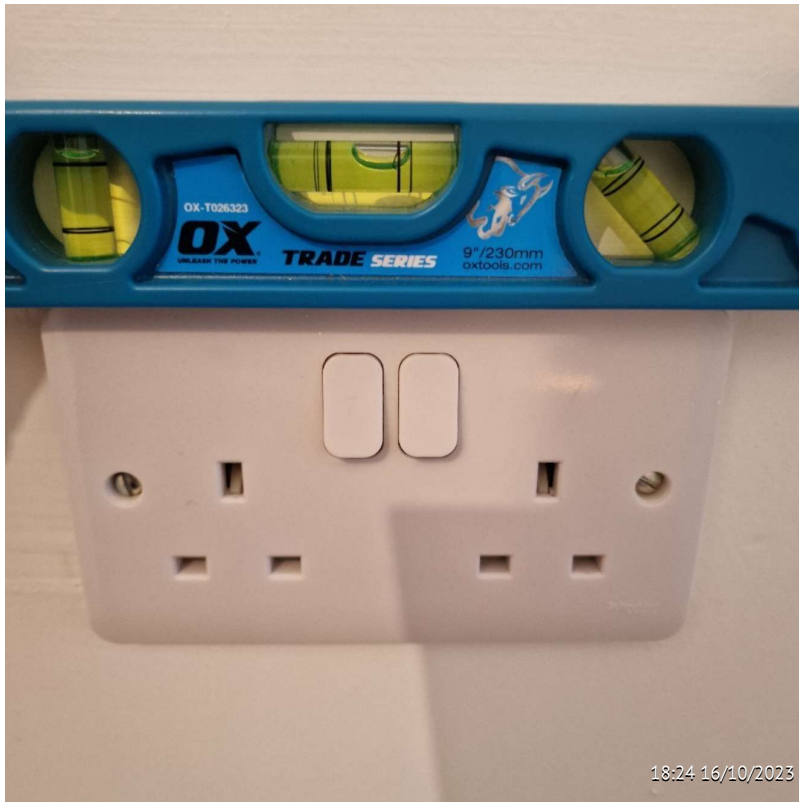
Location: Upper Hall

Double socket backing onto ensuite 1 off level

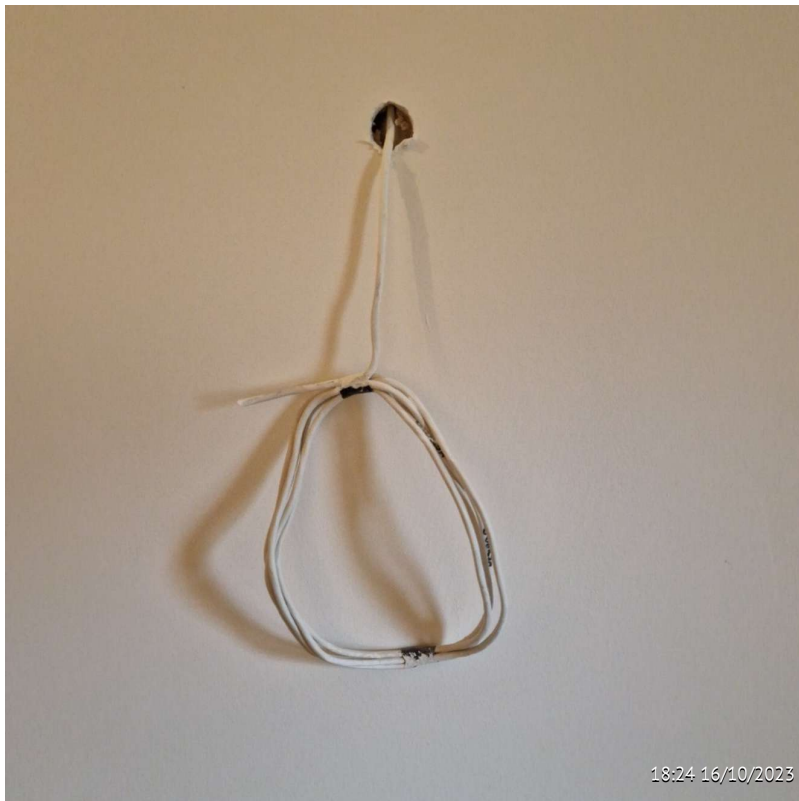
Location: Vestibule

Suspected live cable. On inspection of consumer unit, no breakers were found to be isolated. Therefore, the assumption is that cables are live

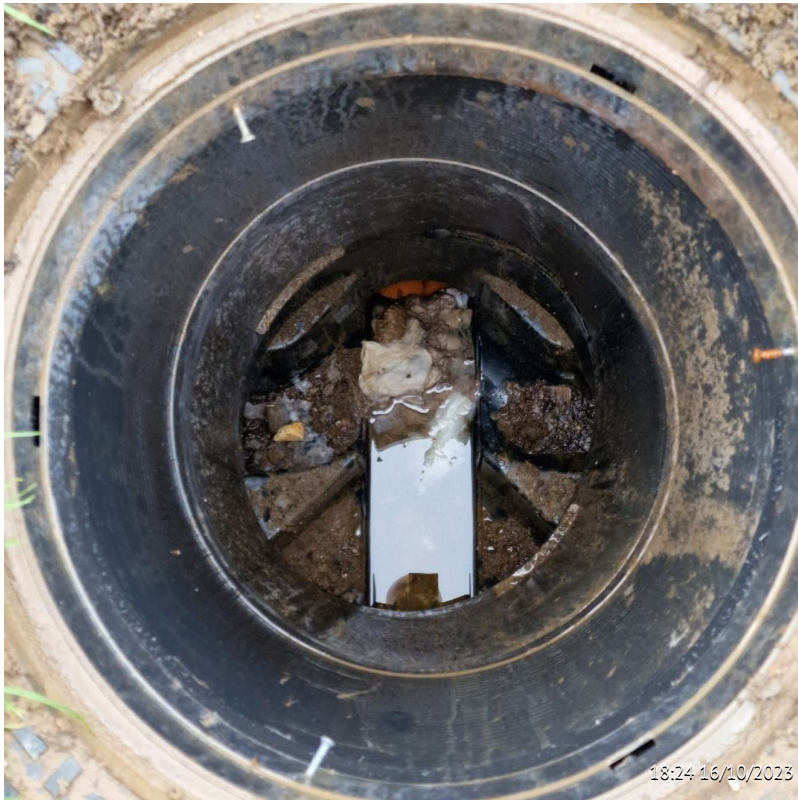
Location: Foul Disconnection Chamber

Drainage line chocked

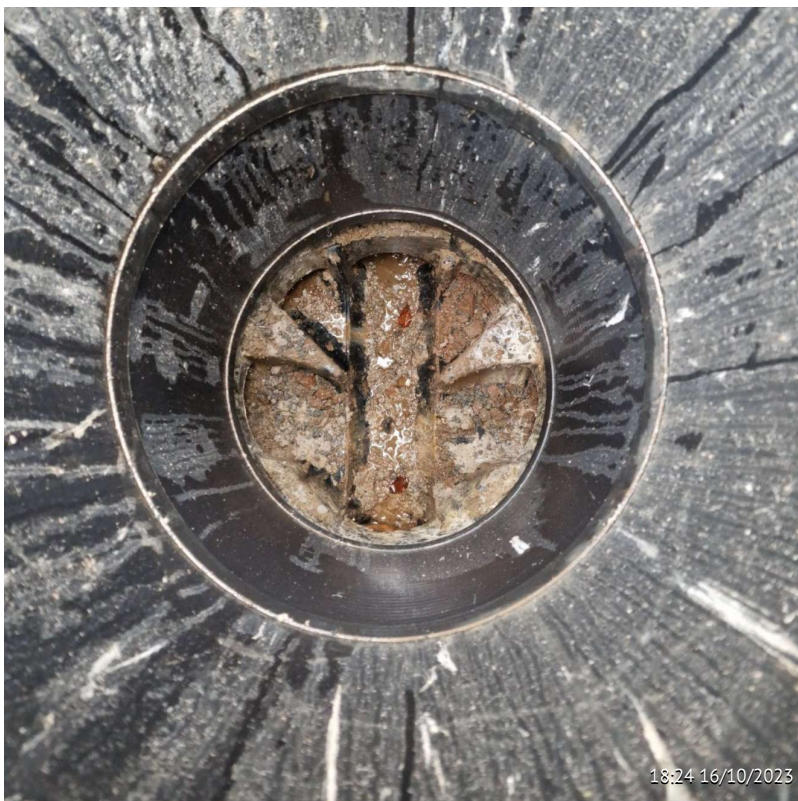
Location: Storm Disconnection Chamber

Drainage line choked with cement

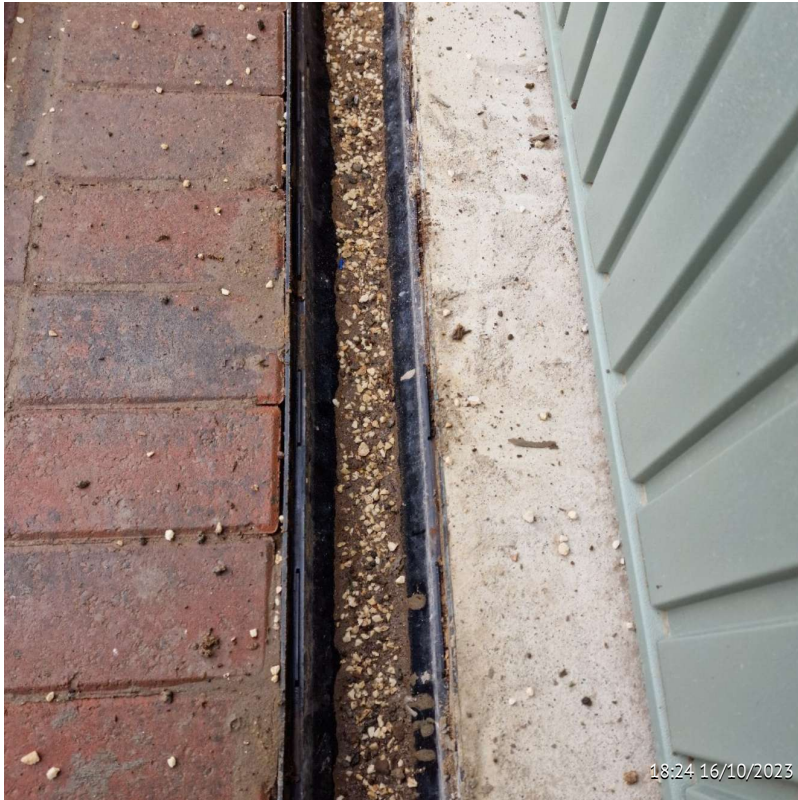
Location: Aco Channel

Drainage line chocked with debris

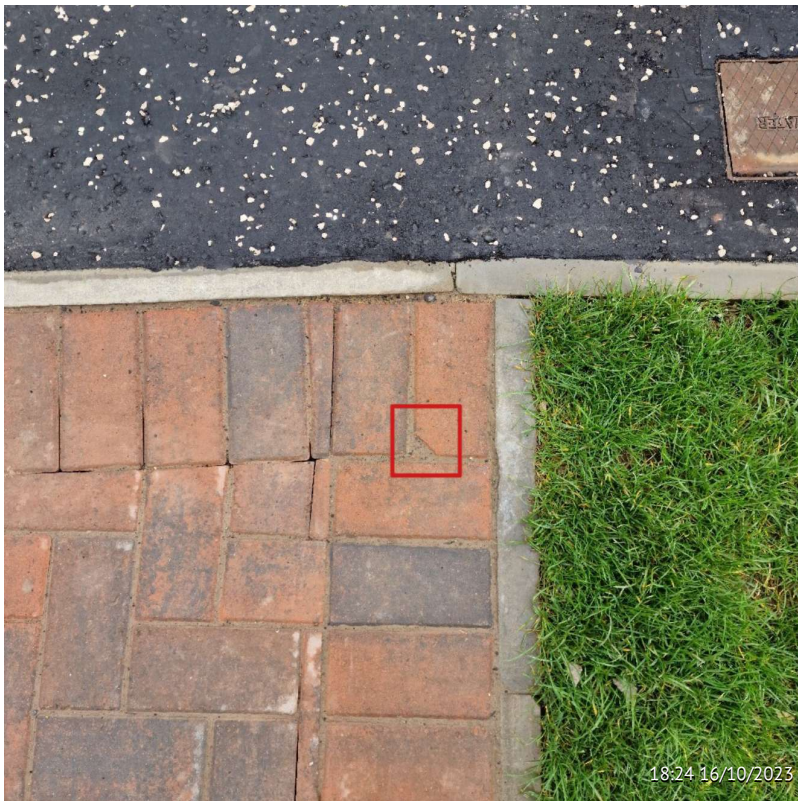
Location: Driveway

Damage to mono block

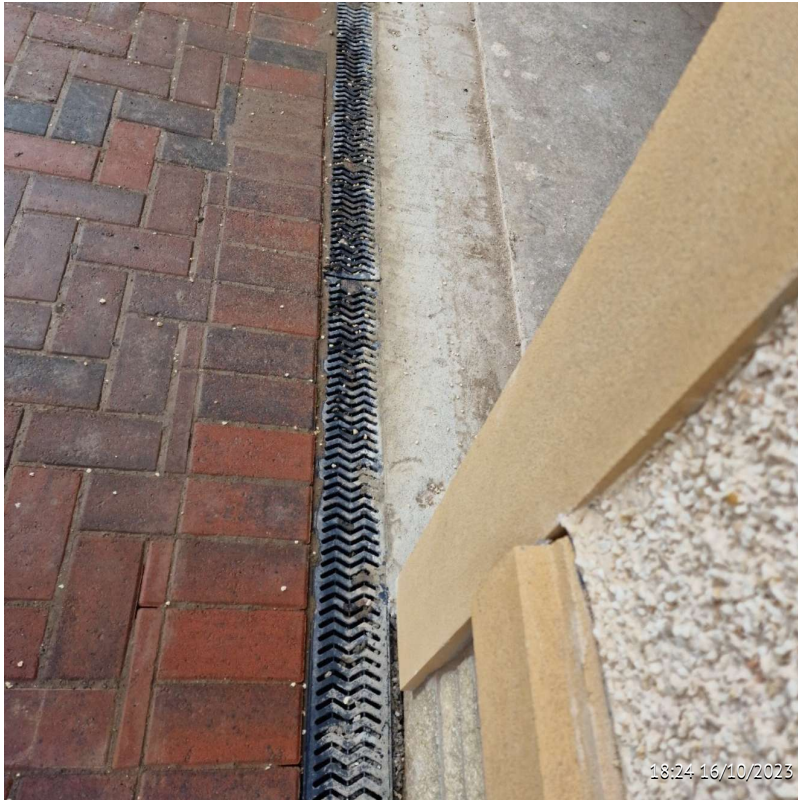
Location: Driveway

Cement stained aco gratings

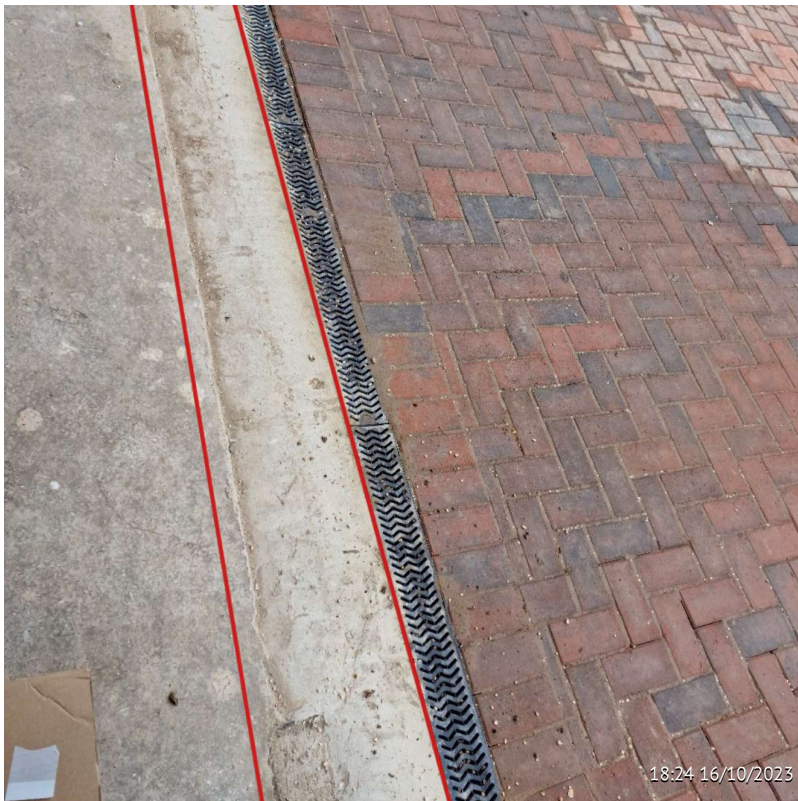
Location: Garage Floor Slab

Insufficient step to floorslab.
Minimal tolerance of 25mm water
check to avoid water ingress

Aco Channel set higher than
garage floorslab, resulting in
water ingress

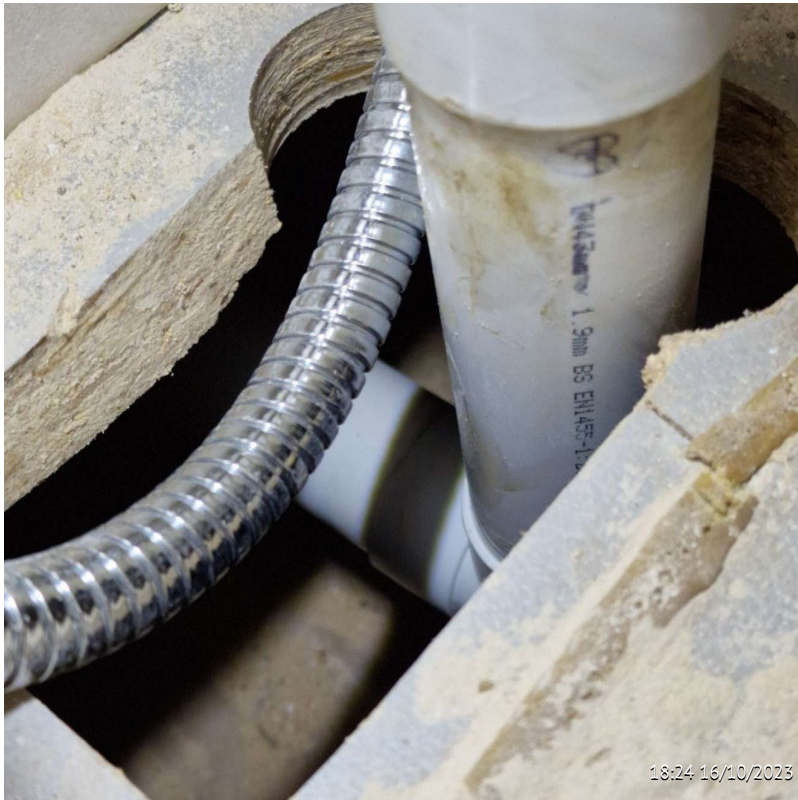
Location: Master Bathroom

No insulation visible in the mid floor level at bath waste opening

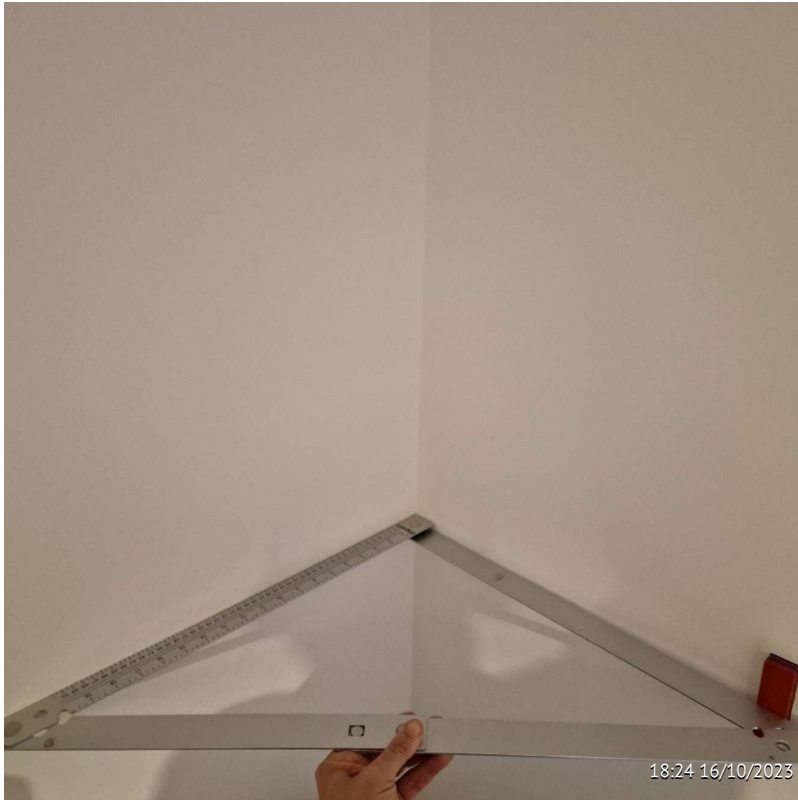
Location: Bed 1

Partition backing onto ensuite
gable out of alignment +19mm
within 500mm

Tolerance of maximum +10mm
within 500mm

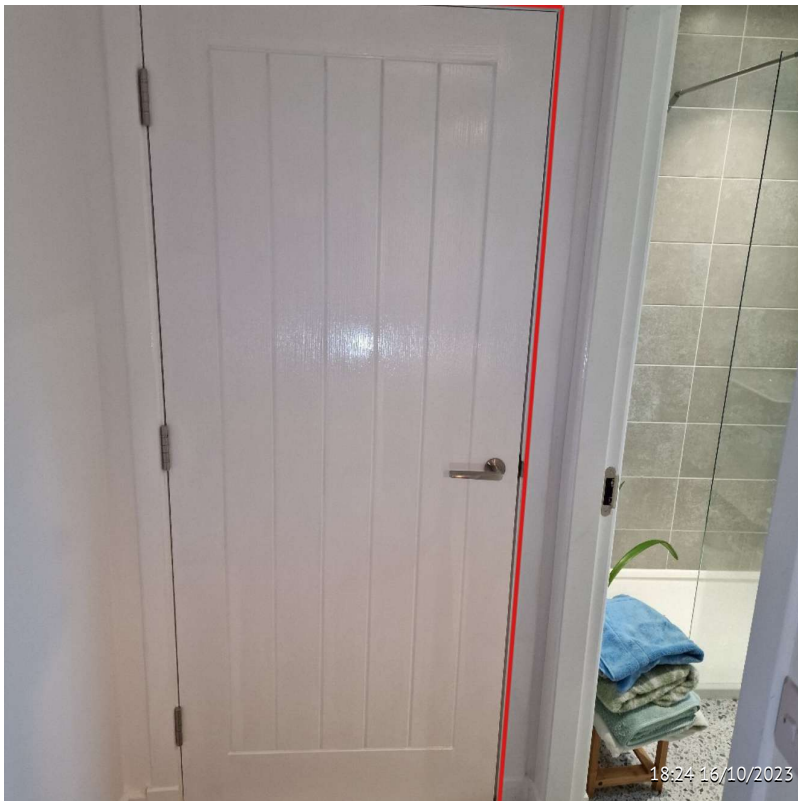
Location: Bed 1

Inconsistent door margins
exceeding 4mm tolerance gap

Door margins 8mm to 0mm

Door rubbing at head

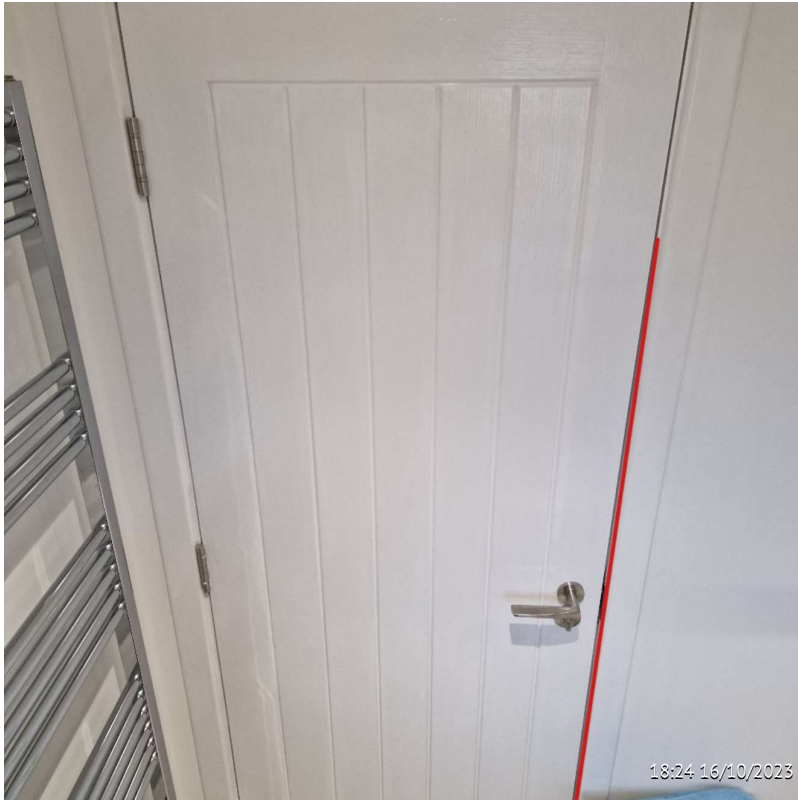
Location: Ensuite 1

Inconsistent door margins
exceeding 4mm tolerance gap

Door margins 5.5mm to 2mm

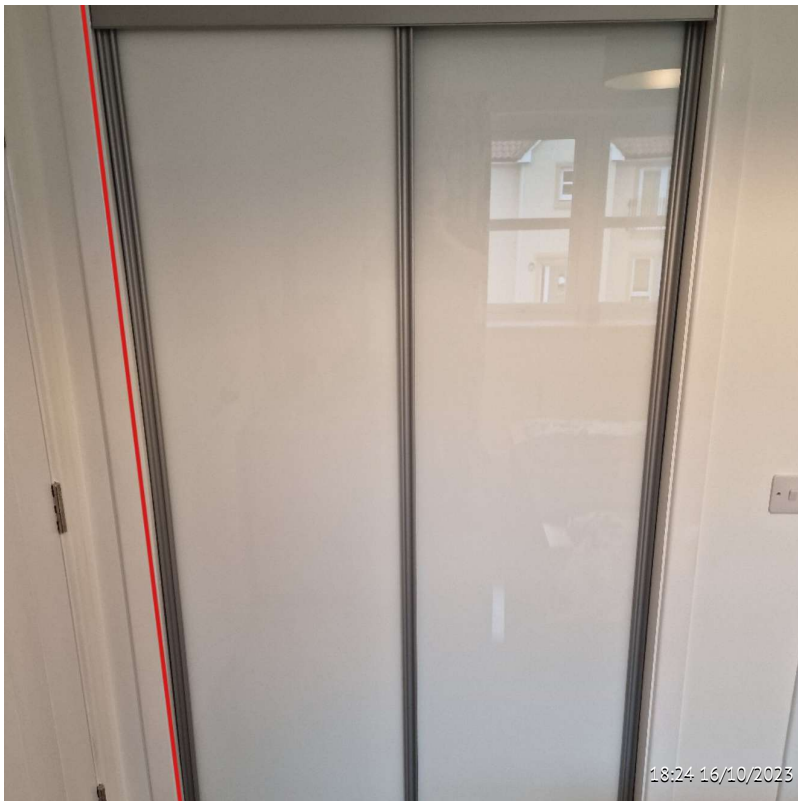
Location: Bed 2

Inconsistent alignment of
wardrobe margins

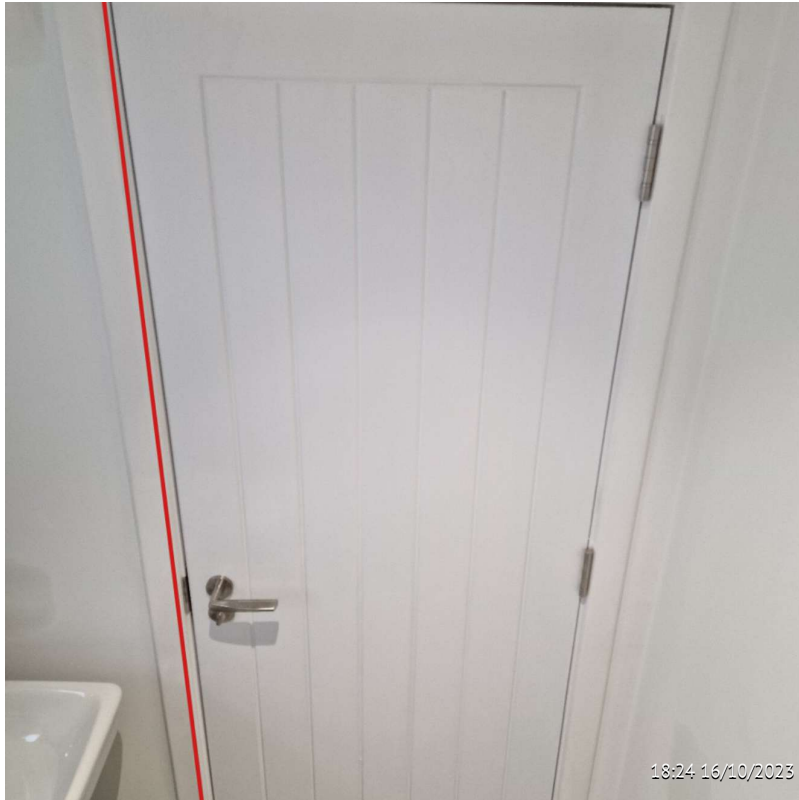
Location: Ensuite 2

Inconsistent margins exceeding 4mm tolerance gap

Door margins 6.5mm to 4.5mm

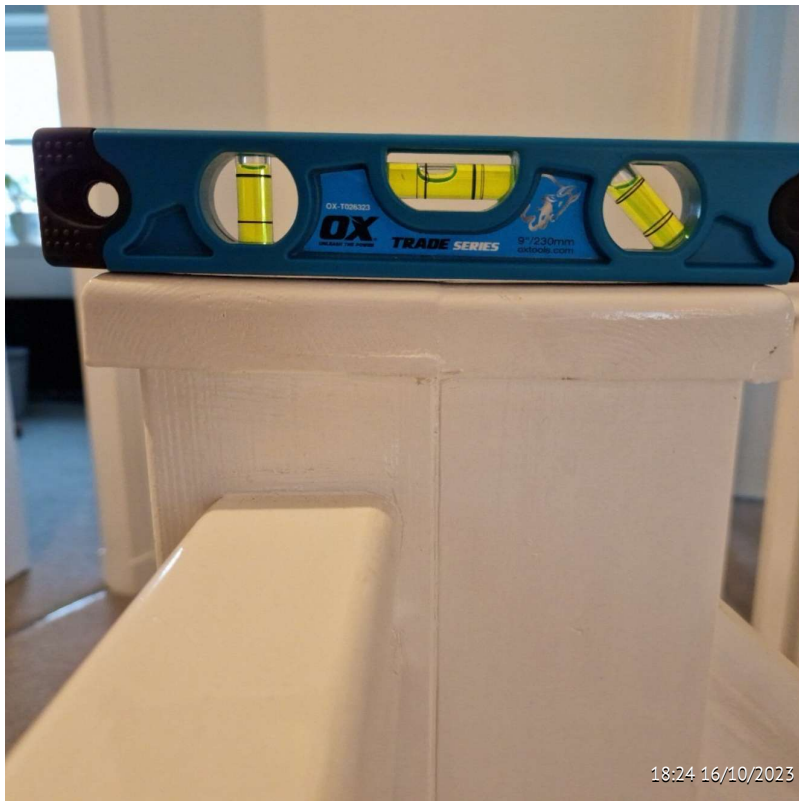
Location: Upper Hall

Upper Hall newel caps off level

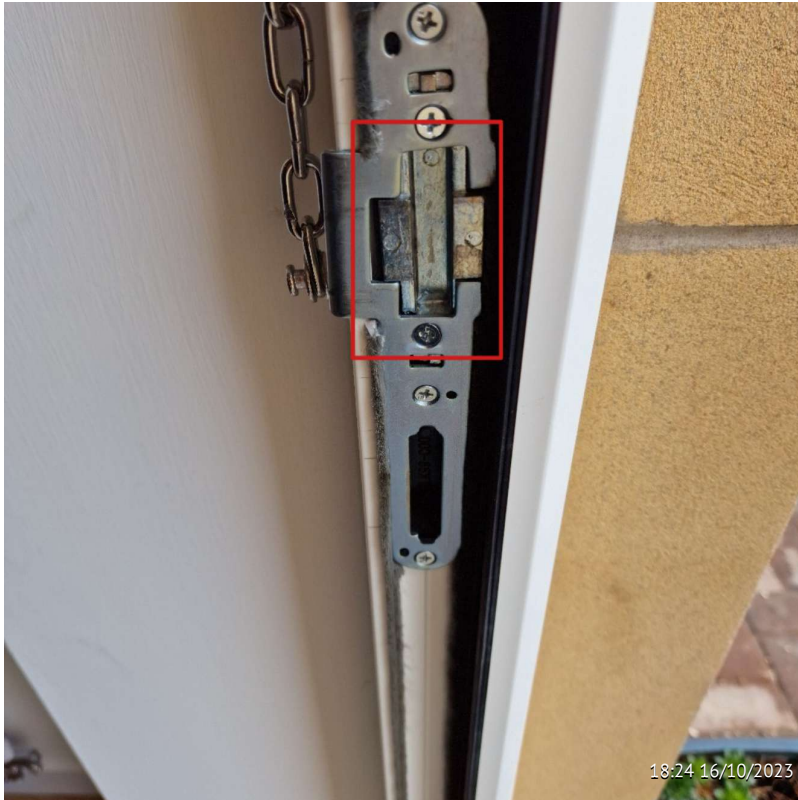
Location: Front Door

Loose locking keeper

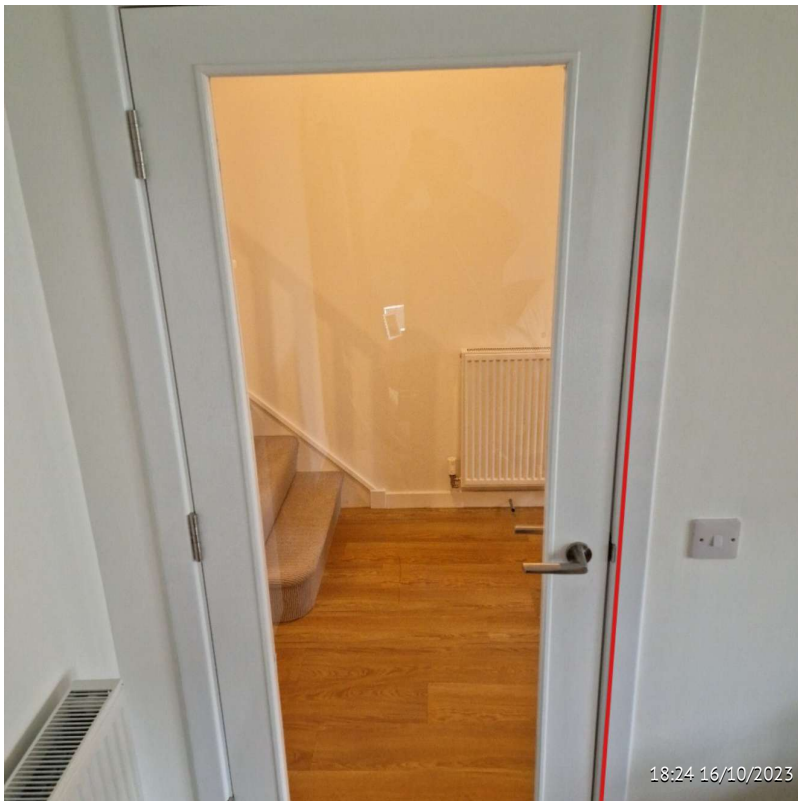
Location: Lounge

Inconsistent door margins
exceeding 4mm tolerance gap

Door margin gap 6mm to 2mm

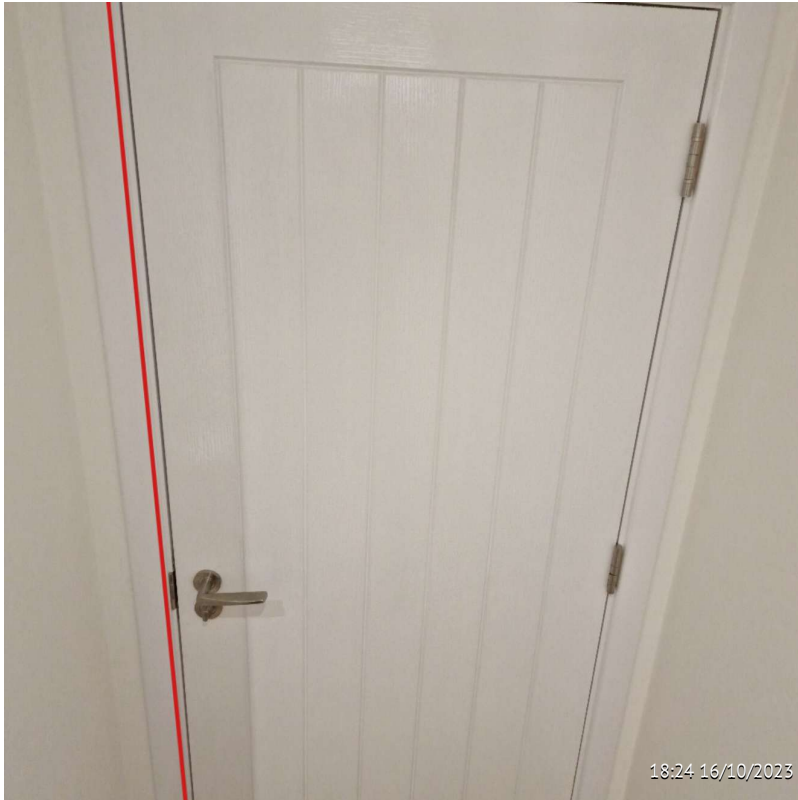
Location: WC

Inconsistent door margins
exceeding 4mm tolerance gap

Door margin gap 7mm to 3.5mm

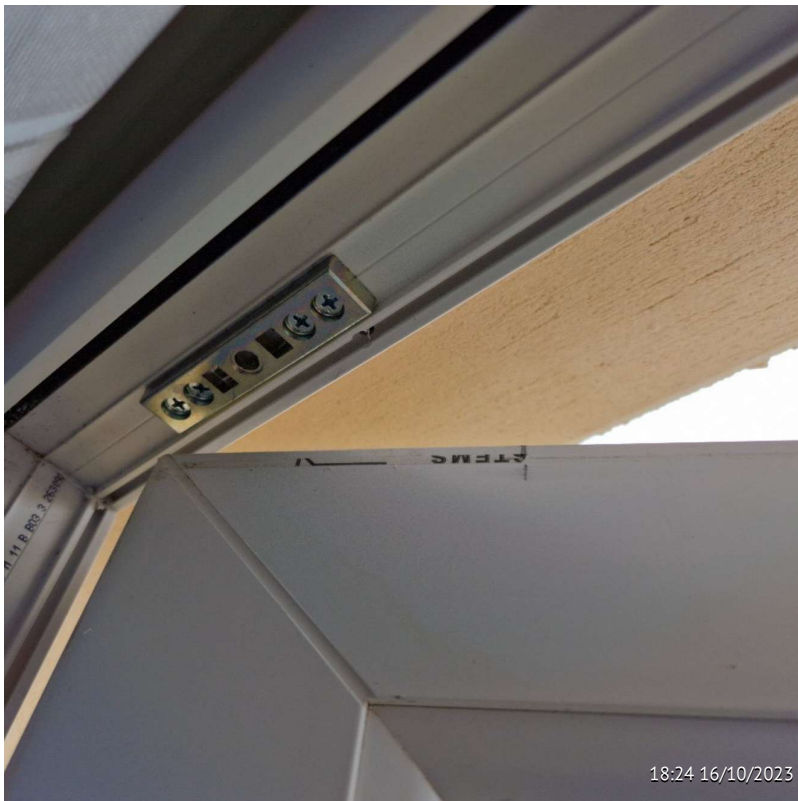
Location: French Doors

French door stays removed, no
restriction to avoid doors
connecting with external reveals

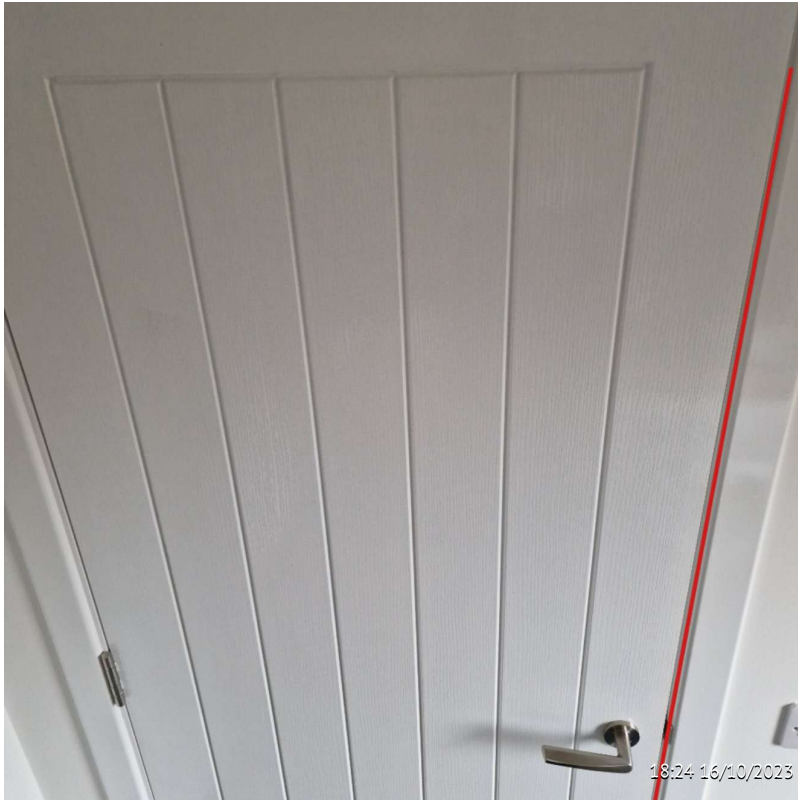
Location: Kitchen/Utility

Inconsistent door margins
exceeding 4mm tolerance gap

Door margin gap 7m to 4mm

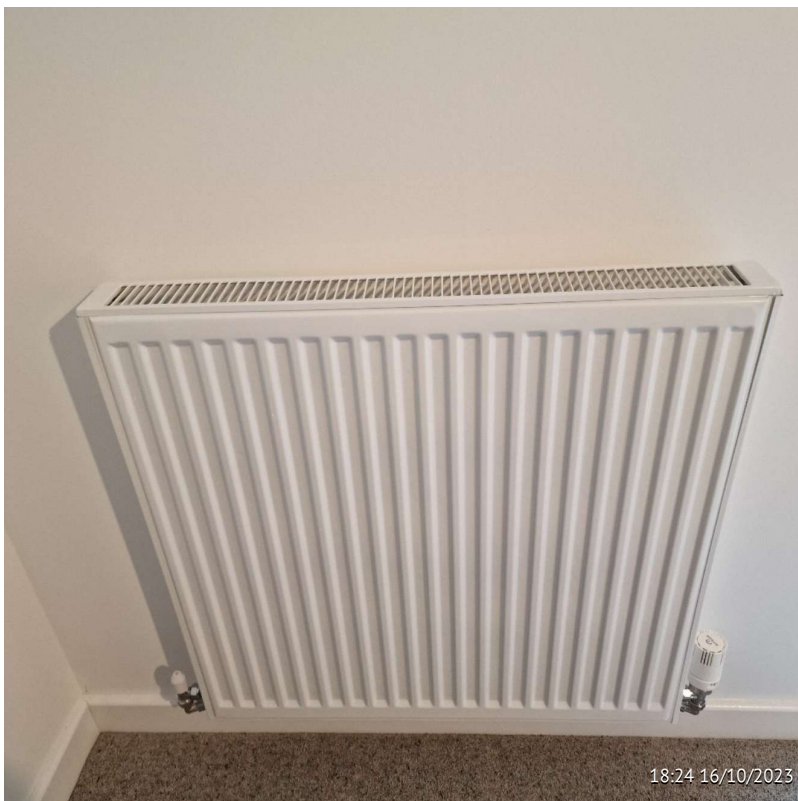
Location: Bed 1

Radiator not heating fully

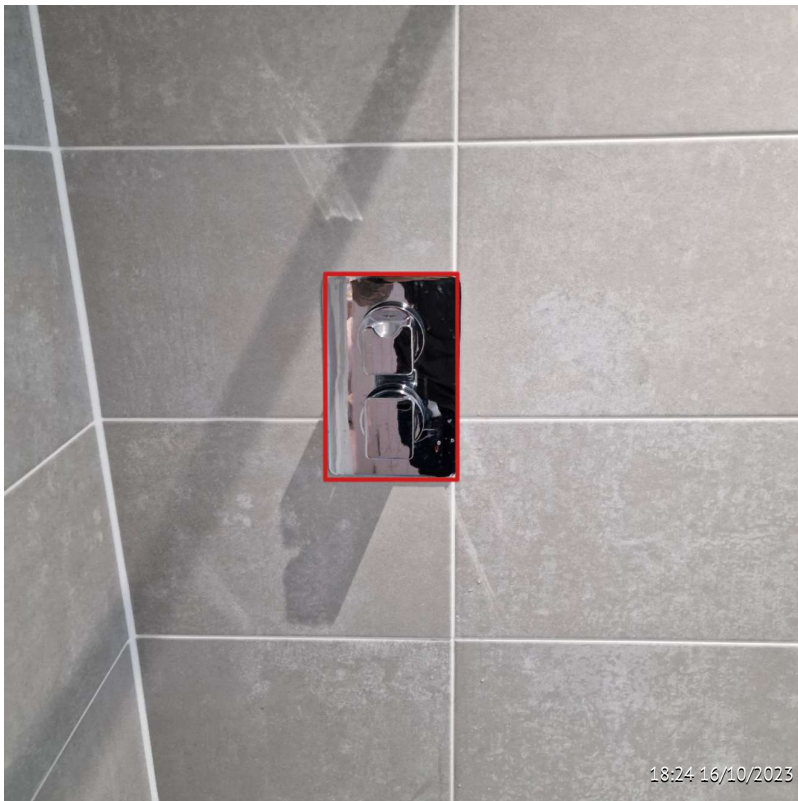
Location: Ensuite 1

Loose shower face plate
