Developer, Development, House Type, Plot Number

Saturday, 01 April 2023

102 Identified

Boiler Commissioning

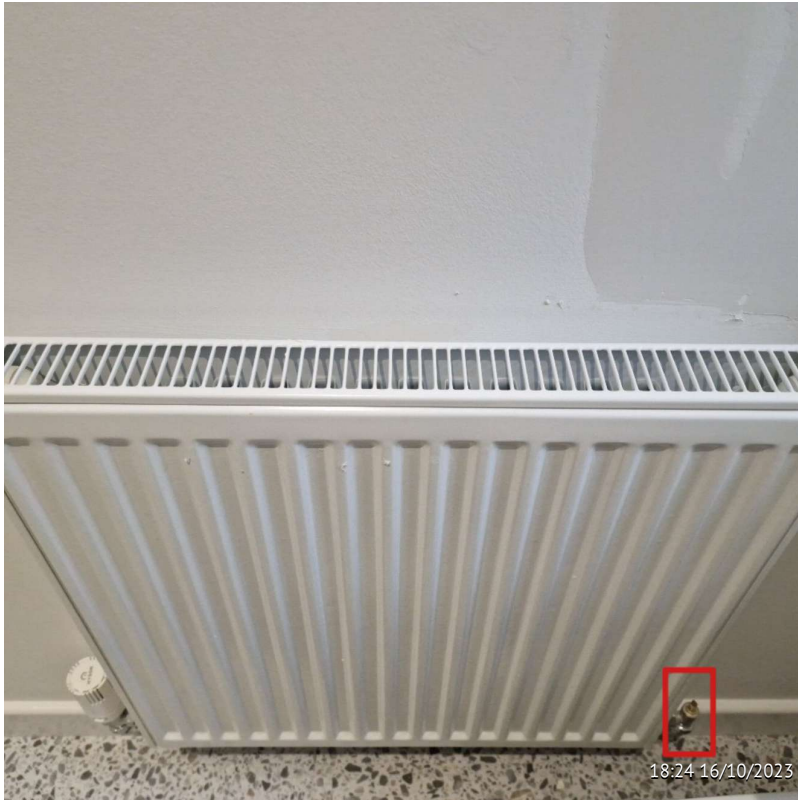
Location: Ensuite 2

Radiator not heating fully

Cover cap missing at right hand side

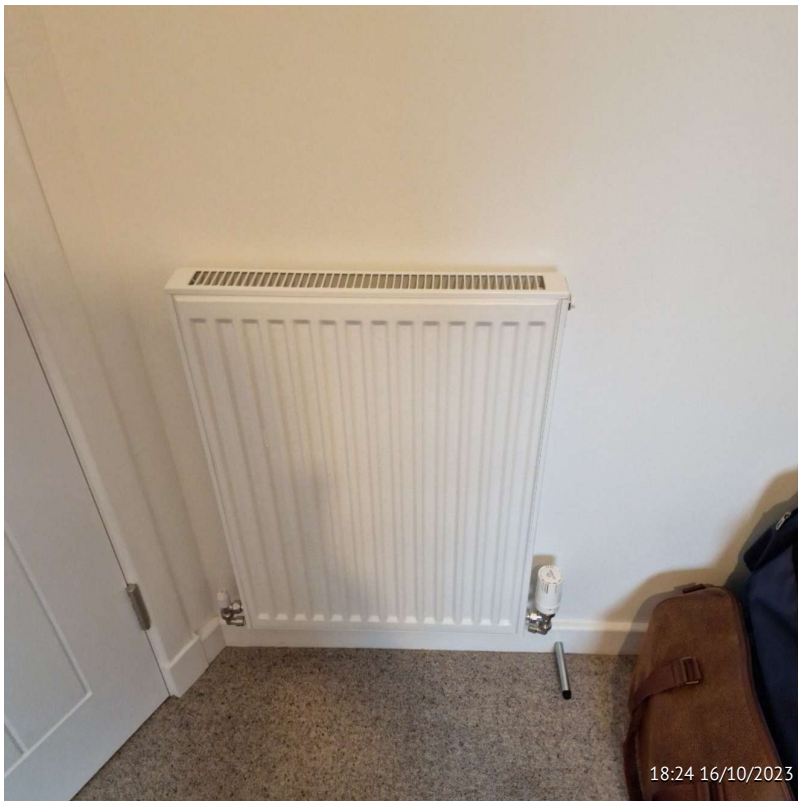
Location: Bed 4

Radiator not heating fully

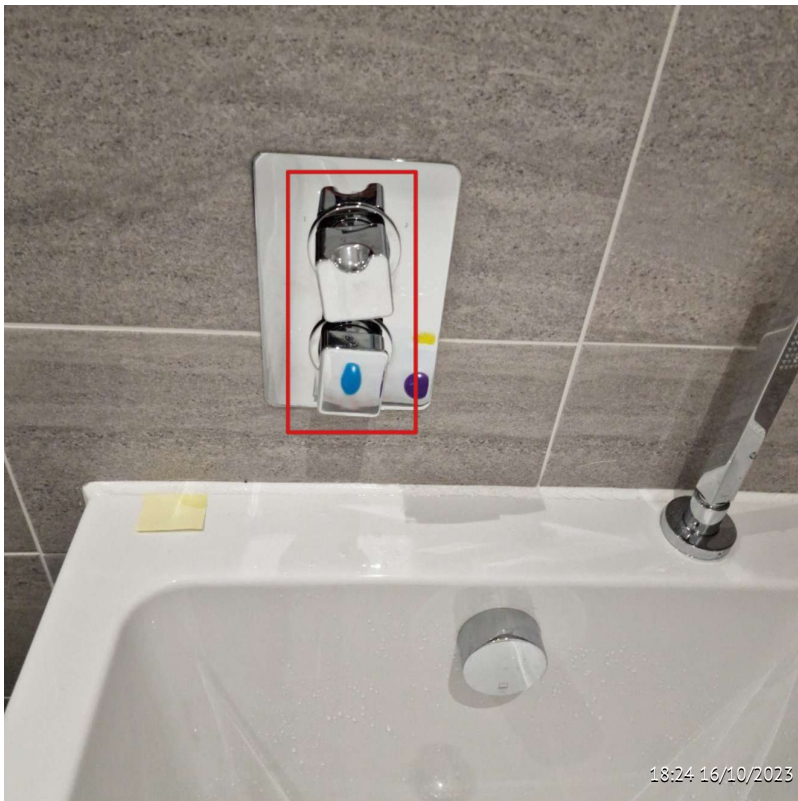
Location: Master Bathroom

Adjustment required to align bath controls

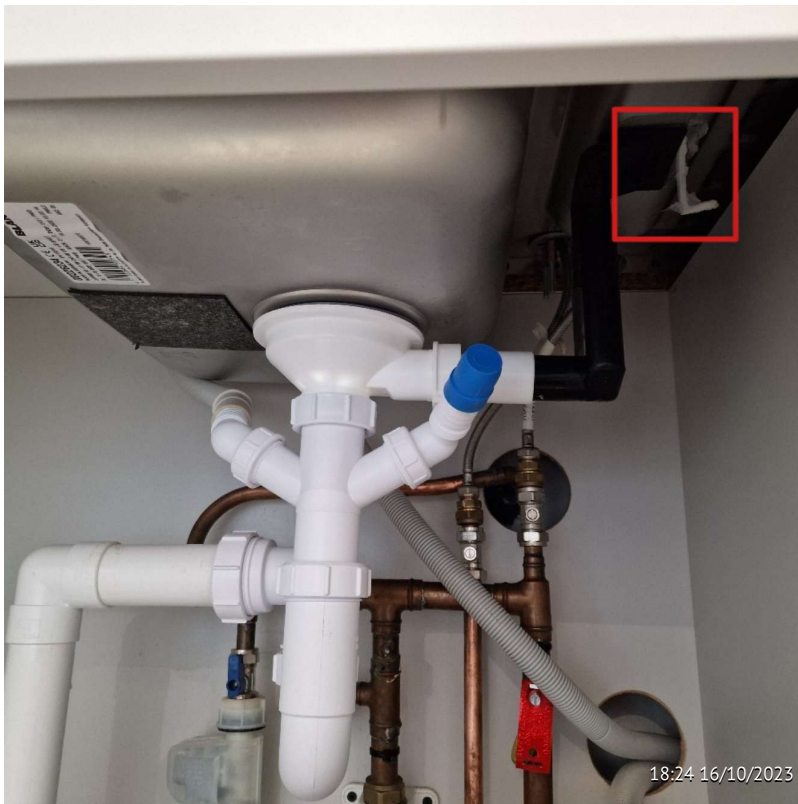
Location: Kitchen

Kitchen overflow leaking

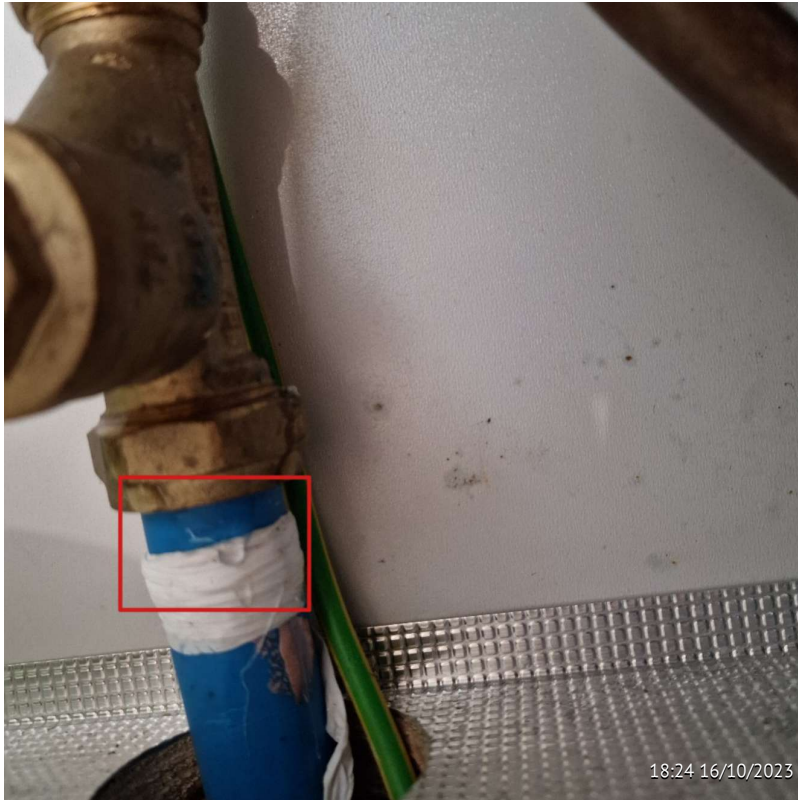
Location: Kitchen Base Unit

Leak visible at water pipe fitting

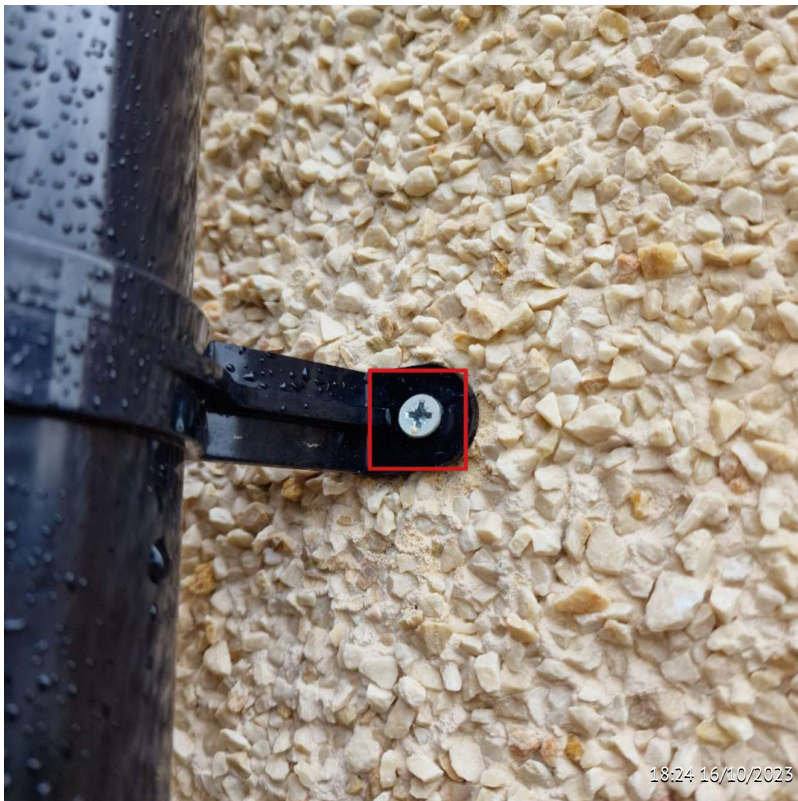
Location: Down Pipes

Incorrect fixings in use at
downpipe brackets.

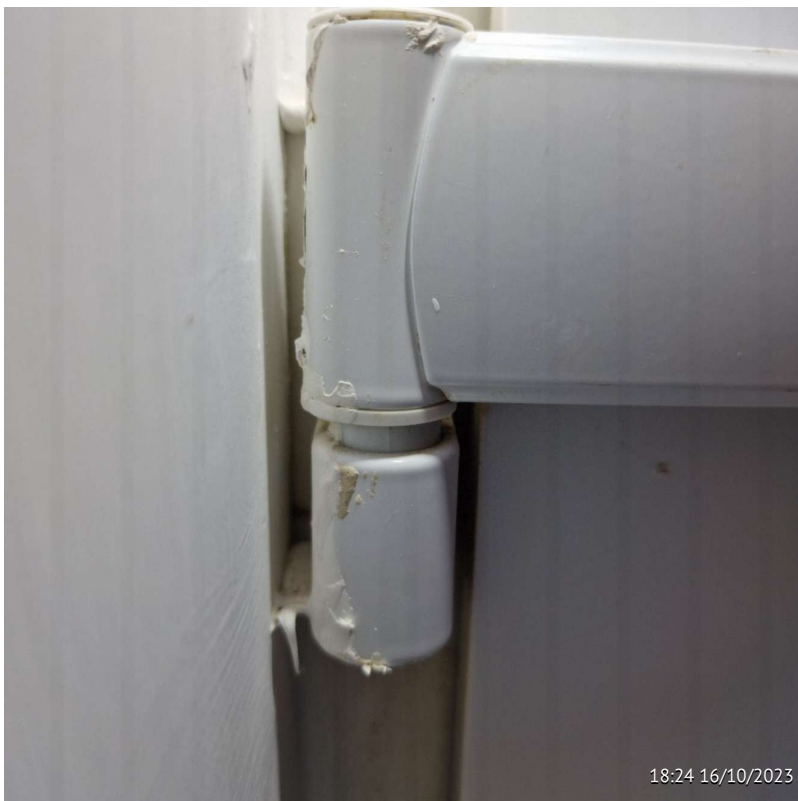
Location: Bed 1

Missing sealant to rear of external door hinges

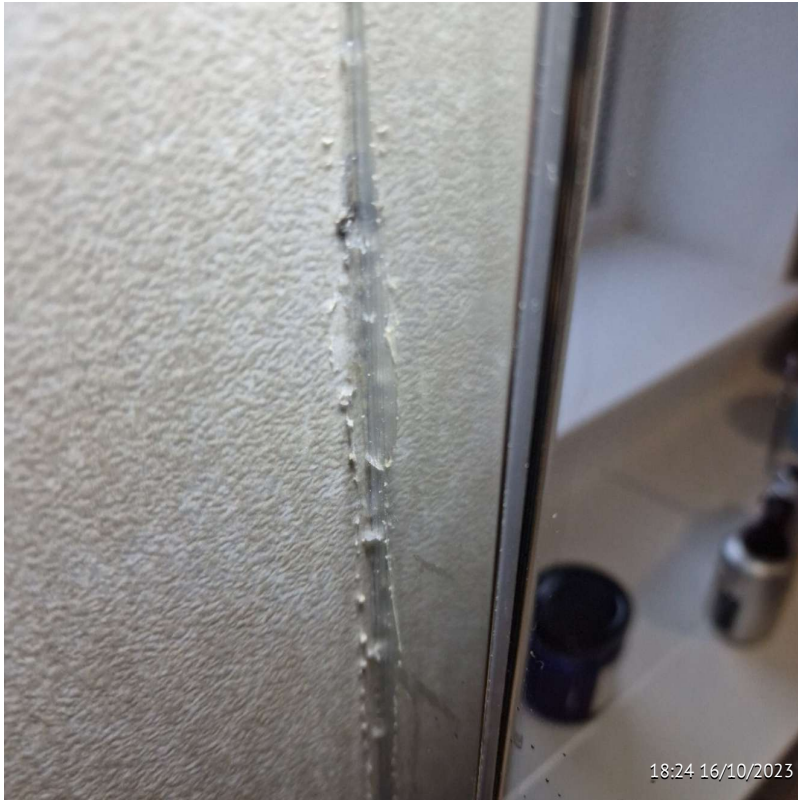
Location: Ensuite 1

Unsatisfactory finish to shower screen

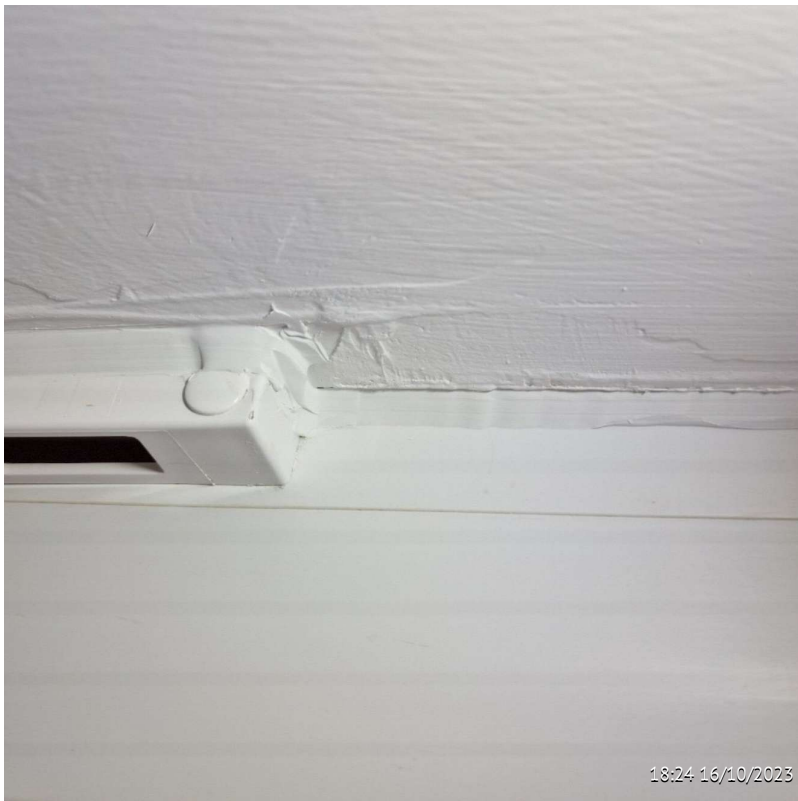
Location: Bed 2

Unsatisfactory finish to window reveals

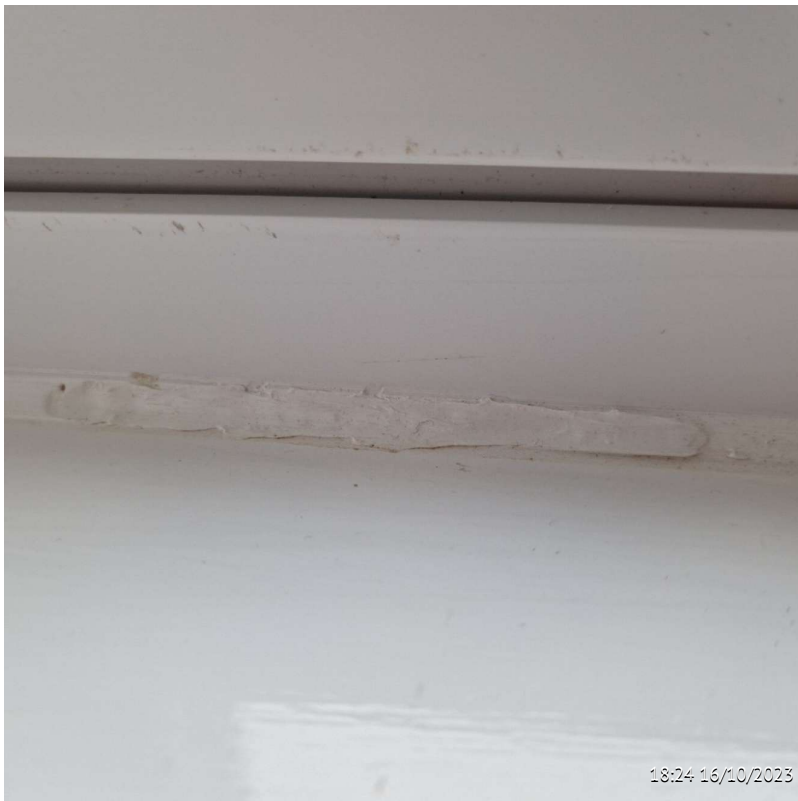
Location: Bed 3

Unsatisfactory finish to window reveals

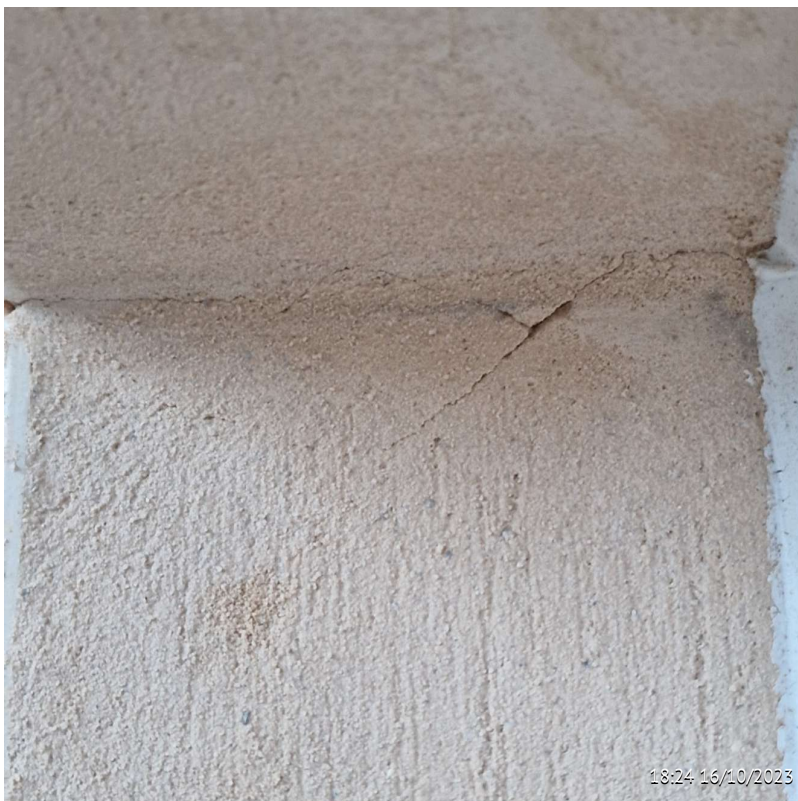
Location: Bed 1

Cracking to rendered reveals

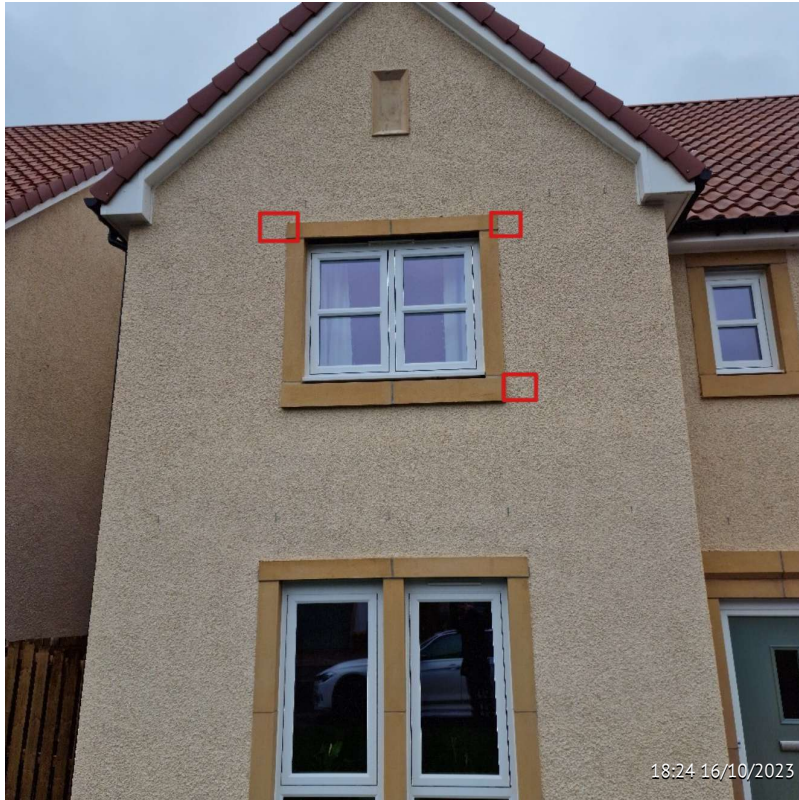
Location: Bed 3

Weep holes should be provided at a maximum of 450mm intervals. Each opening should have at least two weep holes.

Requirement for weep vents at each end of external sill and supporting lintles

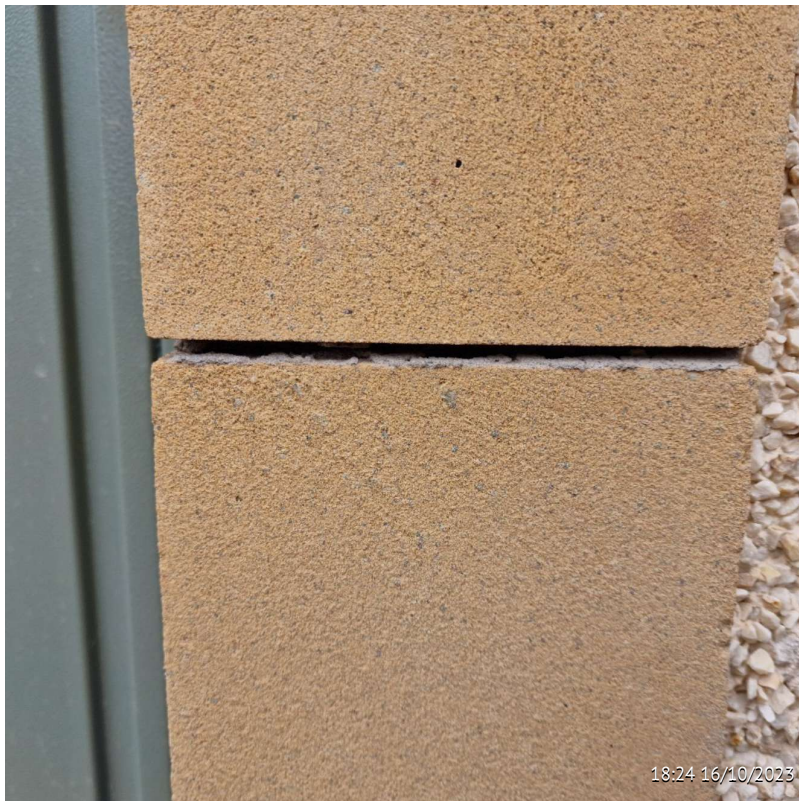
Location: Extent Of Pointing

Insufficient pointing at stoneworks

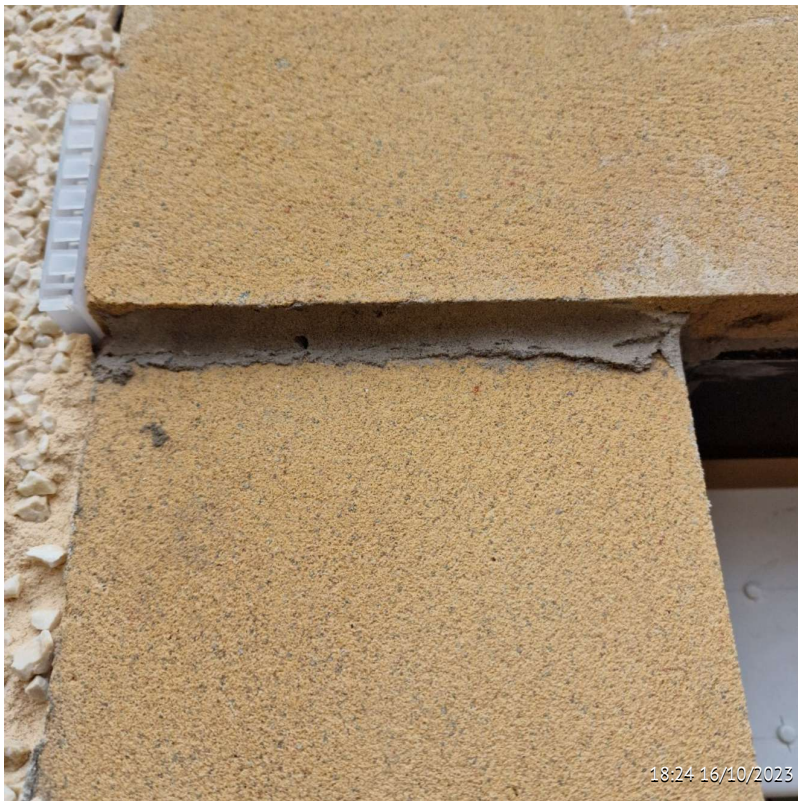
Location: Extent Of Pointing

Insufficient pointing at stoneworks

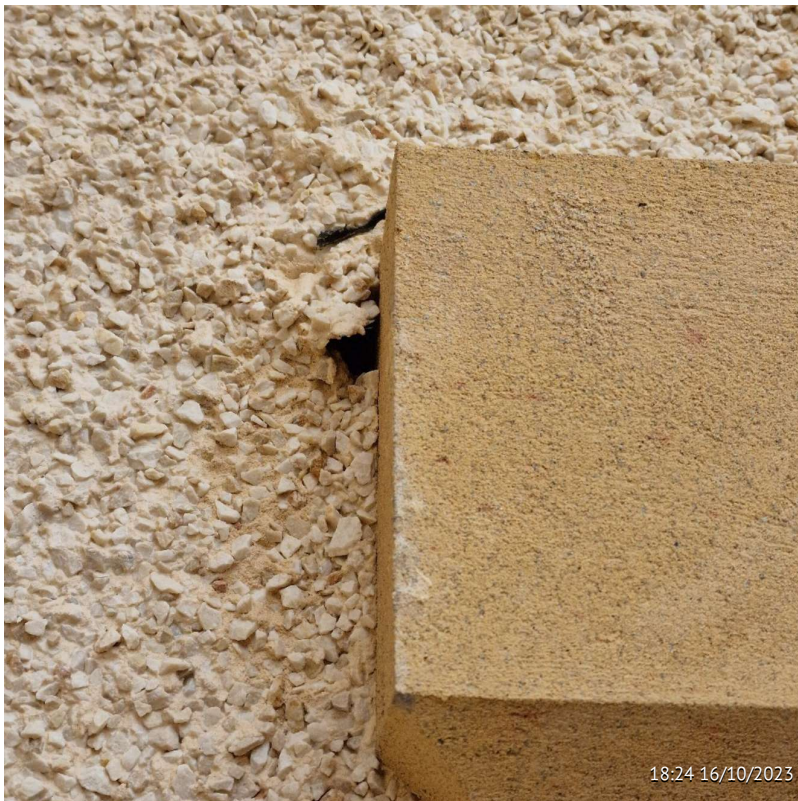
Location: Front Elevation, Front
Door

Horizontal DPC unsatisfactory
finish to extent of superstructure

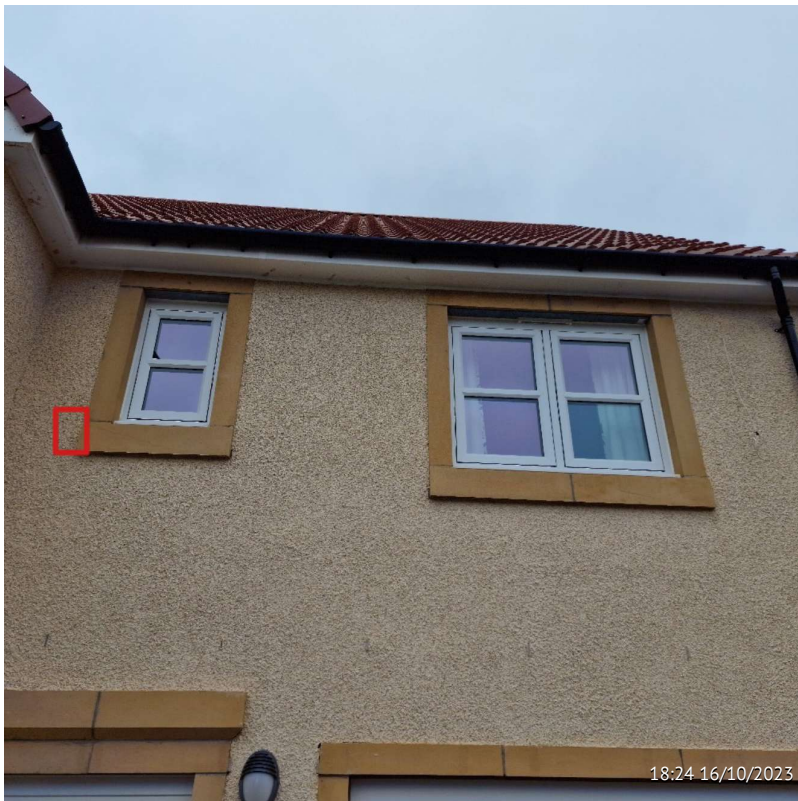
Location: 1st Floor Hall

Weep holes should be provided at a maximum of 450mm intervals. Each opening should have at least two weep holes.

Requirement for weep vents at each end of external sill and supporting lintles

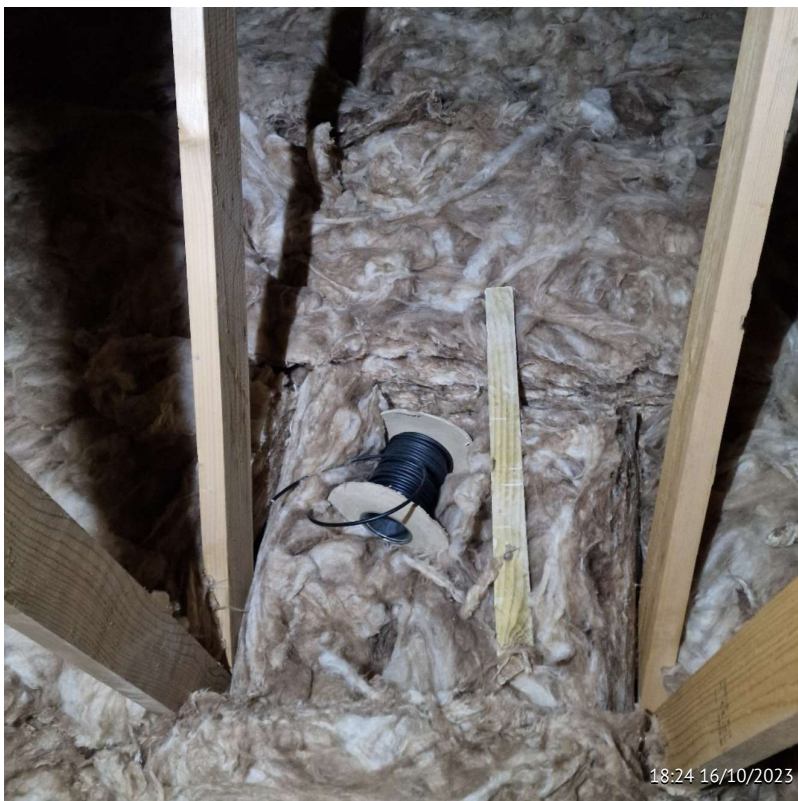
Location: Loft Space

Discarded materials

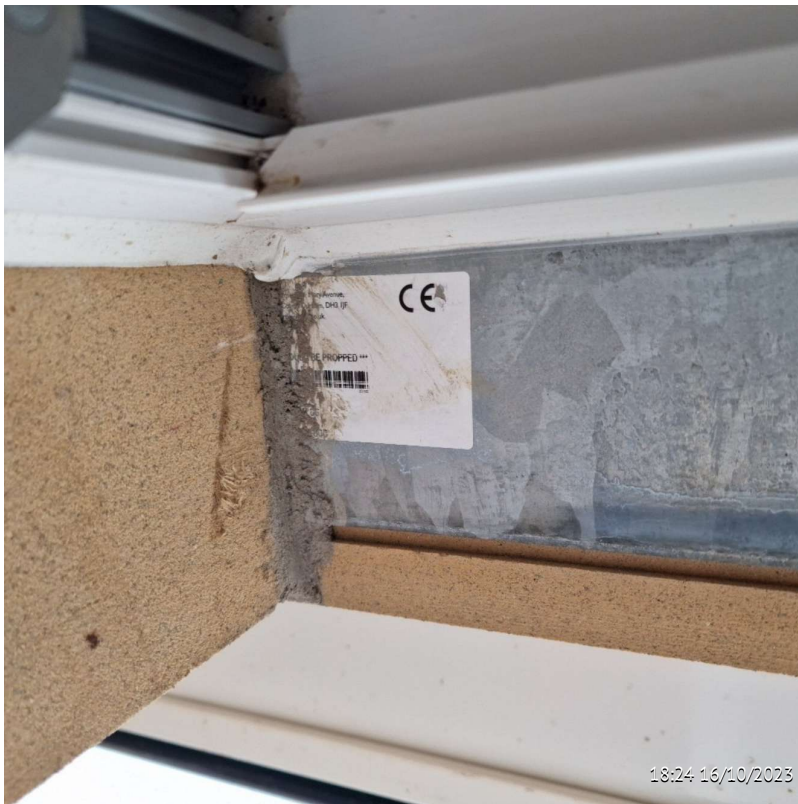
Location: Bed 2

Labeling left on underside of
external lintel

Unpainted lintel inconsistent with
others

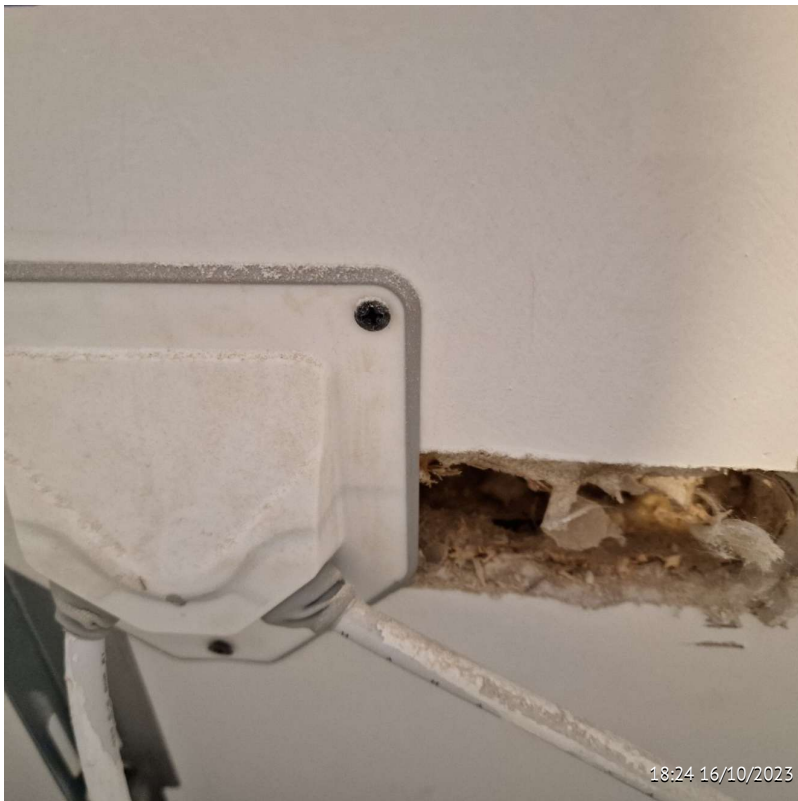
Location: Bed 2

Opening in plasterboard to rear of radiator

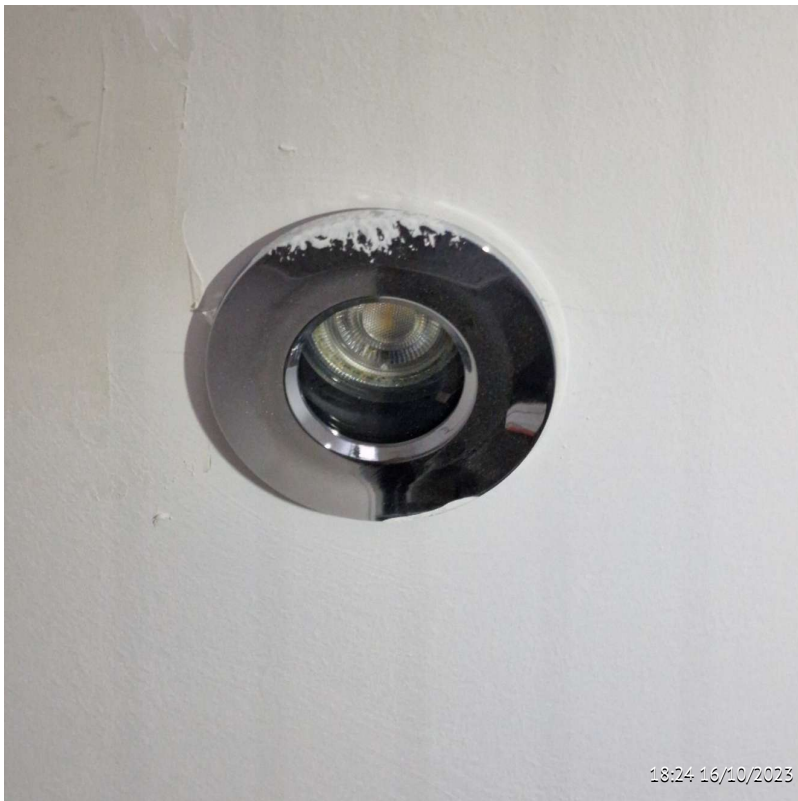
Location: Ensuite 2

Paint work on downlighters

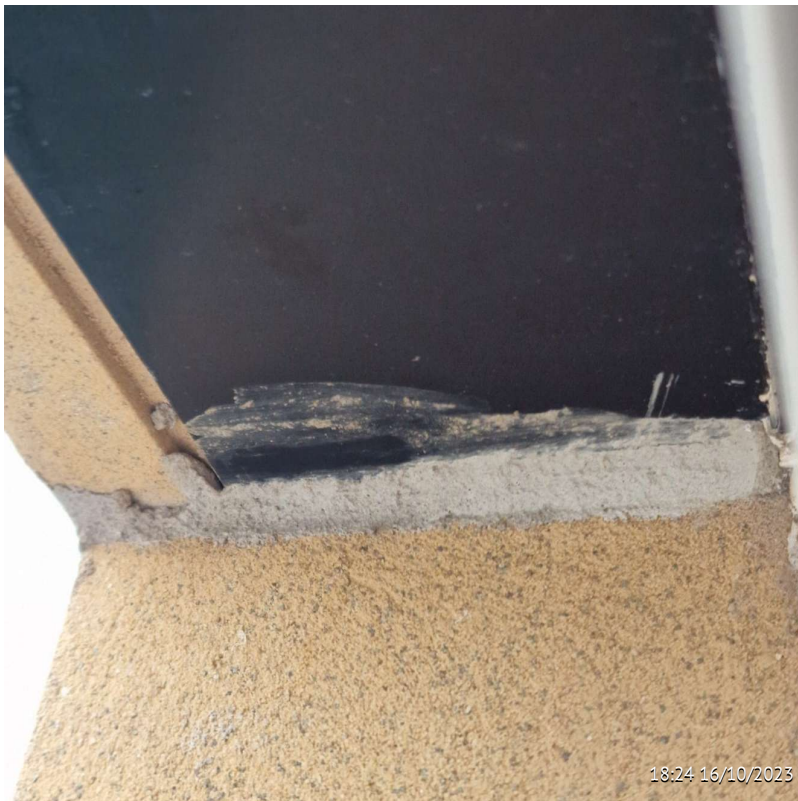
Location: Bed 3

Mortar staining to external lintle

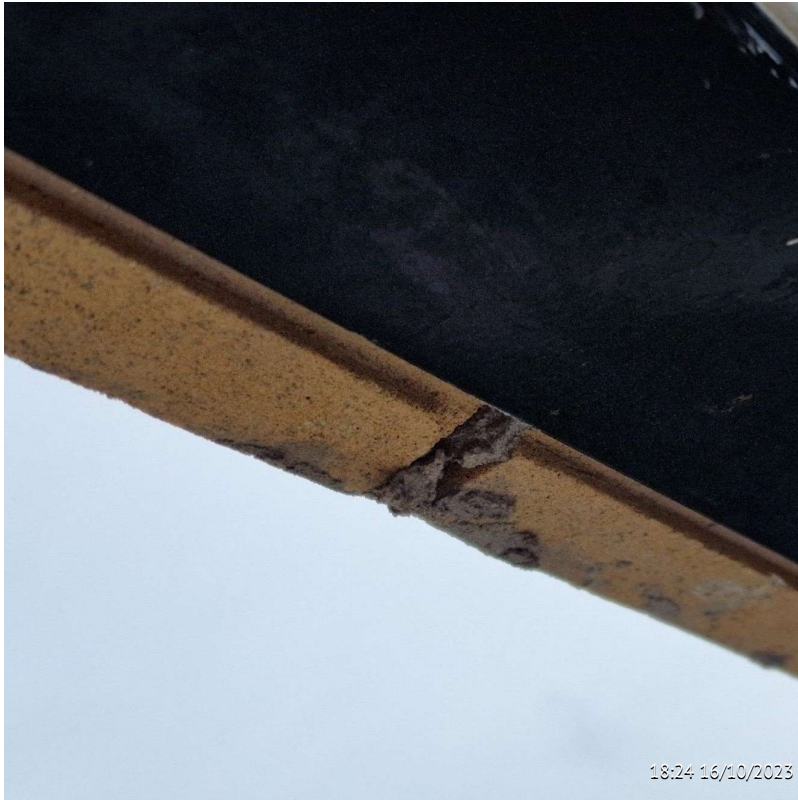
Location: Bed 3

Unsatisfactory pointing to
decoration lintle

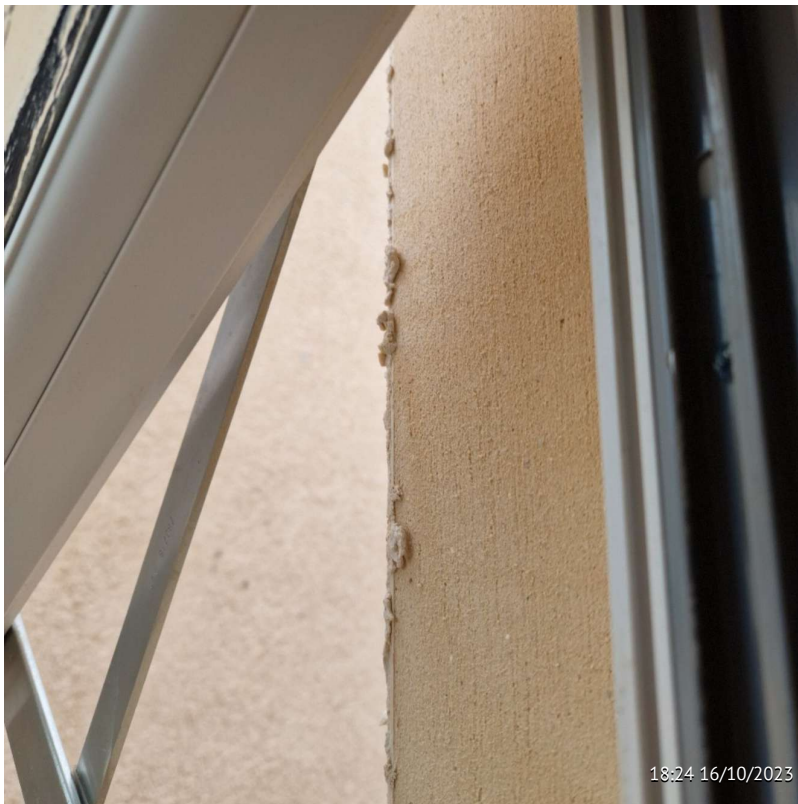
Location: Master Bathroom

Unsatisfactory finish to window
reveals

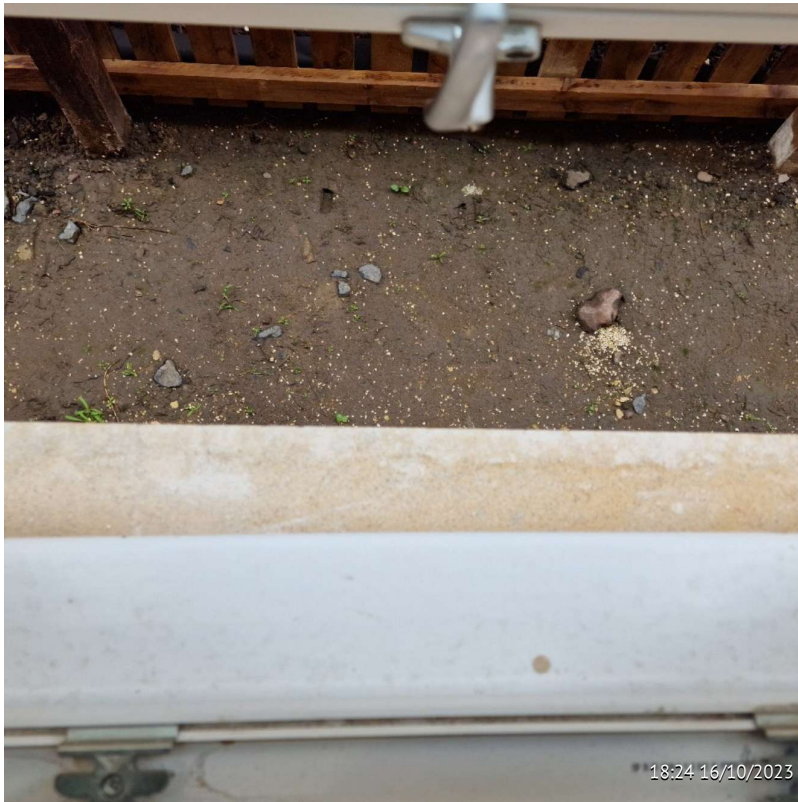
Location: WC

Excessive mortar staining to
external sill

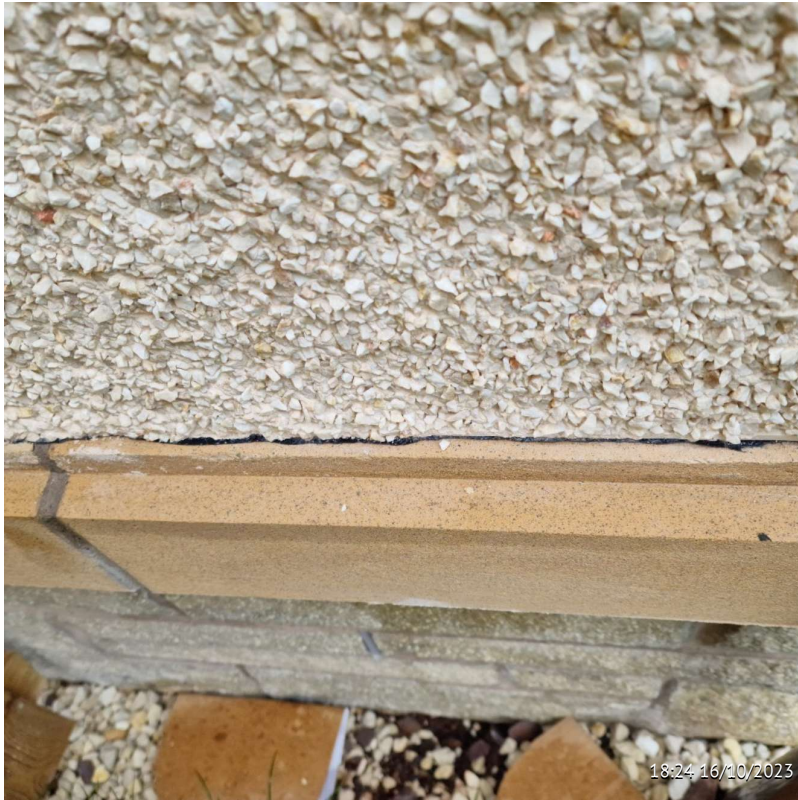
Location: External

Horizontal DPC unsatisfactory
finish to extent of superstructure

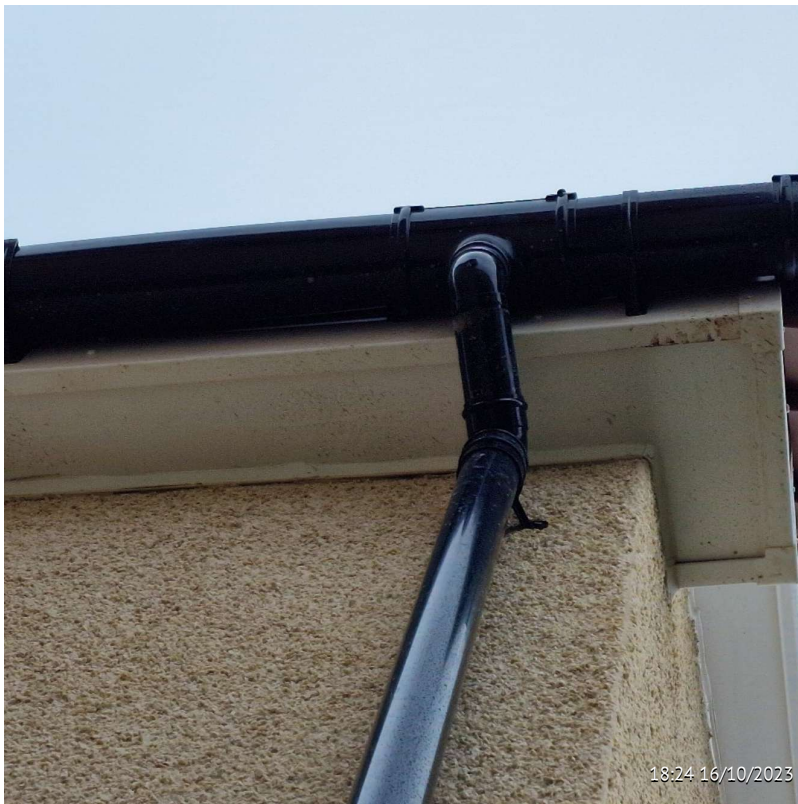
Location: Fascias And Soffits

Excessive mortar and render
staining

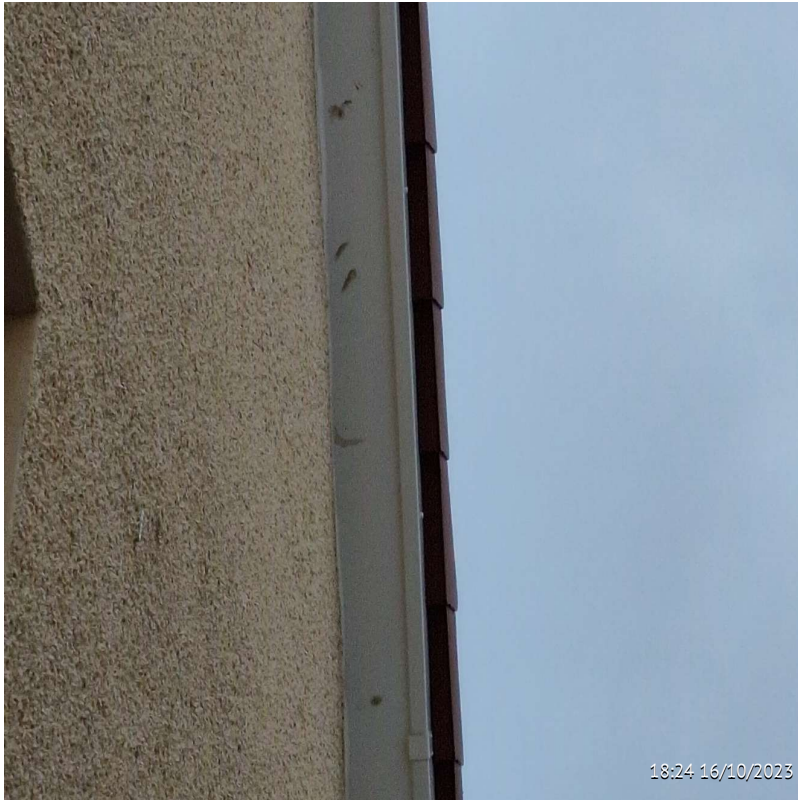
Location: Fascias And Soffits

Excessive mortar and render staining

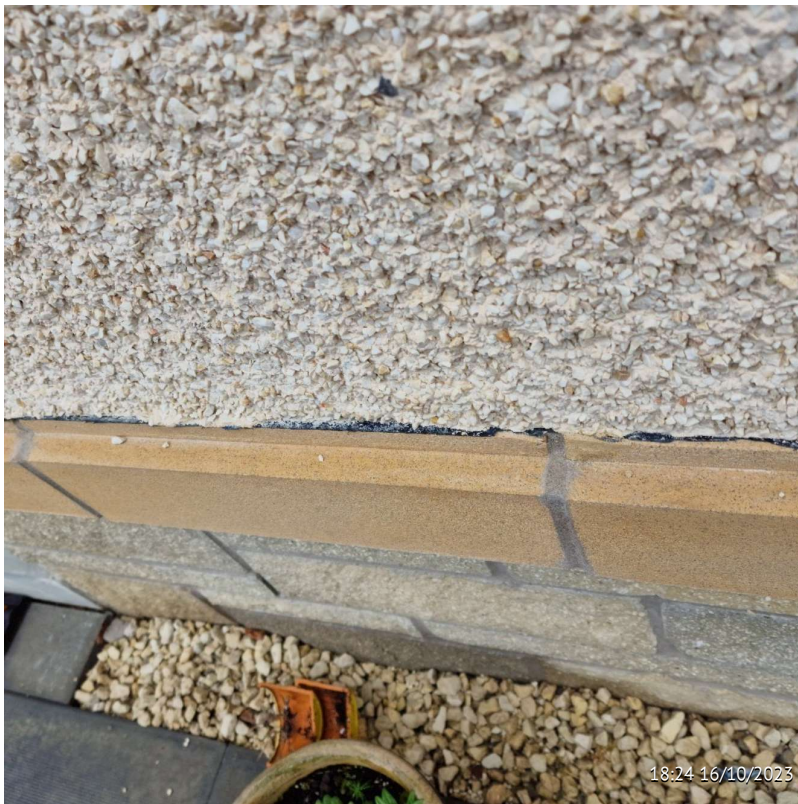
Location: Superstructure

Horizontal DPC unsatisfactory finish to extent of superstructure

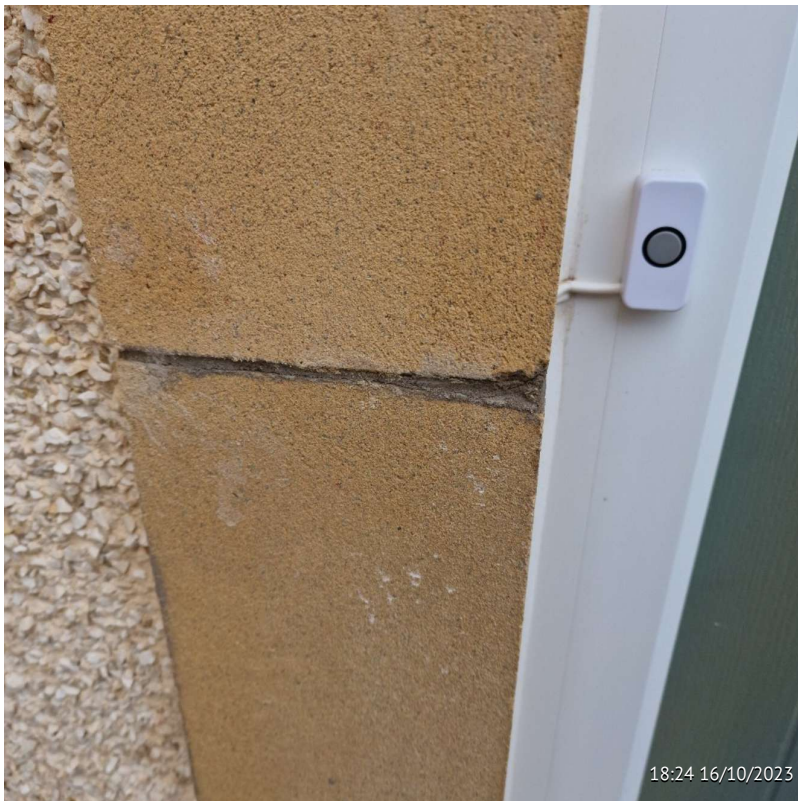
Location: Stoneworks

Excessive mortar and render staining

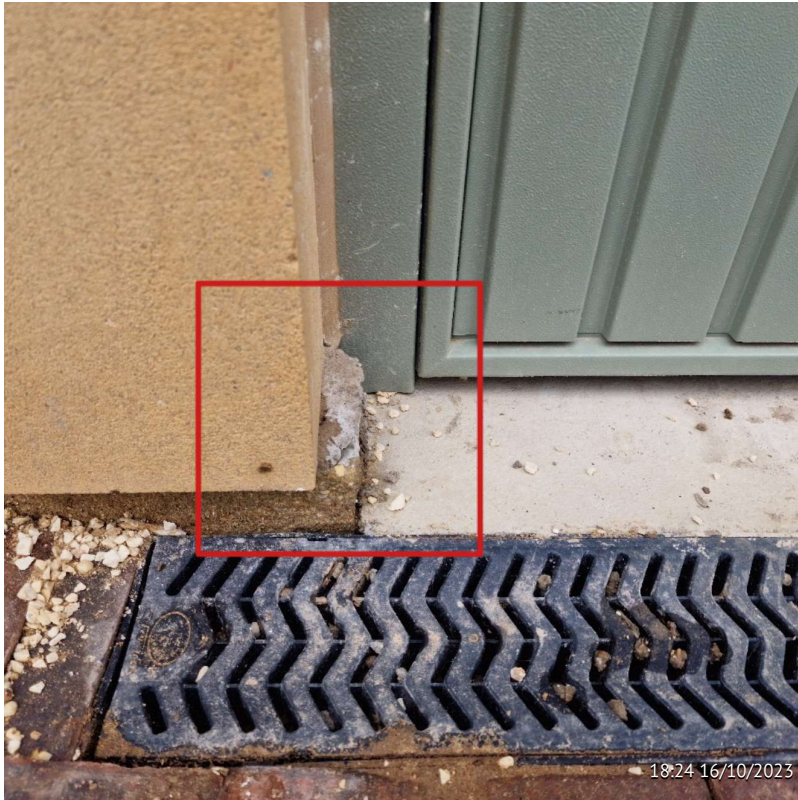
Location: Front Elevation

Stepped block to left of garage door opening

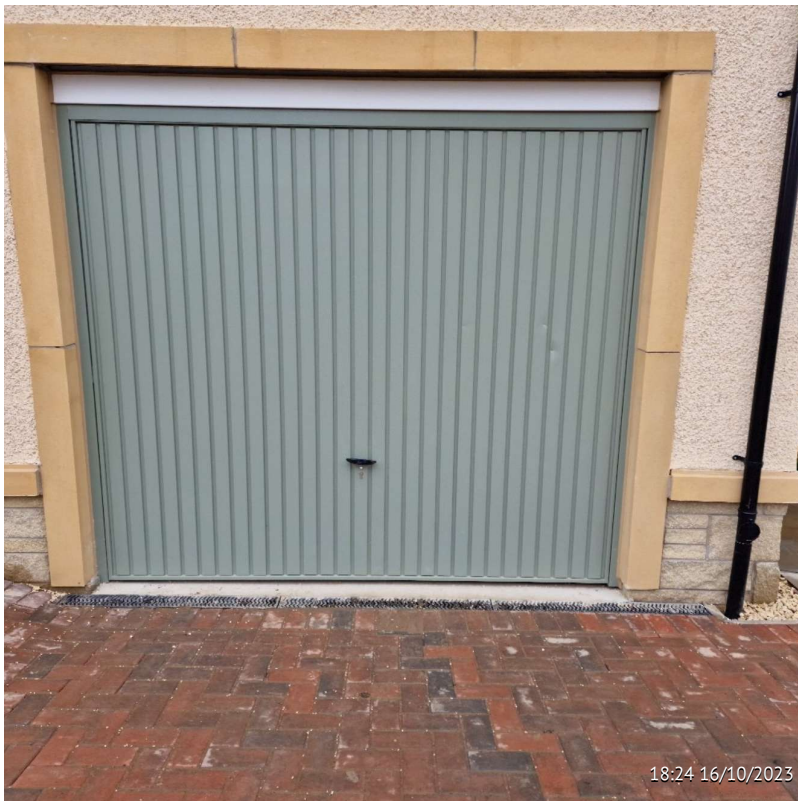
Location: Front Elevation, Garage Door

Excessive gap below garage door leaf and frame

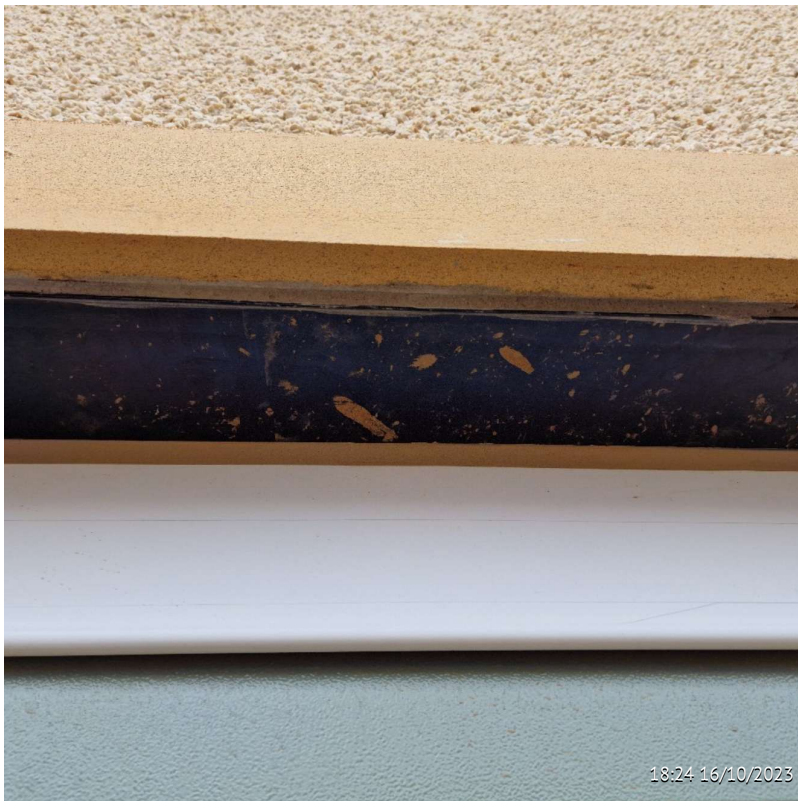
Location: Front Elevation, Garage
Lintel
Excessive mortar and render
staining

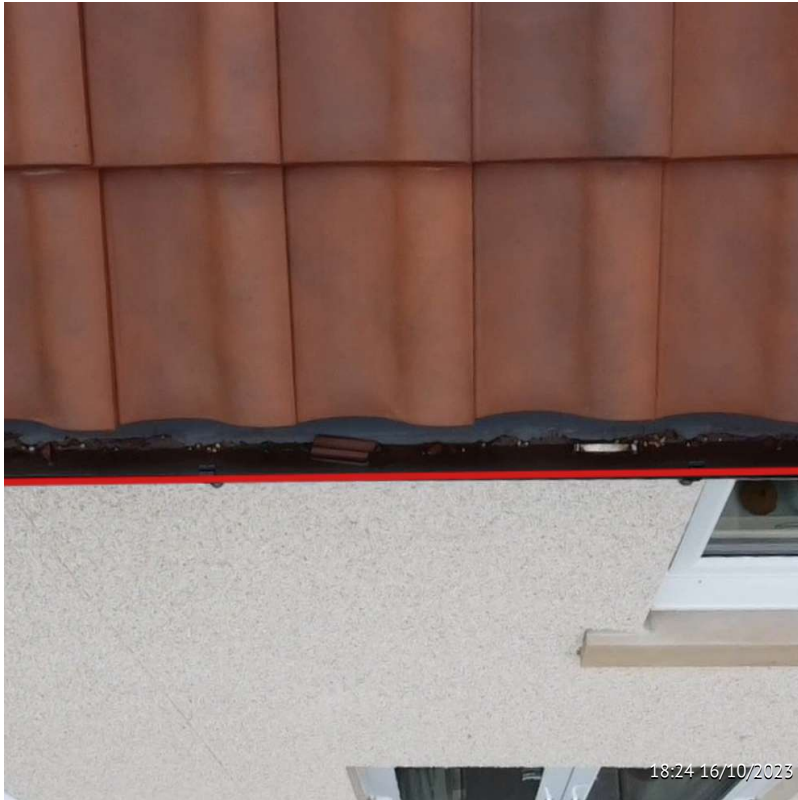
Location: Rear Guttering

Debris found in rear gutter line

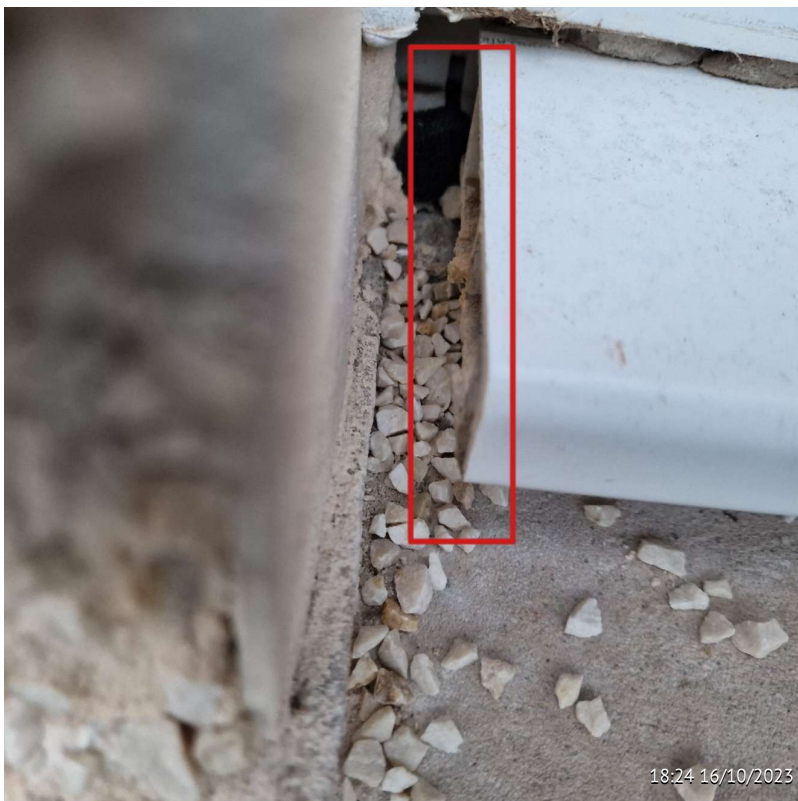
Location: Bed 1

Missing external end sill caps
