Developer, Development, Plot Number, PropertyType, Handover Inspection

24 Issues Identified

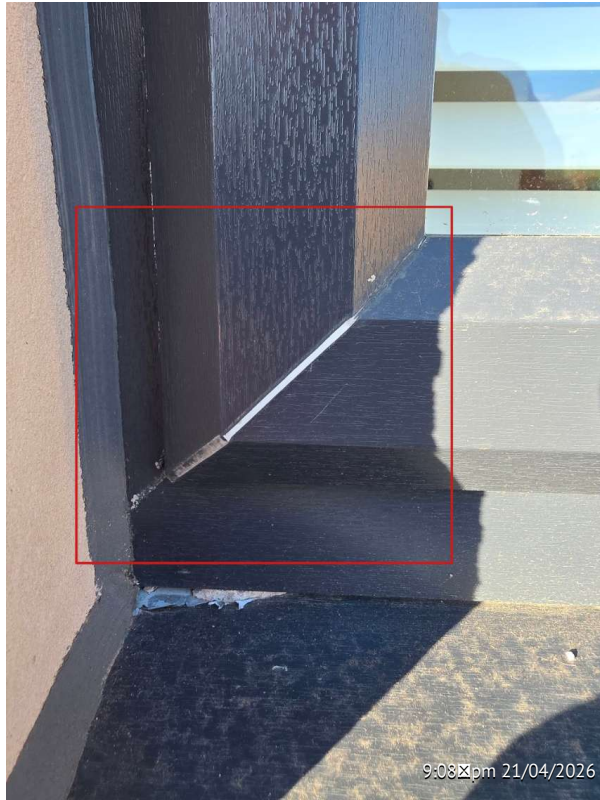
Location External, Window Sash Welds

Incomplete and inconsistent finish to external window sashes; weld points lack anthracite coating

Aesthetic and durability defect; exposed weld points without the applied finish detract from the visual quality and may be more susceptible to weathering, UV degradation, or discolouration over time. This indicates incomplete finishing and reduces the overall perceived quality of the installation

Chapter 6.7 — window frames and sashes must have a consistent, complete finish, including at joints and welds, to ensure durability and an acceptable appearance

Scottish Building Standards Technical Handbook (Domestic), Section 3.10 Windows and external finishes — window components must be fully finished and protected to maintain weather resistance, durability, and visual quality

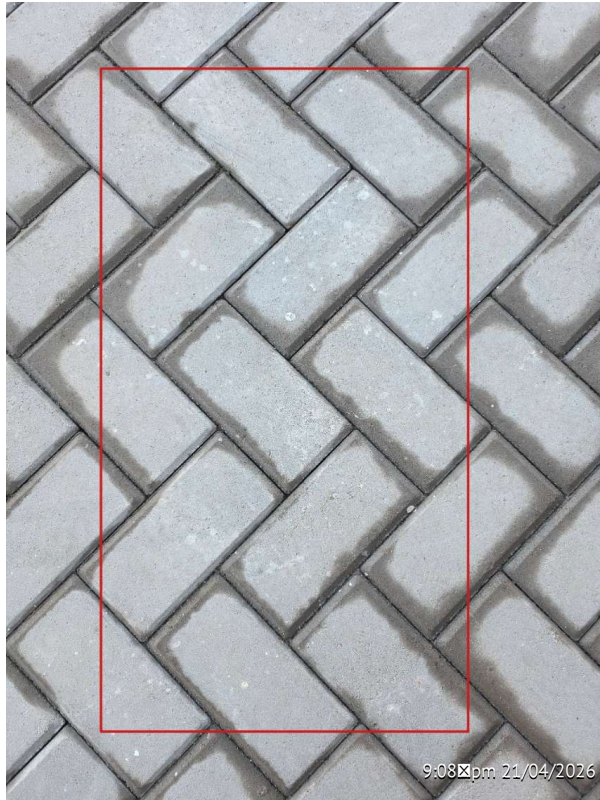
Location External, Driveway Mono Block Surface

Spot staining present to driveway mono-block surface

Aesthetic defect; staining detracts from the visual appearance of the driveway and may indicate contamination during construction. While not affecting immediate function, it can become more pronounced over time and reduce the overall perceived quality of the external finish

Chapter 6.7 — external paved surfaces should be clean, free from staining, and finished to an acceptable standard at handover

Scottish Building Standards Technical Handbook (Domestic), Section 3.10 External hard landscaping — paving surfaces must be free from defects and contamination to maintain visual quality, durability, and overall finish

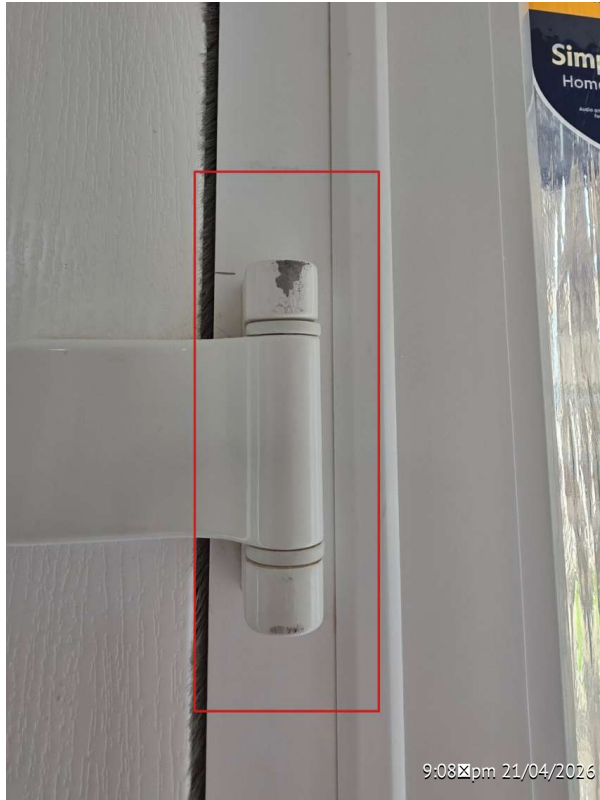
Location External Front Door,
Internal Hinges

Aesthetic damage present to
external front door hinges

Aesthetic and minor durability
defect; surface damage detracts
from the visual finish of the door
assembly

Chapter 6.7 — external door
ironmongery must be free from
damage and provided with a
durable, protective finish to ensure
longevity and an acceptable
appearance

Scottish Building Standards
Technical Handbook (Domestic),
Section 3.10 External doors —
door hardware must be installed
in good condition, with finishes
intact to maintain durability,
weather resistance, and visual
quality

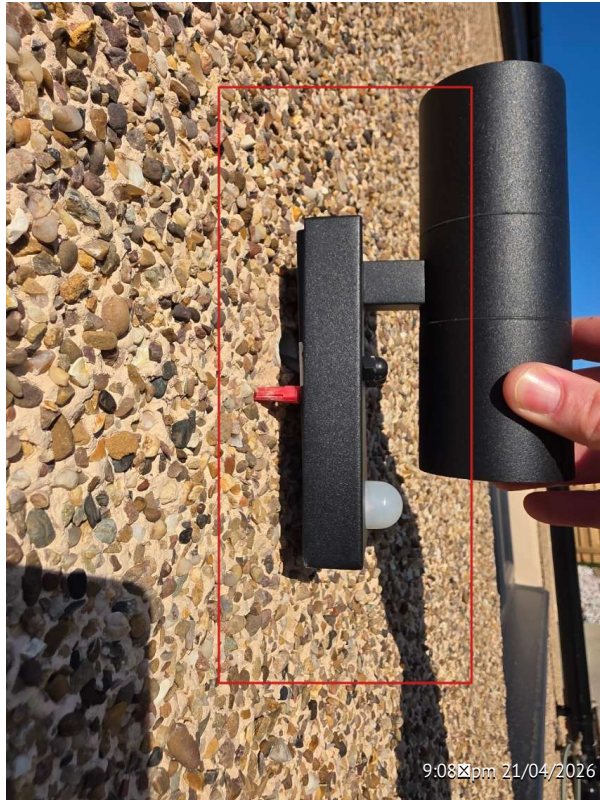
Location External, External Light Fittings To Rear Elevation

Observation:
External light fitting is inadequately secured to the superstructure

Implication:
Functional and safety defect; insufficient fixing can result in movement or detachment of the light fitting, increasing the risk of electrical damage, water ingress, or exposure of live components. This also presents a potential personal injury hazard and indicates poor installation practice

Chapter 7.2 — external electrical fittings must be securely fixed to the structure to ensure safe operation, durability, and resistance to environmental exposure

Scottish Building Standards Technical Handbook (Domestic), Section 3.11 Electrical installations — external electrical accessories must be properly secured to a suitable substrate to maintain safety, durability, and long-term performance in external conditions

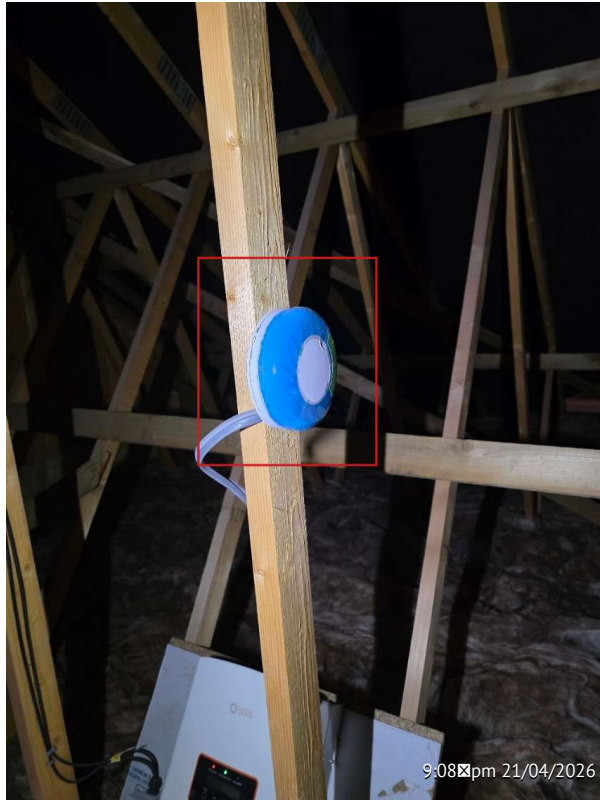
Location Loft Space, Fire/Smoke Detection

Smoke alarm within loft space adjacent to solar inverter found with protective film still in place at time of inspection. Film removed during inspection.

Protective film can obstruct ventilation openings and impair correct operation of the smoke alarm, potentially delaying or preventing effective detection.

Chapter 9.1 — electrical installations and associated equipment should be commissioned and handed over free from protective coverings that could affect operation.

Scottish Building Standards Technical Handbook (Domestic), Section 2.11 Fire detection and fire alarm systems — smoke alarms must be fully operational and unobstructed to ensure effective fire detection.

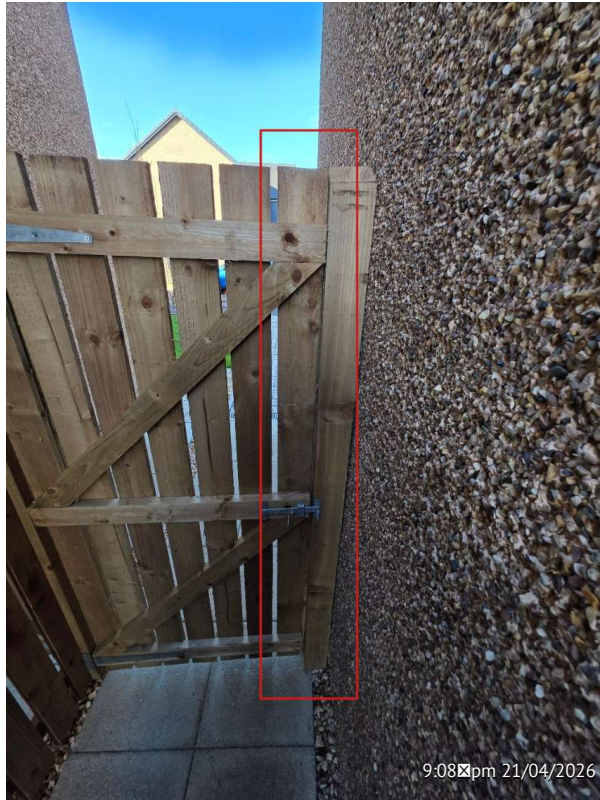
Location External, Side Gate

Inconsistent margins to the external side gate, with the leading edge making contact with the adjacent post

Functional and durability defect; inadequate clearance and poor alignment prevent smooth operation of the gate, causing friction against the post. This can lead to accelerated wear of timber surfaces, damage to fixings, distortion of the gate over time, and difficulty in opening/closing

Chapter 10.2 — external gates must be correctly aligned with adequate clearances to ensure smooth operation, prevent contact with adjacent structures, and maintain durability

Scottish Building Standards Technical Handbook (Domestic), Section 3.10 External structures — gates must be installed with sufficient tolerances to allow free movement without contact, ensuring safe operation, durability, and long-term performance

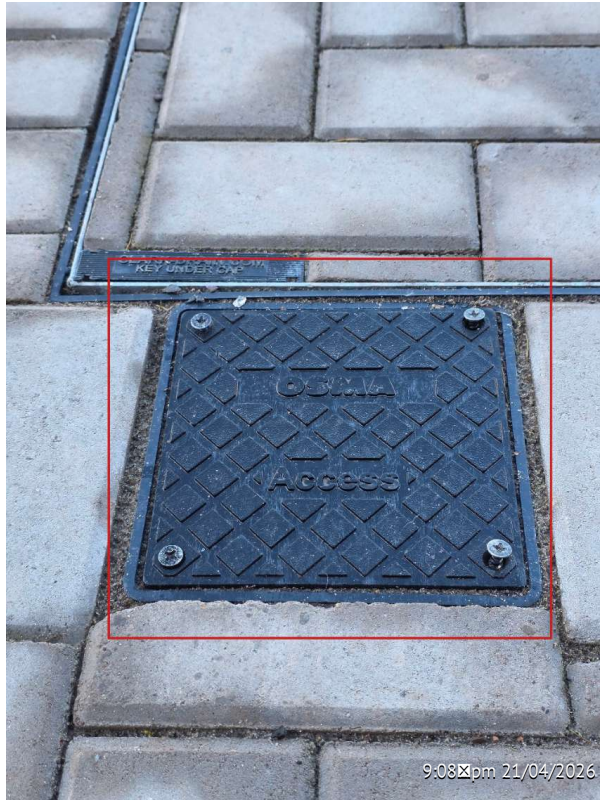
Location External, Drainage
Access Points To Driveway

Drainage access covers are
insufficiently secured

Functional and safety defect;
loose or inadequately secured
access covers present a trip
hazard, risk of displacement, and
potential access to drainage
systems by unauthorised persons.
This can also allow debris ingress,
leading to blockages and reduced
drainage performance

Chapter 5.3 — drainage inspection
chambers and access covers
must be securely fitted, stable,
and safe for pedestrian or
vehicular traffic where applicable

Scottish Building Standards
Technical Handbook (Domestic),
Section 3.6 Drainage — access
covers must be properly secured
and installed to ensure safe use,
prevent displacement, and
maintain effective drainage
system operation

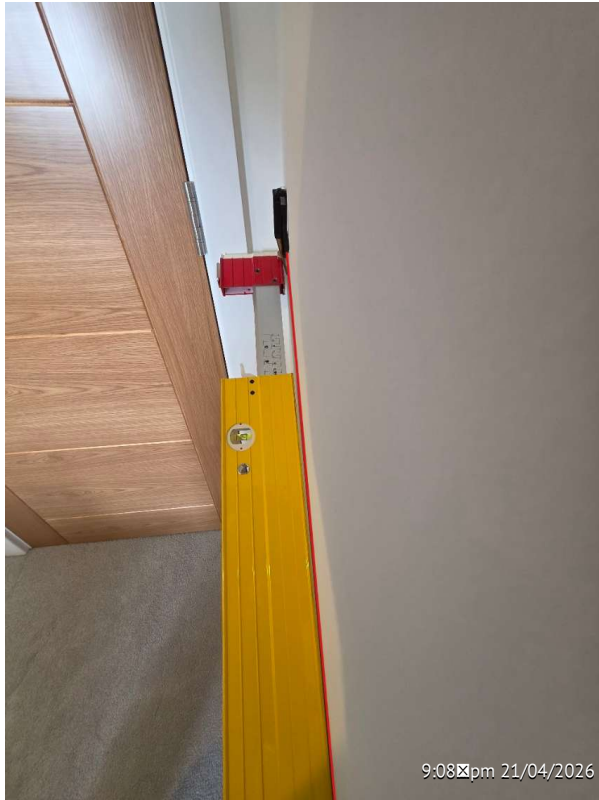
Location Bed 2, Partition Backing
Onto Ensuite 2

Elevation is out of alignment by
8 mm over 2 m

Deviation may affect finishes, and
visual alignment, potentially
causing functional or aesthetic
issues

NHBC Standard: Chapter 6.1
“Internal walls and partitions” —
walls should not deviate more
than ± 3 mm over 2 m to ensure
flat, even finishes

Scottish Building Standard:
Section 3.10 Internal finishes —
walls must be installed within
tolerances to maintain proper
alignment and aesthetic
appearance

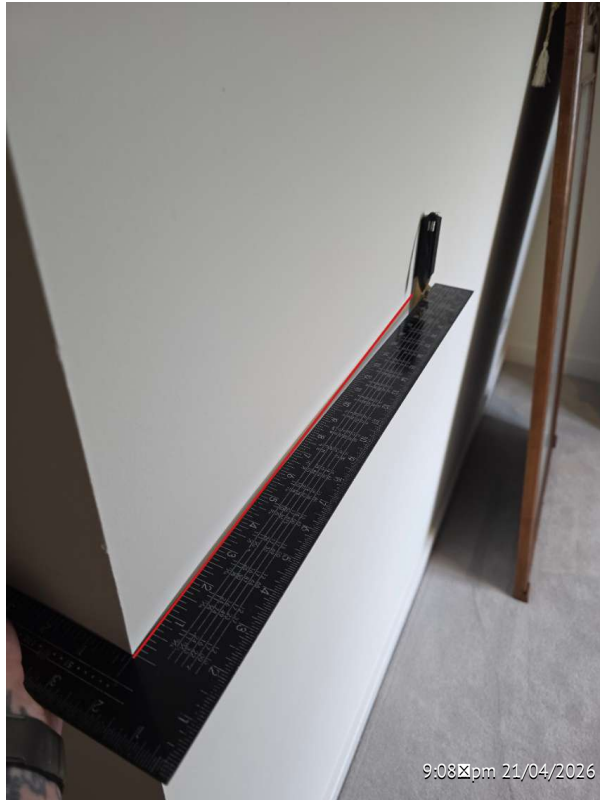
Location Bed 4, External Corner

External corner measured 13 mm out of square over 500 mm

Aesthetic defect; deviation exceeds NHBC recommended tolerance of 10 mm over 500 mm, affecting visual alignment of finishes, trims, or joinery, and may impact fitting of fixtures

Chapter 6.1 — internal corners should be finished true and square, with a maximum deviation of 10 mm over 500 mm. Measured 12 mm exceeds this tolerance and is outside acceptable limits

Scottish Building Standards Technical Handbook (Domestic), Section 3.11 Internal finishes — internal junctions should be finished accurately within prescribed tolerances to ensure proper alignment, fit of fixtures, and acceptable workmanship

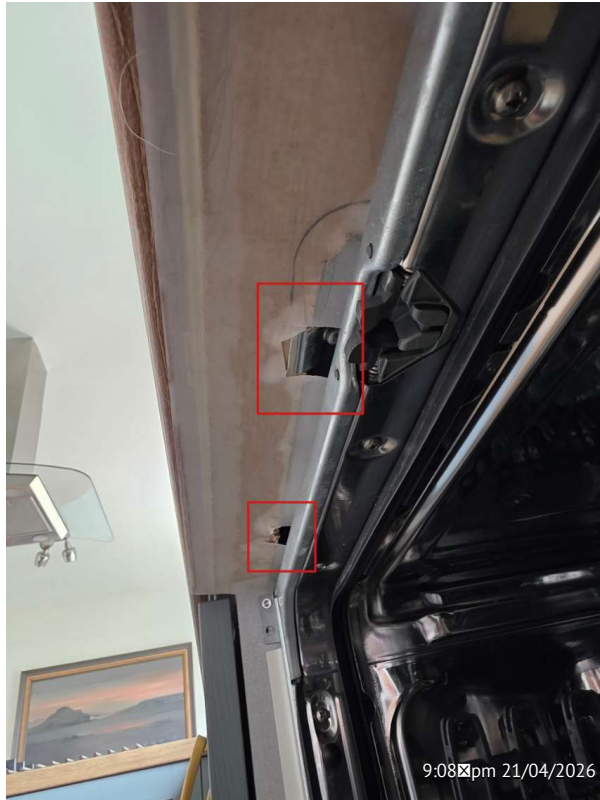
Location Kitchen, Underside Of Worktop At Dishwasher Washer

Steam shield to underside of kitchen worktop above dishwasher is insufficiently installed

Functional and durability defect; inadequate steam protection can allow moisture and heat from the dishwasher to penetrate the worktop, leading to swelling, delamination, and premature deterioration of materials. This reduces the lifespan of the worktop and may lead to hygiene issues over time

Chapter 7.2 — kitchen worktops and adjacent components must be protected from moisture and heat sources to ensure durability and prevent deterioration

Scottish Building Standards Technical Handbook (Domestic), Section 3.11 Fittings and appliances — kitchen installations must be adequately protected from moisture and heat generated by appliances to maintain durability, hygiene, and long-term performance

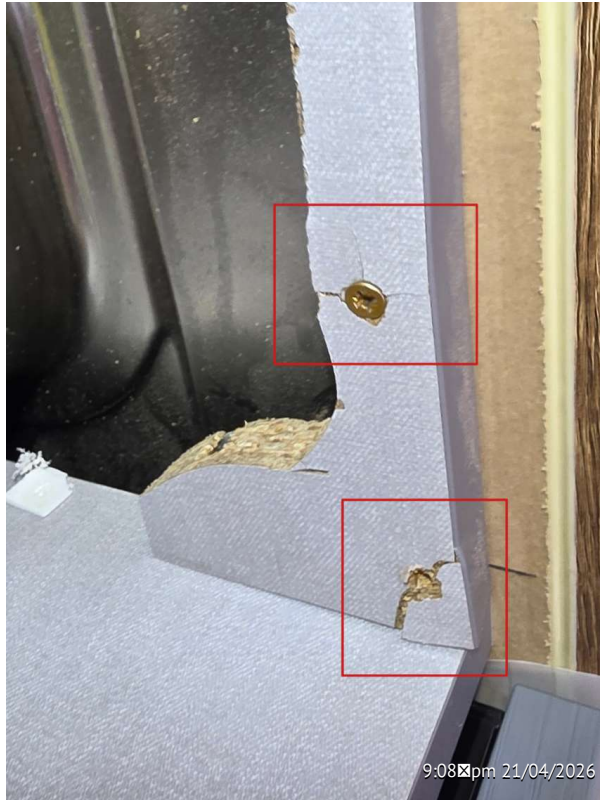
Location Kitchen, Sink Base Unit

Damage present to base unit stiffener at the front of the base unit, at the fixing point to the underside of the worktop

Functional and structural defect; damage to the stiffener reduces the rigidity of the base unit and compromises its ability to properly support the worktop. This can lead to movement, misalignment, stress on fixings, and potential long-term failure of the unit assembly. It also reflects substandard installation or handling during fitting

Chapter 7.2 — kitchen units must be structurally sound, correctly assembled, and adequately fixed to ensure durability, stability, and proper support of worktops

Scottish Building Standards Technical Handbook (Domestic), Section 3.11 Fittings and appliances — kitchen units and associated structural components must be installed in sound condition and securely fixed to maintain stability, durability, and safe long-term performance

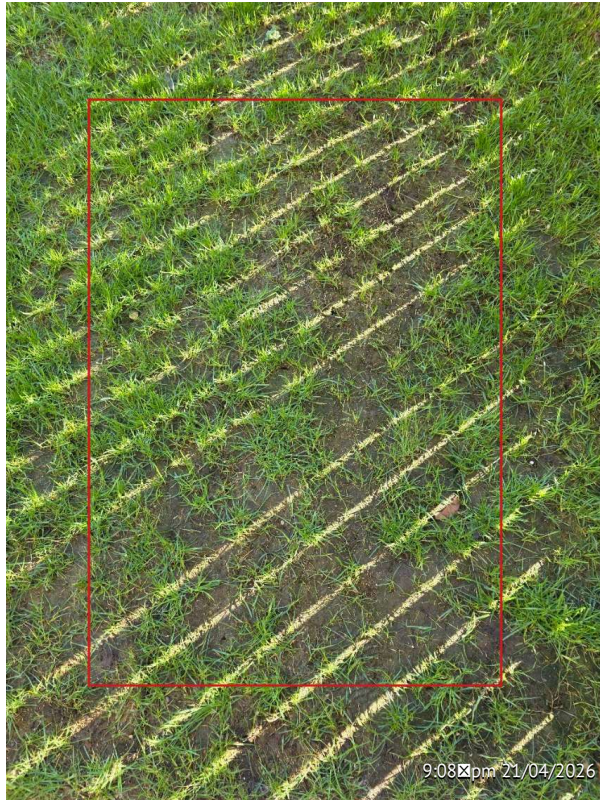
Location External, Rear Garden

Perished turf to rear garden; turf shows signs of long-term saturation with waterlogging present within 3m of the dwelling superstructure

Functional and environmental defect; persistent waterlogging close to the building indicates inadequate ground drainage and poor surface falls. This can lead to softening and degradation of landscaping, restrict usability of the garden, and increases the risk of moisture-related issues affecting adjacent building elements

Chapter 10.2 — external landscaping must be designed and installed to ensure adequate drainage, particularly adjacent to buildings, to prevent water retention that could adversely affect the performance and durability of the superstructure and surrounding ground conditions. Areas within close proximity (typically within 3m of the dwelling) should not retain water in a manner that could lead to damp-related issues or structural impact

Scottish Building Standards Technical Handbook (Domestic), Section 3.10 External hard landscaping — ground surfaces must be adequately drained and graded to prevent water accumulation adjacent to buildings, ensuring protection of

the structure and usability of external areas

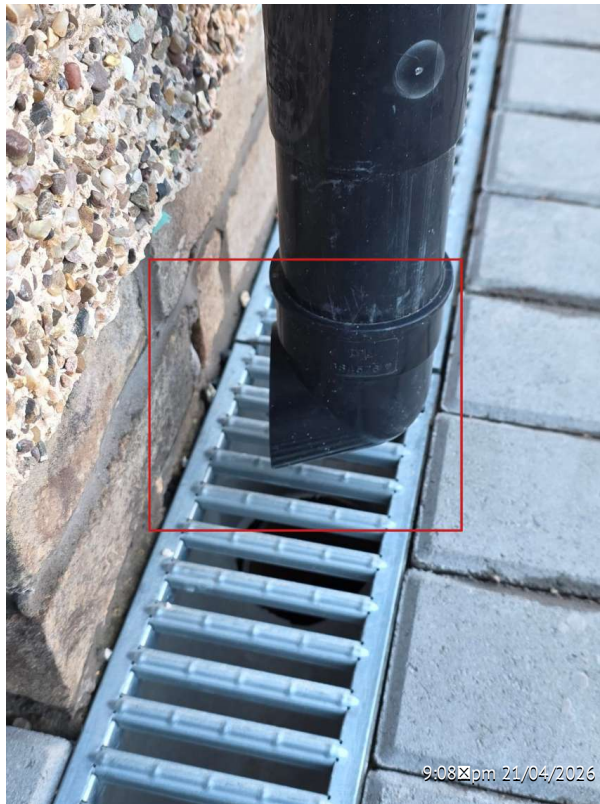
Location External, Front
Elevation, Downpipe Right Of
External Garage Door

Rainwater downpipe shoe is directing discharge into the superstructure

Functional and potentially serious defect; directing rainwater onto or into the building fabric can result in moisture ingress, damp penetration, and accelerated deterioration of external masonry or finishes. Over time this may lead to internal damp issues, staining, or structural damage to affected elements

Chapter 6.7 — rainwater goods must be designed and installed to discharge water safely away from the building to prevent penetration, saturation, or damage to the superstructure

Scottish Building Standards Technical Handbook (Domestic), Section 3.10 Rainwater drainage — rainwater disposal systems must be installed to safely convey water away from the building to prevent moisture ingress and protect the building fabric from damage

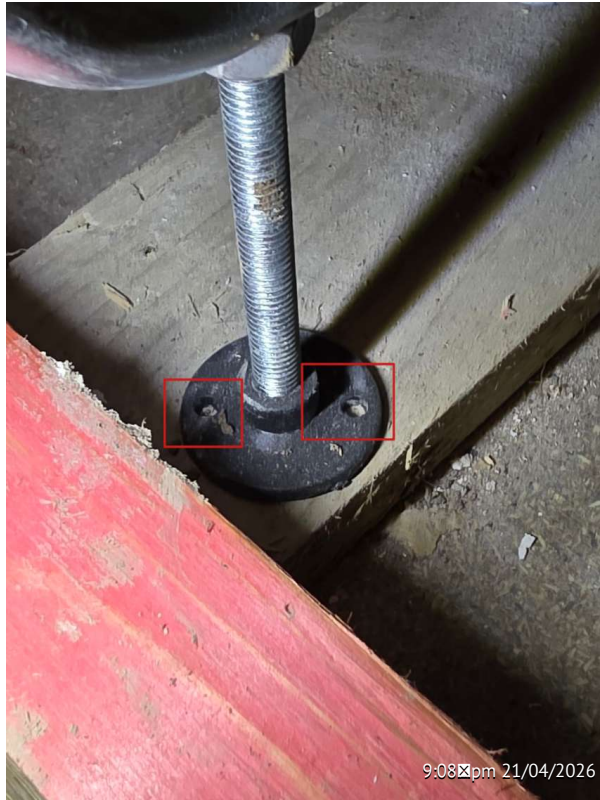
Location Master Bathroom, Bath Feet

No means of fixings provided to any of the bath feet

Functional and structural defect; absence of fixings means the bath is not properly secured to the substrate, resulting in potential movement during use. This can lead to instability, stress on waste and pipe connections, seal failure at perimeters, and long-term damage to surrounding finishes or flooring. It indicates incomplete installation and non-compliance with manufacturer requirements

Chapter 7.4 — baths must be securely supported and fixed in accordance with manufacturer instructions to ensure stability, durability, and safe use

Scottish Building Standards Technical Handbook (Domestic), Section 3.12 Sanitary facilities — baths must be properly installed and adequately secured to prevent movement, ensure safe operation, and protect adjacent finishes from damage

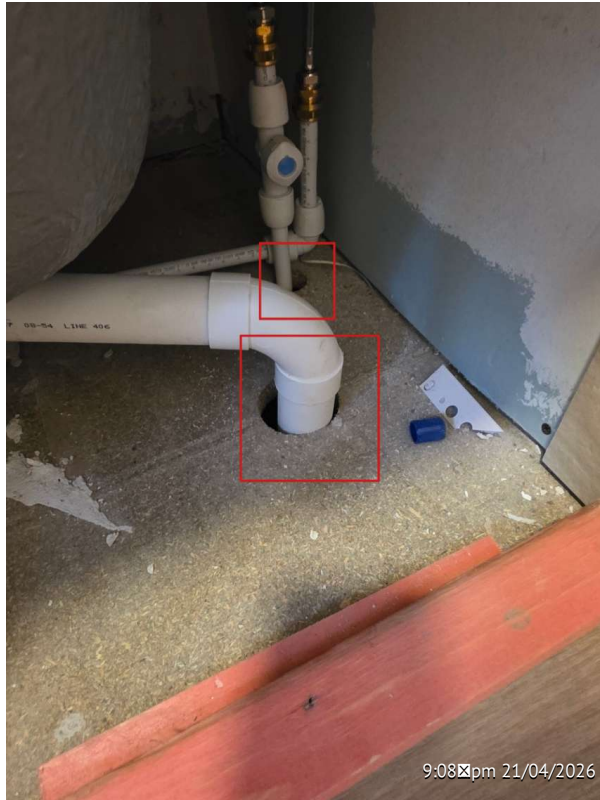
Location Master Bathroom,
Waste Pipework

Expansion and contraction noises were heard during testing of the master bathroom hot and cold water supplies

Functional installation issue; audible pipe movement typically indicates inadequate allowance for thermal expansion, insufficient pipe clipping, or pipework in contact with structural elements. Over time, this can lead to loosening of fixings, noise nuisance, potential abrasion of pipework against surrounding materials, and increased risk of leaks at joints or connections

Chapter 8.1 — water supply pipework must be adequately supported, restrained, and installed to accommodate thermal movement without causing noise, damage, or undue stress on the system

Scottish Building Standards Technical Handbook (Domestic), Section 3.9 Water services — pipework must be properly supported and installed to allow for thermal expansion and contraction without causing damage, noise, or compromise to the system

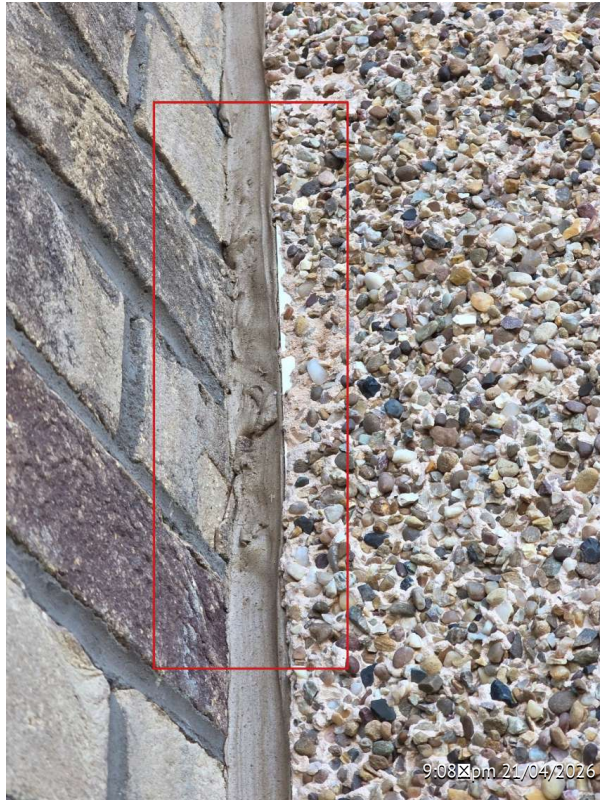
Location External, Front
Elevation, Left Of Garage Door
Opening

Unsatisfactory and inconsistent approach to the finish of external mastics

Aesthetic and durability defect; inconsistent application and finishing of mastic joints detracts from the overall visual quality of the external envelope and may result in weak points within the sealant line. Poor tooling or inconsistent coverage can reduce long-term weather resistance, increasing the risk of water ingress, air leakage, and premature deterioration of the seal

Chapter 6.7 — external sealants must be applied in a neat, continuous, and consistent manner, properly tooled and free from defects to ensure effective weatherproofing and an acceptable appearance

Scottish Building Standards Technical Handbook (Domestic), Section 3.10 External finishes — sealants and mastics must be applied uniformly and correctly to maintain weather resistance, durability, and visual quality of the building envelope

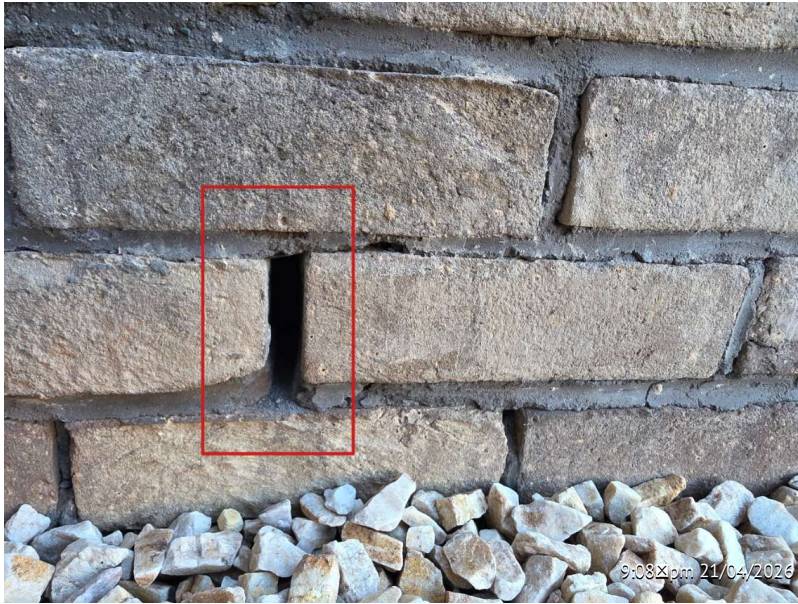
Location External, Left Of External Front Door

Weep vents are missing, exposing cavity pathways through the external superstructure into the timber frame kit construction

The absence of weep vents compromises the designed drainage and ventilation strategy of the external wall system. This can allow uncontrolled moisture ingress into the cavity, bridging into the timber frame structure, increasing the risk of damp penetration, timber decay, mould growth, and long-term structural degradation. It also undermines the ability of the wall system to safely evacuate moisture

Chapter 6.2 / 6.7 — cavity walls and timber frame interfaces must include appropriate weep vents and ventilation openings to ensure moisture is properly discharged from the cavity and does not reach the structural timber elements, maintaining durability and weather resistance

Scottish Building Standards Technical Handbook (Domestic), Section 3.10 Moisture from external sources — external wall systems must be designed and constructed to prevent moisture penetration into structural elements, with appropriate provision for drainage and ventilation of cavities to protect timber frame construction

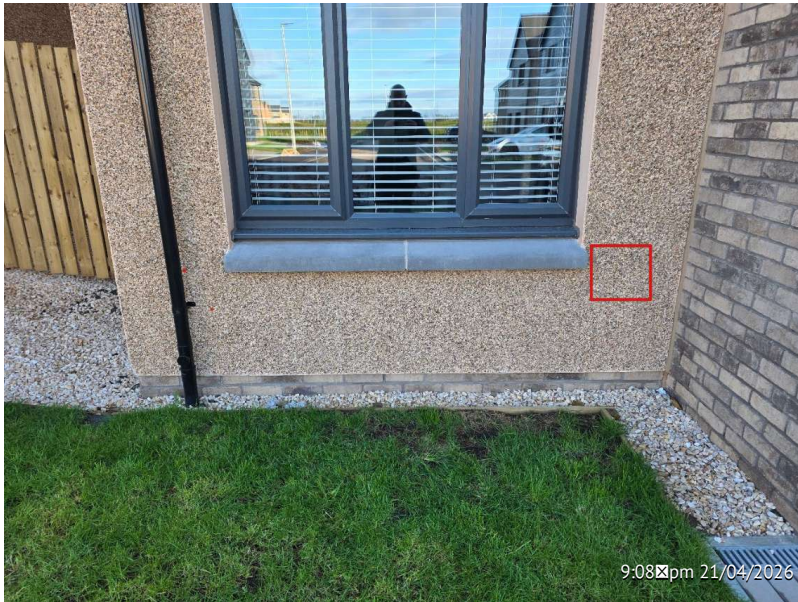
Location External, Front Elevation, Below Lounge Window Opening

Missing weep vent identified to the lower right-hand side of the window opening and associated precast sill

Functional and durability defect; absence of weep vents prevents designed drainage of moisture from the cavity above openings and sill interfaces. This can result in trapped water, increased risk of moisture ingress, staining to masonry, and potential long-term deterioration of adjacent building elements, including timber frame components if present. It indicates incomplete installation of the cavity drainage system

Chapter 6.2 / 6.7 — cavity walls above openings must incorporate effective weep vents to allow moisture to drain safely from the cavity, preventing water accumulation and protecting the building fabric and internal structure

Scottish Building Standards Technical Handbook (Domestic), Section 3.10 Moisture from external sources — external wall systems must include appropriate drainage provisions such as weep vents at openings to ensure moisture is safely expelled from cavities and does not penetrate the building envelope

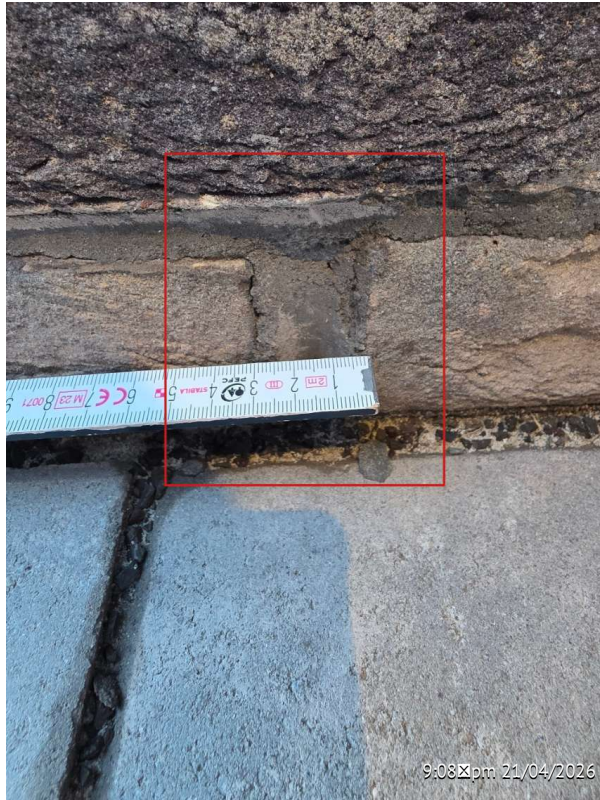
Location External, Brickwork bonds

Brickwork bond exhibits inconsistent perp joint widths ranging from approximately 10mm to 30mm

Significant aesthetic and workmanship defect; excessive variation in mortar joint width indicates poor setting-out and inconsistent laying practices. This results in a visibly irregular bond pattern, reducing the visual quality of the façade. In addition, excessively wide joints (up to 30mm) can be more susceptible to shrinkage, cracking, and long-term weathering issues, potentially reducing durability of the mortar joints.

In practice, acceptable tolerances are generally in the region of 8–12mm depending on brick type and specification. Joint widths exceeding approximately 15mm are generally considered poor workmanship, and variations approaching 20–30mm fall outside normal acceptable standards and indicate defective setting-out and laying practice.

Chapter 6.1 — masonry work must be constructed with consistent joint thickness and alignment to ensure structural integrity, durability, and an acceptable appearance. Joints should be fully filled, properly compacted, and consistently formed in accordance with design and good workmanship practice

Scottish Building Standard:
Scottish Building Standards
Technical Handbook (Domestic),
Section 3.10 External wall finishes
— masonry construction must be
carried out to a consistent
standard with uniform jointing to
ensure durability, weather
resistance, and satisfactory visual
quality

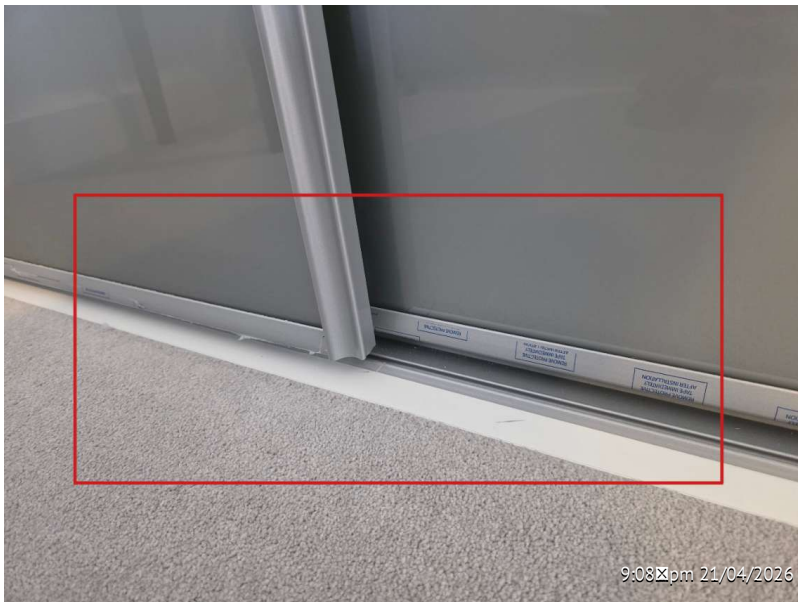
Location Bed 2, Sliding Wardrobe
Doors

Protective tape remains present
on wardrobe door profiles

Aesthetic and finish defect;
residual protective materials
indicate incomplete completion
and detract from the visual
quality of the fitted joinery. If left
in place, adhesive degradation
over time can lead to staining,
edge marking, and difficulty in
removal without damaging the
underlying finish

Chapter 7.2 — internal joinery and
fitted furniture must be fully
completed, clean, and free from
temporary protective materials to
ensure an acceptable appearance
and durability of finishes

Scottish Building Standards
Technical Handbook (Domestic),
Section 3.11 Fittings and
appliances — fitted furniture must
be properly finished and free from
temporary protective materials to
ensure visual quality, hygiene, and
durability

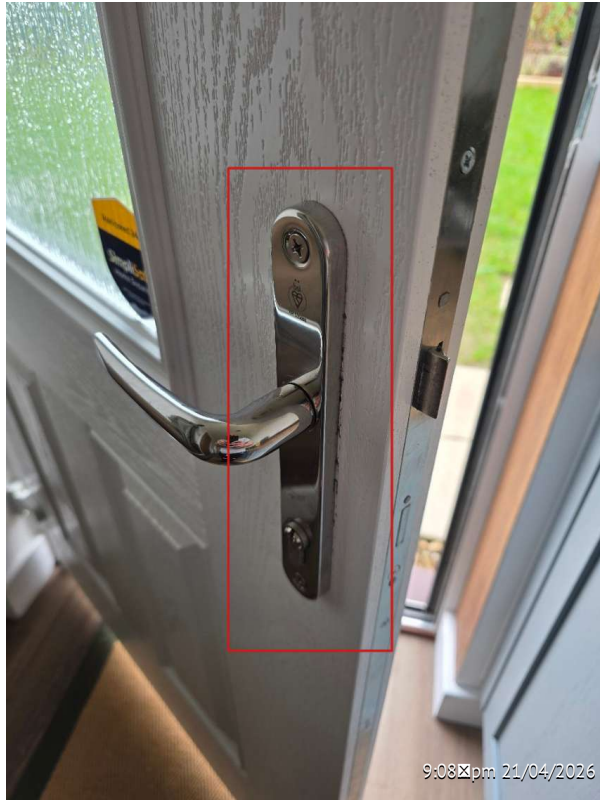
Location Utility Room, External
Rear Door Handles

External door handles are loose

Functional, security, and safety defect; loose door furniture can impair correct operation of the locking mechanism, reduce resistance to forced entry, and lead to progressive wear or failure of internal fixings

Chapter 6.7 — external doors and associated ironmongery must be securely fixed and correctly installed to ensure safe operation, durability, and security performance

Scottish Building Standards Technical Handbook (Domestic), Section 3.10 External doors and windows — external door assemblies and ironmongery must be properly secured to ensure safe operation, durability, and adequate security against unauthorised access

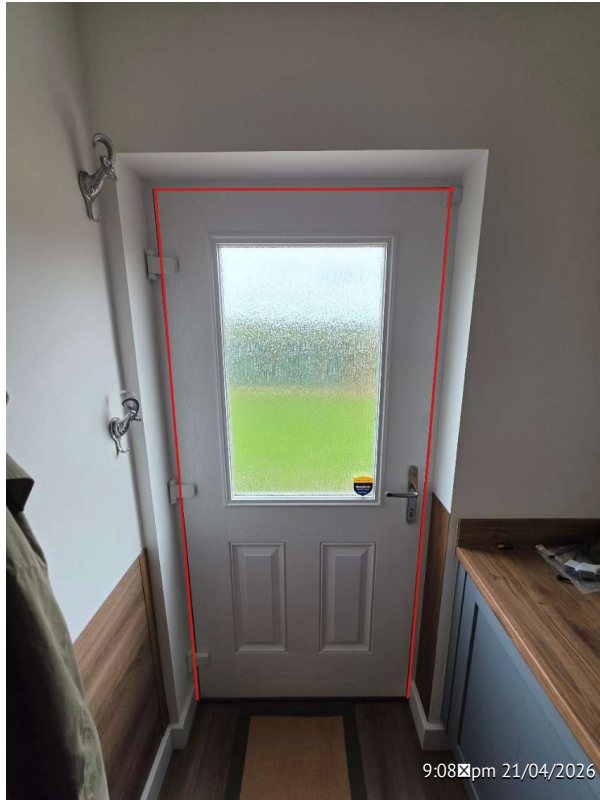
Location Utility Room, External
Rear Door Margins

Inconsistent door margins to external door ranging from approximately 3mm to 7mm

Functional and aesthetic defect; uneven margins indicate incorrect alignment or inadequate adjustment of the door leaf within the frame. This can lead to impaired operation, uneven compression of seals, potential draughts, and localised wear on hinges or locking components. Margins outside a consistent tolerance also detract from the visual quality of the installation and indicate incomplete commissioning.

External doors are expected to be installed in accordance with manufacturer tolerances and good workmanship standards, with consistent clearances typically around 3–4mm on modern doorsets. The key requirement is uniformity, correct operation, and effective sealing. Variations such as those observed (3–7mm) indicate inconsistent adjustment and fall outside normal workmanship expectations.

Chapter 6.7 — external doors must be correctly installed and adjusted to achieve consistent clearances, ensuring smooth operation, effective sealing, and an acceptable appearance

Scottish Building Standards
Technical Handbook (Domestic),
Section 3.10 External doors and
windows — external doors must
be correctly aligned and adjusted
to ensure uniform margins,
weather tightness, and
satisfactory operational
performance
