## POST-HANDOVER INSPECTION REPORT

# Website Sample Property

## Sample New-Build Home

### CLIENT-ISSUE SAMPLE REPORT

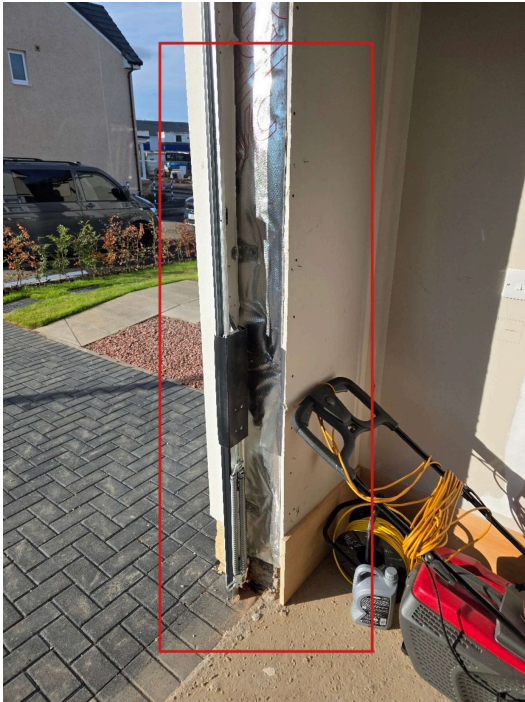
Integral Garage, Garage Door Reveal

The fire-protective plasterboard lining to the garage door reveal is incomplete, leaving the reveal construction exposed. The intended fire-resisting lining cannot be considered continuous at this location.

Where the garage lining forms part of the required fire-resisting separation, incomplete board coverage and exposed edges can reduce continuity of the protective layer and permit earlier fire and smoke spread through concealed construction.

NHBC Chapter 6.3, clause 6.3.6 - fire-resisting construction should be completed to maintain the required resistance to fire, including the separation associated with an integral or attached garage.

Scottish Standard 2.2, Separation, including the domestic-garage guidance, is relevant where the garage construction forms part of the fire-resisting separation between the dwelling and garage.

**HIGH - Fire Safety / Joinery. Prompt rectification and verification are required.**

Complete the reveal with the specified fire-resisting lining system, including the correct board type, layers, fixings, joints, edge protection and fire-stopping. Verify the completed detail against the approved garage fire-separation design.

Use the tested plasterboard/fire-lining system manufacturer detail for board type, layers, fixings, joints, edge protection and associated fire-stopping.

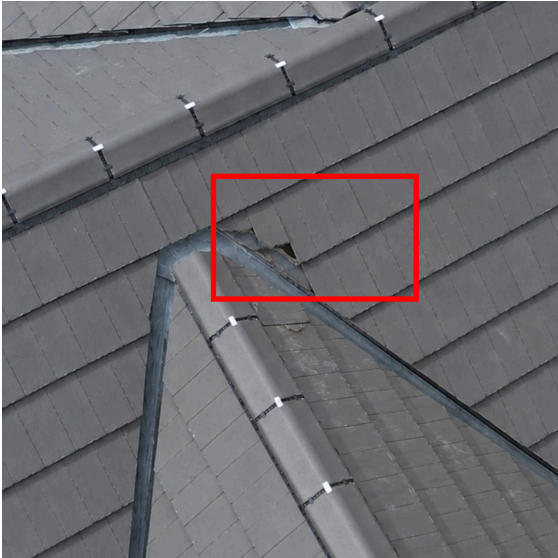
Roof, Pitched Roof Junction / Abutment Detail

Drone inspection identified damaged/displaced roof tiles at the pitched-roof junction, with local gaps and incomplete tile coverage visible around the intersection detail.

Displaced or damaged tiles and incomplete junction detailing can reduce weather protection and increase the risk of wind-driven rain or moisture reaching the underlay and concealed roof construction.

NHBC Chapter 7.2: clauses 7.2.19 and 7.2.20 are relevant to secure tile/slate fixing and effective weathering at abutments, intersections and changes in roof geometry.

Scottish Standard 3.10, Precipitation, is relevant because the roof and associated weathering details should prevent rain penetration from causing dampness or damage.

**HIGH - Roof / Weathering. Prompt close-range inspection and rectification are required.**

Inspect the affected junction at close range. Replace damaged tiles, reinstate the covering securely to the correct bond/fixing arrangement and confirm the junction/abutment detail is complete and weather-tight.

BS 5534 and the roof-tile manufacturer fixing/detailing instructions are relevant to tile fixing, laps, restraint and weathering at junctions and abutments.

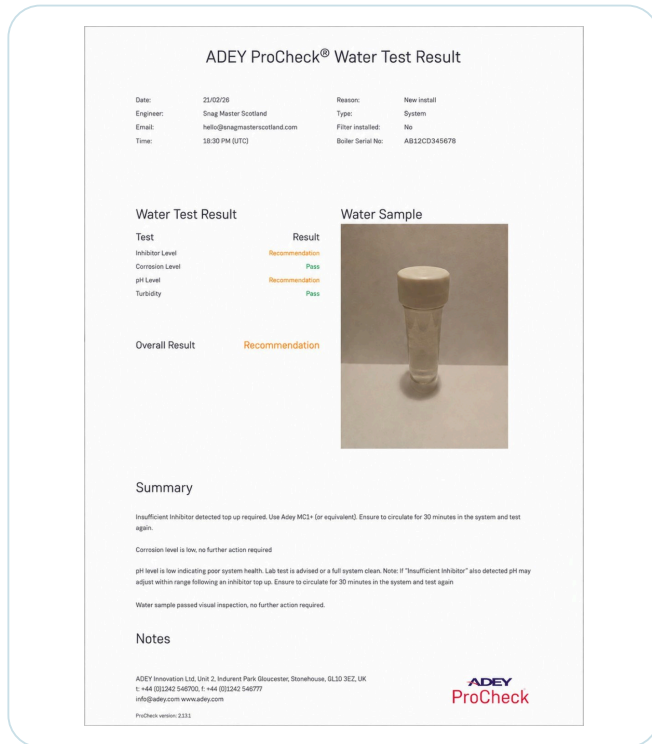
Central-Heating System, ADEY ProCheck Analysis

The ADEY ProCheck result records an overall Recommendation, with inhibitor level and pH requiring attention while corrosion level and turbidity are recorded as Pass.

Insufficient inhibitor and an unsuitable pH can reduce corrosion protection within a wet central-heating circuit and may adversely affect long-term system condition if not corrected.

NHBC Chapter 8.1, clause 8.1.10 - water-based space-heating systems should be installed and commissioned in accordance with recognised standards so they operate safely and satisfactorily.

Scottish Standards 6.3 (Heating system) and 6.7 (Commissioning building services) are relevant to effective operation and commissioning of the fixed heating system.

**MEDIUM - Heating System / Water Treatment. Corrective treatment and retesting are required.**

Treat the system in accordance with the ADEY result and heating-system manufacturer guidance. Restore the correct inhibitor concentration, circulate fully and retest. Investigate pH further if it remains outside the recommended range after treatment.

BS 7593, BS EN 14336 and the ADEY / heating-system manufacturer treatment instructions are relevant to water treatment, commissioning and verification.

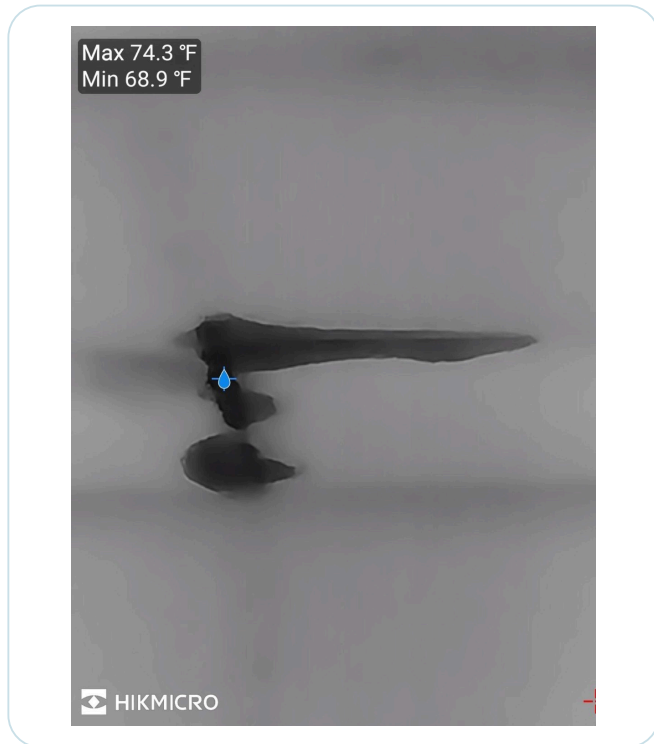
Ceiling Junction, Localised Thermal Anomaly

Thermal imaging recorded a pronounced localised cold anomaly at the ceiling junction. The pattern is indicative only but is consistent with possible concealed moisture or another localised thermal irregularity.

If moisture is confirmed, concealed saturation can damage plasterboard, decoration and insulation and may promote mould growth. The thermal image alone does not identify the source or prove active leakage.

The relevant NHBC requirement depends on the confirmed source: Chapter 7.2 where roof/weathering defects permit moisture ingress, or Chapter 8.1 where internal services are leaking.

Scottish Standard 3.10 is relevant where precipitation ingress is confirmed; Standard 3.15 is relevant where the anomaly is caused by condensation. Final classification depends on source tracing.

**HIGH - Thermal / Moisture. Prompt source tracing and moisture confirmation are required.**

Confirm the finding with appropriate moisture testing and inspect above/behind the affected area where practicable. Trace and rectify the source, dry affected materials and recheck after drying.

BS 5250 is relevant where condensation or building-fabric moisture management is confirmed. Any plumbing, roof or product defect should also be checked against its specific system requirements.

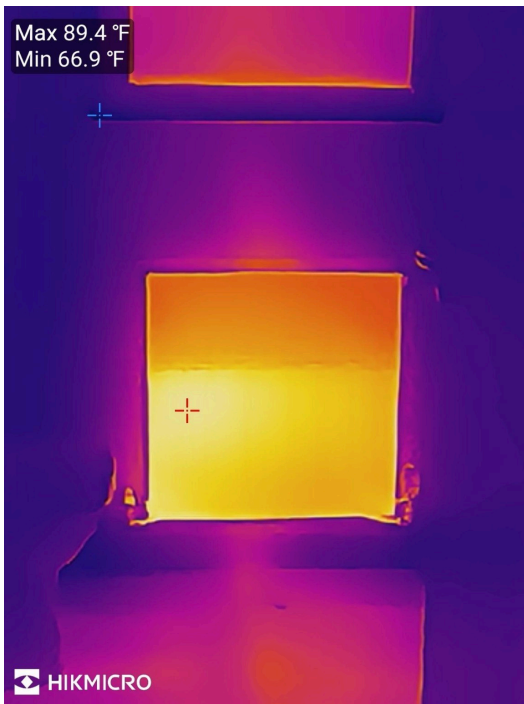
Radiator Assembly, Uneven Heat Distribution

Thermal imaging shows uneven heat distribution across the radiator, with the upper section operating cooler than the lower section during the heating check.

The thermal pattern may indicate trapped air, inadequate balancing or restricted circulation, reducing emitter performance and preventing even heat output.

NHBC Chapter 8.1, clause 8.1.10 - heating systems should be installed and commissioned in accordance with recognised standards so emitters operate satisfactorily.

Scottish Standards 6.3 (Heating system) and 6.7 (Commissioning building services) are relevant to satisfactory operation and commissioning of fixed heating services.

**MEDIUM - Heating / Commissioning. Bleeding, balancing and functional recheck are required.**

Bleed the radiator, check valve operation and system pressure, balance the heating circuit as necessary and repeat the heat-up test once the system has reached steady operating temperature.

BS EN 14336, BS EN 12828 and the radiator / valve manufacturer instructions are relevant to commissioning, balancing and normal system operation.

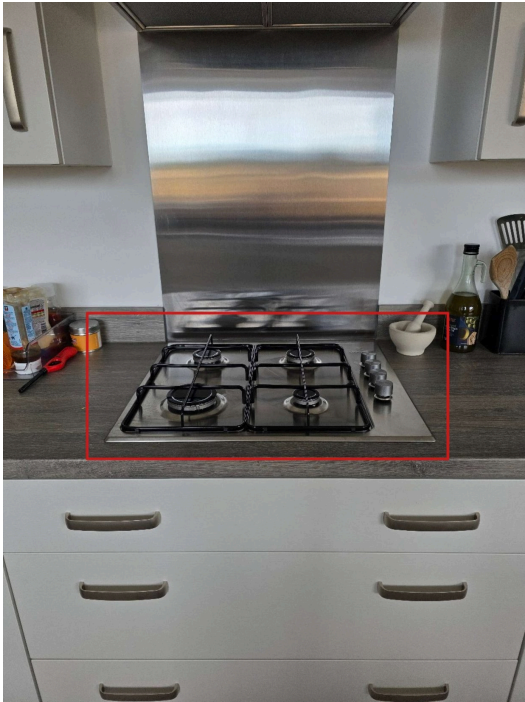
LOCATION Kitchen, Gas Hob Appliance

The gas hob is not securely fixed within the worktop cut-out and moves under hand pressure. The appliance should remain stable during normal use and be secured using the manufacturer-specified fixing arrangement.

Movement can damage the worktop seal and place avoidable mechanical strain on the appliance and gas connection. Because this concerns a gas appliance, the installation requires competent review.

NHBC Chapter 8.1 is relevant to the proper installation of fixed services and appliances and to satisfactory operation of the completed installation.

Scottish Standard 3.17, Combustion appliances - safe operation, is relevant to the completed appliance installation. The fixing method is also controlled by gas-safety and manufacturer requirements.

**HIGH - Gas Appliance / Installation. Competent review and secure fixing are required.**

Arrange inspection by a Gas Safe registered engineer. Fit the specified retaining clips/brackets and sealing arrangement, confirm the hob is secure and complete appropriate gas-soundness and operational checks.

BS 6172:2010+A1:2017 and the hob manufacturer installation instructions are directly relevant to the installation and secure fixing of domestic gas cooking appliances.

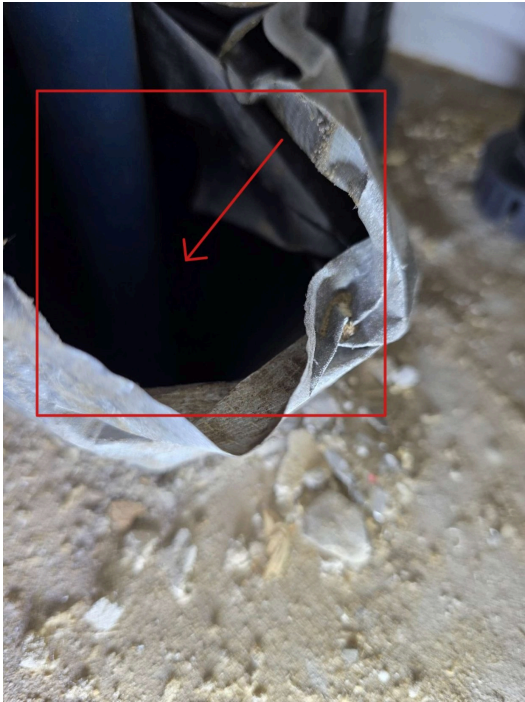
Incoming Water Service, Service Entry

The incoming water service is not insulated at the entry zone and the surrounding service duct / penetration remains incompletely sealed.

The incomplete entry detail can leave the pipe vulnerable to low temperatures and can permit uncontrolled air, moisture, debris or pests through the service penetration.

NHBC Chapter 8.1, including the incoming-utilities and water-services provisions, is relevant to properly completed and protected service entries and water supplies.

Where the service penetration passes through the insulation / air barrier, Scottish Standard 6.2 is relevant to continuity of the building insulation envelope. The service-entry detail must also follow the approved warrant design.

**MEDIUM - Water Service / Sealing & Insulation. The entry detail should be completed and protected.**

Complete the service entry in accordance with Scottish Water and the pipe/duct system requirements. Protect and insulate the incoming pipework and seal the surrounding penetration while preserving any required sleeve movement.

Scottish Water service-entry requirements, BS EN 806-4 and the pipe/duct manufacturer installation instructions are the principal references for protection, insulation and completion of the incoming service.

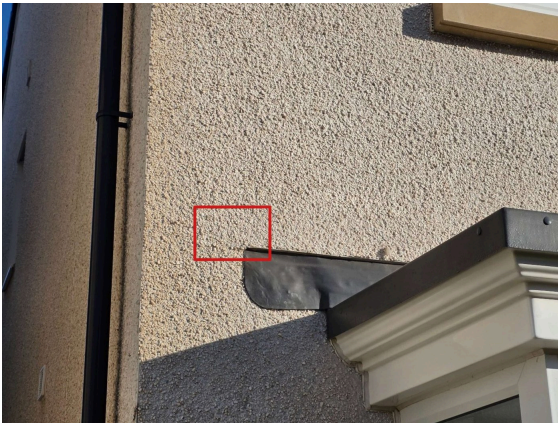
External, End of Lead Abutment

No weep vent is visible at the expected end of the stepped cavity-tray / lead-abutment drainage position.

Where the approved cavity-tray detail requires discharge at this point, missing or blocked weep provision can prevent intercepted moisture draining safely to the exterior and increase the risk of moisture tracking into the wall.

NHBC Chapter 6.1, clause 6.1.17 - DPCs and cavity trays at roof abutments should be correctly detailed, with stop ends and weep provision where required to discharge water from the cavity.

Scottish Standard 3.10, Precipitation, is relevant to external-wall weathering and cavity drainage so rain penetration does not reach the inner face or cause damage.

**MEDIUM - Superstructure / Drainage. Detail confirmation and rectification are required where the outlet is absent or blocked.**

Confirm the approved cavity-tray / abutment construction and check for concealed or blocked outlets. Where required by the detail, install or reinstate the specified weep outlet, tray stop-end and clear discharge route.

BS 8215 and the installed cavity-tray / lead-abutment manufacturer detail are relevant to DPC/cavity-tray arrangements, stop ends and drainage to the exterior.
