Road Safety Audit Report

Location: Bogong High Plans Road, Falls Creek, Victoria
Issue: Proposed Change Above Windy Corner
Audit Stage: Concept Design
Client: Jonathan Spring

Report Issue Date: 12 August 2022

RSA Reference: 12931

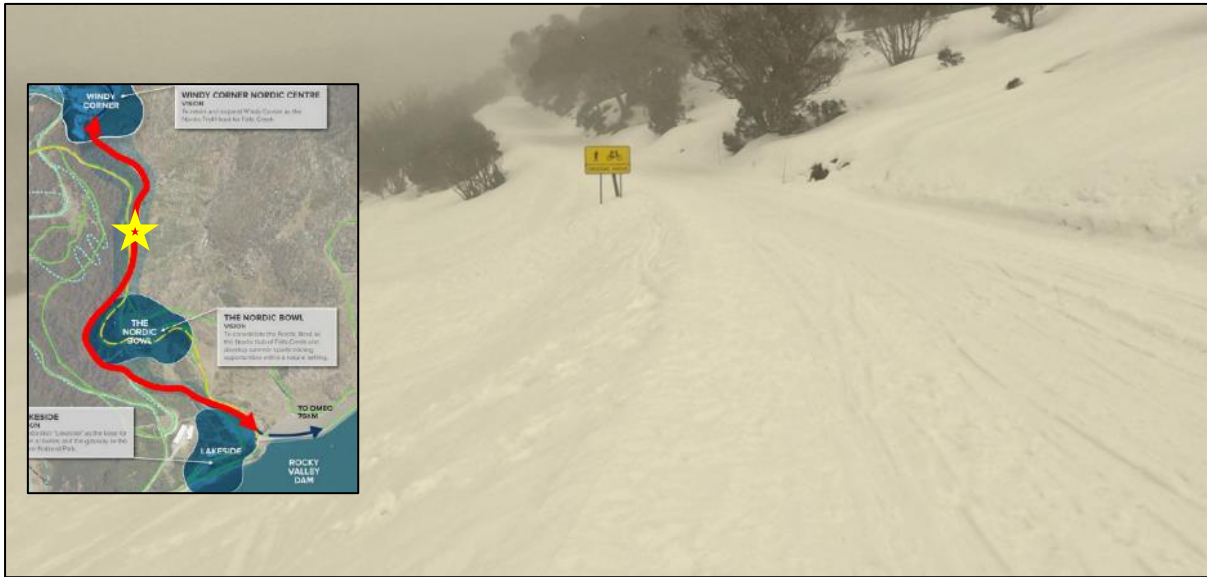
It's understood that the edge of the road has subsided in the area below (adjacent to the existing sign), just north of the Nordic Bowl. This section has a reduced width of approximately 5.5 to 6m (conservative estimate).

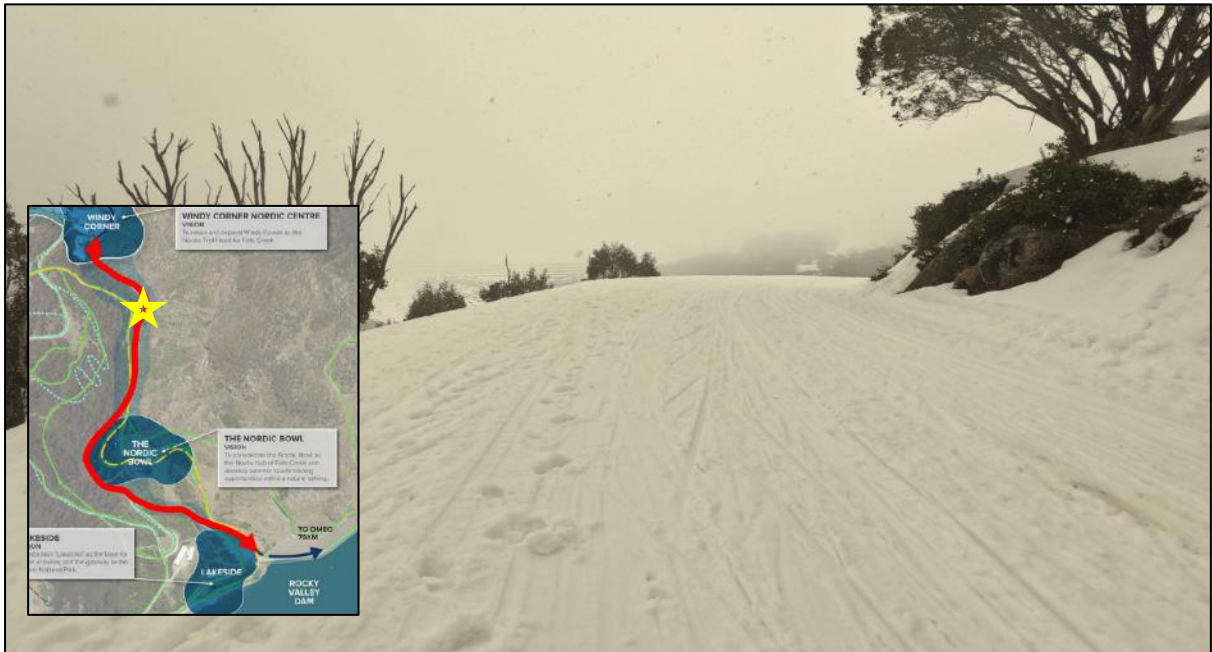
Other narrower road section is the first corner south of Windy Corner, estimated at 6m.

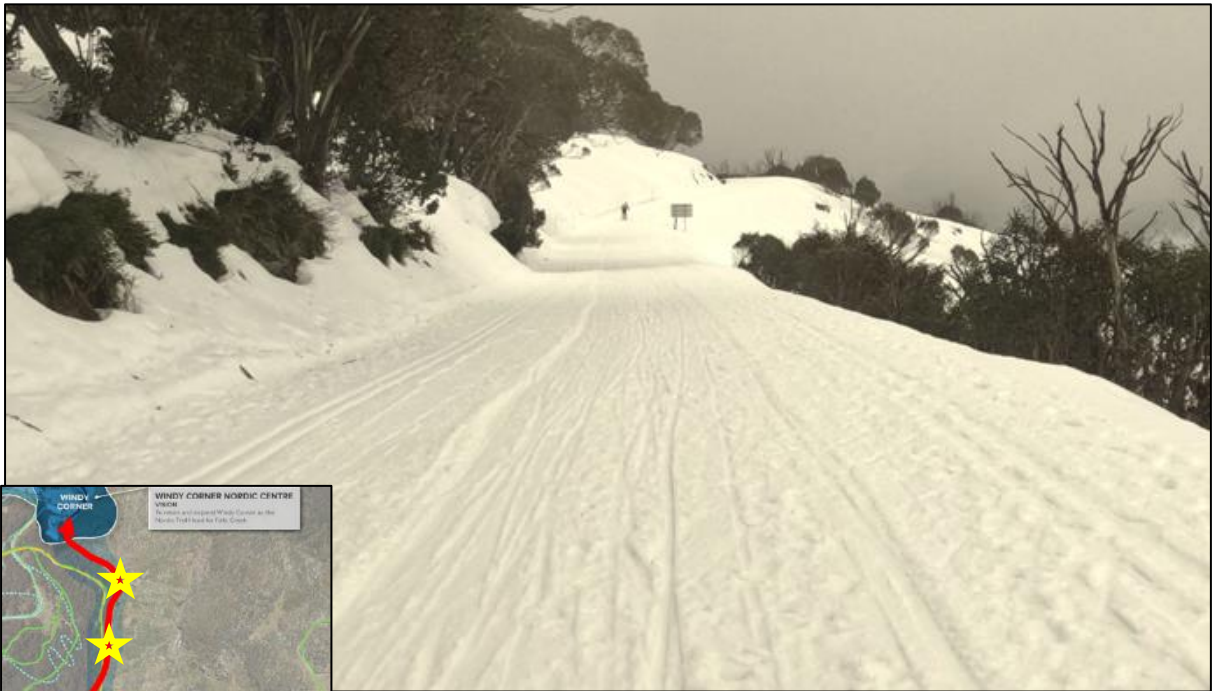
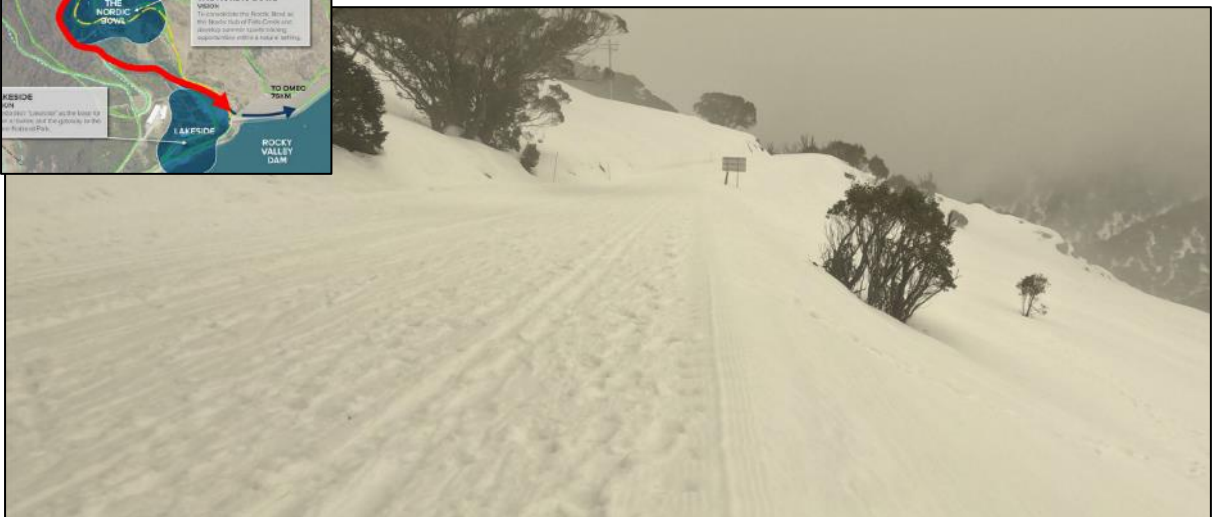
A third narrow road section was the first corner south of Windy Corner, estimated at 6m.

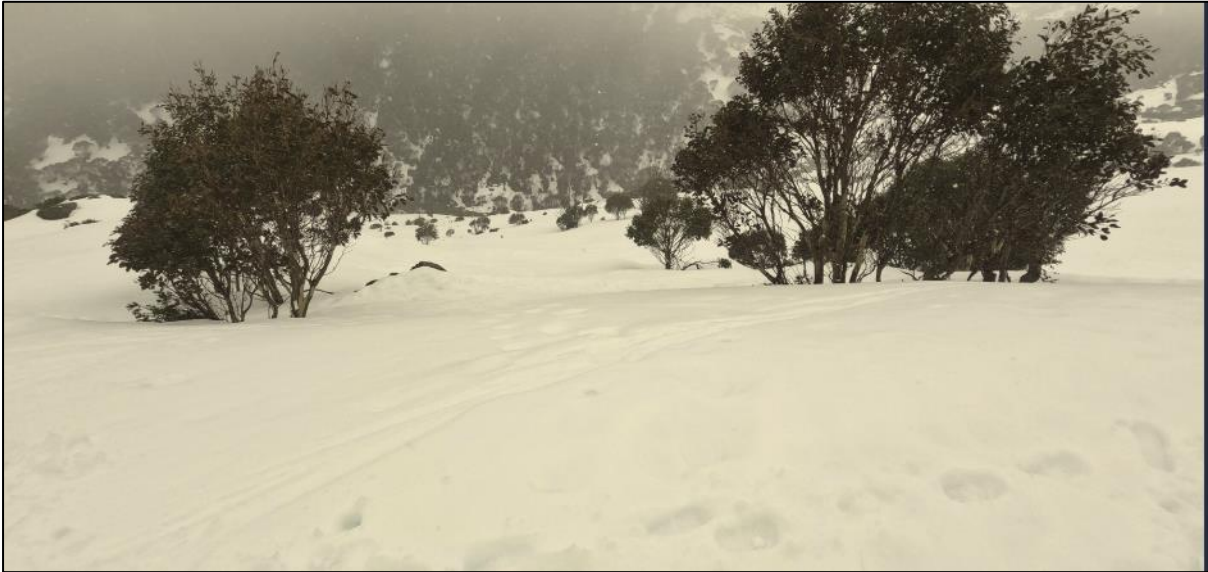
Drop-off at the first curve down tiered embankments with occasional trees

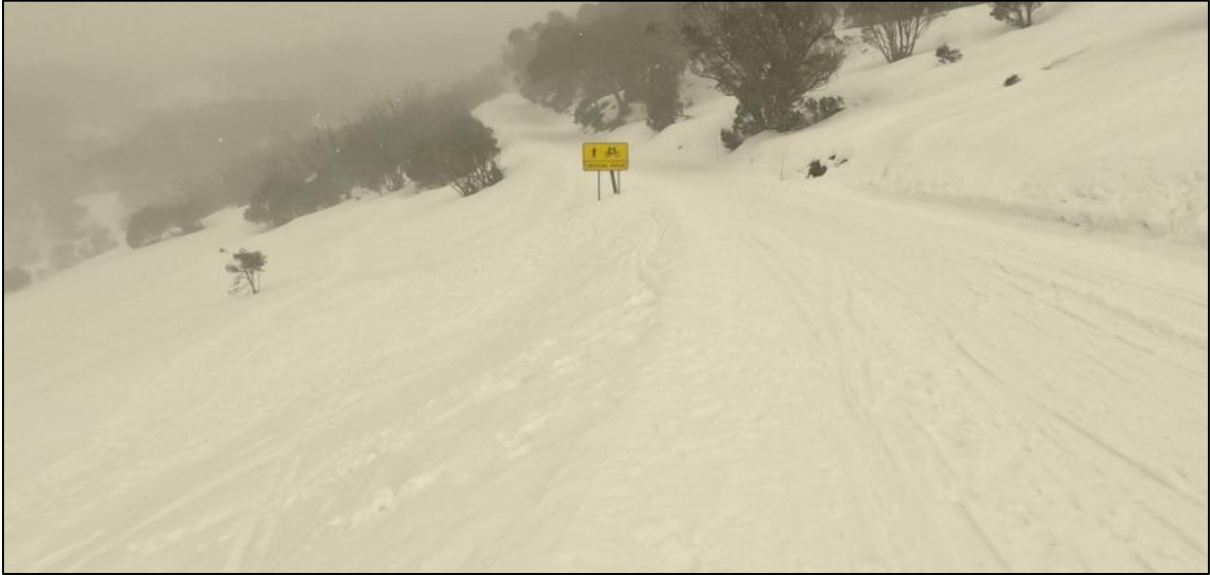
The section of road that has slipped

| Risk | Affected Road Users | Risk Rating (Austroads GRS Part 6) |
|--|---|--|
| Embankment slip, creating narrow sections. Increased risk to passing vehicles, and pedestrians. | Drivers and pedestrians | Risk Rating: Rare (>7Y) + Moderate = Low |

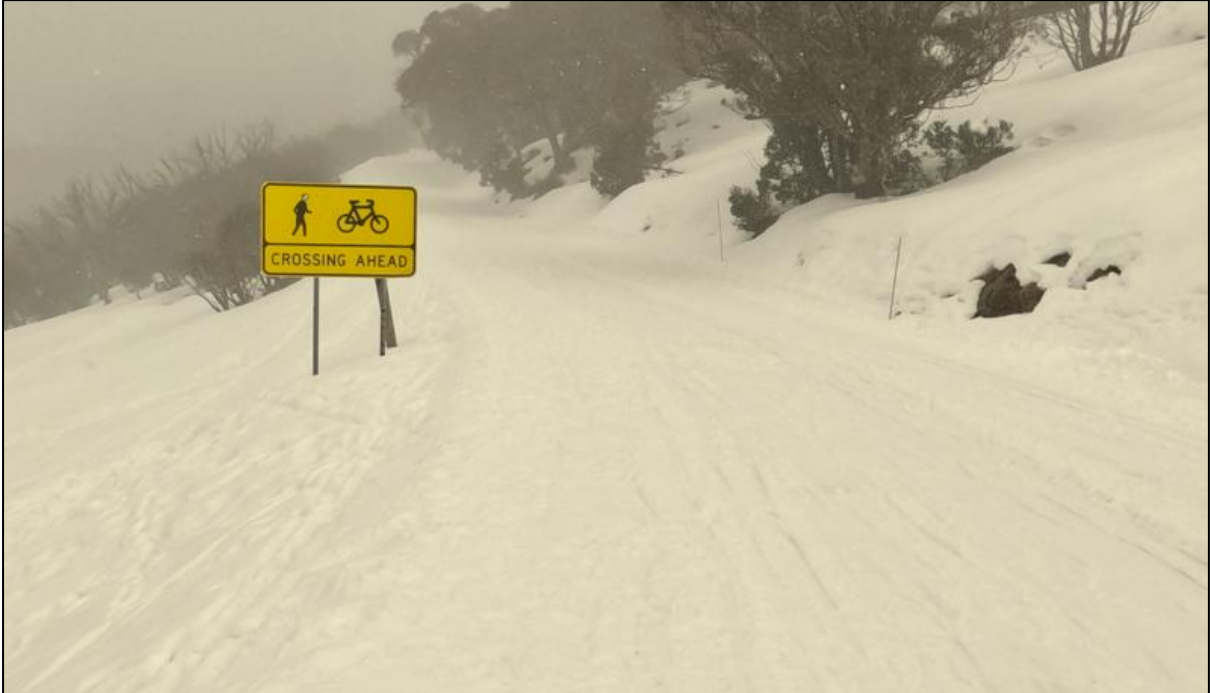
The section of road that has slipped

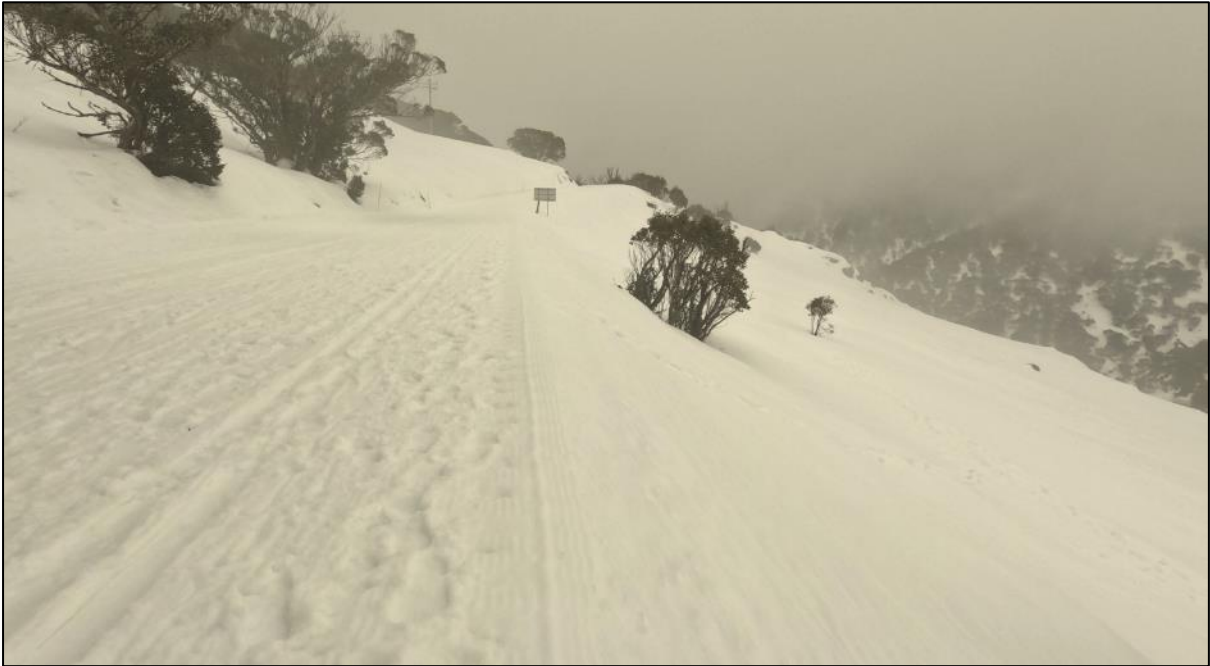
Approaching the bowl intersection looking back towards Falls Creek : showing the steep batter drop-off

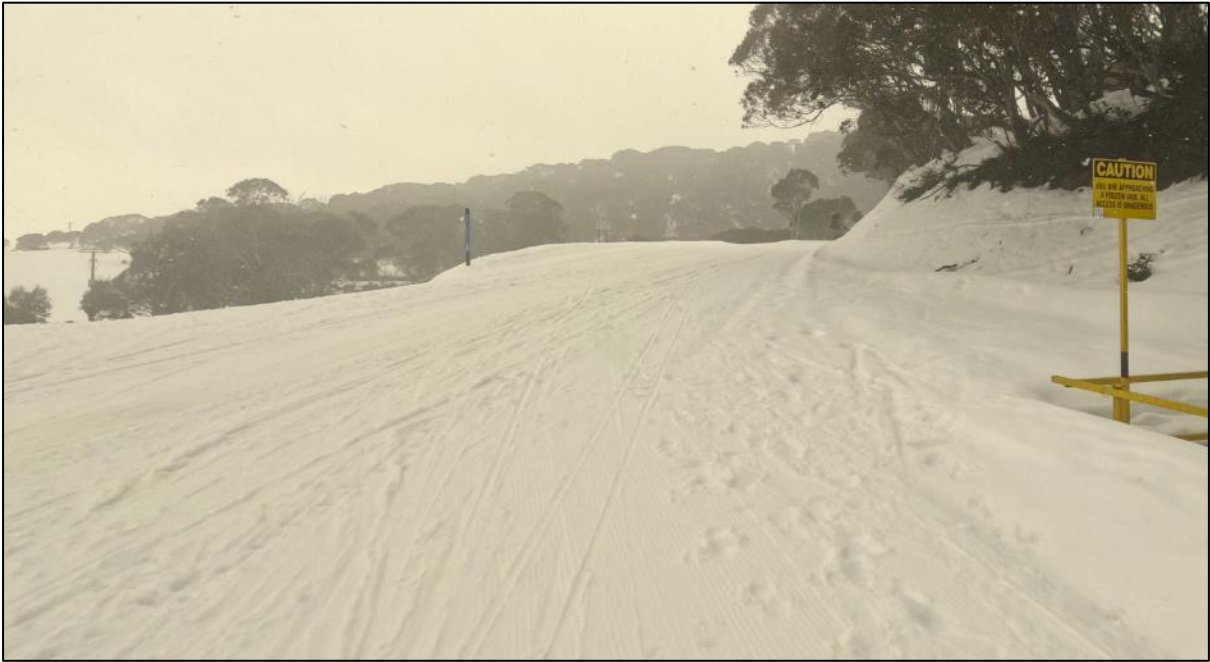
At the bowl intersection (restricted sight distance to the south from the ski trail)

| Risk | Affected Road Users | Risk Rating (Austroads GRS Part 6) |
|--|---|--|
| Bowl intersection: skier at eastern trail struck by vehicle due to restricted sight distance to the south. | Skier | Risk Rating = Unlikely (3-7Y) + Moderate = Medium |

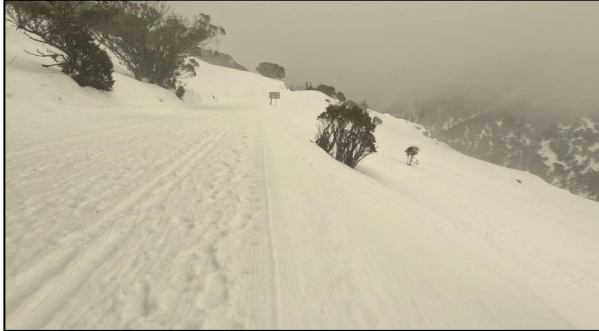
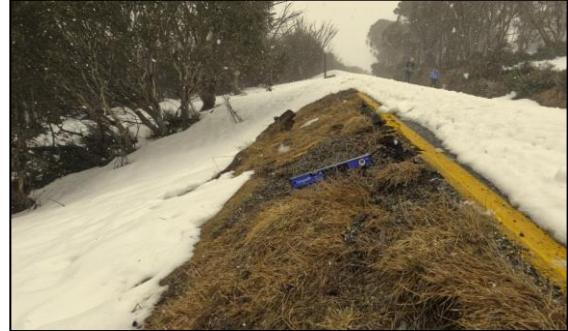
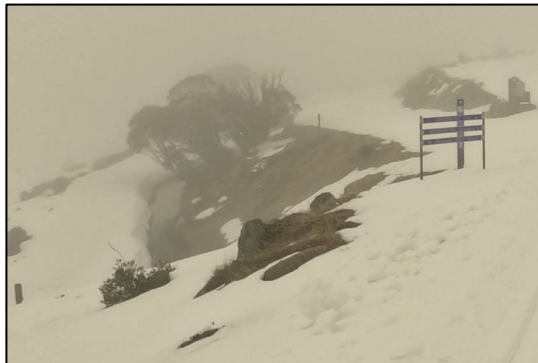
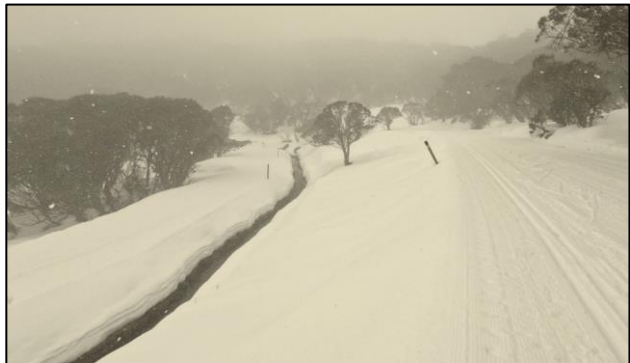
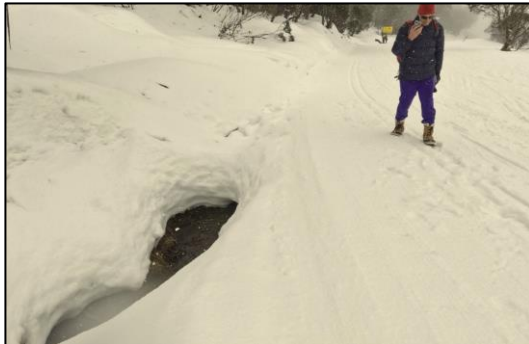
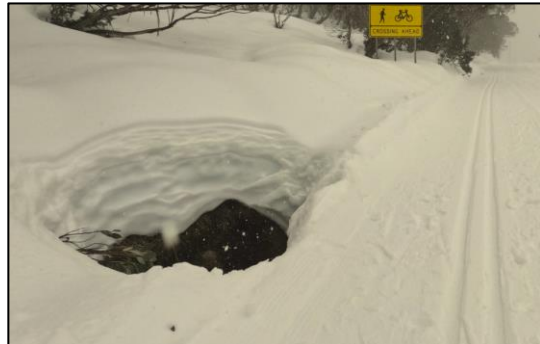
Typical roadside features that could result in occupant injury from point hazards or vehicles overturning included: the steep batters which were mostly 2(h):1(v) at their flattest, and as steep as 1:1; longitudinal drains at the bottom of embankments; deep holes formed from transverse road culverts; and trees of diameter 200mm+. The steep batters of 1:1 likely increase the risk of road edge slippage due to reduced structural support at those locations.

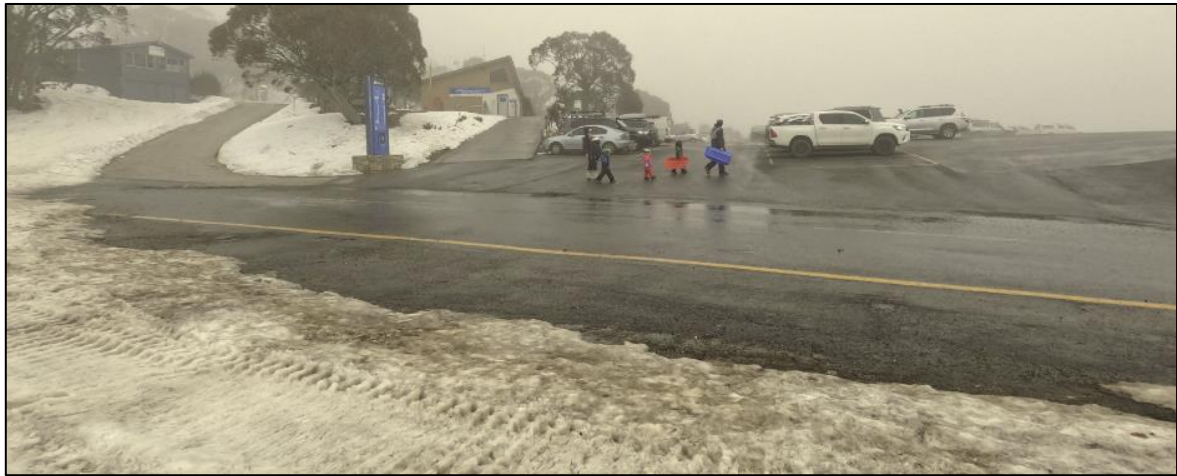
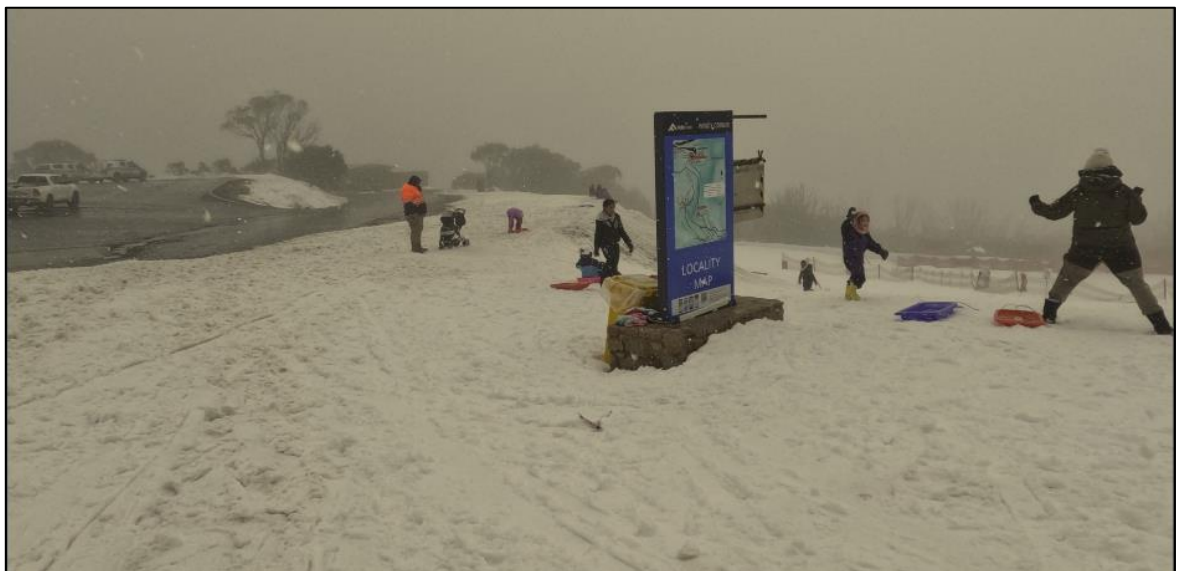
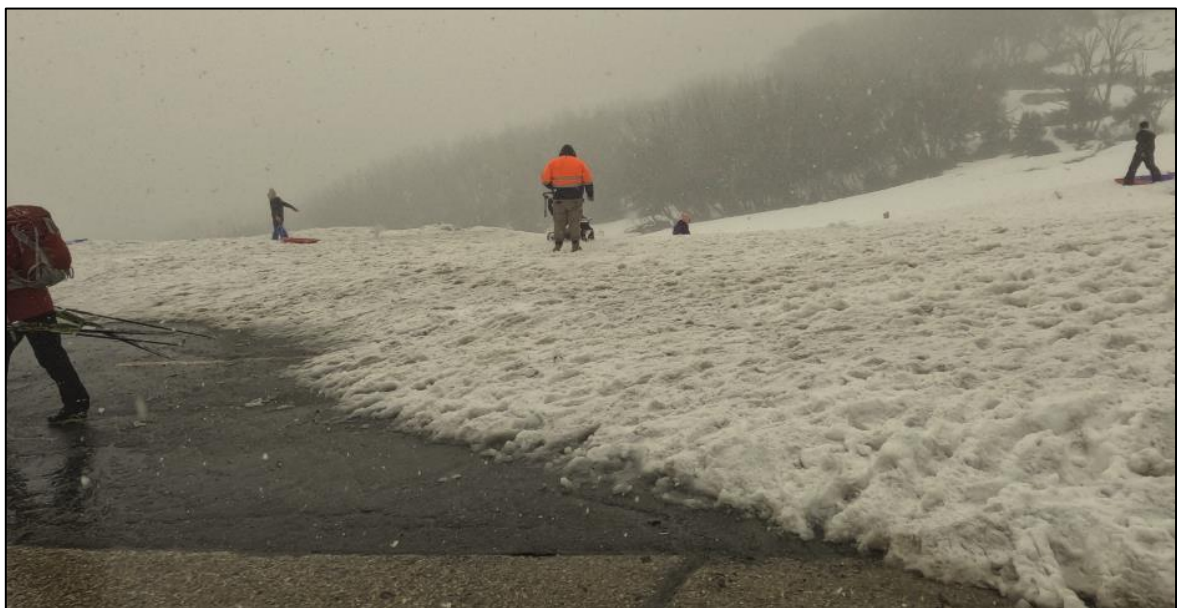
There will be significantly more traffic, including heavy vehicles, travelling past this toboggan area where people, including many children, are mingling, playing and crossing the road.

| Risk | Affected Road Users | Risk Rating (Austroads GRS Part 6) |
|--|---|--|
| Pedestrians struck by vehicle at toboggan area. | Pedestrians | Risk Rating = Possible (1-3Y) + Moderate = High |

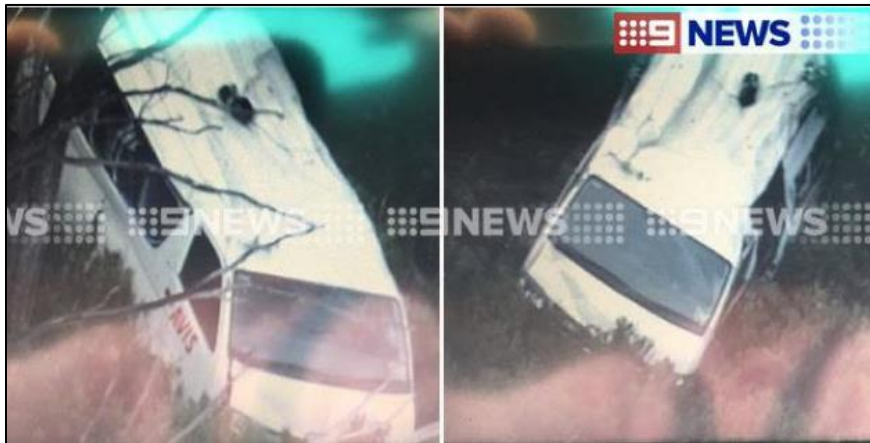
The Age, 23 March 2015

A coach bus was heading down past the Nordic Bowl entrance (on BHP road) and a minibus was heading up from Windy Corner. When they crossed paths (between the Nordic Bowl and the Apex in the road towards Windy Corner), they each moved to their left and the road subsided under the minibus causing it to roll down the steep embankment. Two teenagers were taken to hospital. The road has not been repaired.

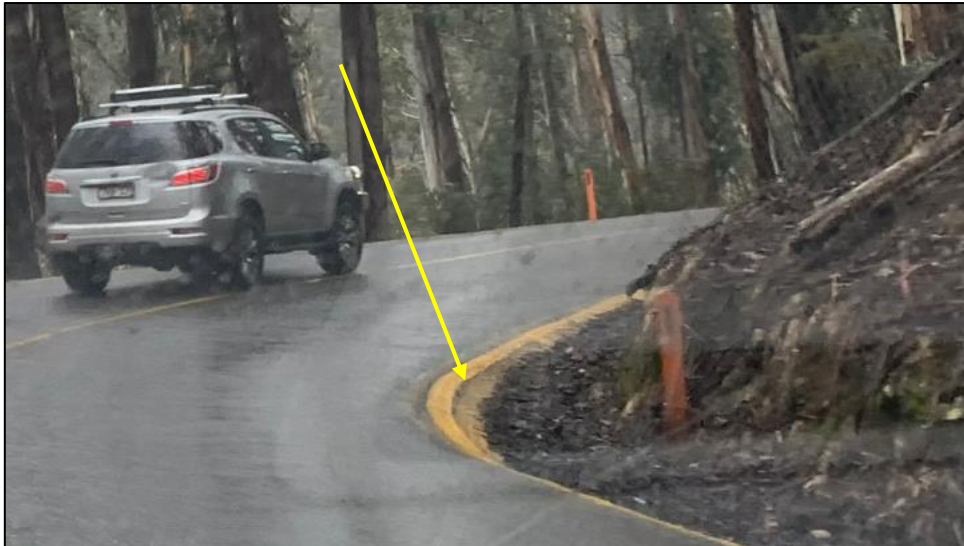
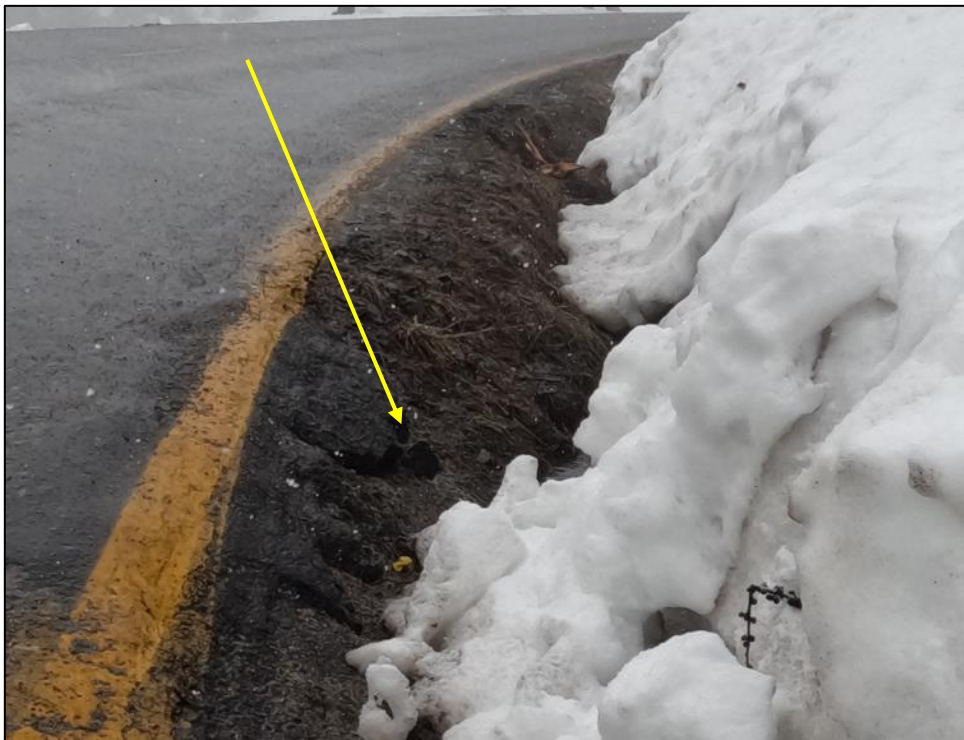
It is understood from local information that drivers regularly end up in the drain adjacent to the road on the upper-embankment side (the 'fill' side of the road) during heavy snow fall when the drain is hidden and/or there is a lower friction road surface (ie ice). This is understood to occur when drivers move away from traffic coming up-hill, or otherwise misjudge the curve, and drop their wheels down into the ditch which forms hard up against the edge of the road at the solid yellow line. It is understood that these incidents do not result in occupant injury, but occur frequently, and reduce the available road width for the remaining traffic.
