The Brooks-Park Arts and Nature Center Building Conditions Report

Prepared for:
The Town of East Hampton
159 Pantigo Road
East Hampton, NY 11937

Prepared by:
Jan Hird Pokorny Associates, Inc.
39 West 37th Street, Floor 12A
New York, NY 10018
(212) 759-6462

15 March, 2023

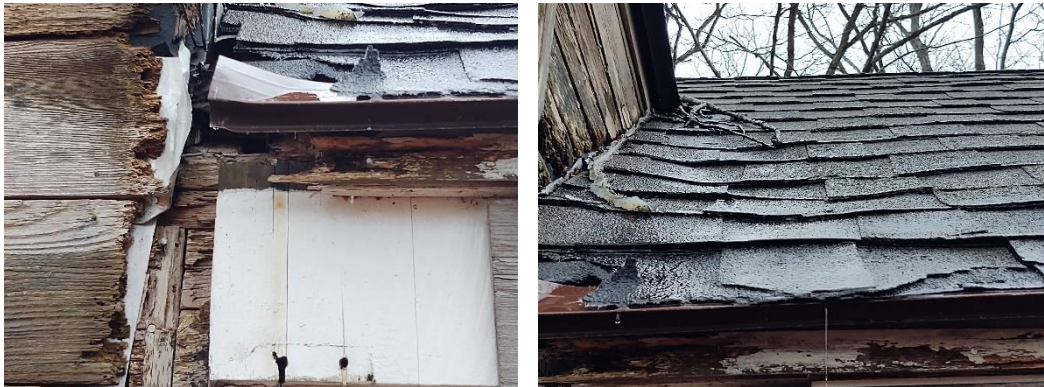
The extant roofing is in poor condition. The asphalt shingles have exceeded their useful service life. There is a hole in the roof at the south façade in the location where the asphalt shingles are installed over the earlier wood.

Photo No. 2 and 3: Asphaltic shingles have been installed over the original wood shingle roofing. There is extensive damage to the ceiling below this location.

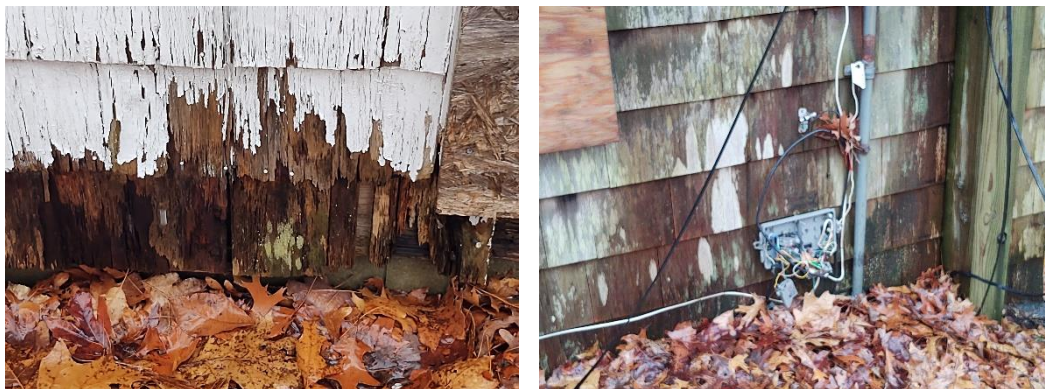
The minimal overhang and lack of gutters has exacerbated deterioration of the wood cladding along the base of the wall due to splash-back and accumulation of plant detritus.

Photo No. 4 and 5: Minimal roof overhang, excessive soil overburden, and accumulated organic detritus are all contributing to cladding damage at the residence.

The upper walls are in fair condition. The wood shakes and clapboards are weathered throughout. The lower 3'-0" of the walls is more compromised as a result of roof runoff. At the earlier portions of the residence the deterioration has extended into the sill at the west façade. In general, perimeter grade is excessively high in relation to the exterior

cladding (especially at the east façade) resulting in cladding deterioration and insect damage from moisture.

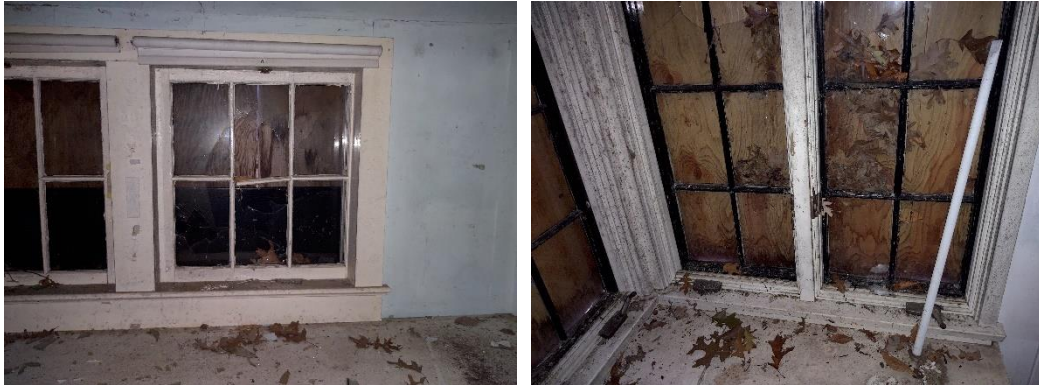
Most of the windows only require replacement of broken glazing and the addition of weather-stripping to be re-useable. Ten windows have broken or heavily damaged mullions, requiring restoration. The five large casement windows at the south façade are all heavily damaged and will require replication.

Photo No. 6 and 7: The windows all require some level of repair.
While most only require re-glazing, some have damaged mullions requiring sash restoration.

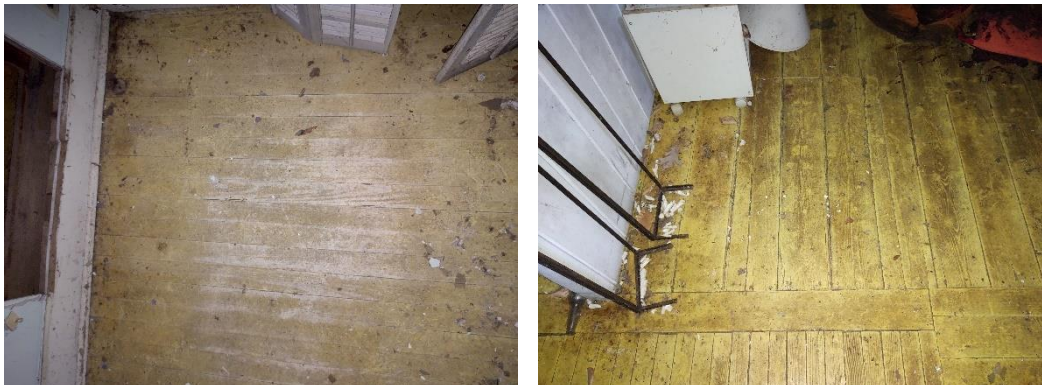
There is a heavy paint build up on the floor in the earliest section of the house, with normal wear to the paint finish. The floor register is damaged.

Photo No. 8 and 9: The floors are level and in generally good condition. The primary issue is finish deterioration.

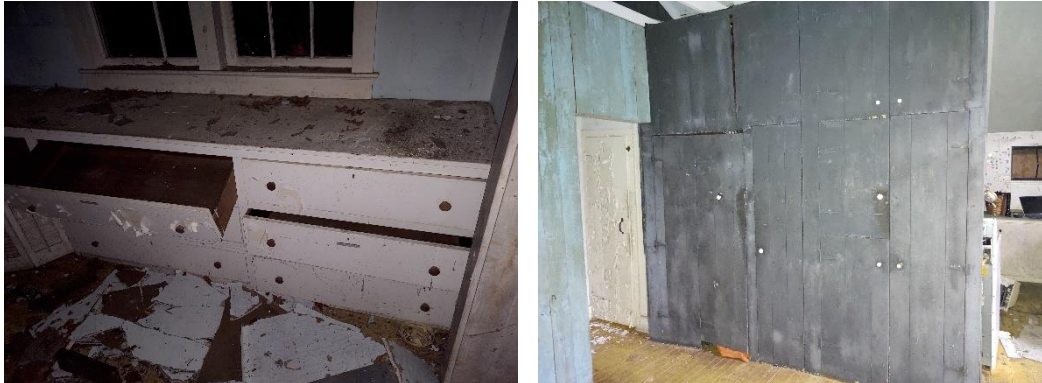
The cabinetry at the original portion of the residence exhibits heavy paint damage, but is in generally good condition. The joinery is separating at one drawer.

Photo No. 10 and 11: The cabinetry primarily requires only minor repairs and repainting.

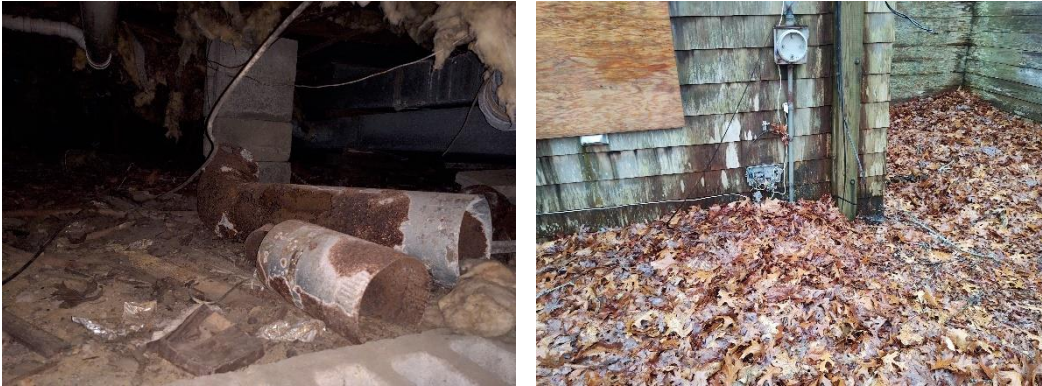
The oil-fired furnace is in poor condition and is not operational. A new heating system must be installed as part of any repair campaign for new program use.

Photo No. 12 and 13: The building systems are non-operational and will require upgrades for any proposed re-use of the residence.

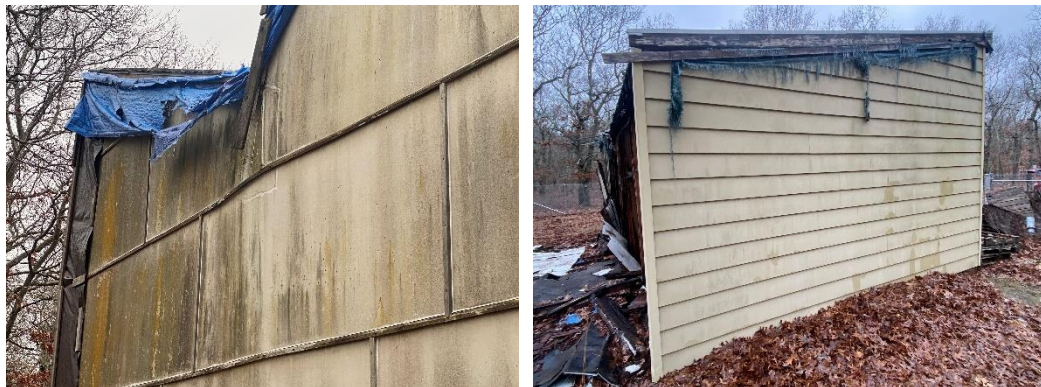
At the studio block, the north and south walls are plumb, and appear to be in serviceable condition, with the exception of the cellulose fiber siding which, in addition to being an ACM, exhibits significant biological growth on the north wall. There are some broken cladding sheets on the east and west south wall sections. The underlying plywood sub-sheathing was concealed on these two walls. At the west facade wall, a portion of the framing exposed at the interior face reveals a small section of rotted floor plate near the center of the wall. This condition is at the location of a previous vent installation, and is likely isolated. Above, a section of wall has been displaced by failure of a non-original steel 'I' beam intended to provide supplemental support the roof/skylight. A similar upper wall condition is apparent at the east end wall as well; at both locations the framing is displaced and the Transite board is broken and/or distressed. Failure/displacement of the steel 'I' beam has resulted in bending of the two iron wall collar rods that extend between the north and south walls.

**Photo No. 16 and 17: Note the distressed Transite panels where the "I" beam has failed.
The aluminum siding is in good overall condition with only minor damage.**

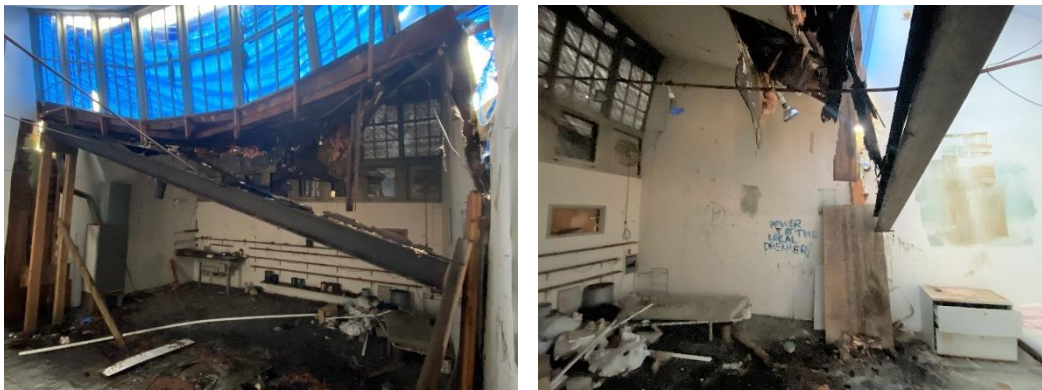
The original studio block wooden roof framing is undersized and deficient. Chronic water infiltration at the roof, likely through deficient flashing at the central skylight/roof junction, has resulted in near complete failure of the studio block roof system. The non-original steel beam, intended to provide supplemental support, has failed, and a considerable deflection of the roof has resulted. The resulting deflection has caused damage to the adjacent end walls, and distortion of the easternmost skylight (see windows section). The studio roof south slope appears to be intact and only moderately distorted, but the undersized framing is a dangerous condition.

Roof sheathing at the storage wing is in poor condition, and staining of the interior ceiling finishes at the storage wing suggests that there is advanced deterioration of the roof decking, and possibly framing, of this section.

Photo No. 18 and 19: Chronic water infiltration has resulted in significant damage to the roof and skylight.

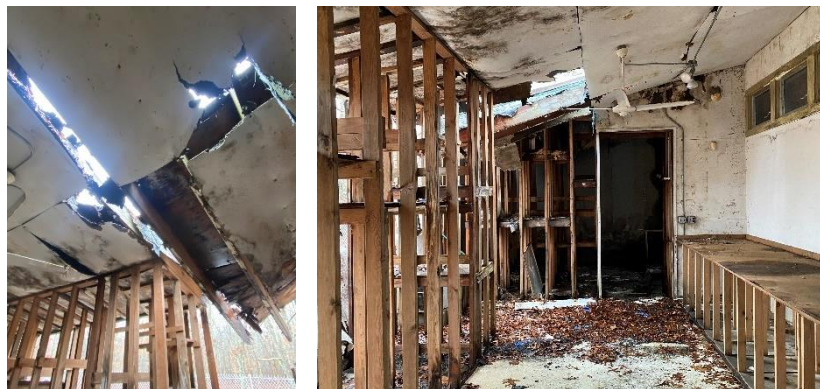
Within the storage wing, all ceiling sheathing is in poor condition, exhibiting some deformation, and significant water damage.

Within the storage wing, all wallboard is damaged to some extent: the east and north walls are heavily water-stained, the south wall is missing, the west wall is deteriorated.

Photo No. 20 and 21: Ceiling and Wall finishes at the storage wing are heavily damaged from failure of the roof and rear wall.

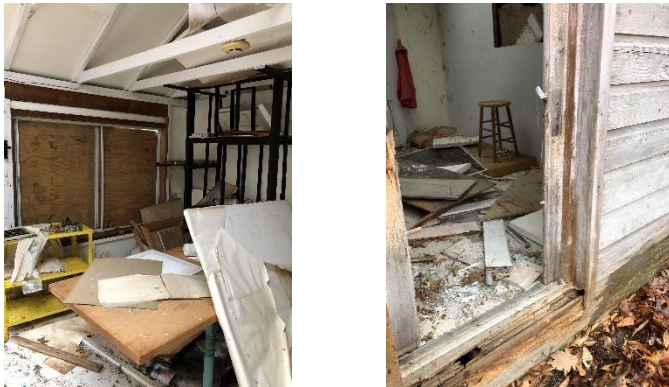
Windows on both the north and south walls are in salvageable condition, but the glazing in each has been shattered. The frames are in serviceable condition.

Photo No. 24 and 25: The window sash and frames are salvageable but will require re-glazing. The entry door is heavily damaged and will require full restoration.

The south entry door is off the hinges and severely damaged; the frame and casing are also damaged. The north door is intact, but will require some restoration and refinishing.

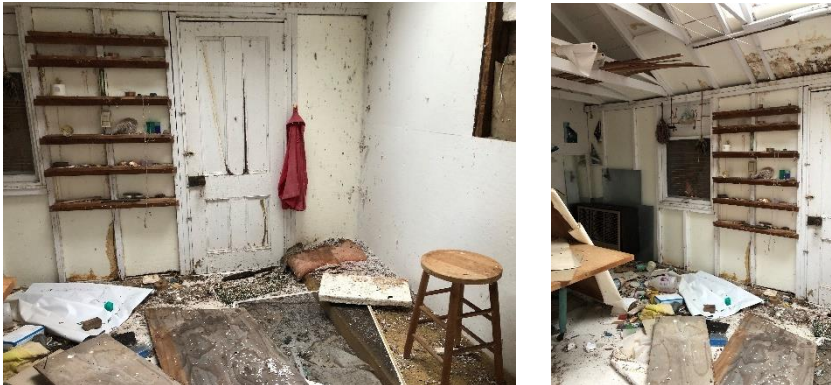
Photo No. 26 and 27: The extant furnishings and artifacts require proper documentation and cataloging.

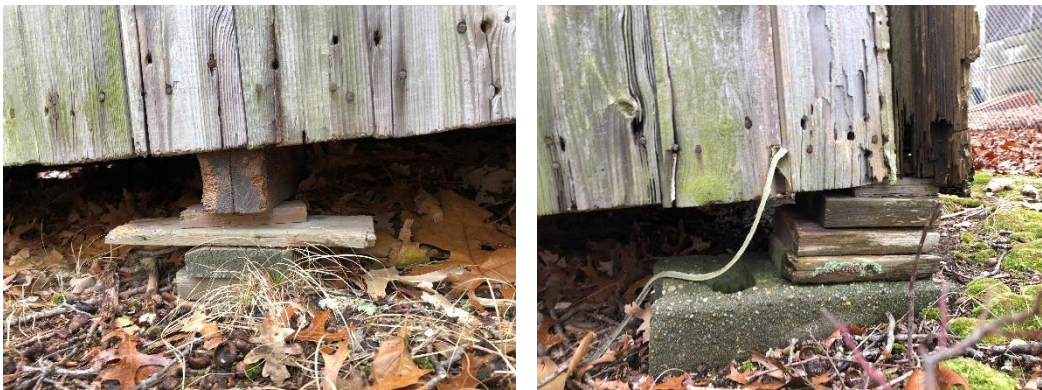
The CMU and wood foundation elements are inadequate for appropriate support of the building and warrant replacement with adequate footings, but piers replicating the extant CMU elements.

Photo No. 30 and 31: The foundation elements do not properly support the structure.

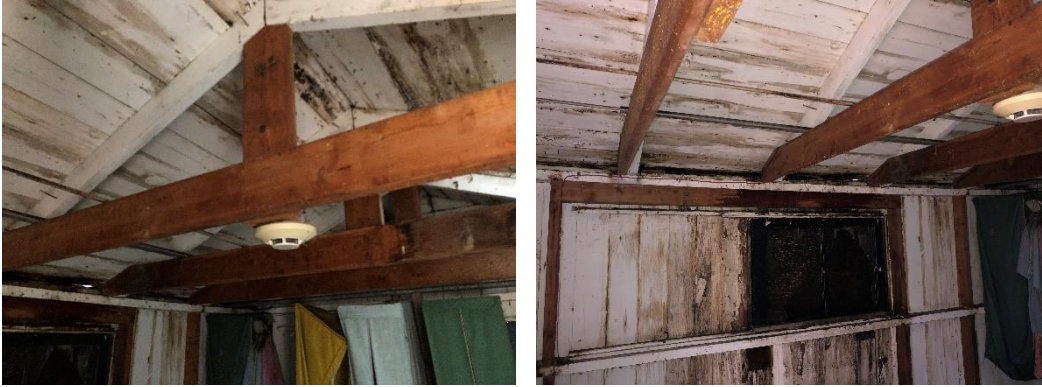
The wooden ceiling (underside of roof deck) is in serviceable condition, requiring only preparation and repainting.

Photo No. 32 and 33: The ceiling and wall cladding is water damaged, but only requires preparation and repainting.
