BROOKS-PARK HISTORIC SITE

Adopted Management Plan

SUBJECT: Supplemental Condition Assessment Report
Brooks Park Buildings
128 Neck Path
Springs, NY
SCTM# 300-103-8-6
Purchase Order # 2022-0677

Brooks Park Cottage Condition Photos

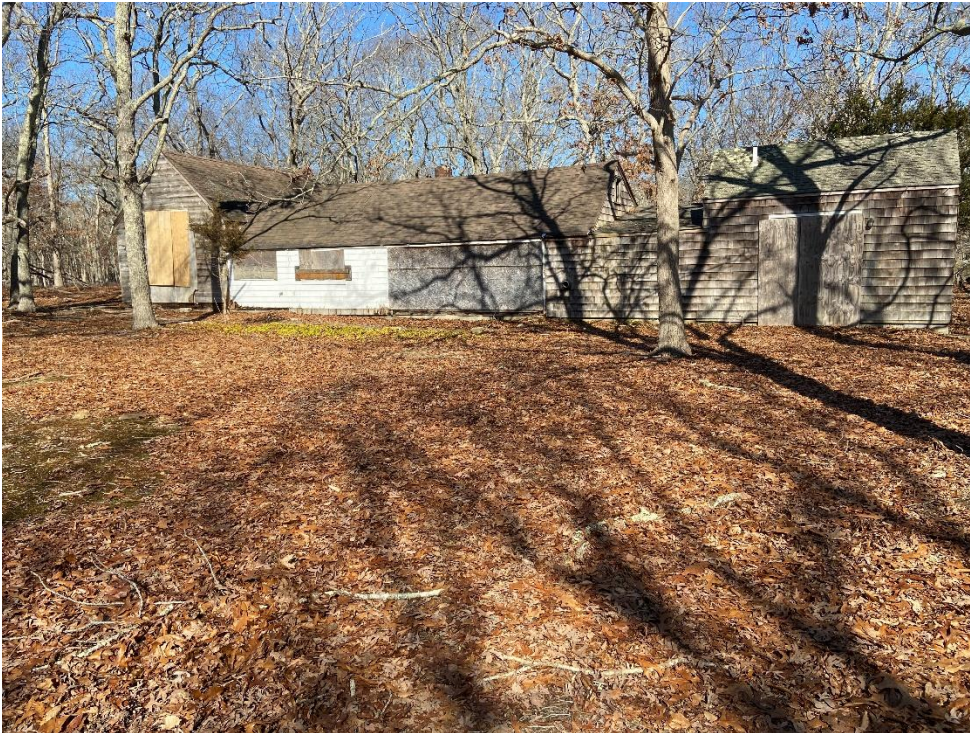
South elevation of cottage

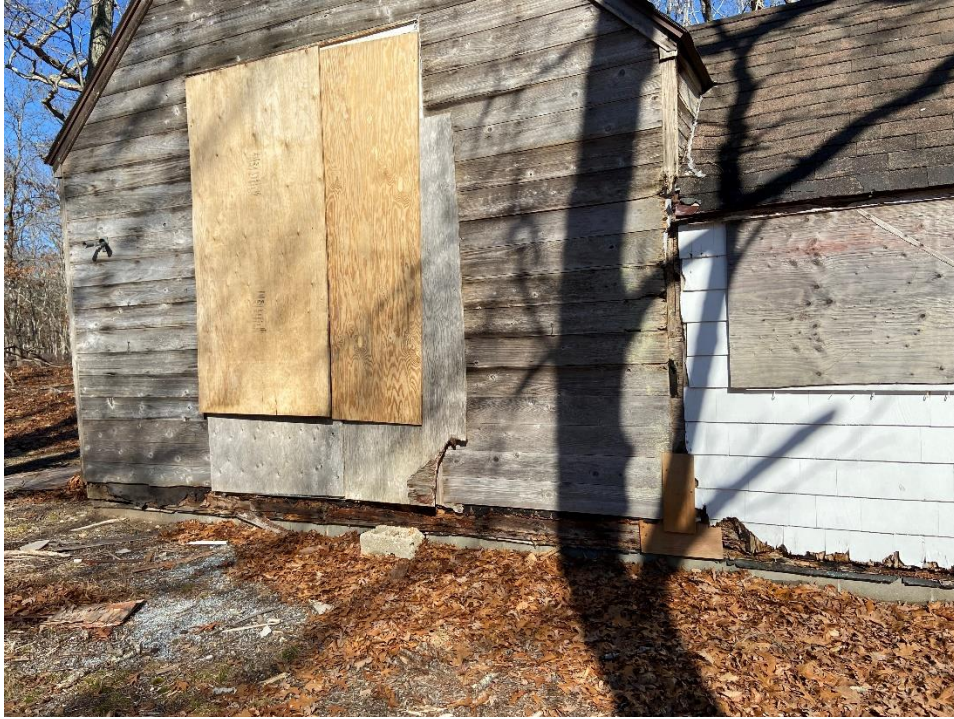
During the 2015 inspection, we noted that exterior decks and ramps were rotten and should be removed for safety reasons. This has been done. The removal has revealed extensive sill and wall stud rot on the south facing wall.

Cottage sill rot

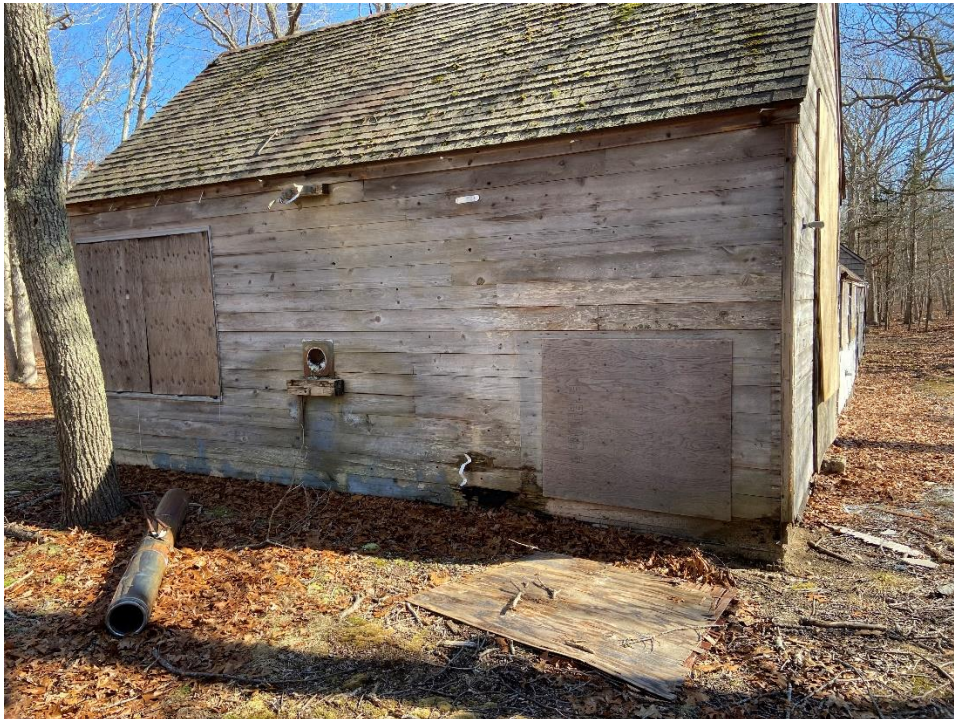
Cottage west wall

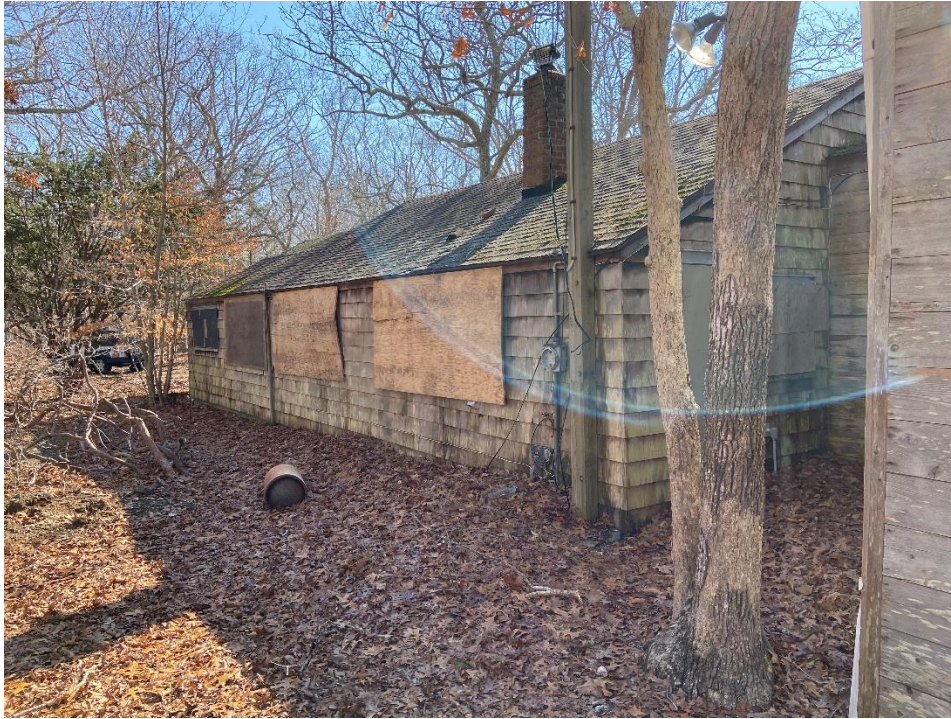
Cottage north elevation

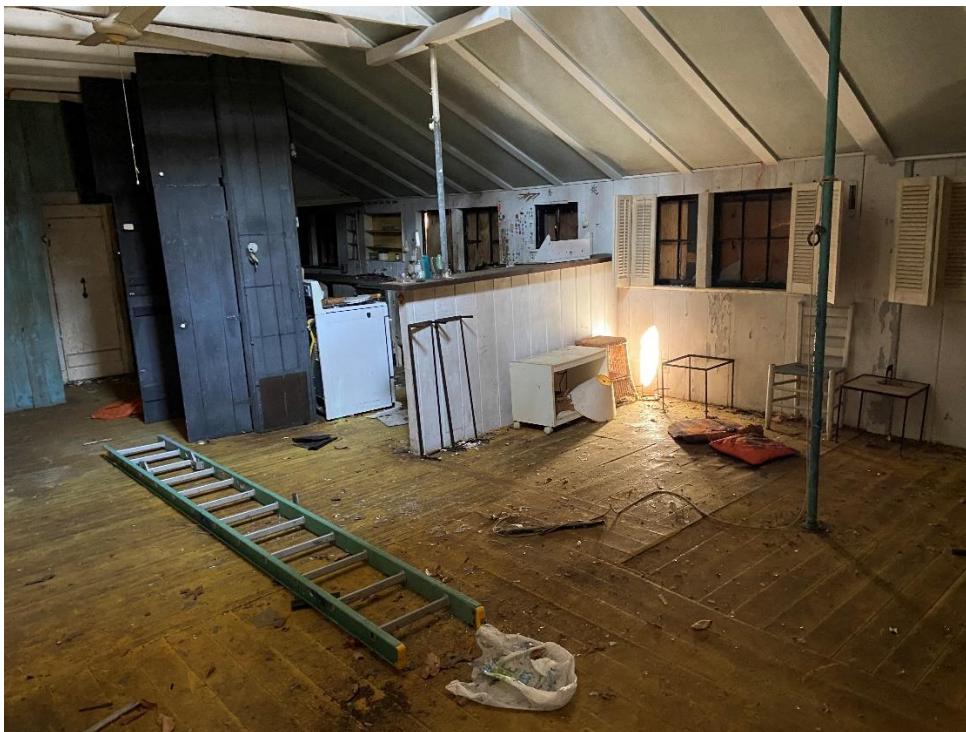
Cottage interior..center column is punching through the floor due to rot. Beam at roof is rolling

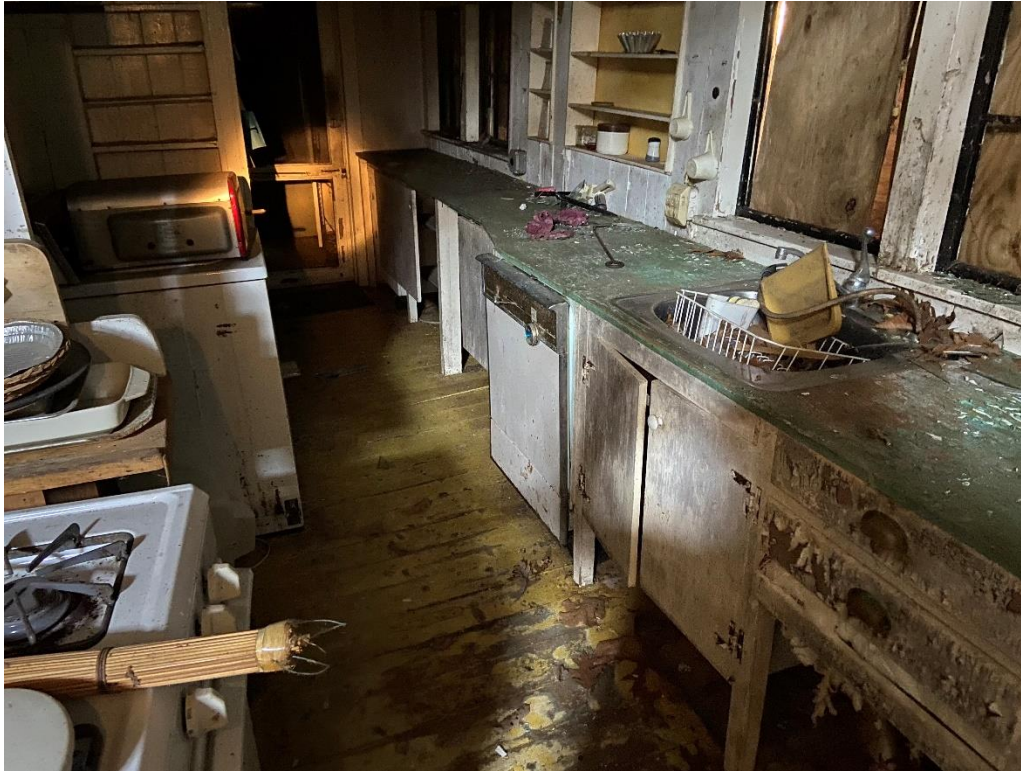
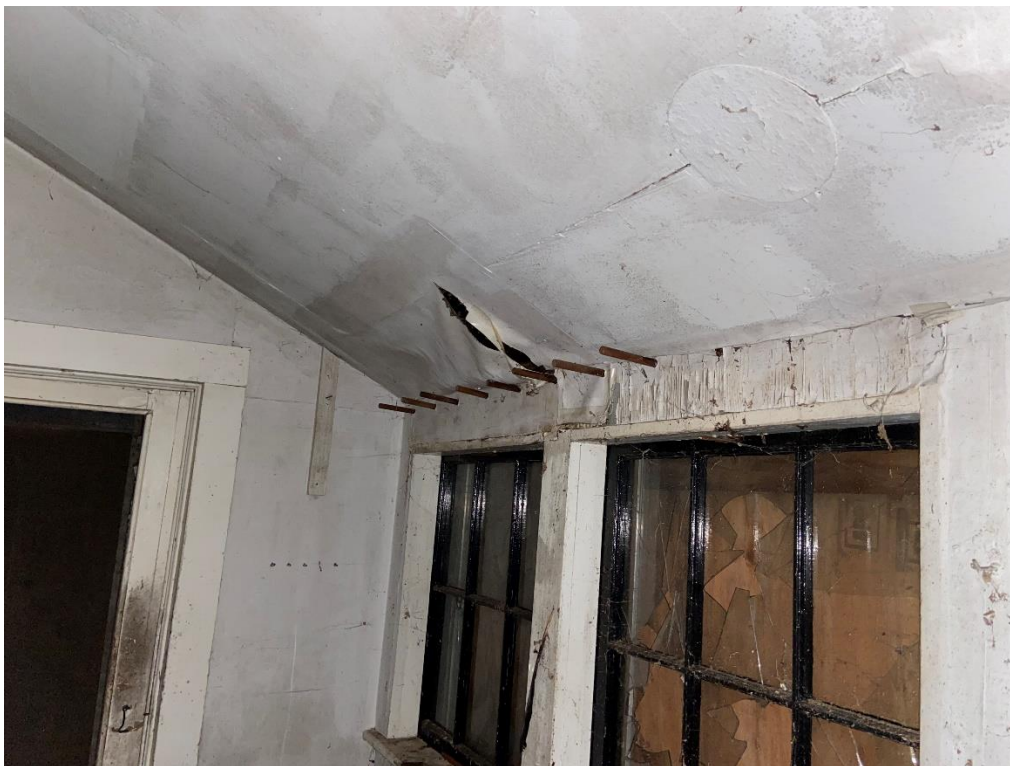
The kitchen ceiling has dropped was water penetration through a roof leak. Several roof leaks have developed and framing rot has developed in local areas. The wall framing remains reasonably plumb, but roof sag is developing from the roof leaks

Roof leak above kitchen

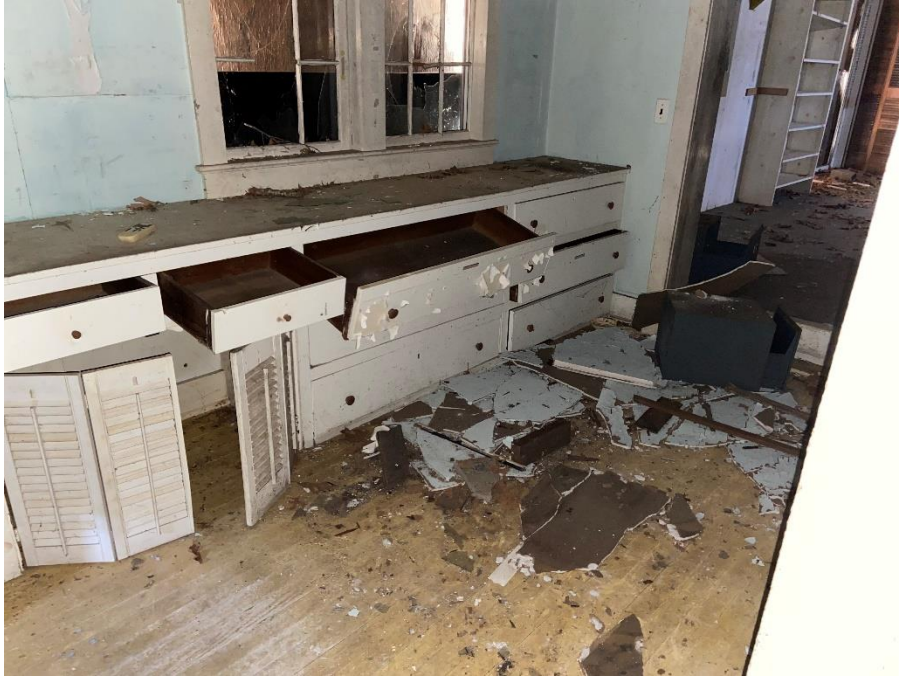
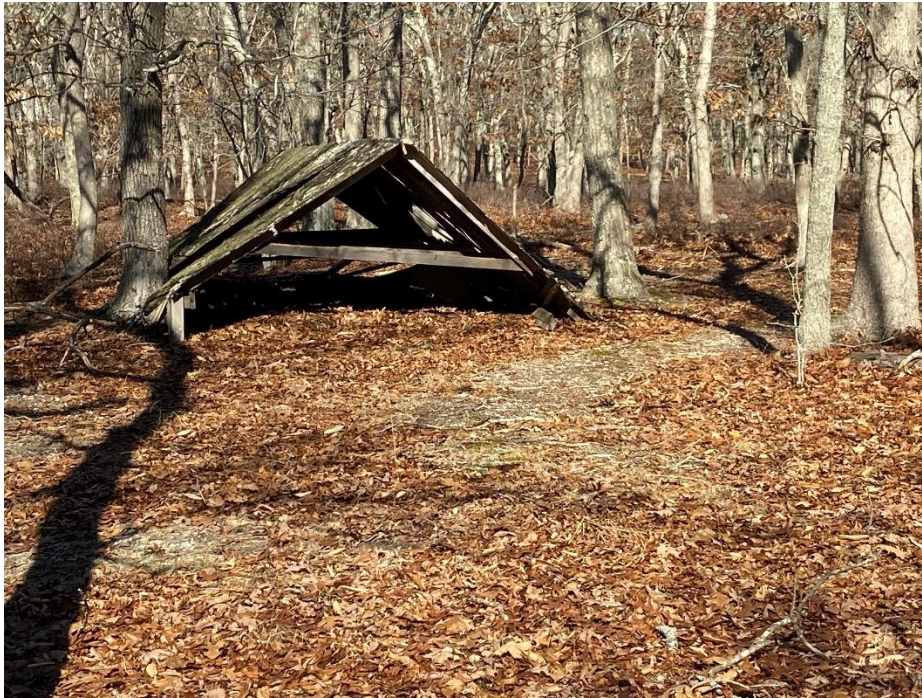
Collapsed Carport

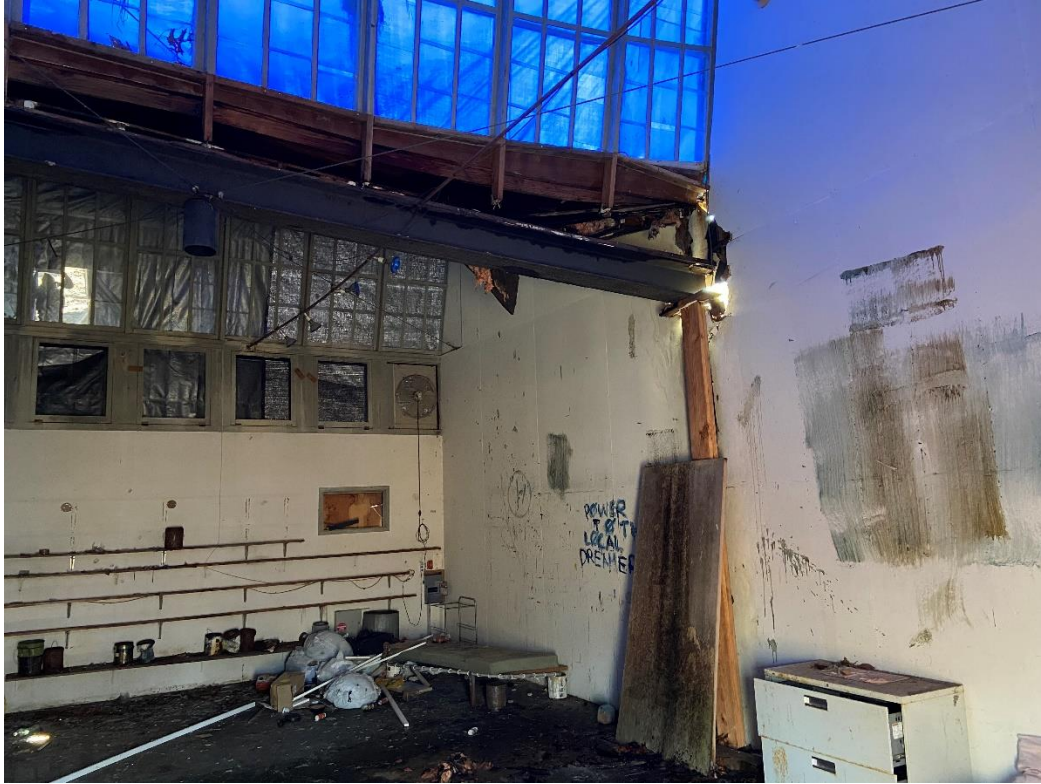
beams Continued water penetration has led to floor decay and failure near the perimeter. Roof supporting posts have dropped through the rotten floor. This has resulted in a steel I-beam that supports the roof to drop several feet and roll. This has led to the upper walls to twist and lean inward in a collapsing motion.

Brooks Studio Parapet roof beam collapsing

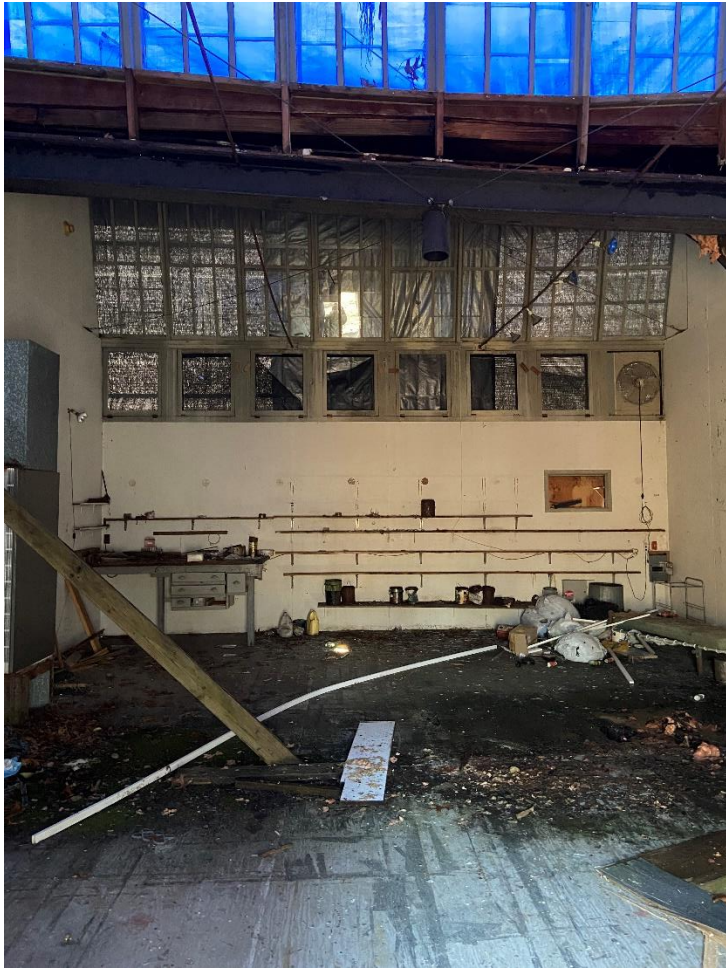
The studio service/storage area roof and walls have a number of rotten holes allowing daylight and weather into the building. The studio service/storage area was found to be flooded with water and leaf debris. Extensive roof and wall framing rot is present in this area and the roof is collapsing.

Studio storage area

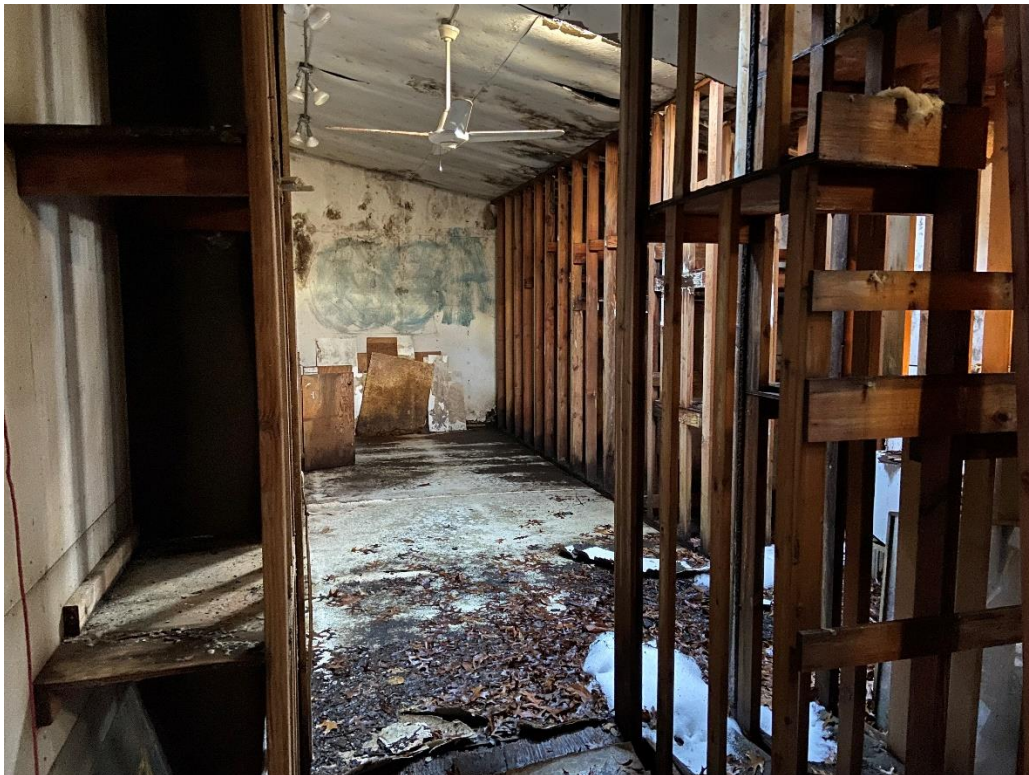
Studio storage area – daylight through roof

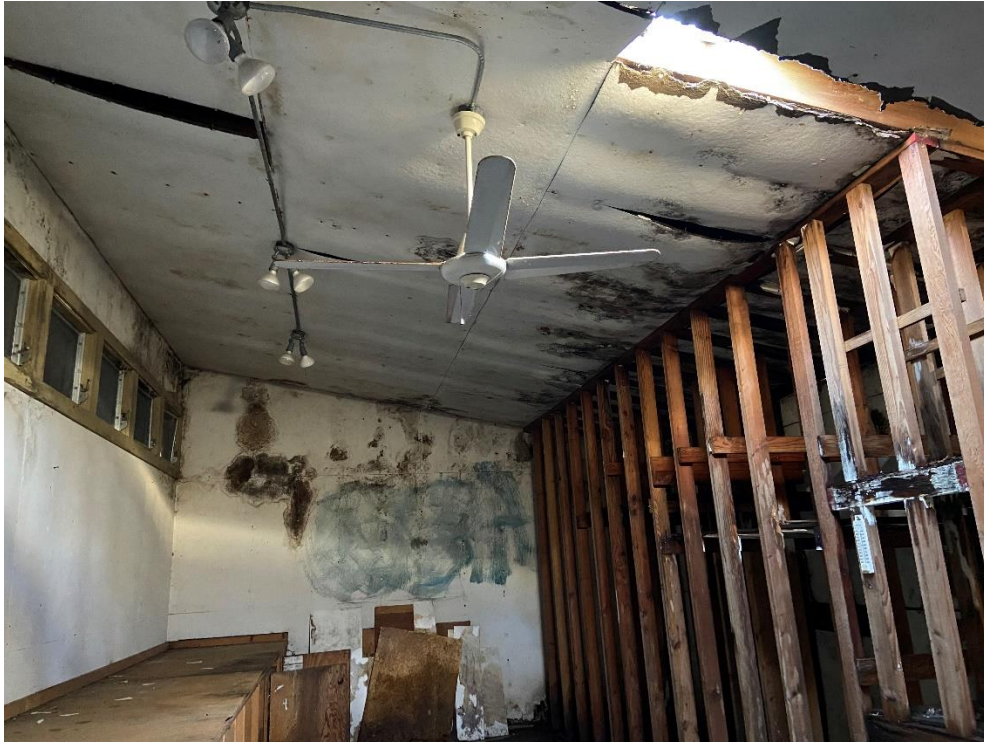
Studio floor

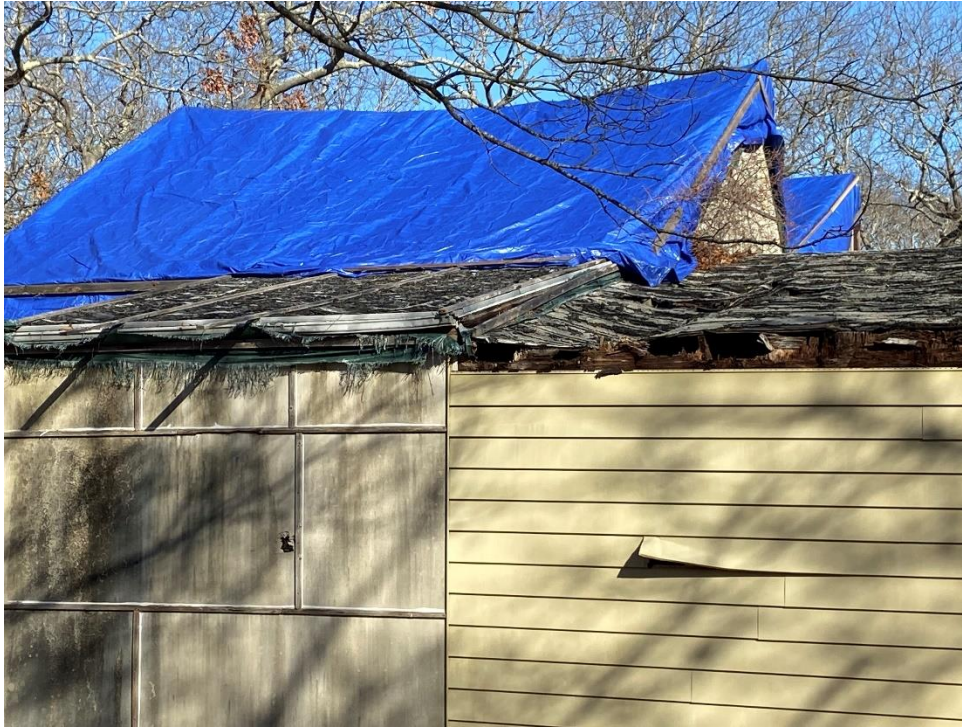
Studio storage roof

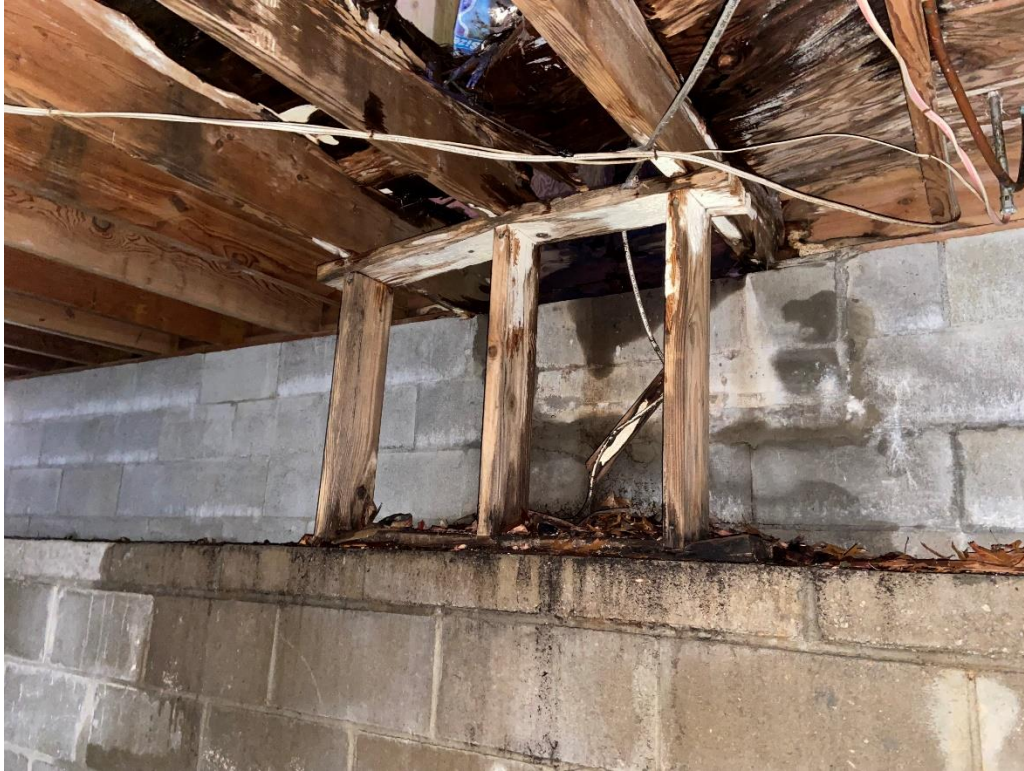
The basement area under the studio is flooded with water and reveals the extent of floor and wall frame rot. The foundation remains serviceable.

Studio floor frame rotted and temporary support rotted

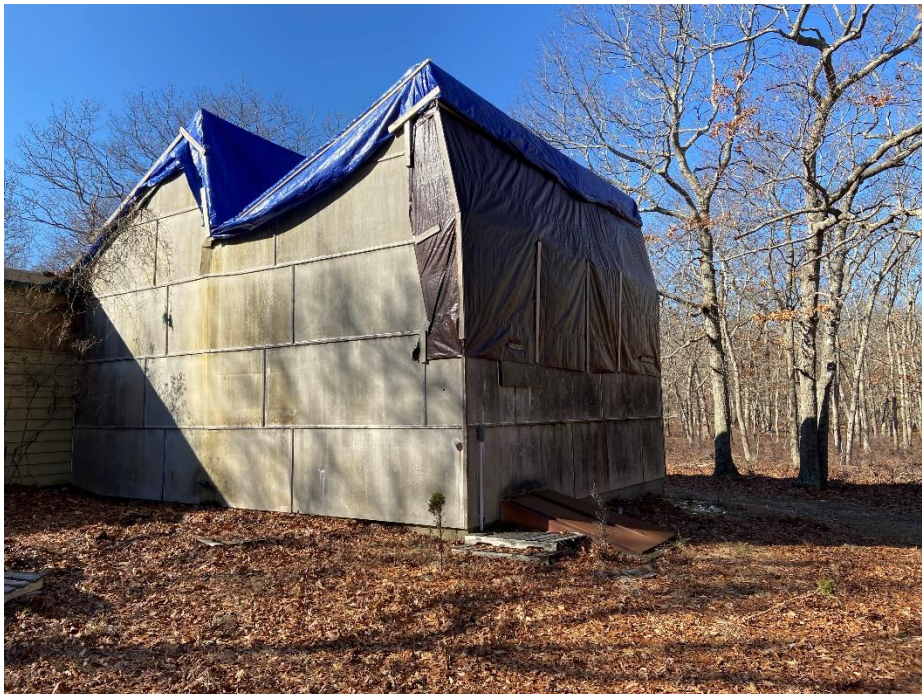
Studio roof leaking through tarp, upper walls are twisting and buckling

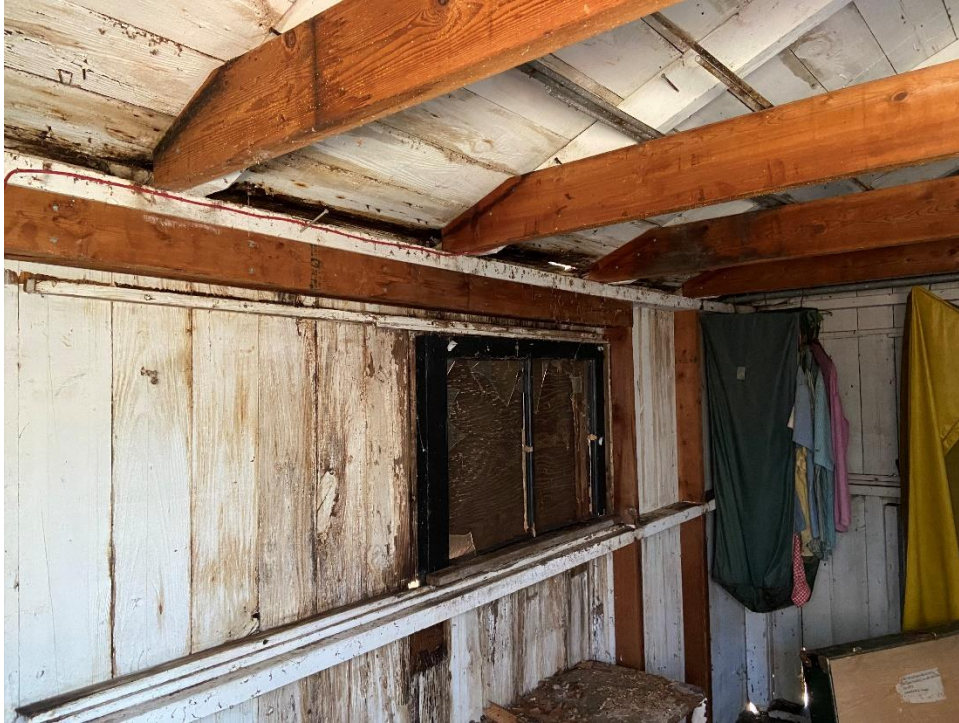
The second small accessory building appears to have been used for storage. It has been vandalized and is tarped and boarded up. The exterior siding and roof leak and are decayed. The simple structure is leaning. The interior also has rot from water penetration. This building is in poor condition.

Inside shed, water penetration, sheathing rot

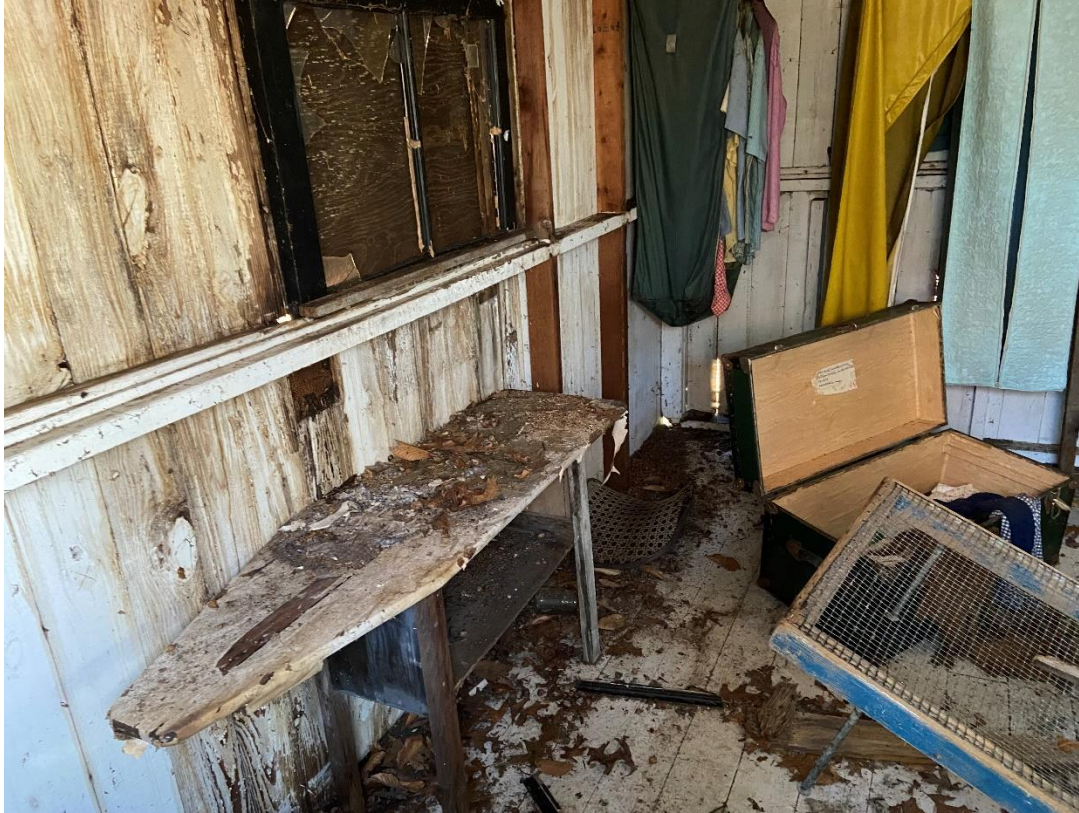
Inside vandalized shed

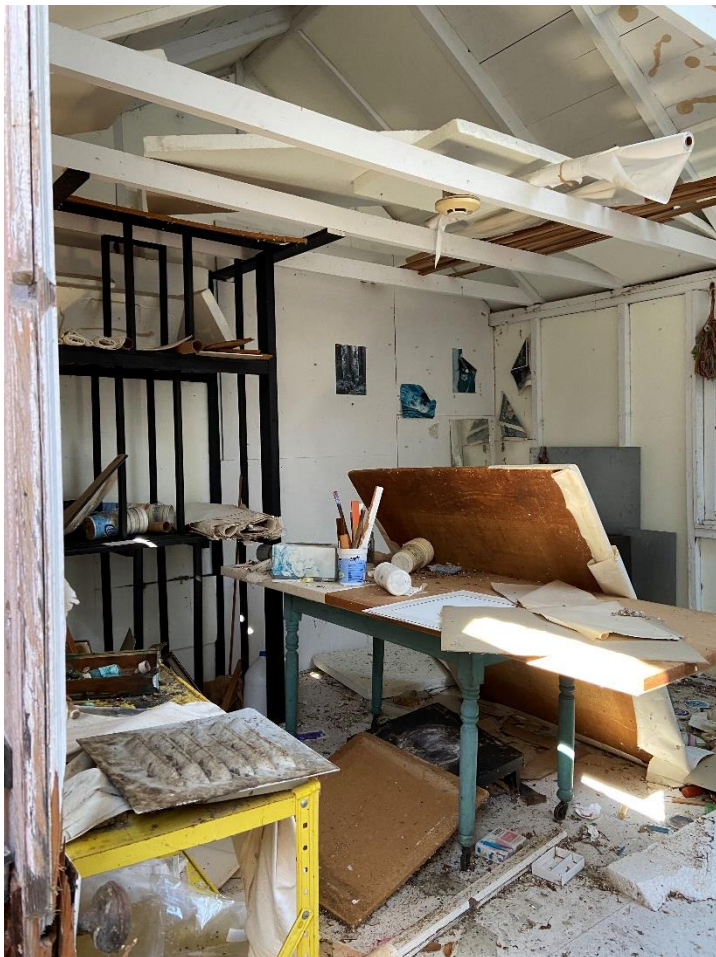
The interior is damaged by vandals and infested with mold and mildew. This building is probably salvageable with a substantial amount of work. It is also small enough, that it is feasible to relocate it to a safer setting.

Inside vandalized Park Studio

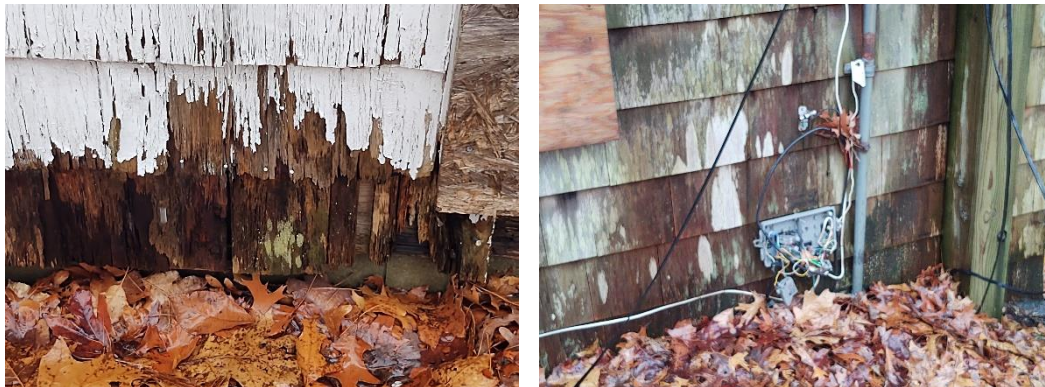
Photo No. 4 and 5: Minimal roof overhang, excessive soil overburden, and accumulated organic detritus are all contributing to cladding damage at the residence.

The upper walls are in fair condition. The wood shakes and clapboards are weathered throughout. The lower 3'-0" of the walls is more compromised as a result of roof runoff. At the earlier portions of the residence the deterioration has extended into the sill at the west façade. In general, perimeter grade is excessively high in relation to the exterior

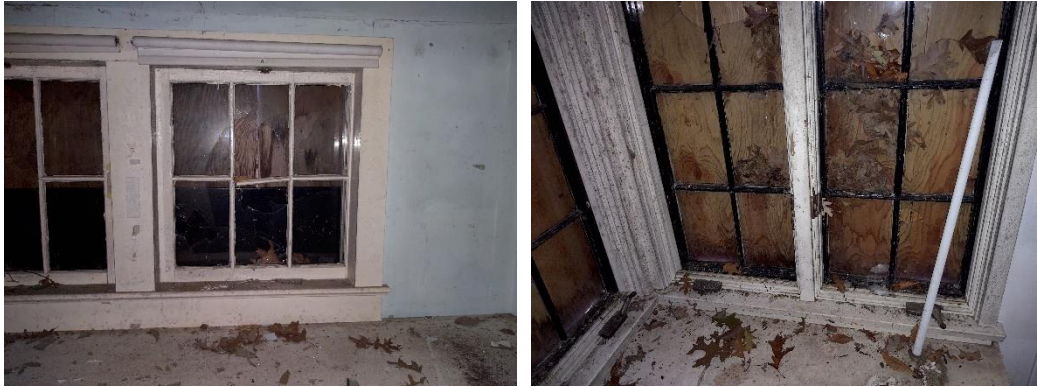
Most of the windows only require replacement of broken glazing and the addition of weather-stripping to be re-useable. Ten windows have broken or heavily damaged mullions, requiring restoration. The five large casement windows at the south façade are all heavily damaged and will require replication.

Photo No. 6 and 7: The windows all require some level of repair.
While most only require re-glazing, some have damaged mullions requiring sash restoration.

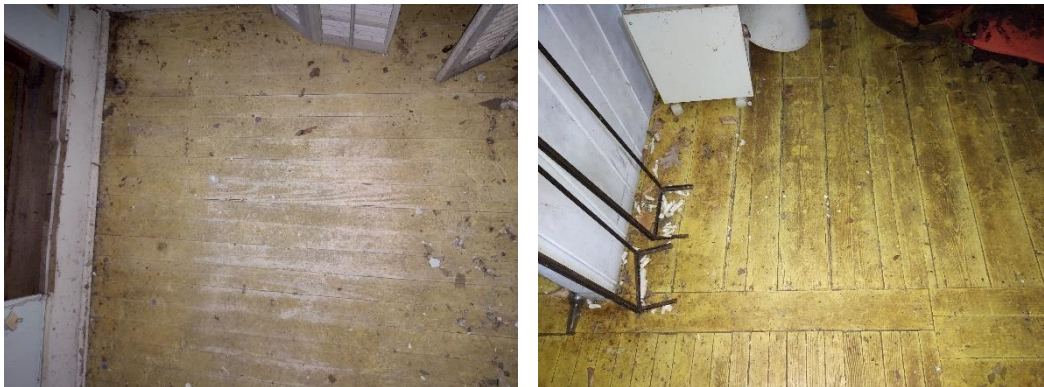
There is a heavy paint build up on the floor in the earliest section of the house, with normal wear to the paint finish. The floor register is damaged.

Photo No. 8 and 9: The floors are level and in generally good condition. The primary issue is finish deterioration.

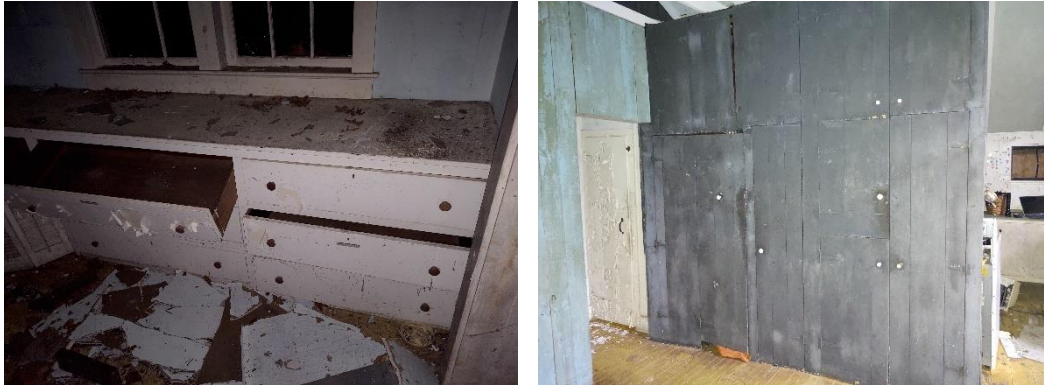
The cabinetry at the original portion of the residence exhibits heavy paint damage, but is in generally good condition. The joinery is separating at one drawer.

Photo No. 10 and 11: The cabinetry primarily requires only minor repairs and repainting.

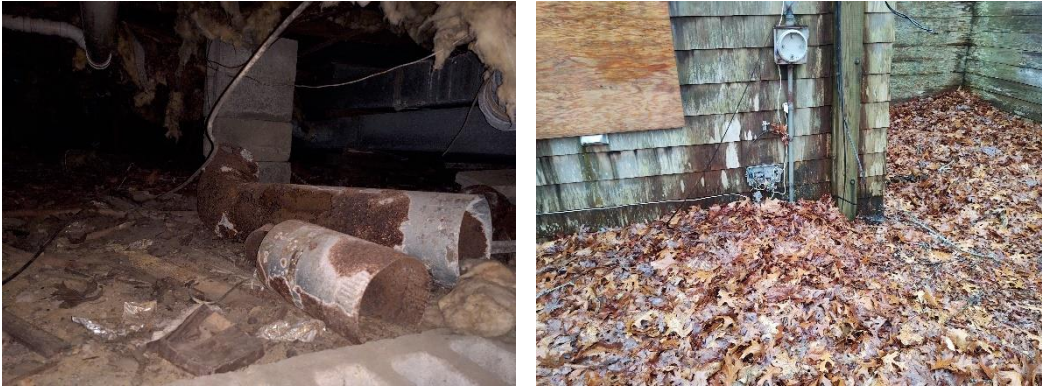
The oil-fired furnace is in poor condition and is not operational. A new heating system must be installed as part of any repair campaign for new program use.

Photo No. 12 and 13: The building systems are non-operational and will require upgrades for any proposed re-use of the residence.

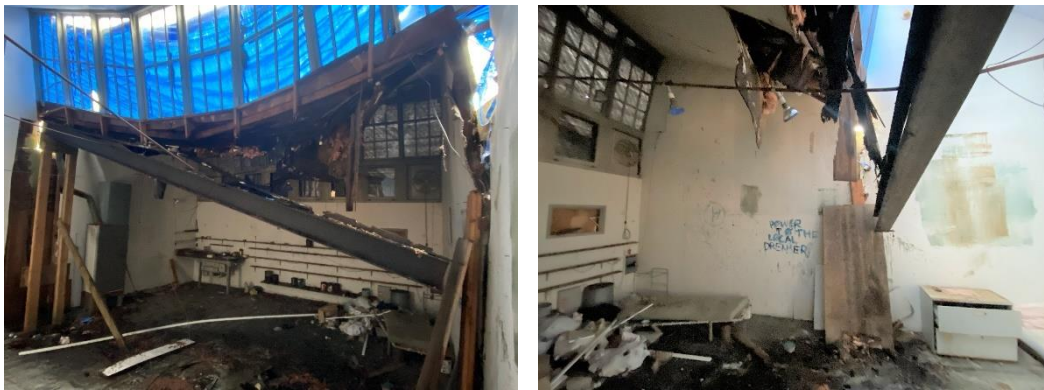
Roof sheathing at the storage wing is in poor condition, and staining of the interior ceiling finishes at the storage wing suggests that there is advanced deterioration of the roof decking, and possibly framing, of this section.

Photo No. 18 and 19: Chronic water infiltration has resulted in significant damage to the roof and skylight.

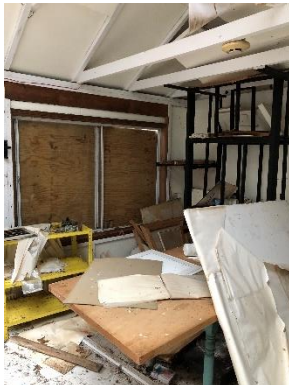
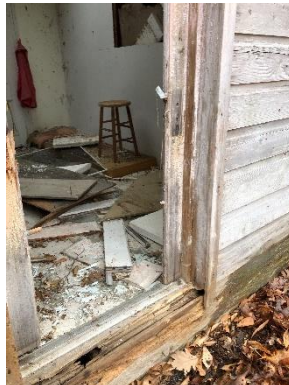
Windows on both the north and south walls are in salvageable condition, but the glazing in each has been shattered. The frames are in serviceable condition.

Photo No. 24 and 25: The window sash and frames are salvageable but will require re-glazing. The entry door is heavily damaged and will require full restoration.

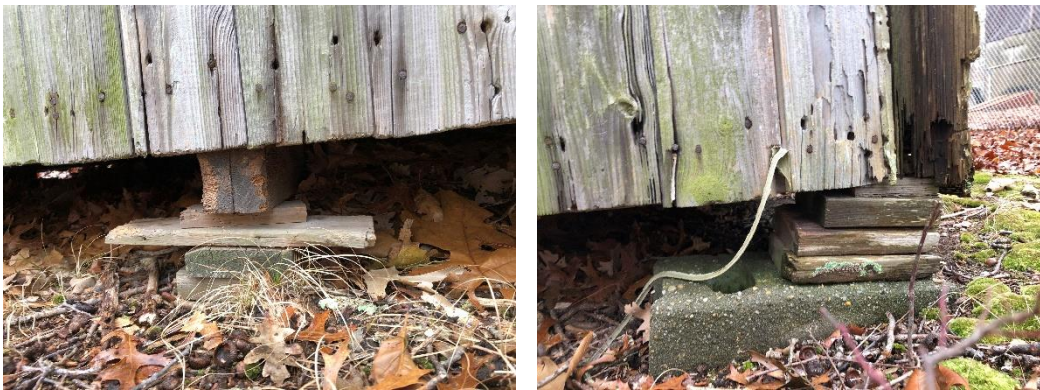
The CMU and wood foundation elements are inadequate for appropriate support of the building and warrant replacement with adequate footings, but piers replicating the extant CMU elements.

Photo No. 30 and 31: The foundation elements do not properly support the structure.
