SUBJECT: Supplemental Condition Assessment Report  
Brooks Park Buildings  
128 Neck Path  
Springs, NY  
SCTM# 300-103-8-6  
Purchase Order # 2022-0677

### Brooks Park Cottage Condition Photos

By DB Bennett on 2/9/22

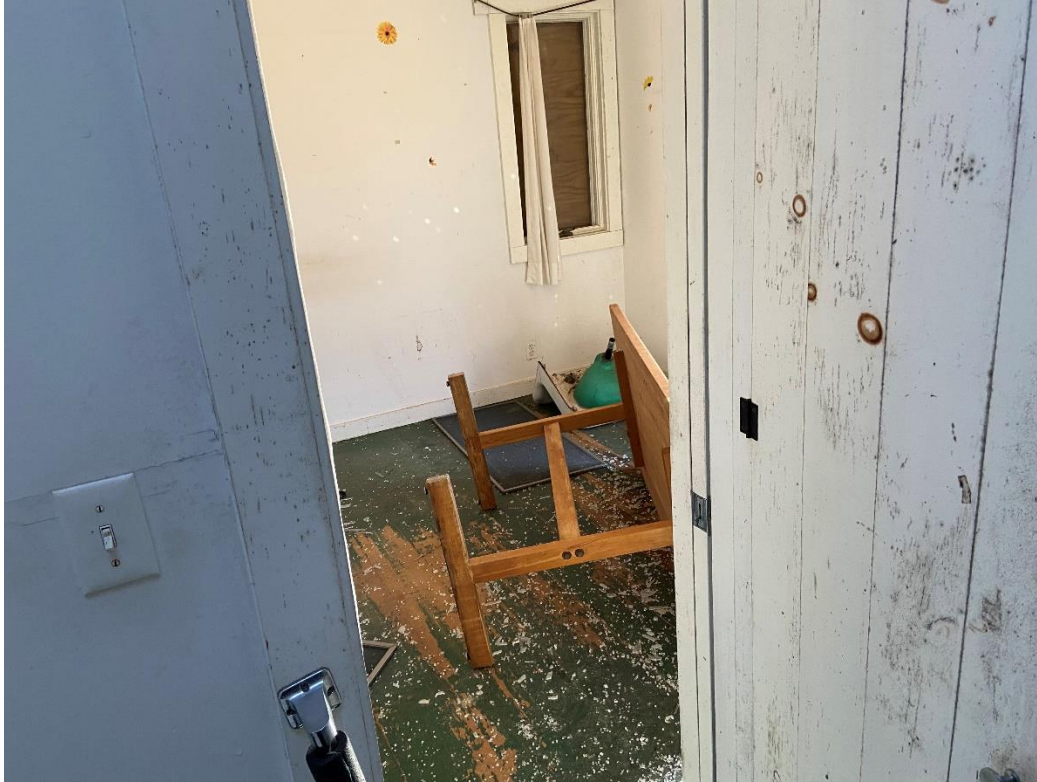
Cottage Interior

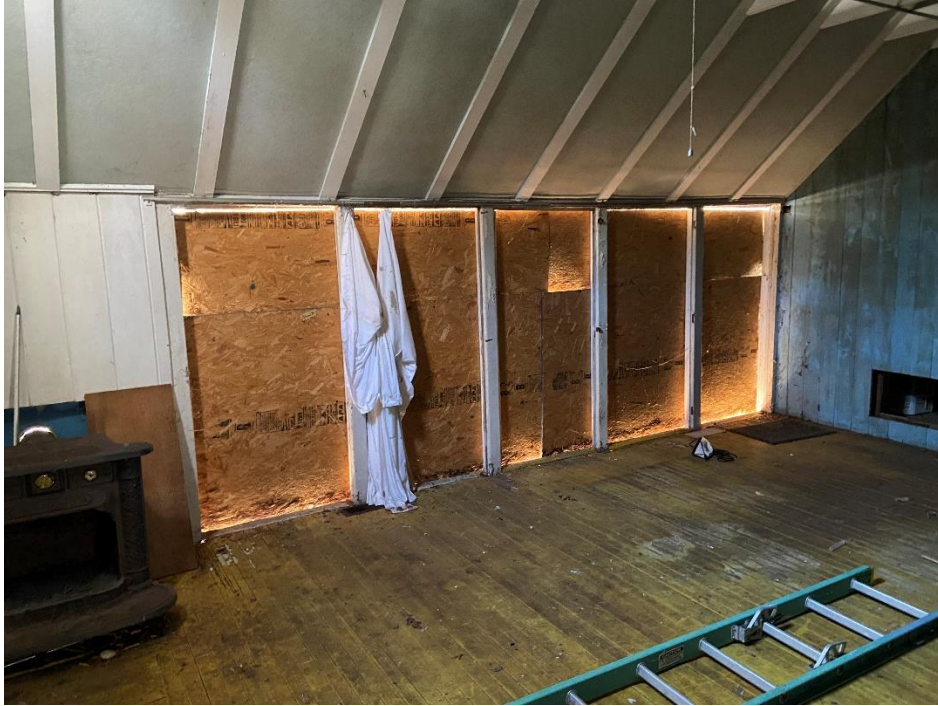
Cottage interior

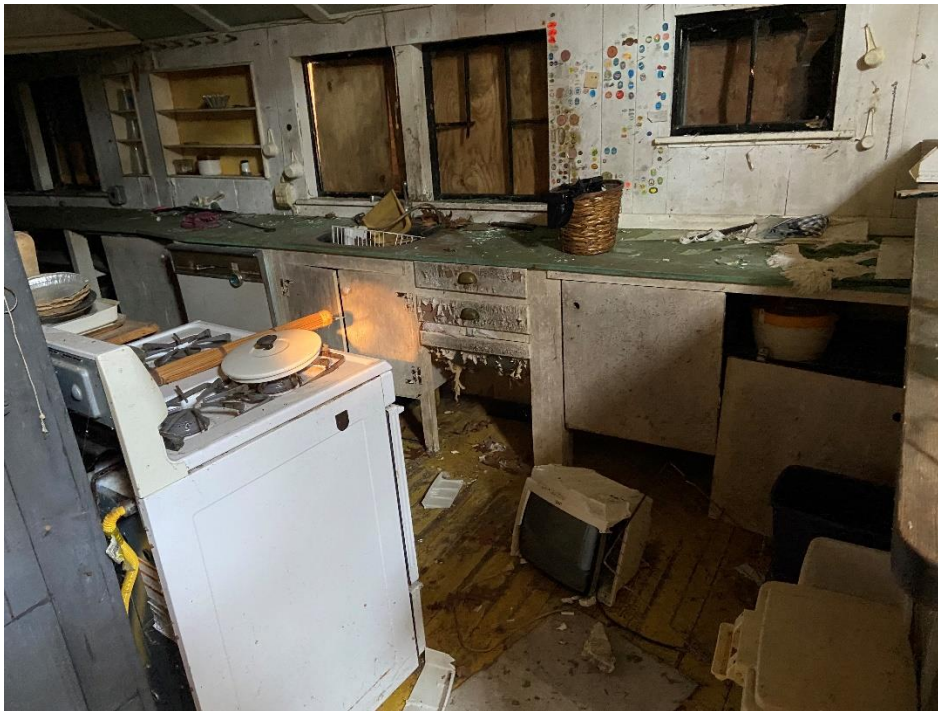
Cottage kitchen area

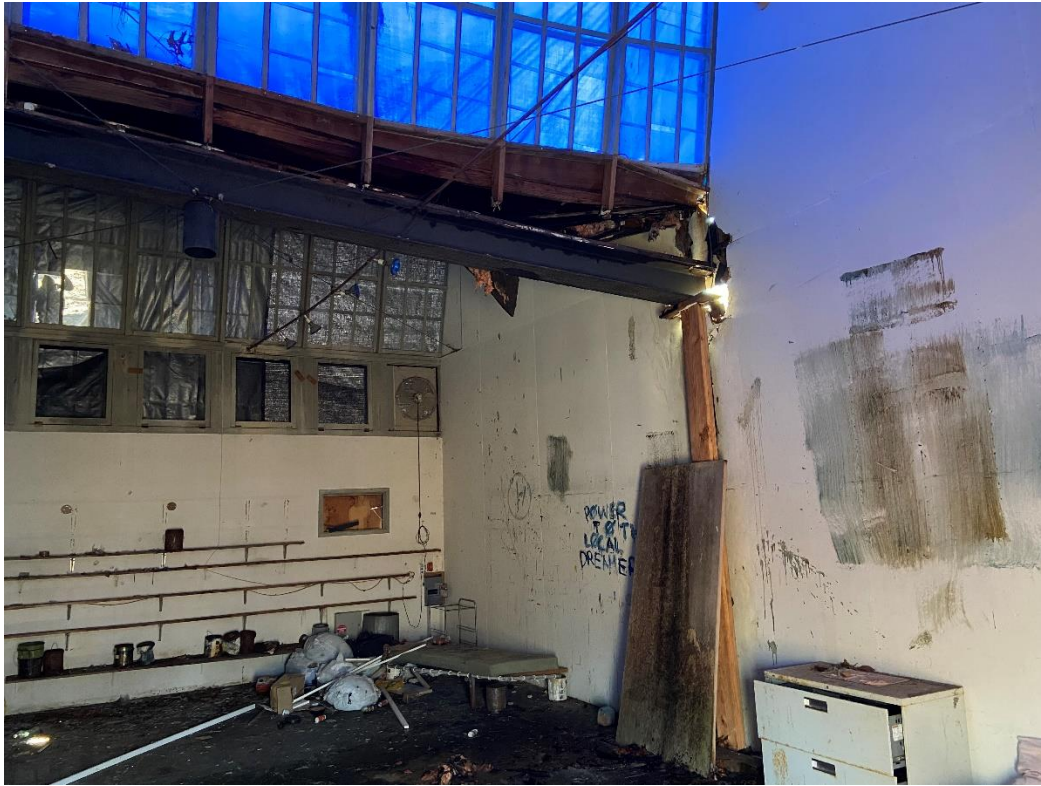
beams Continued water penetration has led to floor decay and failure near the perimeter. Roof supporting posts have dropped through the rotten floor. This has resulted in a steel I-beam that supports the roof to drop several feet and roll. This has led to the upper walls to twist and lean inward in a collapsing motion.

Brooks Studio Parapet roof beam collapsing

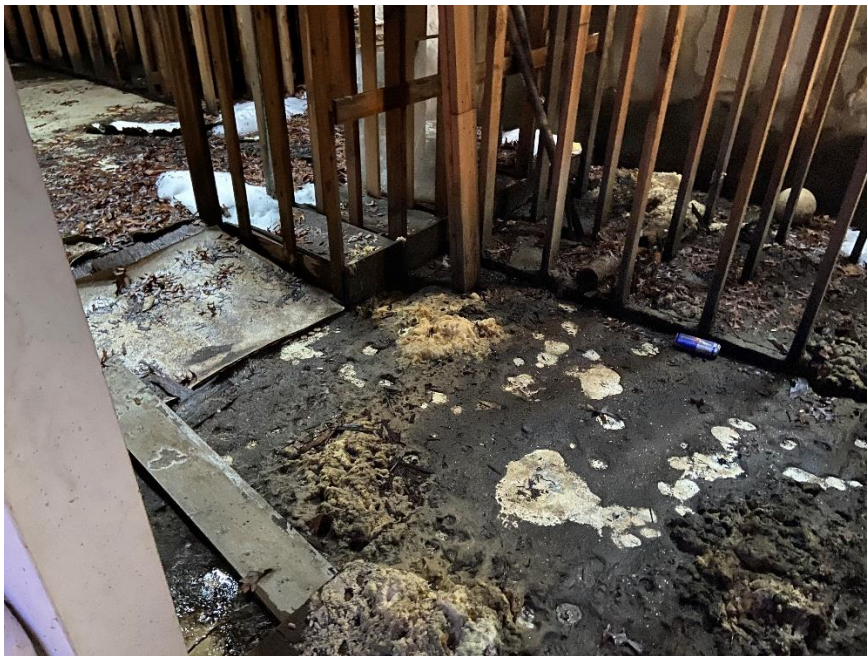
Studio storage area

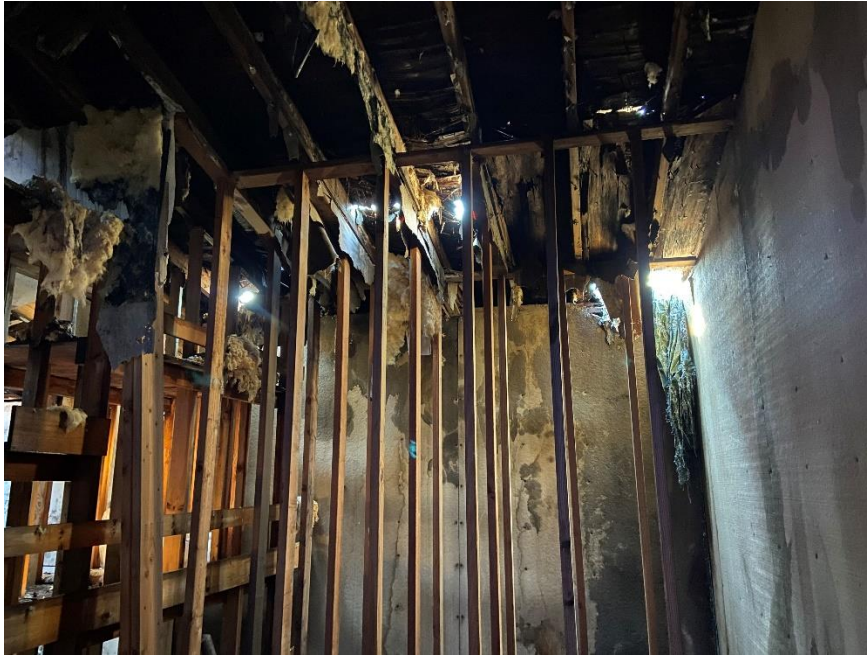
The studio service/storage area roof and walls have a number of rotten holes allowing daylight and weather into the building. The studio service/storage area was found to be flooded with water and leaf debris. Extensive roof and wall framing rot is present in this area and the roof is collapsing.

Studio storage area – daylight through roof

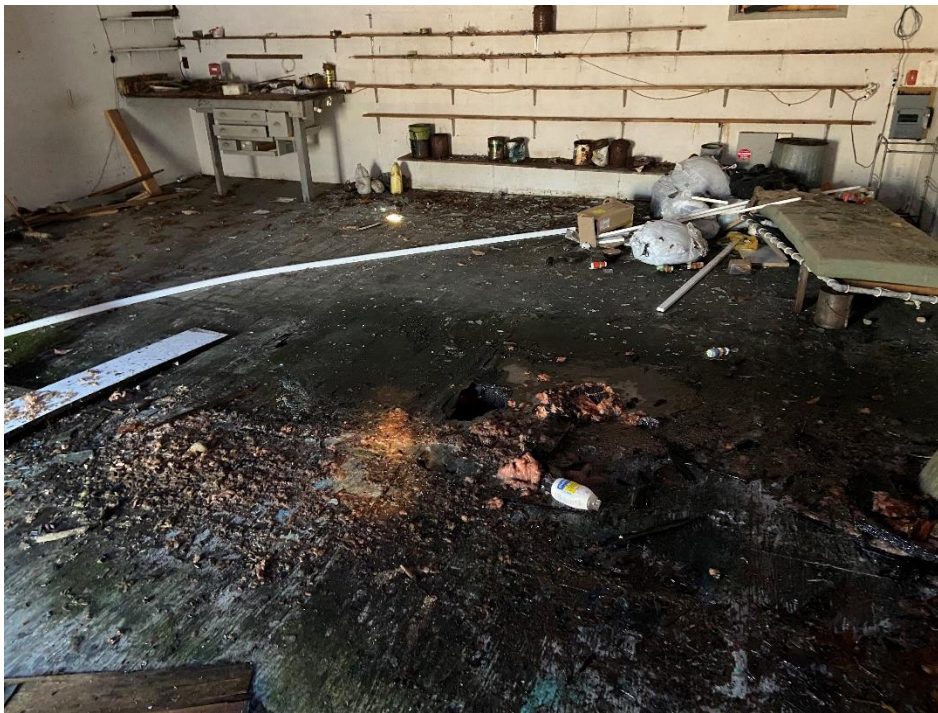
Studio floor

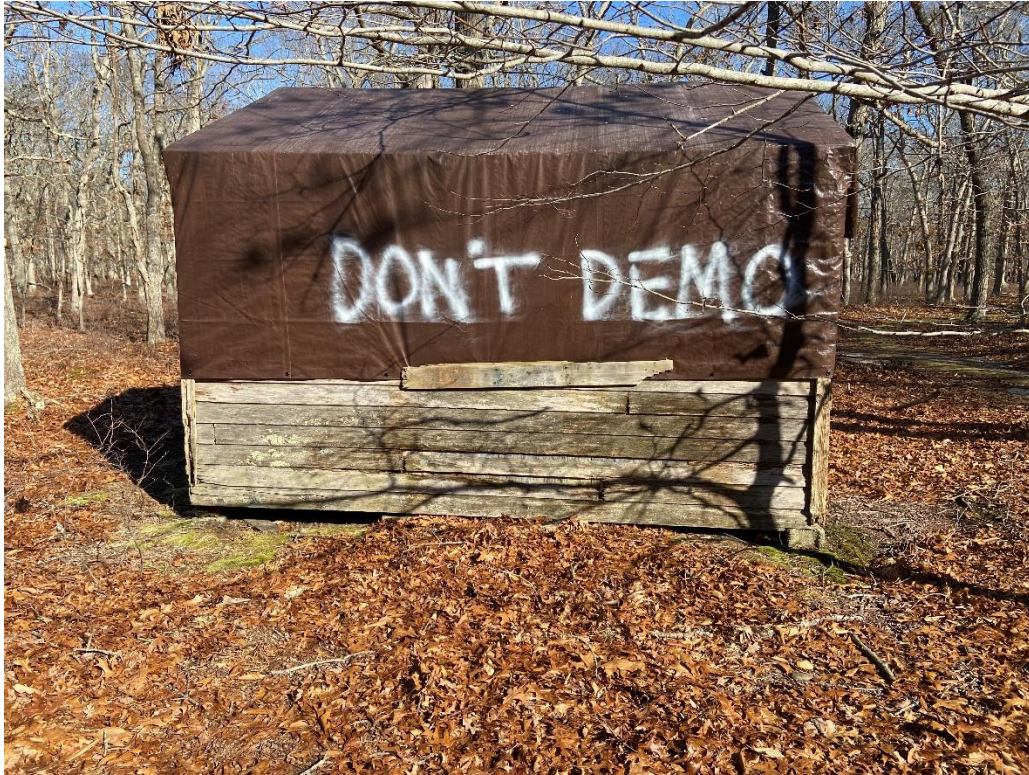
The second small accessory building appears to have been used for storage. It has been vandalized and is tarped and boarded up. The exterior siding and roof leak and are decayed. The simple structure is leaning. The interior also has rot from water penetration. This building is in poor condition.

Shed

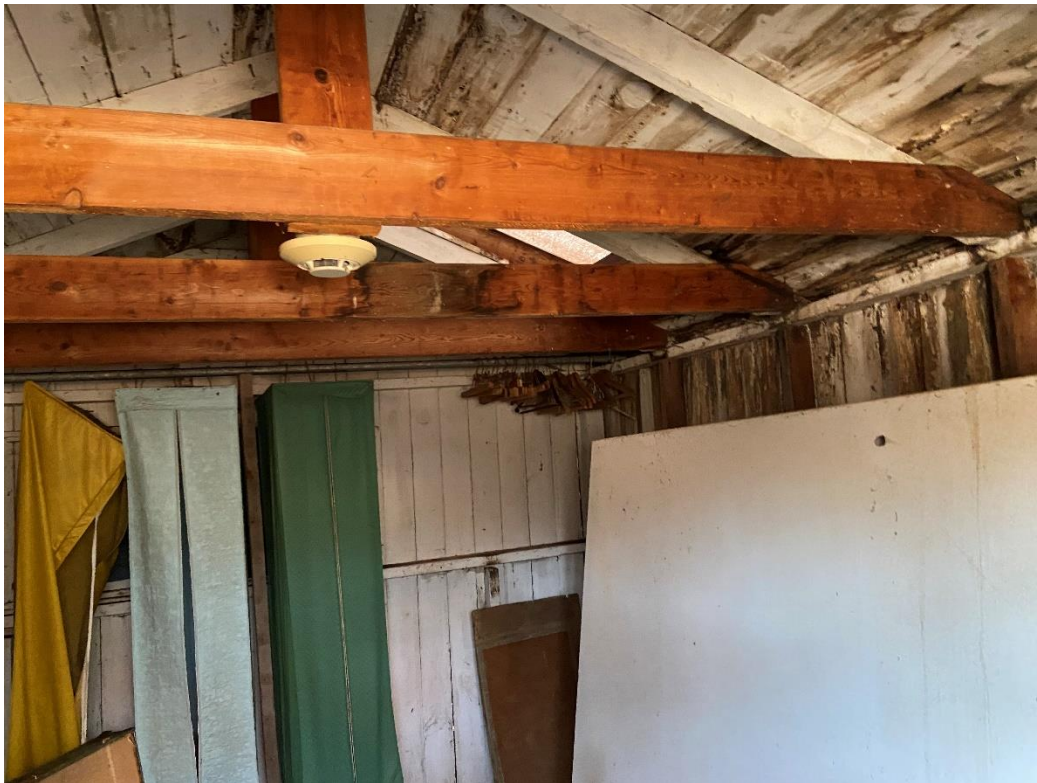
Inside shed

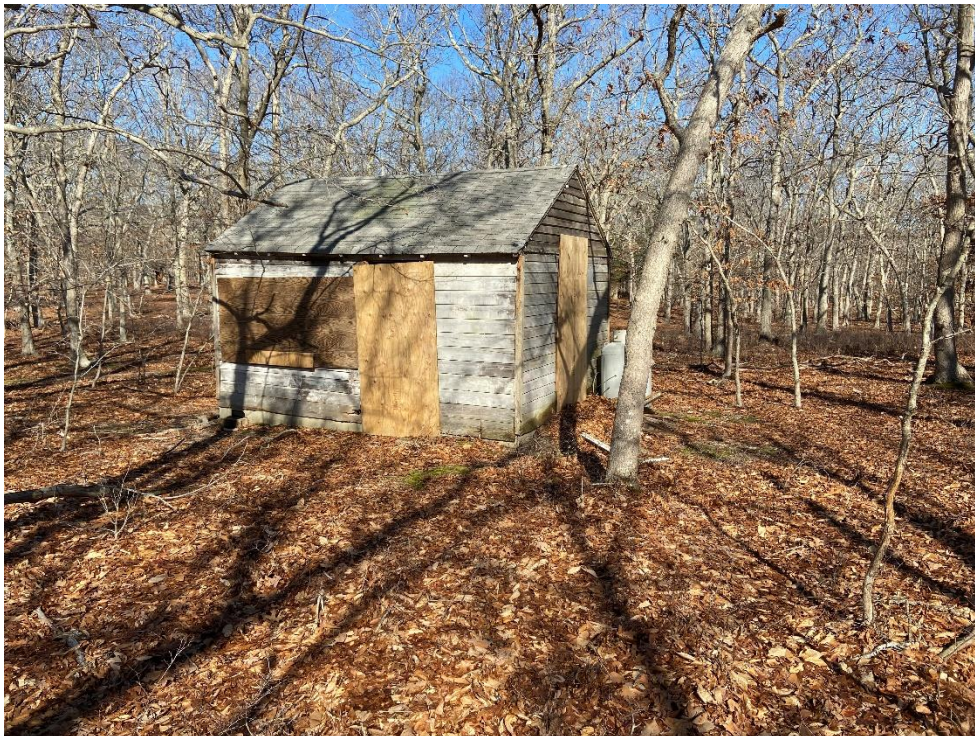
Park Studio

This is a small accessory building reportedly used as Ms. Park's studio space. It too has been vandalized and openings have been boarded up with plywood. The wood siding has decayed and needs repair. The asphalt roof and skylight are more than 50 years old have relatively small leaks. They need to be replaced. The doors and windows will need to be replaced.

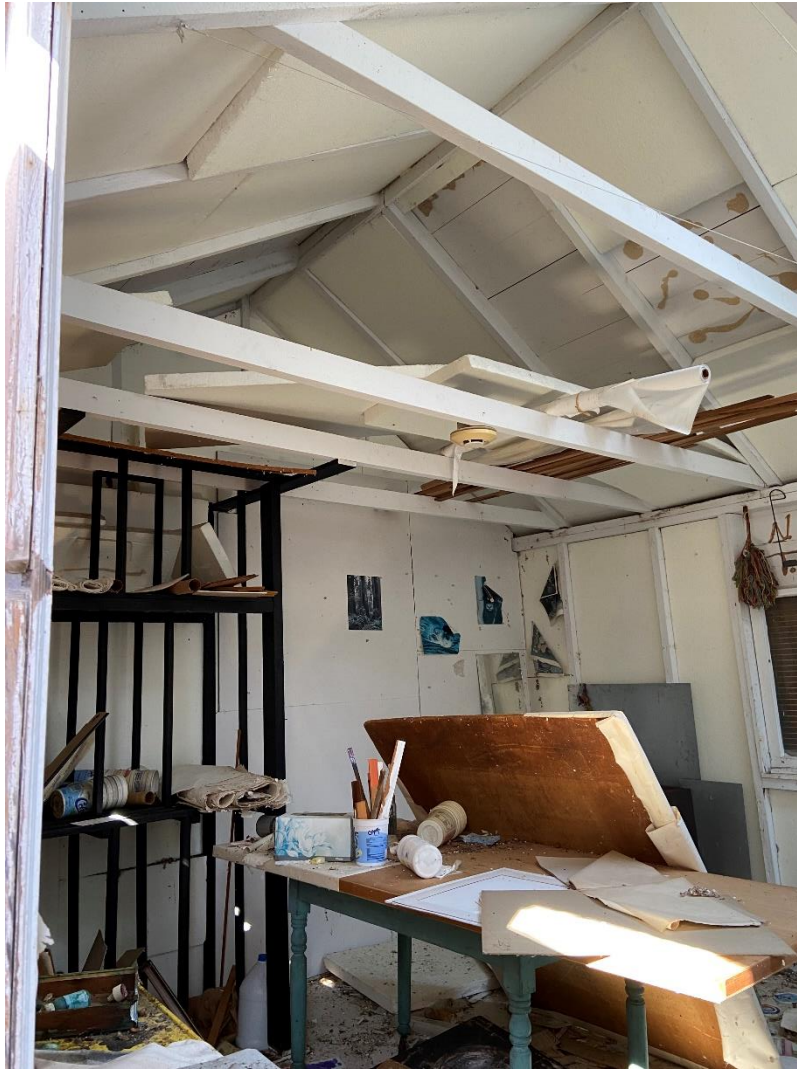
Inside Park Studio
