Title (Titre): *IB-DL A-Pillar Inspection (SB-42-022-2019) #5-19*

Reference :	Référence :
SB-42-022-2019 Rev. 1 Inspection of A-pillar at C42 A/B/E-Series with A-pillar passing through fuselage tube Lufttüchtigkeitsanweisung – LTA - Nr.: LSG 19 - 002 - Rev.1

SB-42-022-2019 Rev. 1 Inspection of A-pillar at C42 A/B/E-Series with A-pillar passing through fuselage tube (C42A up to Serial No.: 1604-7449 C42B up to Serial No.: 1503-7383 C42E up to Serial No.: 1804-7529)

Lufttüchtigkeitsanweisung
LTA-Nr.: LSG 19-002 – Rev.1
Datum der Bekanntgabe: 30.07.2019

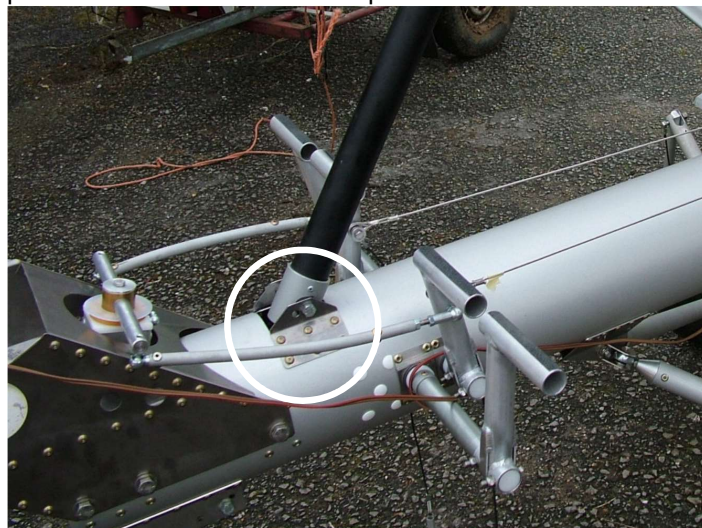
An aircraft with severe cracking of the main fuselage tube emanating from the upper cut-out for the A-pillar was also found to have suffered severe cracking of the A- pillar around its entire circumference. This was hidden within the outer sleeve positioned at the connection between the A- pillar and the upper surface of the main fuselage tube. The load path was maintained by the single small rivet used to locate the outer sleeve on the A- pillar. See Figures 1 & 2.

It is believed that the cracking was a result of excessive loads placed upon the A- pillar due to the near-failure of the main fuselage tube. One other similar historical case is known to have occurred abroad, on an aircraft known to have suffered landing gear damage.

However, it is also possible that the cracking may also be related to fatigue due to flexing of the A- pillar at this point. Therefore inspection on high-hours aircraft is recommended, as well as those which have suffered damage which could have applied excessive loads to the A- pillar.

Figure 1: A- pillar attachment to upper surface of main fuselage tube. Lower attachment bolt visible beneath main fuselage tube at aft end of bracket attached to nose leg.

We recommend visually inspecting the inner surface of the A- pillar in the area where the bolt penetrates the connection to the top of the fuselage tube. The visual inspection must be carried out with an endoscope which can be inserted at the lower end (hole in hull boat behind nose wheel carrier) of the A- pillar. If the cable length of the camera is long enough (more than 1m), the roof can be removed and the endangering spot can be inspected from above. This check has been included in the IKARUS C42 Series Maintenance Manual (Edition VIII) and should be repeated every 300 operating hours after the initial check.

If cracks are found during the inspection, the aircraft **must not be flown**. The A-pillar must be replaced before it is put back into operation.

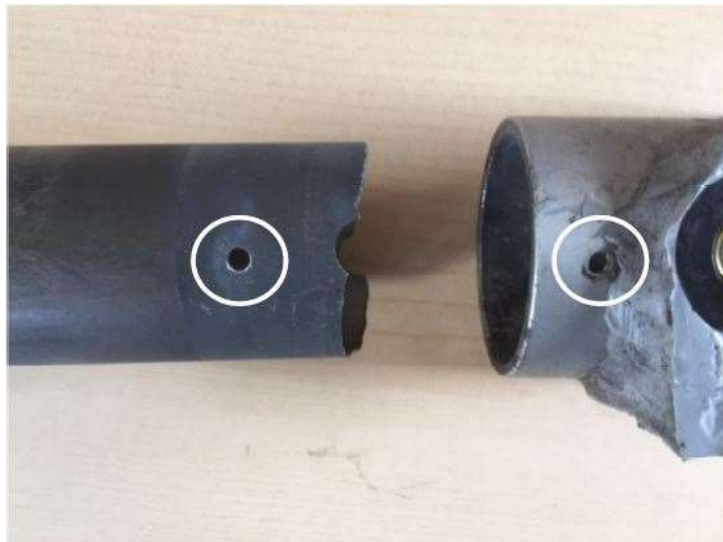
Figure 2: Failed A- pillar removed from outer sleeve part on right of picture. Circled holes show location of the rivet which was holding the parts together.
