Sample Commercial Technical Site Assurance Report

Commercial Refurbishment, Newman Street

Report reference	Sample NS-06	Inspection period	2026
Project	Newman Street	Sector	Commercial refurbishment
Report type	Clerk of Works / Technical Site Assurance	Project stage	Demolition, enabling and temporary works
Primary focus	Temporary works, demolition, piling and structural interfaces	Status	Anonymised sample
Prepared by	ITSA Ltd	Public issue	Names and appointment details redacted
Location	Fitzrovia, London	Sample use	Website and client preview

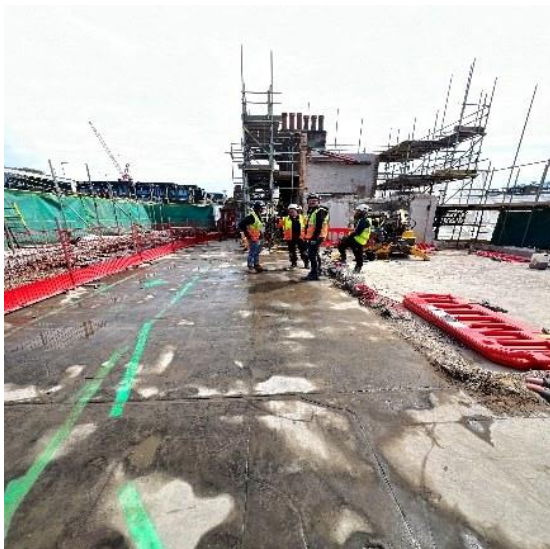
Observation	Roof level demolition had progressed, with the former plant room and stair overrun areas opened up. Upstand elements were being removed progressively using a revised approach intended to reduce noise and vibration transfer to adjoining structures. Saw cuts were visible to concrete slab and upstand elements, creating separation lines before breakout and supporting a more controlled demolition sequence.
Risk / implication	Potential impact on structural stability, demolition sequencing, temporary works compliance, neighbour protection or handover quality if not verified and controlled.
Recommended action	Continue to use controlled demolition methods where works interface with neighbouring buildings. Record any changes in methodology and confirm the approach remains consistent with the Section 61 agreement and temporary works strategy.

Roof level demolition zone and controlled breakout sequence

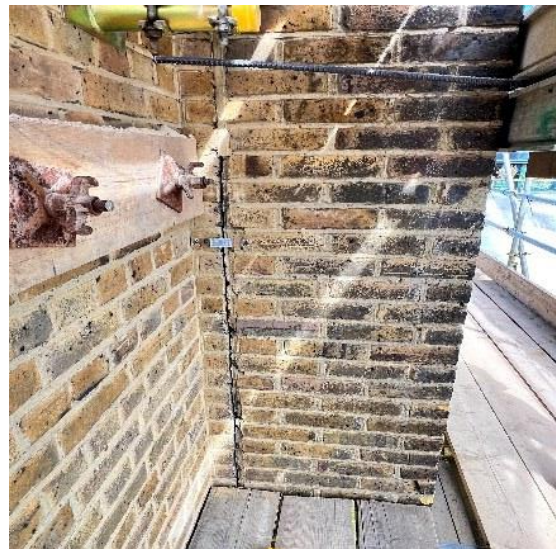
Roof slab and upstand removal in progress

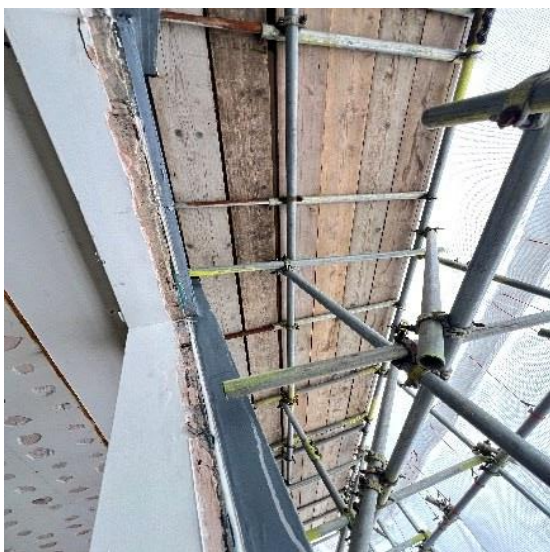
Observation	Temporary works were actively in place across the site, including backpropping, crash decks, protected openings and temporary support to areas affected by demolition. The temporary works approach appeared well managed, with barriers and exclusion zones provided around open voids and demolition areas.
Risk / implication	Potential impact on structural stability, demolition sequencing, temporary works compliance, neighbour protection or handover quality if not verified and controlled.
Recommended action	Maintain live temporary works inspections, keep the register updated and verify installations against approved designs before demolition advances into dependent areas.

Two-level debris protection and local guarding

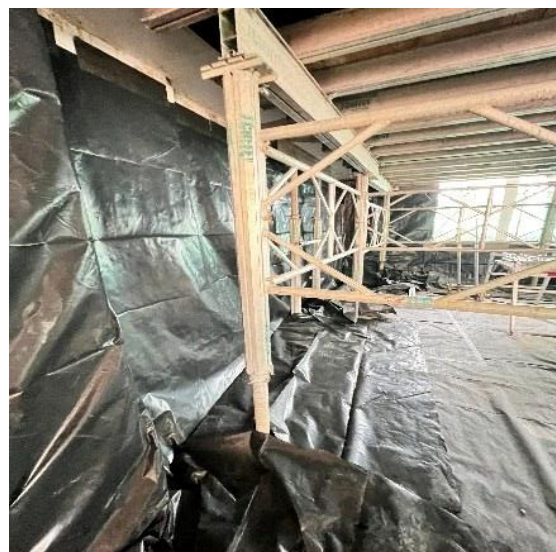
Temporary weathering to exposed party wall areas

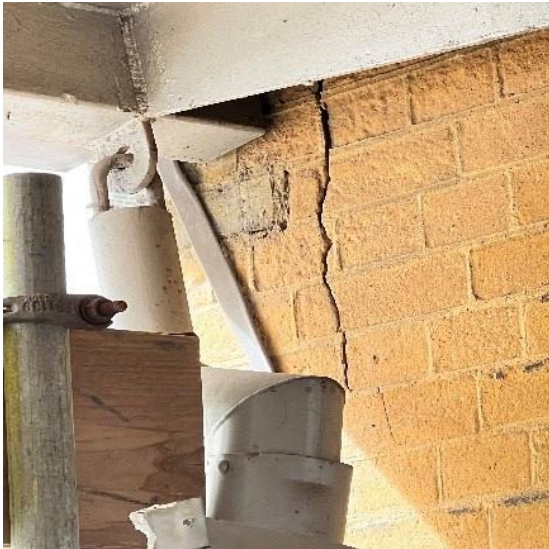
Observation	As the building became progressively less watertight during demolition, temporary weathering measures had started to be installed to exposed party wall areas. An existing chimney and masonry interface issue was also identified once scaffold access became available, with movement monitoring and repair options discussed by the project team.
Risk / implication	Potential impact on structural stability, demolition sequencing, temporary works compliance, neighbour protection or handover quality if not verified and controlled.
Recommended action	Progress temporary weathering as demolition opens up further areas. Complete masonry repairs before scaffold access is removed and retain photographic evidence of before and after condition.

Existing masonry interface identified for repair

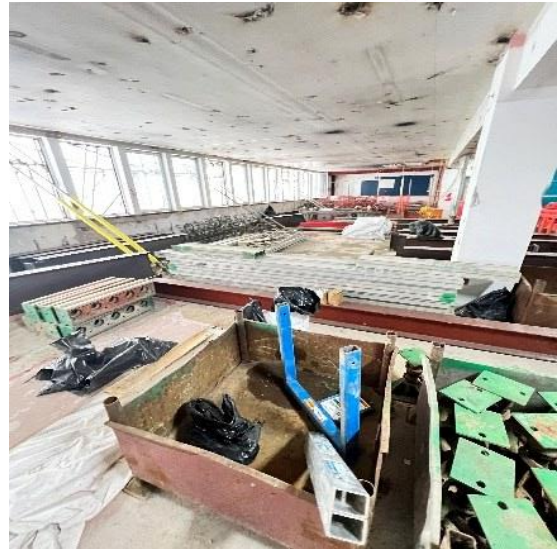
Internal propping and structural alteration interface

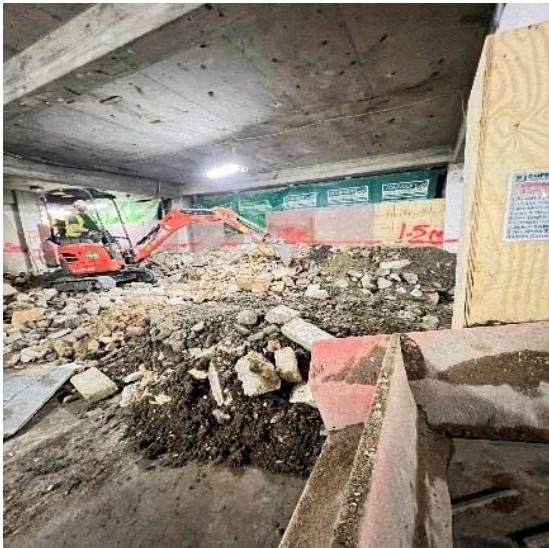
Observation	Basement works were focused on piling operations within a constrained internal environment. The piling rig was operating within the basement, spoil was managed locally and the contractor demonstrated the live piling log and marked-up pile layout plan. These records provided a clear audit trail of pile numbers, dates, depths, obstructions and relevant comments.
Risk / implication	Potential impact on structural stability, demolition sequencing, temporary works compliance, neighbour protection or handover quality if not verified and controlled.
Recommended action	Continue to review pile records and monitor exposed retained structure. Protect vulnerable retained elements where plant interface or material movement could cause accidental impact.

Basement piling activity within constrained working area

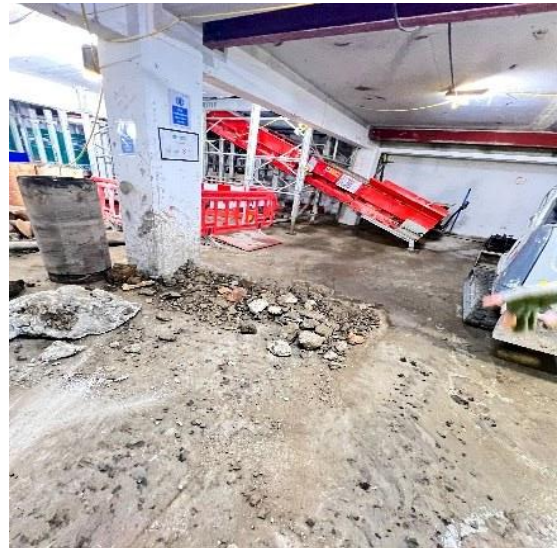
Observation	Ground floor areas were being used to transfer demolition arisings and spoil as part of the waste removal sequence. A temporary loading area was in use, with a marked height limit visible to control material stored on the slab. The loading limit had been assessed within the temporary works process and was subject to ongoing checks.
Risk / implication	Potential impact on structural stability, demolition sequencing, temporary works compliance, neighbour protection or handover quality if not verified and controlled.
Recommended action	Maintain temporary loading limits, undertake daily slab checks where required and keep waste transfer routes clearly segregated from pedestrian access.

Ground floor waste transfer and load management zone
