Sample Technical Site Assurance Report

Residential Development, Hawks Road

Report reference	Sample HR-105	Inspection period	March 2026
Project	Hawks Road	Sector	Residential
Report type	Clerk of Works / Technical Site Assurance	Project stage	Final completion and handover readiness
Primary focus	Risers, firestopping and compartmentation	Status	Anonymised sample
Prepared by	ITSA Ltd	Public issue	Names and appointment details redacted

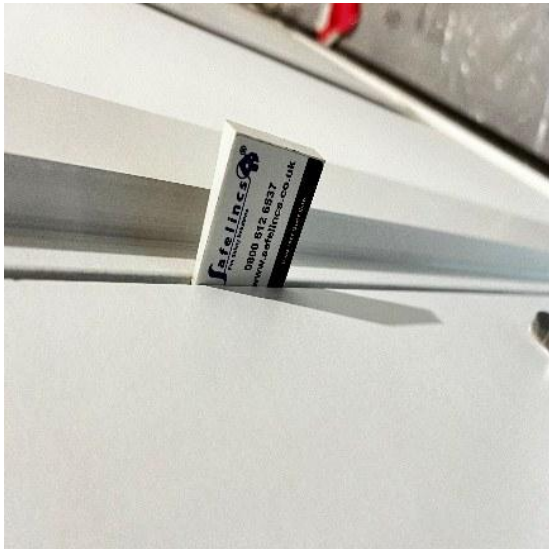
Fire door certification label and installation evidence

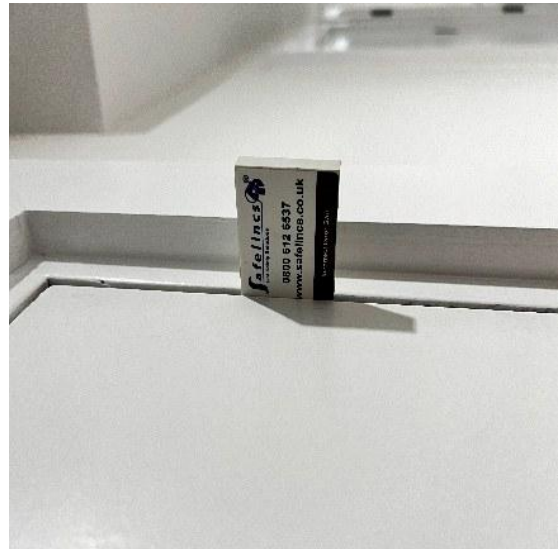
Fire door label and closer review

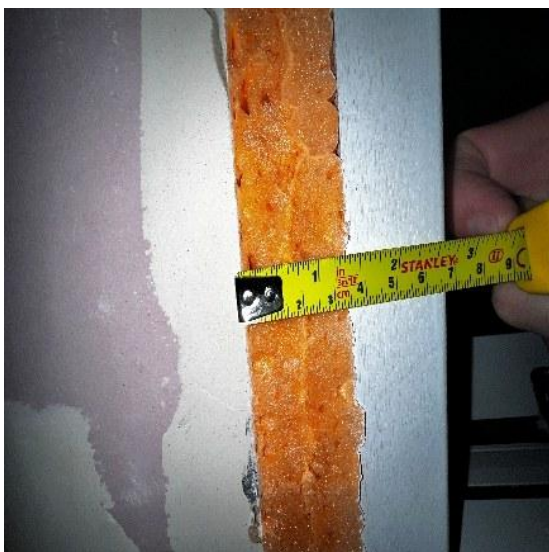
Linear gap check within riser location

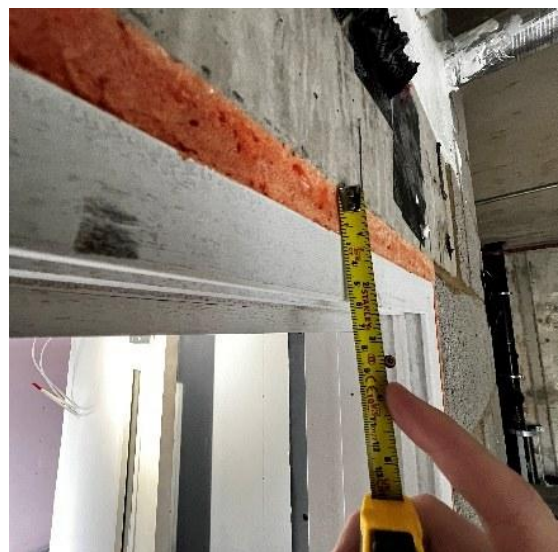
Firestopping interface to service zone

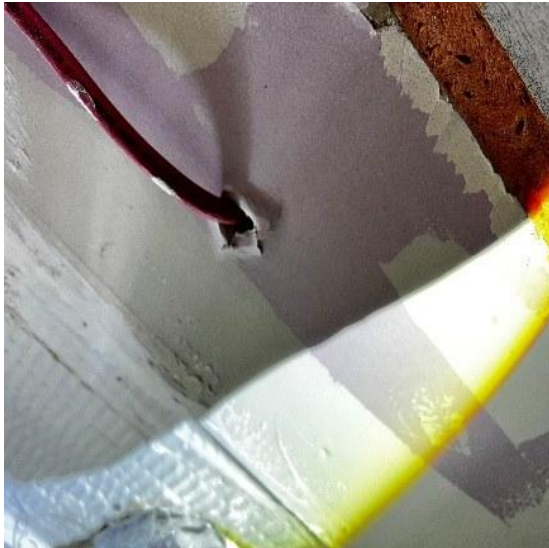
Head track and service penetration review

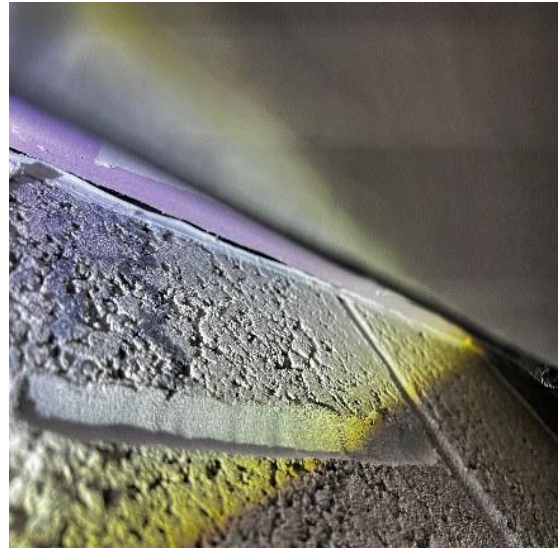
Riser junction and seal continuity review

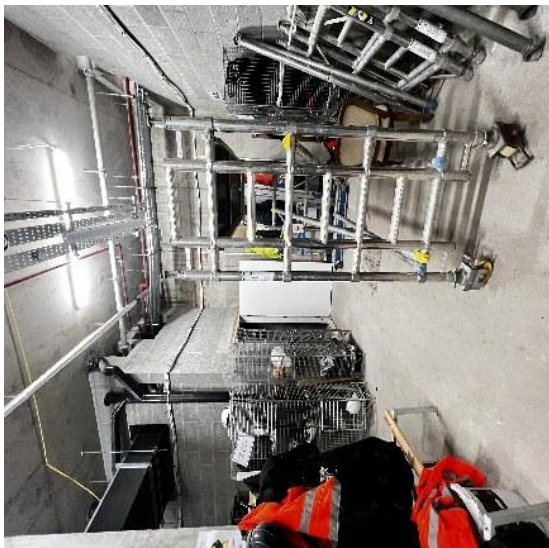
Accessible ceiling void and services interface

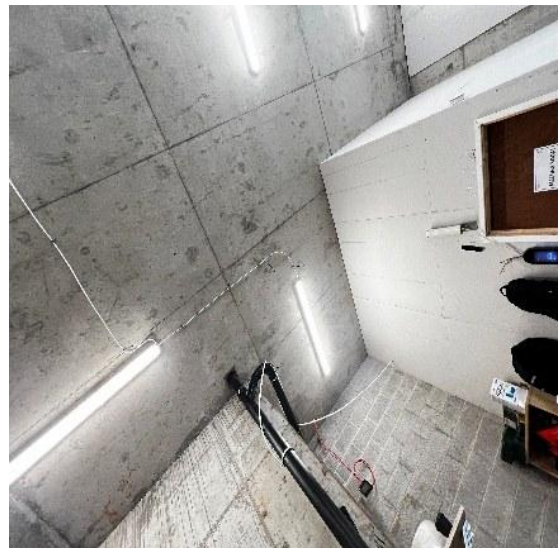
Ancillary space and soffit detail review
