Supercharger System Troubleshooting – 135/150/175/200 Verado L4 and 200/225/250/275/300 Verado L6

This service bulletin is intended to guide the technician to properly diagnose Verado supercharger issues. It is also designed to eliminate the unnecessary replacement of a misdiagnosed supercharger, reduce the instances of no trouble found (NTF) supercharger warranty returns, and eliminate the subsequent warranty rejection of serviceable units.

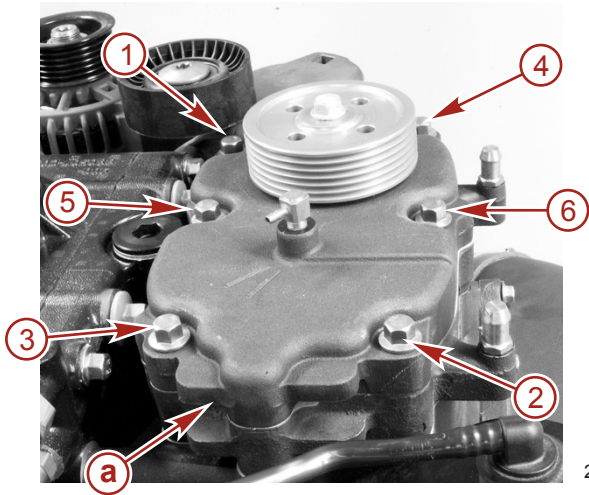
25689

a - Supercharger bearing housing to end cap

- **Correction**
 - Oil leak at supercharger bearing housing to end cap joint.
 - Check the clamp load of the end cap bolts. Torque the end cap mounting bolts to specifications following the torque sequence.

NOTE: Number 1–6 denotes the proper torque sequence.
