# ***Holman Property Inspections, LLC***

**Confidential - Property Inspection Report - Confidential**

1111 Sample Street, Newcastle, OK 73065  
Inspection prepared for: John Doe  
Date of Inspection: 10/23/2023 Time: 12:30  
Age of Home: 2020 Size: 2000  
Weather: dry

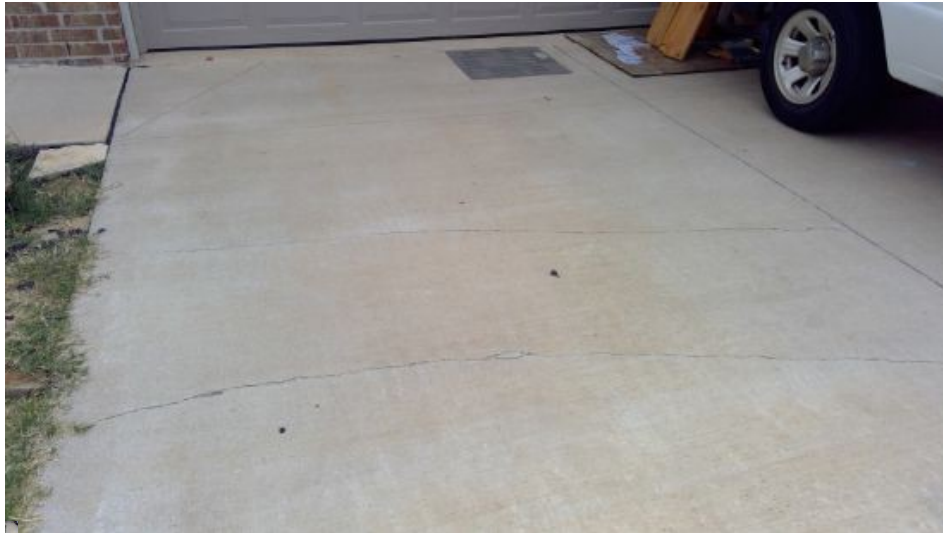
Common cracks, seal as needed.

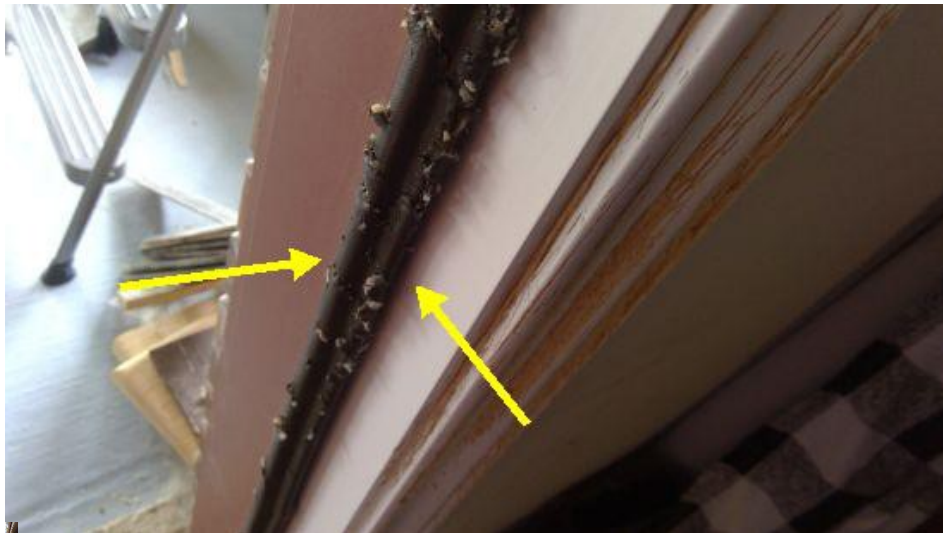
Weatherstripping is loose/damaged at rear door, recommend repairing/replacing

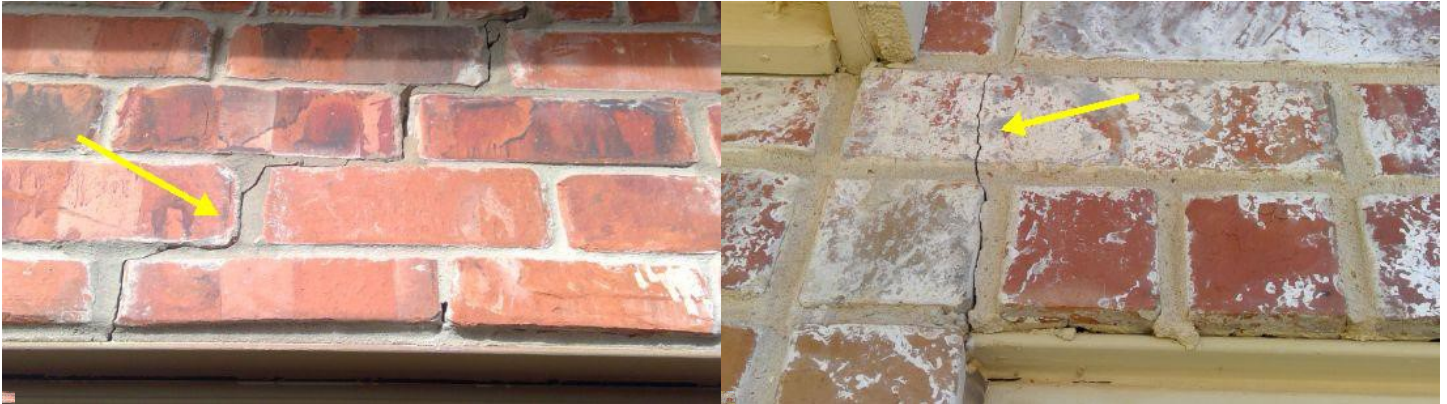
Cracks & sealed cracks observed in brick & mortar: Recommend sealing/tuck pointing by a qualified contractor. These appear to be typical for age of home, however, if a more detailed analysis is desired, a structural engineer is recommended.

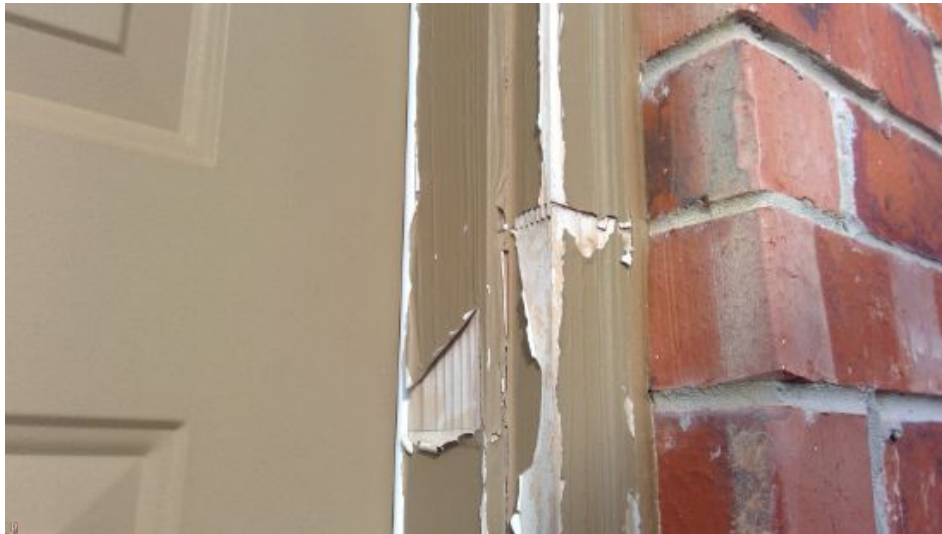
Failing paint/exposed wood surfaces were observed at side door trim, recommend repainting

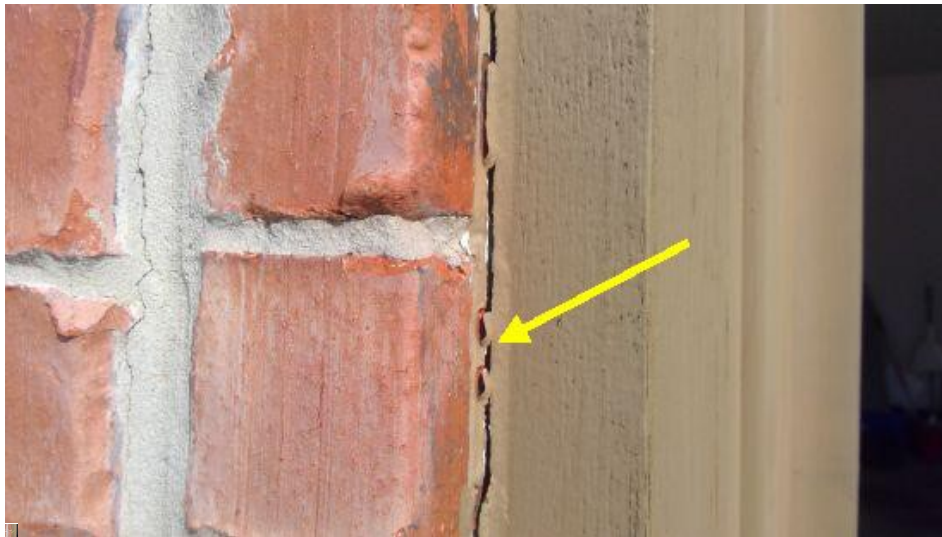
Caulking has failed at some doors/windows. Repair as needed.

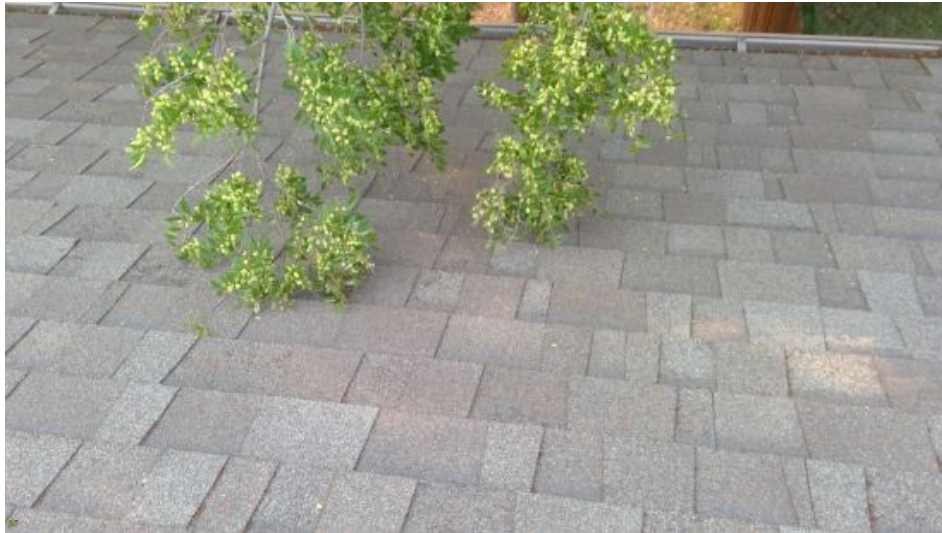
Vegetation too close to the building can cause harm through root damage to the foundation, branches abrading the roof and siding, and leaves providing a path for moisture and insects into the home.

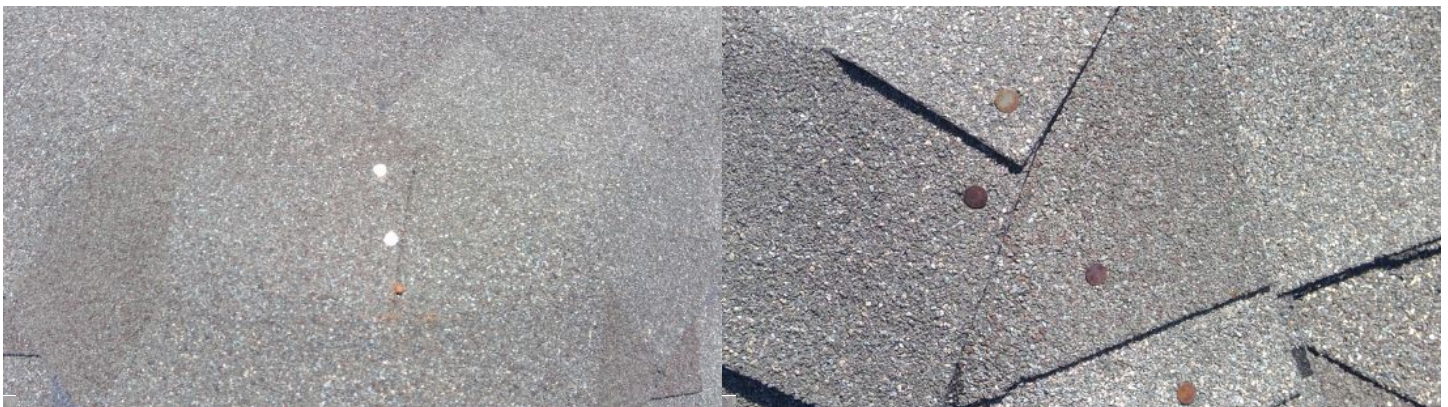
There are exposed roofing nails. Water can penetrate into the framing and interior surfaces. Recommend having the nails properly sealed.

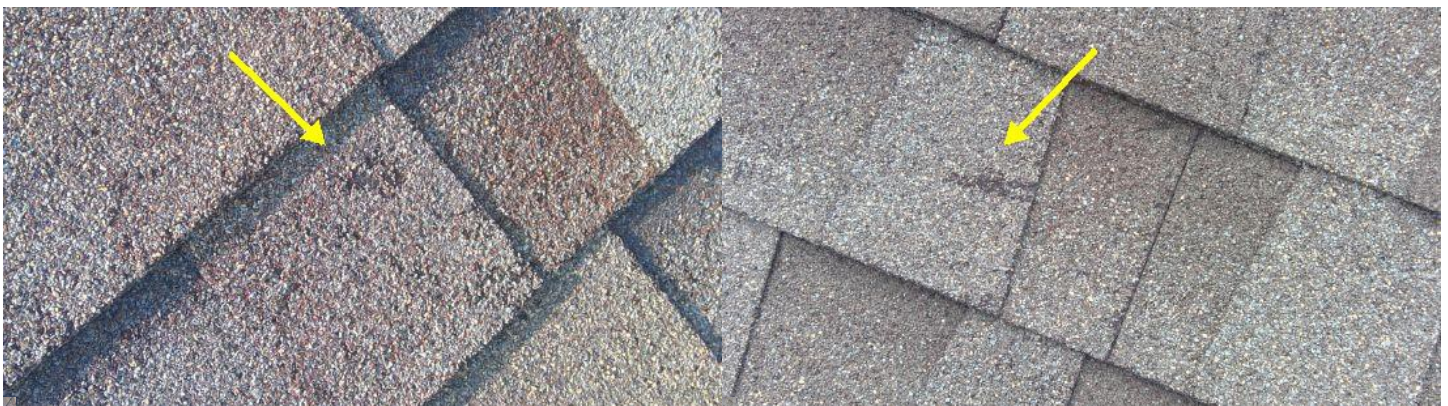
Minor hail damage observed. Recommend a qualified roofing professional evaluate prior to closing

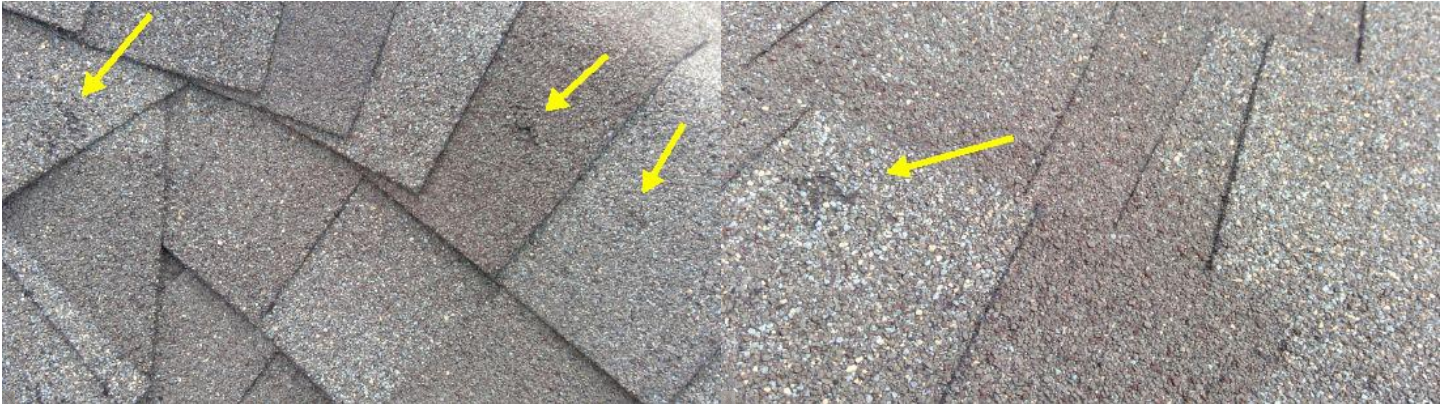
Minor hail damage observed. Recommend a qualified roofing professional evaluate prior to closing

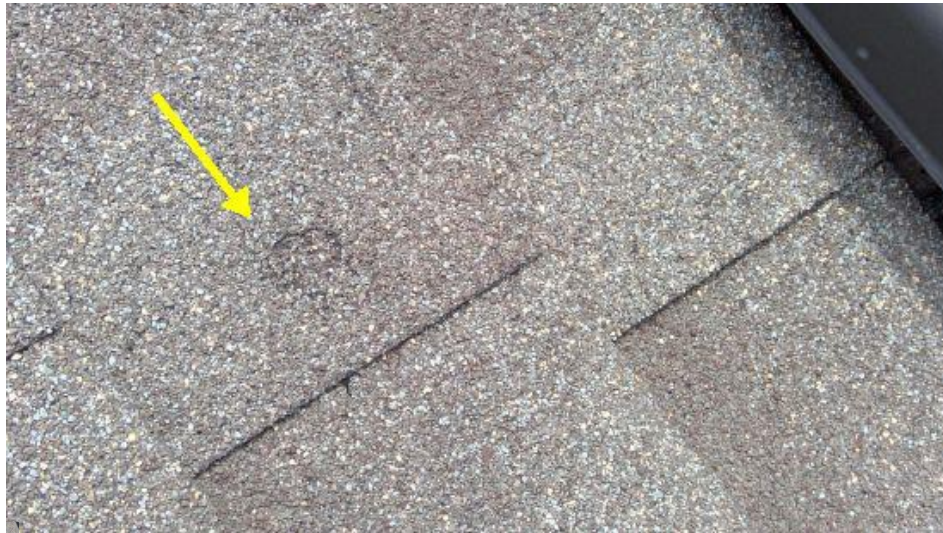
Minor hail damage observed. Recommend a qualified roofing professional evaluate prior to closing

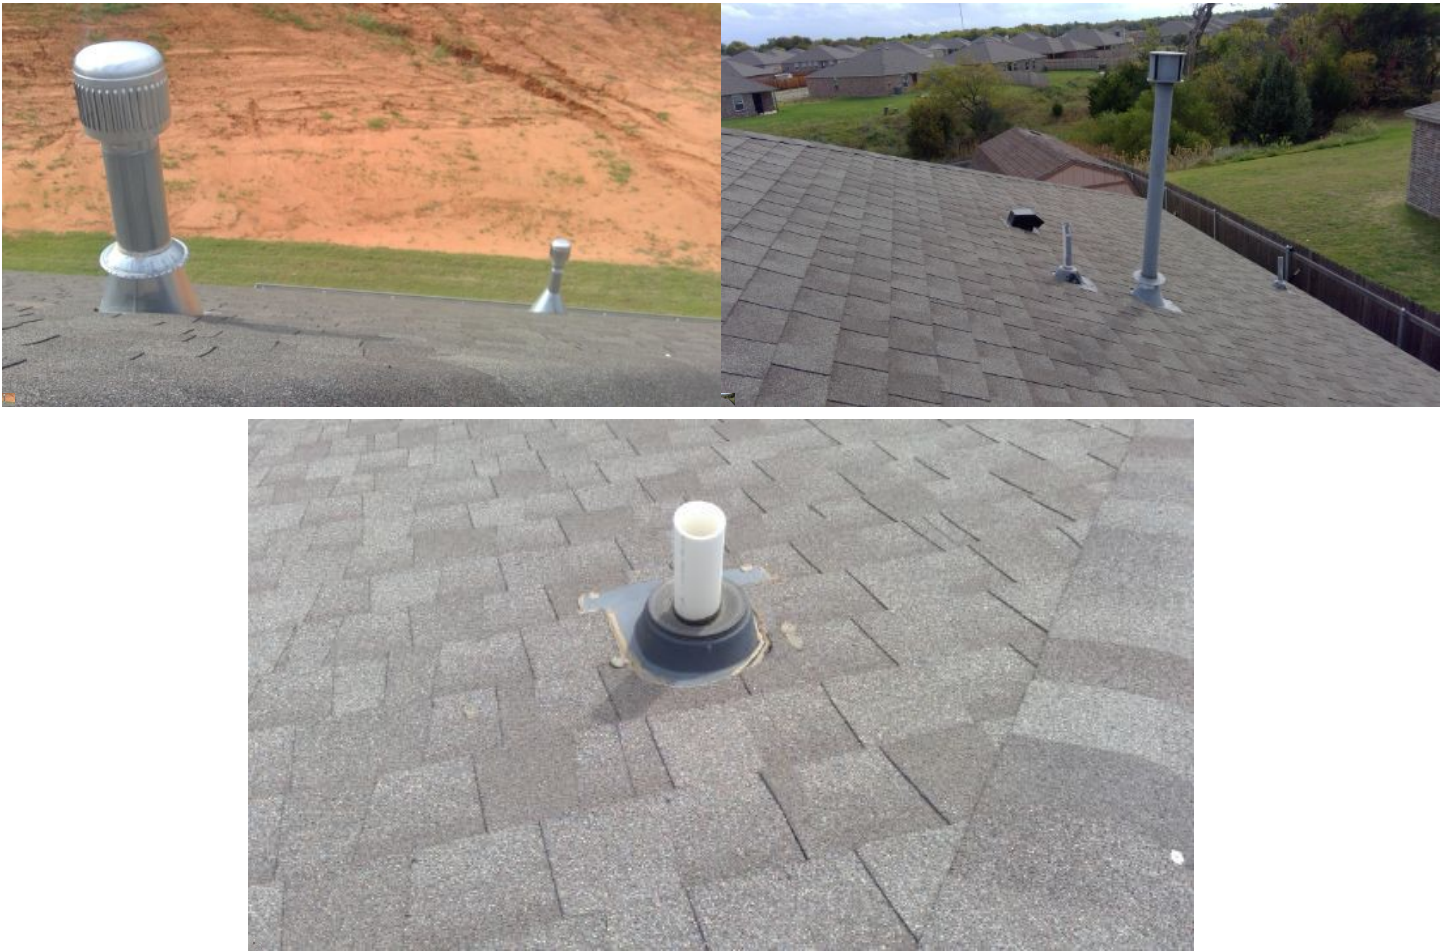
- Metal chimneys are hail damaged, still functional

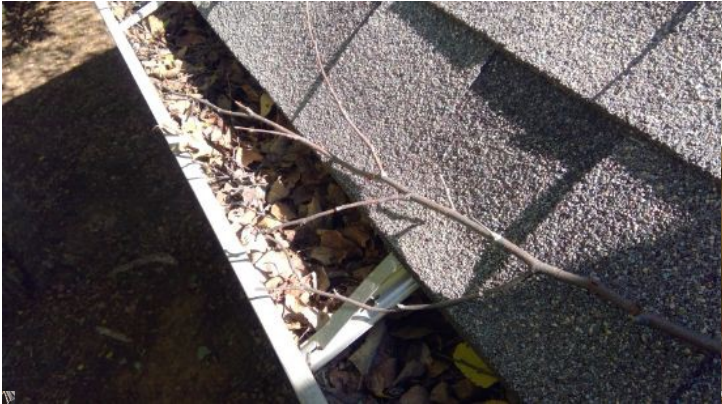
Areas of gutters clogged

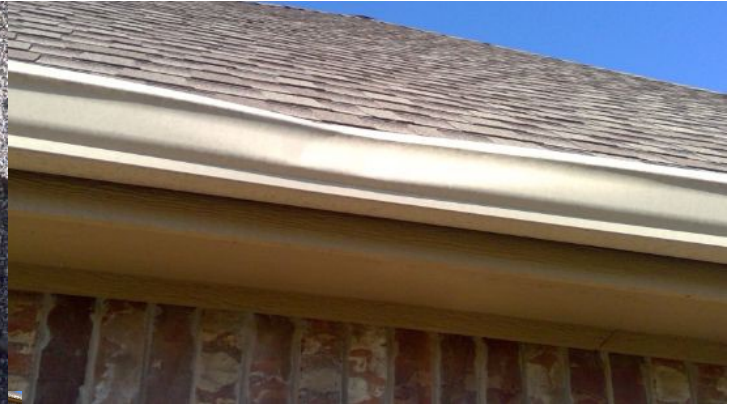
Minor damage noted at gutters. Appears to be functional, repair as needed

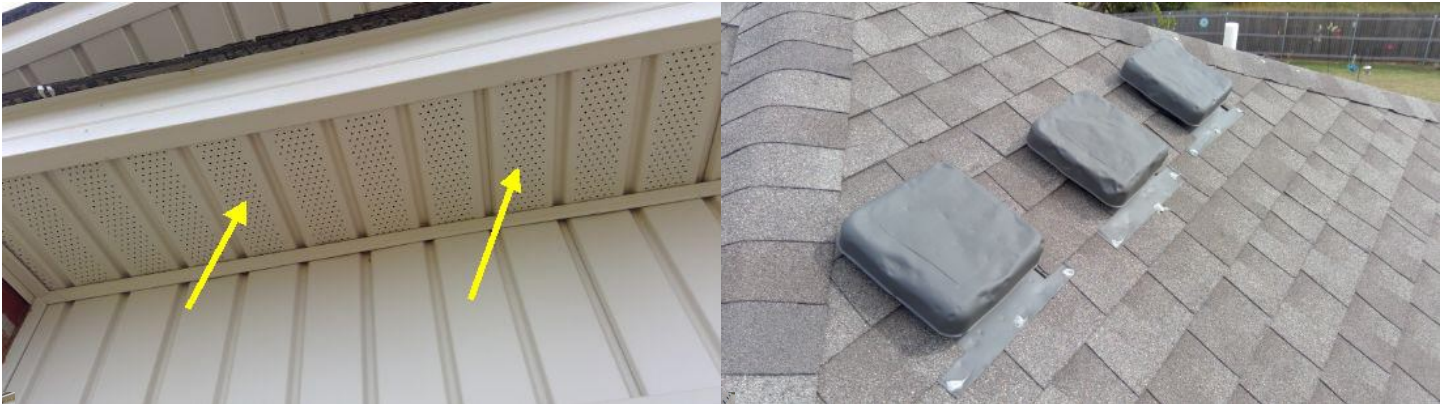
Roof vents are hail damaged, still functional

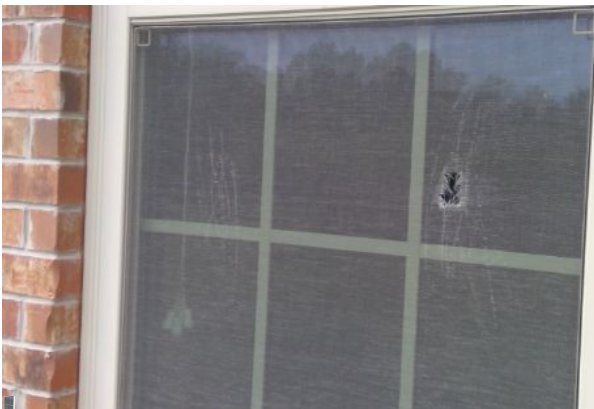
Damaged screens observed.

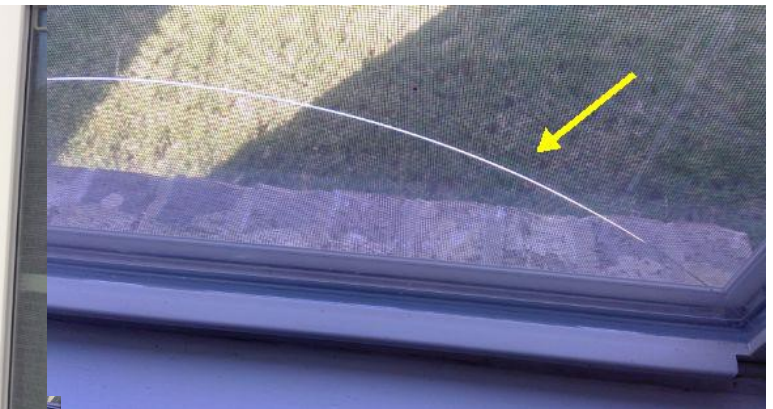
Cracked or broken window glass was observed at north bedroom. Injury could occur. Recommend repair or replacement of the damaged glass.

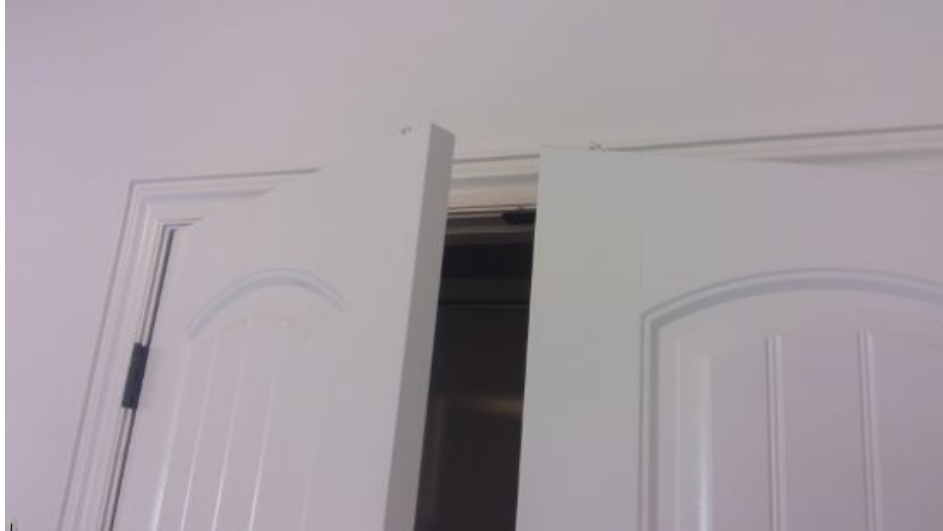
Closet doors did not latch in North bedroom

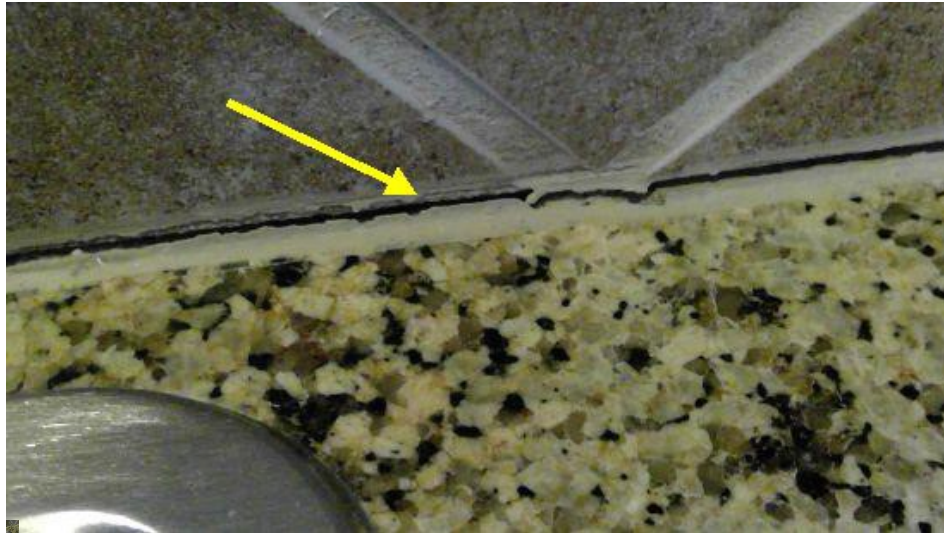
Recommend caulking/grout at Kitchen countertop/backsplash area

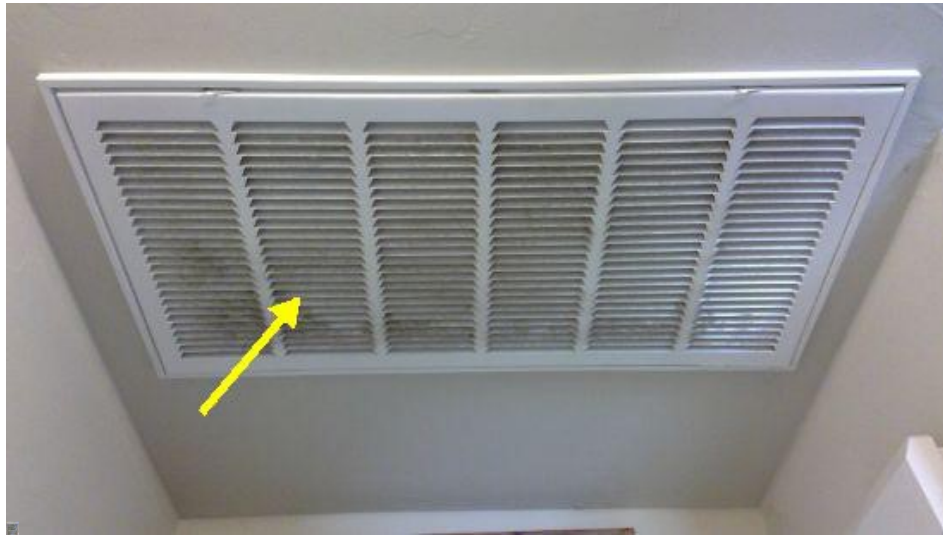
Furnace filter dirty. Needs replacement

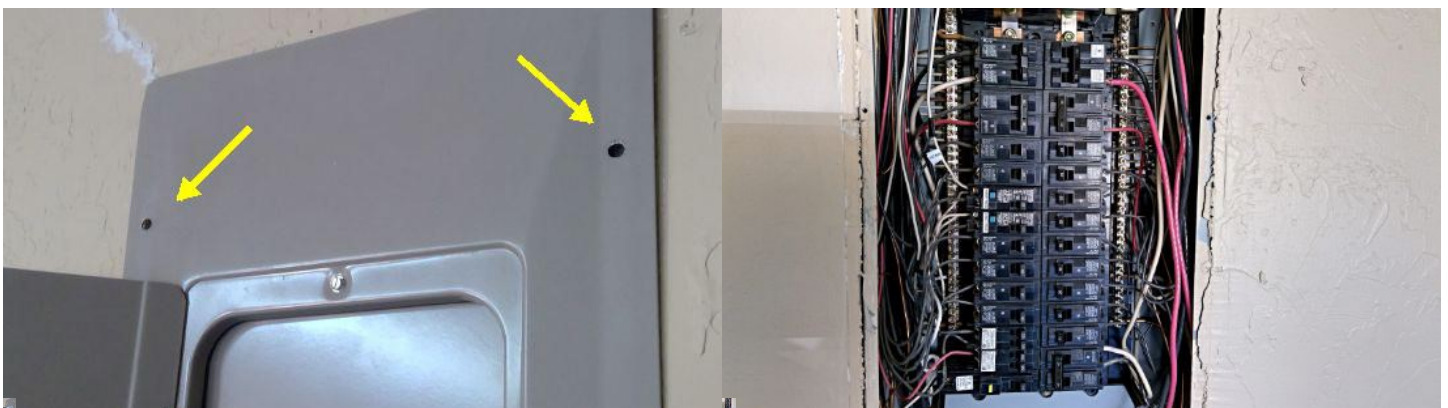
Missing screws observed at main electric panel cover. Recommend replacing

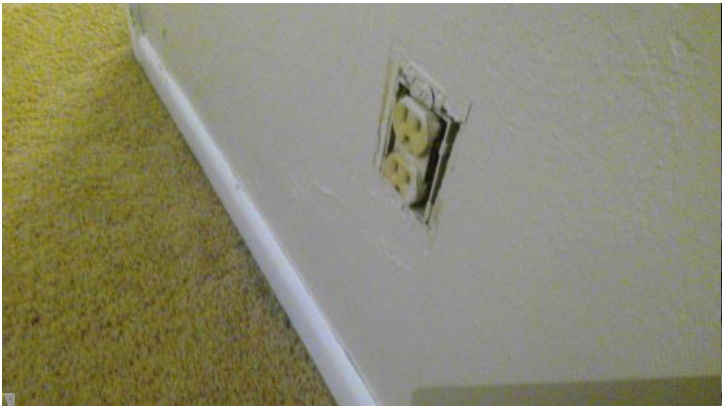
Missing cover plate at garage outlet, recommend correcting

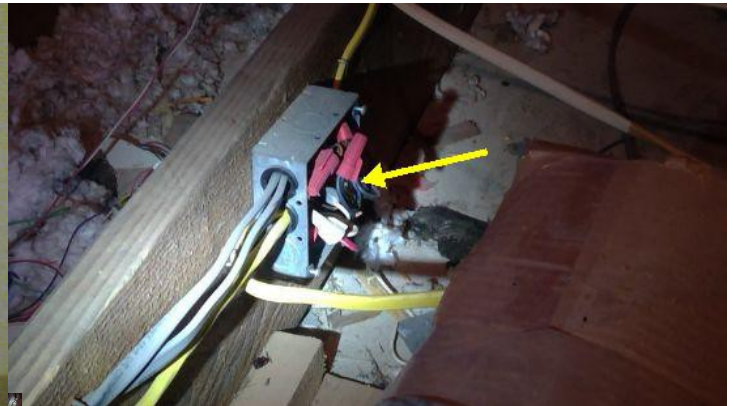
Junction box in attic missing cover plate. Recommend replacing

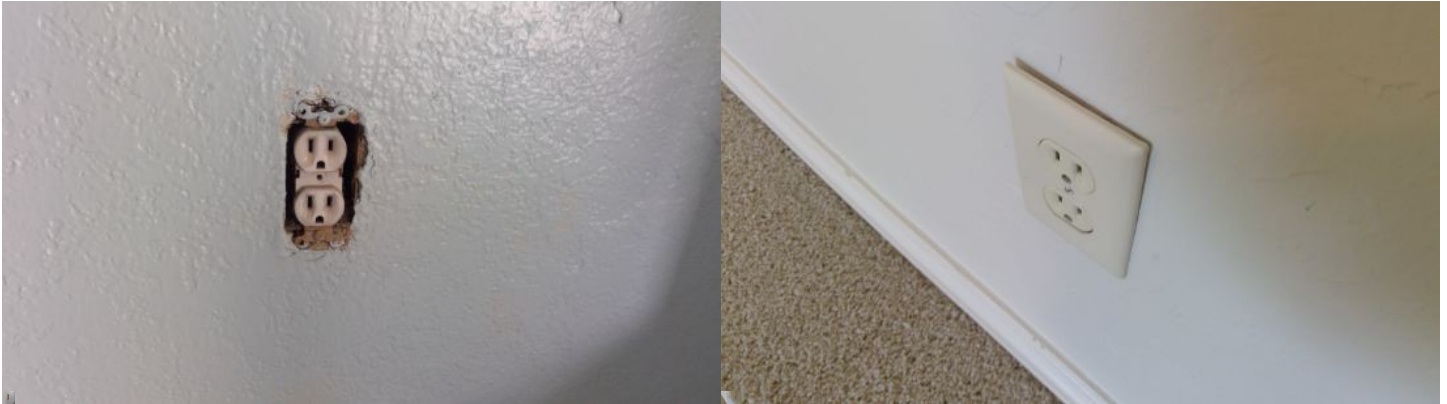
Missing cover plate at garage outlet, recommend correcting

Several loose outlets were observed throughout house, including bedrooms & living room. Repair as needed.

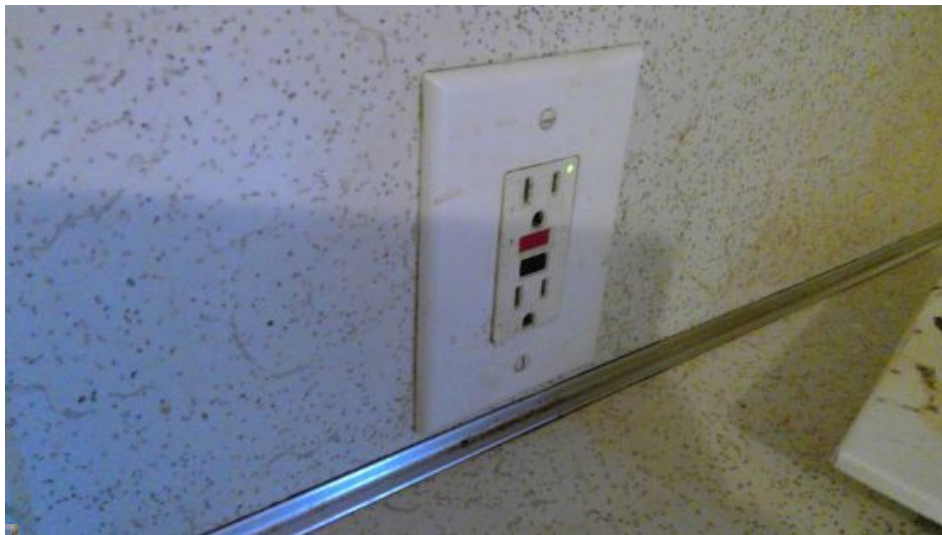
GFCI in hall bath does not respond to test. Recommend repair

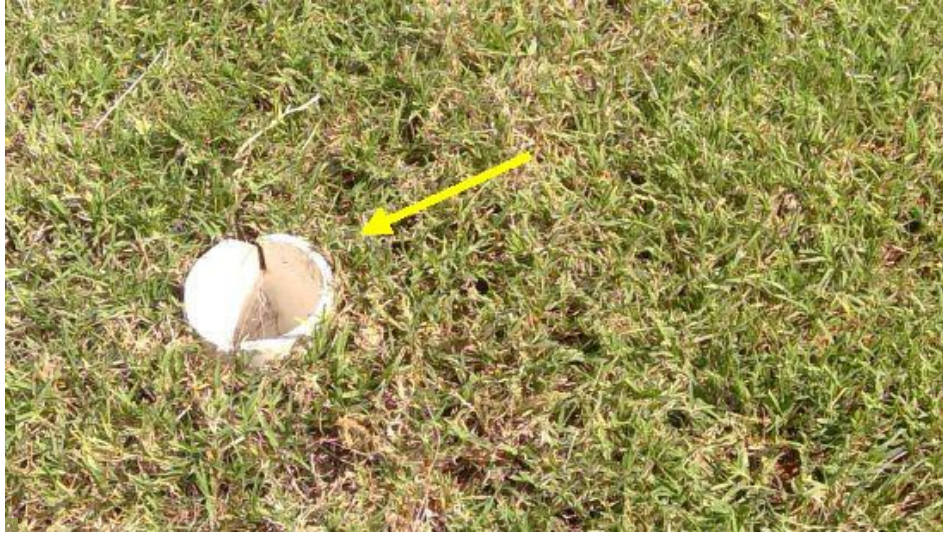
Cleanout cap is missing, recommend replacing

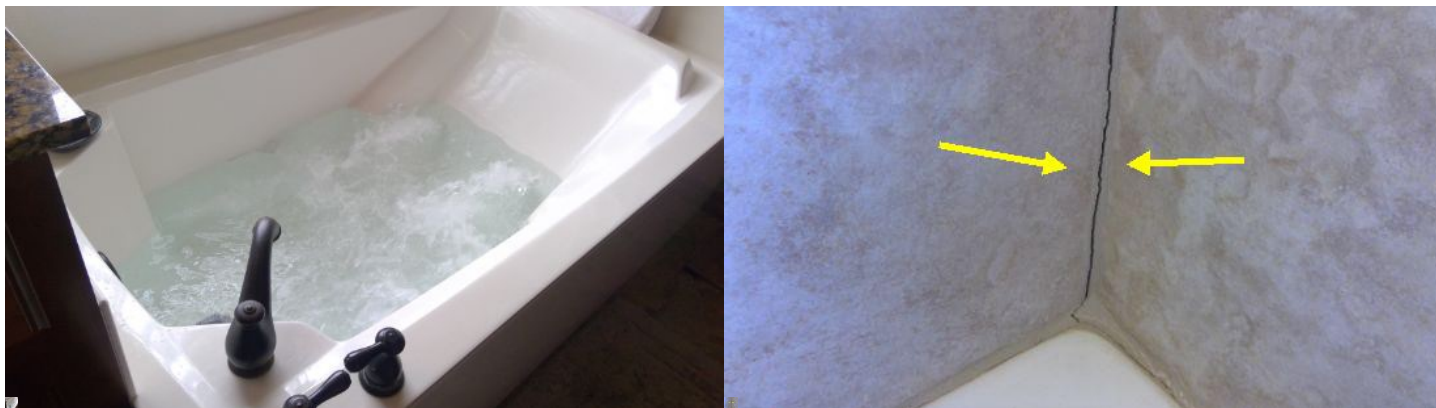
Caulking/grout needed at corners of tub surround in hall bath

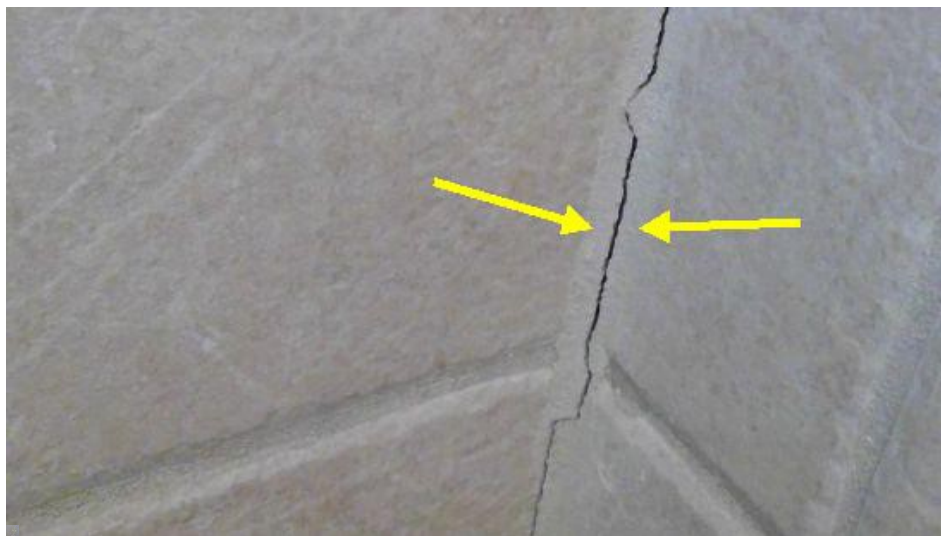
Grout cracking at corners, at & around shower floor in master bath shower. Recommend regrouting or caulking to prevent water damage

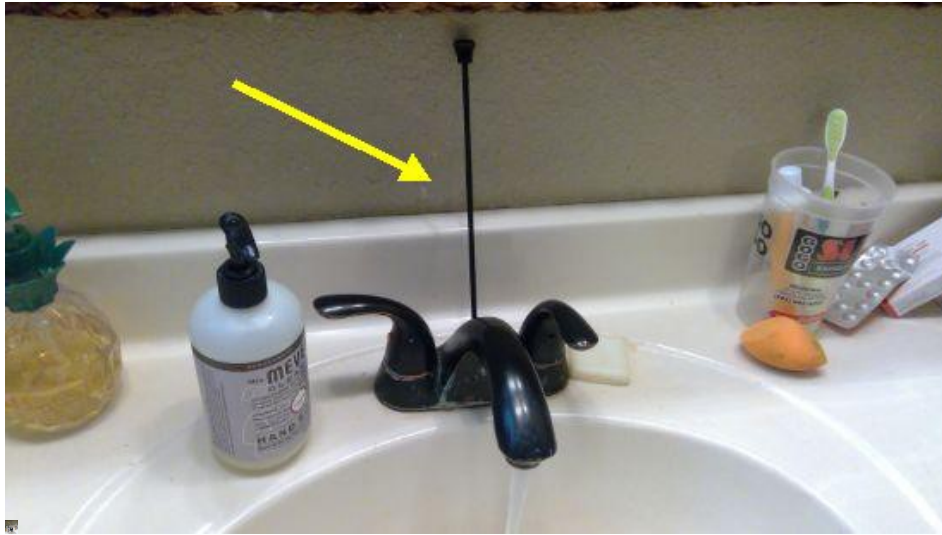
Sink stopper disconnected at master bath

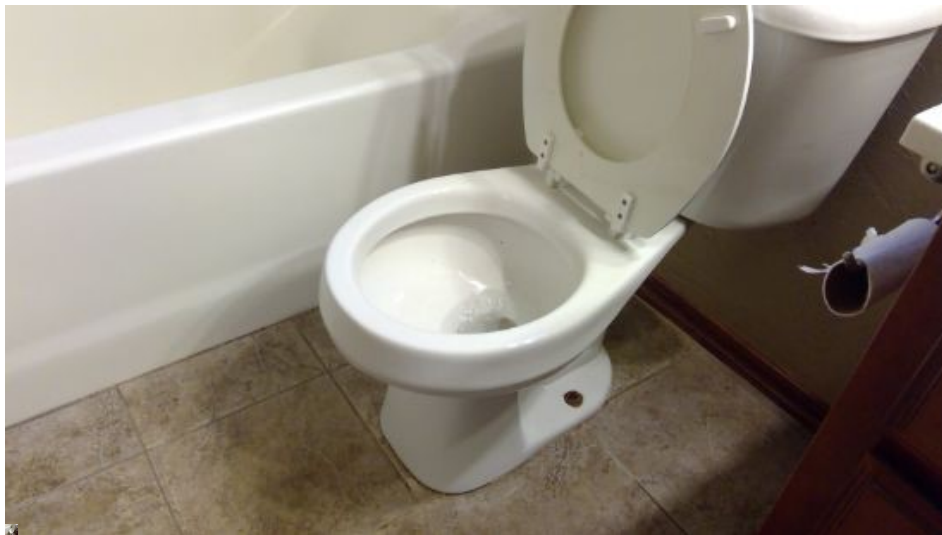
Toilet is loose at the floor in Hall bath, recommend tightening to prevent leak

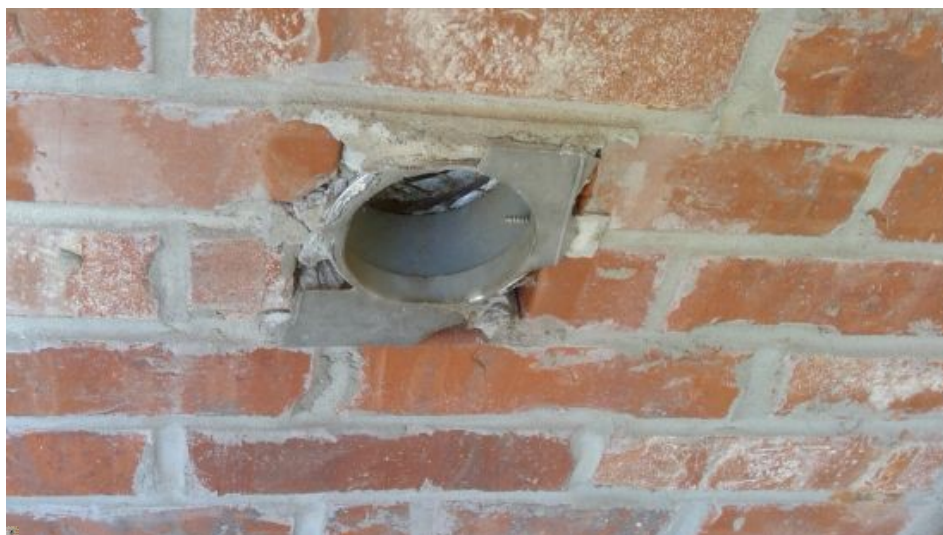
missing exterior cover
