PROPERTY INSPECTION REPORT

Date of Inspection: 10/5/2024

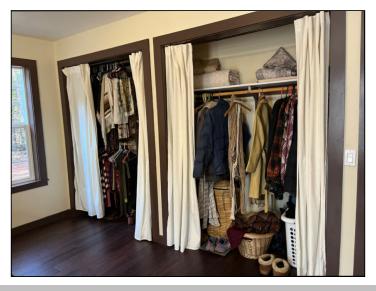
2. Closets

• The closet doors are missing. There is curtains being used to doors at the time of inspection.

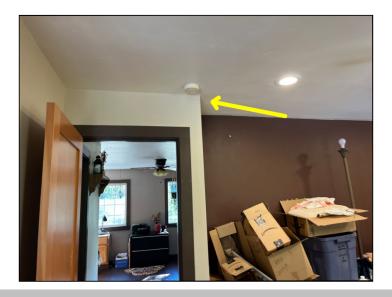
The smoke detectors did not operate during the inspection.

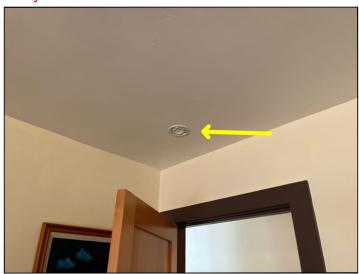
• There was no smoke detector in place in this room during the inspection. Recommend adding one for safety.

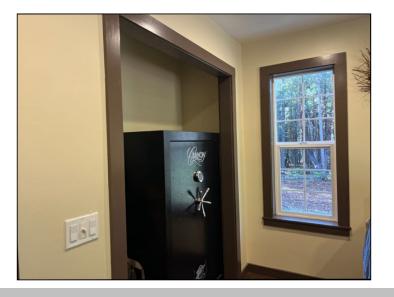
2. Closets

• There is no closet door present in this room at the time of inspection.

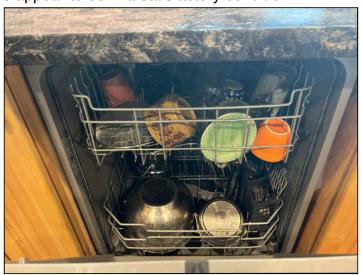
• Dishwasher was not tested at time of inspection due to personal items inside the unit. However, it does appear to be in a satisfactory condition.

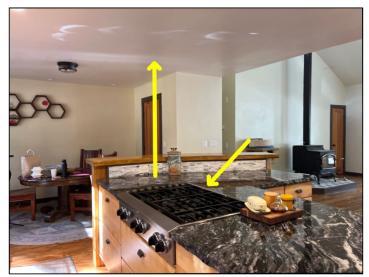
9. Vent Condition

• There is no ventilation system present in this kitchen. Being it is a gas cooktop it would be recommended to add an exterior vented hood.

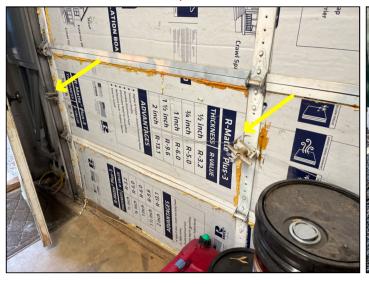
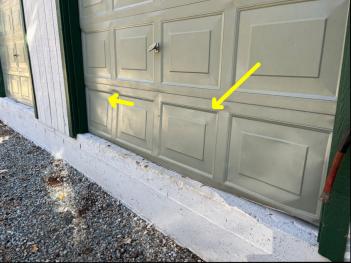
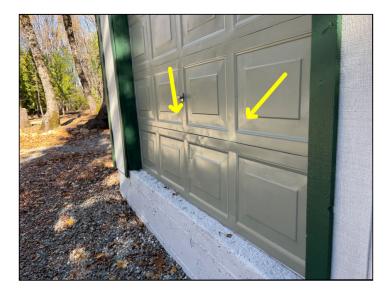
9. Garage Door Condition

Page 38 Item: 9	Garage Door Condition	• Both vertical doors for the garage are in a condition where they are not able to open. There appears to be damage on the outside with visible dents and when I try to open it from the inside, it doesn't move. Recommend recommend repair by qualified professional.

• Both vertical doors for the garage are in a condition where they are not able to open. There appears to be damage on the outside with visible dents and when I try to open it from the inside, it doesn't move. Recommend recommend repair by qualified professional.

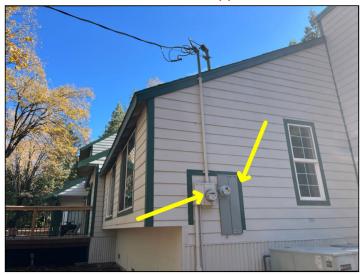
Electrical					
Page 40 Item: 1	Electrical Panel	 There is a 240 volt 50 amp breaker that is unlabeled. It is energized so it would be beneficial to gain clarity as to what this breaker is for. Recommend contacting the sellers agent for more information. Open breaker panel slot at the garage sub panel dead front cover. Electrocution hazard should anyone accidentally reach inside the Floyd. Recommend adding a space filler to prevent the chance of electrical shock. None of the breakers in the garage subpanel are labeled. Recommend gaining clarity from the seller as to where each circuit goes. Additionally there are 3 20 amp breakers and 1, 30 amp 240 volt breaker in the off position. It would be advantageous to gain clarity as to what that circuit is for and why it's off.Or I would recommend further review by qualified electrician. The outlet at the top of the garage stairs near the sub panel is showing an open hot during the inspection. This means it is the energized. Possible this outlet goes to one of the breakers in the opposition. Recommend further review by a qualified electrician.

- No major system safety or function concerns noted at time of inspection at main panel box.
- There is a 240 volt 50 amp breaker that is unlabeled. It is energized so it would be beneficial to gain clarity as to what this breaker is for. Recommend contacting the sellers agent for more information.

- Open breaker panel slot at the garage sub panel dead front cover. Electrocution hazard should anyone accidentally reach inside the Floyd. Recommend adding a space filler to prevent the chance of electrical shock.

- None of the breakers in the garage subpanel are labeled. Recommend gaining clarity from the seller as to where each circuit goes. Additionally there are 3 20 amp breakers and 1, 30 amp 240 volt breaker in the off position. It would be advantageous to gain clarity as to what that circuit is for and why it's off. Or I would recommend further review by qualified electrician.

- The outlet at the top of the garage stairs near the sub panel is showing an open hot during the inspection. This means it is the energized. Possible this outlet goes to one of the breakers in the opposition. Recommend further review by a qualified electrician.

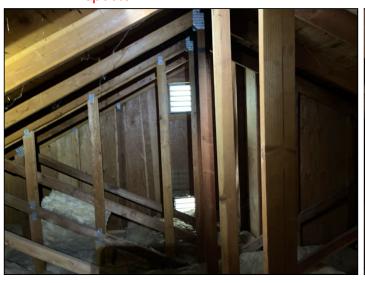
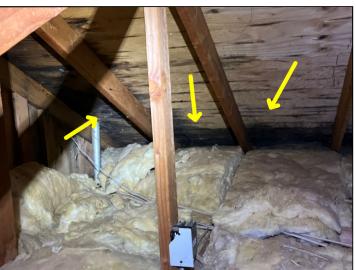
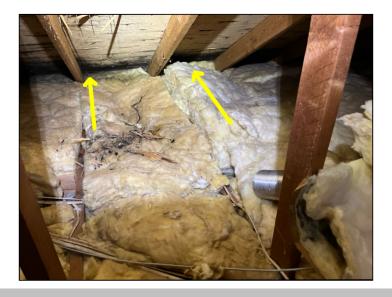
Attic					
Page 45 Item: 3	Ventilation	 There are signs of excess moisture in the attic space. Possibly due to inadequate ventilation. There are gable louver vents. However, the addition of under eve soffit vents would drastically improve the circulating air through the attic. Recommend further review by qualified roofing contractor. There's signs of blackening under the sheathing of the roofing. I cannot confirm, but it's possible that it is a mold like substance. Recommend further review by qualified mold inspector. 			
Page 46 Item: 6	Attic Plumbing	 There is a broken ABS vent pipe in the attic that is not making contact anymore and will need to be repaired to prevent access moisture in the attic space. Recommend further review by qualified plumber. There's an ABS vent pipe in the attic at the northeast end of the house that appears to be dripping condensate back into the attic space. I checked it with my moisture meter and it was dry during the inspection. It's possible this leak has already been repaired. However, it should be monitored and if the condition persist I would Recommend further review by qualified plumber.

- Gable louver vents noted.
- There are signs of excess moisture in the attic space. Possibly due to inadequate ventilation. There are gable louver vents. However, the addition of under eve soffit vents would drastically improve the circulating air through the attic. Recommend further review by qualified roofing contractor.
- There's signs of blackening under the sheathing of the roofing. I cannot confirm, but it's possible that it is a mold like substance. Recommend further review by qualified mold inspector.

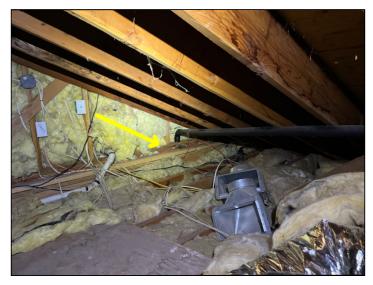
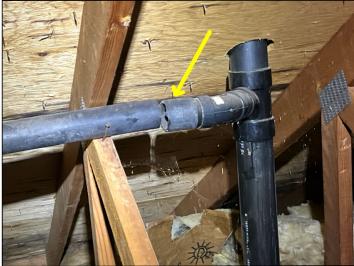
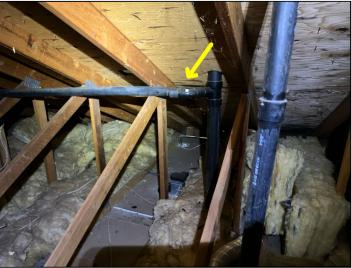
- ABS plumbing vents
- There is a broken ABS vent pipe in the attic that is not making contact anymore and will need to be repaired to prevent access moisture in the attic space. Recommend further review by qualified plumber.
- There's an ABS vent pipe in the attic at the northeast end of the house that appears to be dripping condensate back into the attic space. I checked it with my moisture meter and it was dry during the inspection. It's possible this leak has already been repaired. However, it should be monitored and if the condition persist I would Recommend further review by qualified plumber.

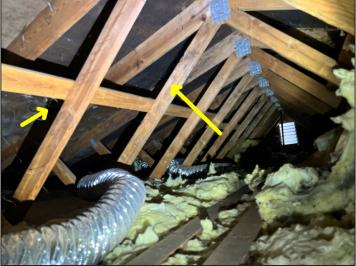
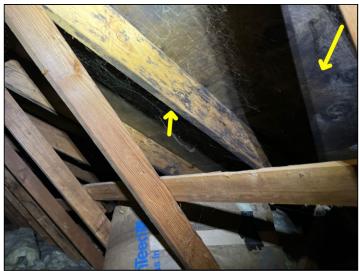
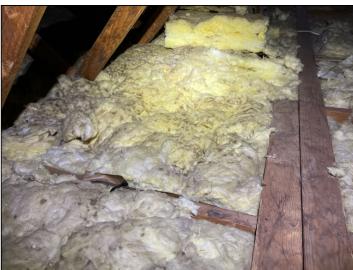
Garage Attic	Garage Attic				
Page 48 Item: 2	Structure	• The roof sheathing for the garage has some blackening on the inside where the attic spaces. Possibly due to access moisture. However, everything appears dry and in a satisfactory condition at the time of inspection. Should the roof sheathing condition be of concern I would recommend further review by a qualified roofing contractor or a mold inspector identify potential repairs needed.			
Page 49 Item: 4	Vent Screens	Vent screens noted as torn.

- The structural components in the attic are of professional quality with no deficiencies observed at the time of the inspection.
- The roof sheathing for the garage has some blackening on the inside where the attic spaces. Possibly due to access moisture. However, everything appears dry and in a satisfactory condition at the time of inspection. Should the roof sheathing condition be of concern I would recommend further review by a qualified roofing contractor or a mold inspector identify potential repairs needed.

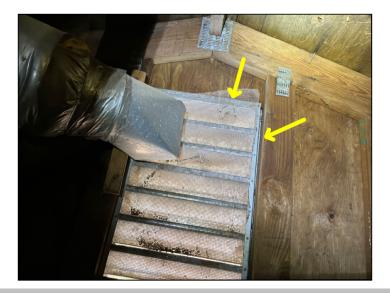
4. Vent Screens

Vent screens noted as torn.

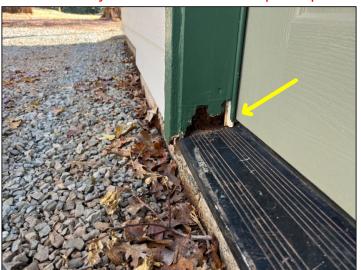
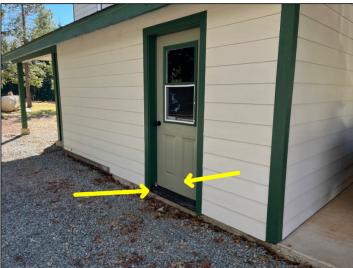
1. Doors and Trim Condition

Exterior Areas				
Page 50 Item: 1	Doors and Trim Condition	There appears to be some rotted wood and visible deterioration at the door jam for the utility room. Recommend repair replaced by a qualified professional as needed.		
Grounds				
Page 55 Item: 7	Grounds Electrical	 The outlets on the exterior of the garage are showing an open neutral at the time of inspection. Recommend further review by qualified electrician. All exterior outlets have weatherproof covers on them and are in a functional condition during the inspection. However, none of the outlets are GFCI rated. This would not be considered a defect, but GFCI is recommended anywhere. The outlets are in wet locations. Something to consider upgrading in the future.

There appears to be some rotted wood and visible deterioration at the door jam for the utility room. Recommend repair replaced by a qualified professional as needed.

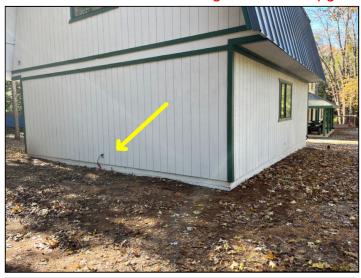
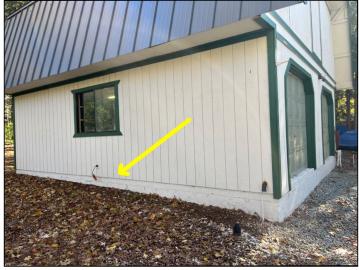
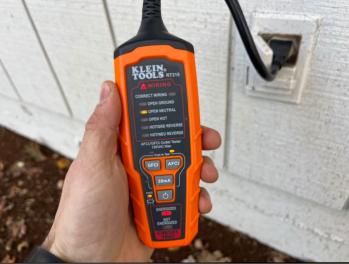
7. Grounds Electrical

- The outlets on the exterior of the garage are showing an open neutral at the time of inspection. Recommend further review by qualified electrician.
- All exterior outlets have weatherproof covers on them and are in a functional condition during the inspection. However, none of the outlets are GFCI rated. This would not be considered a defect, but GFCI is recommended anywhere. The outlets are in wet locations. Something to consider upgrading in the future.
