PROPERTY INSPECTION REPORT

Dustin Keller
Sky Pines Home Inspections

Your address
Inspection Prepared For:
Agent: Dustin Keller - Test Agent

Date of Inspection: 6/10/2025
Size: 1884

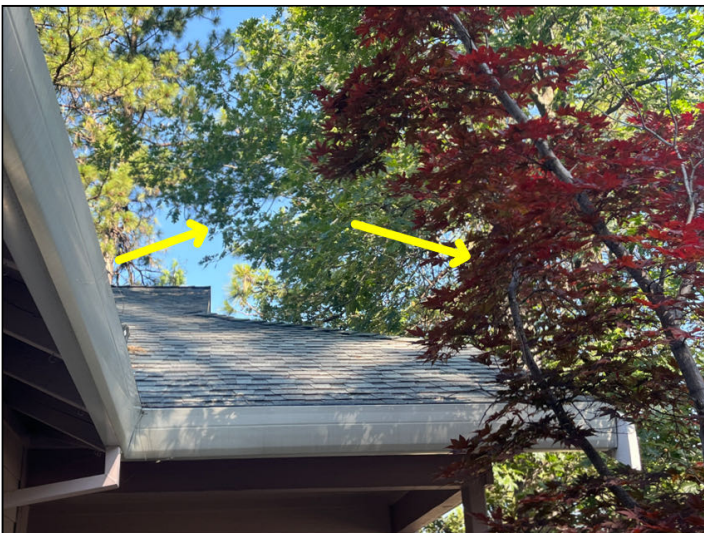
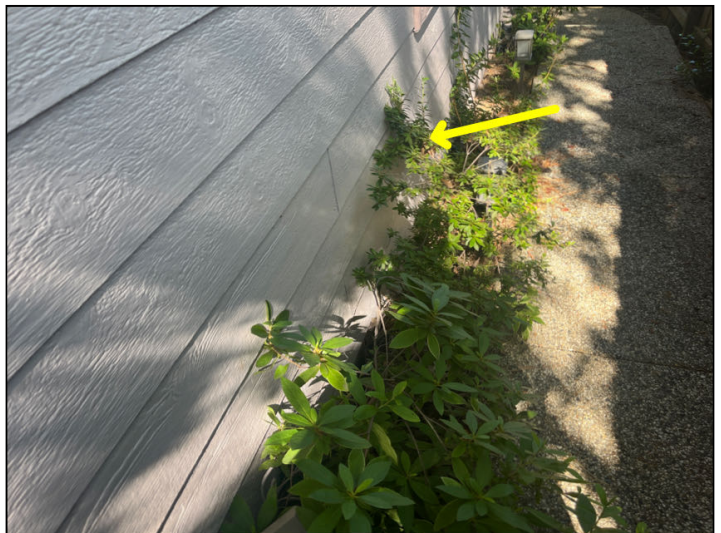
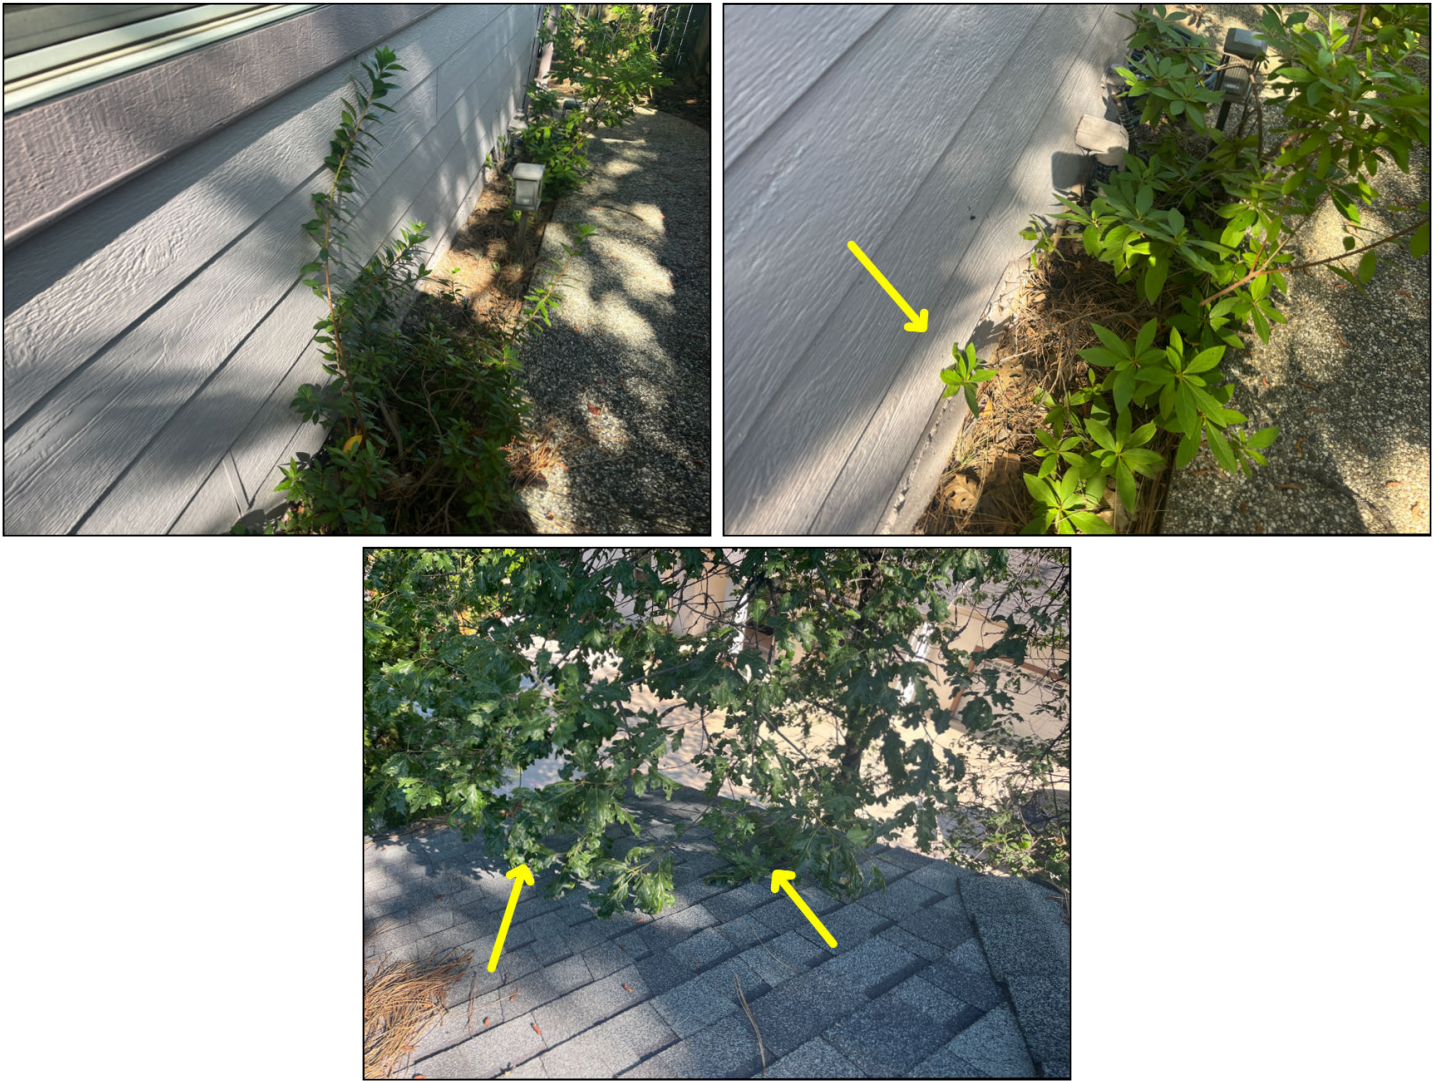
- No immediate vegetation concerns noted at the time of inspection. Annual trimming of trees and shrubs will help maintain clearance to the home.

• Prune or remove any plants that are in contact or proximity to home to eliminate pathways of wood destroying insects.

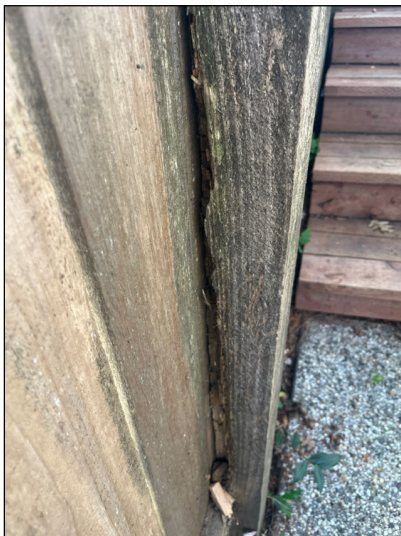
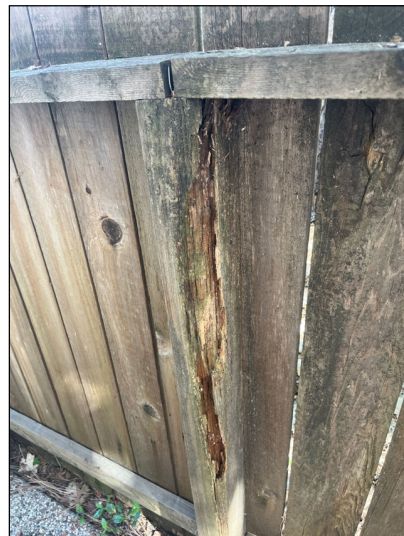
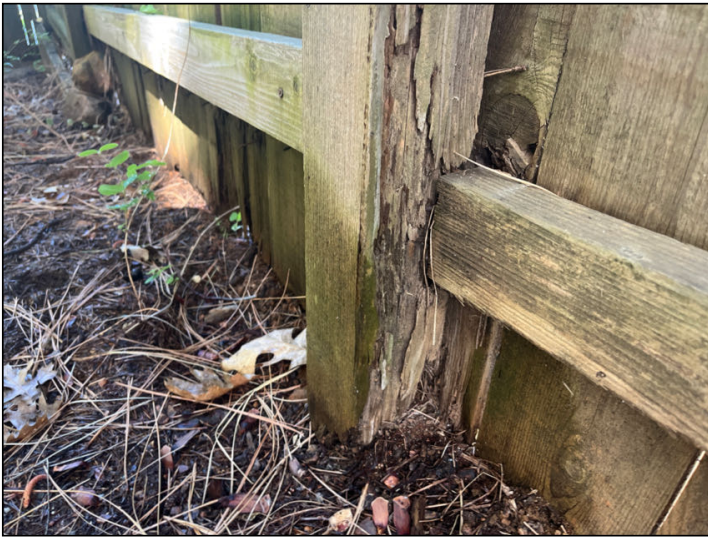
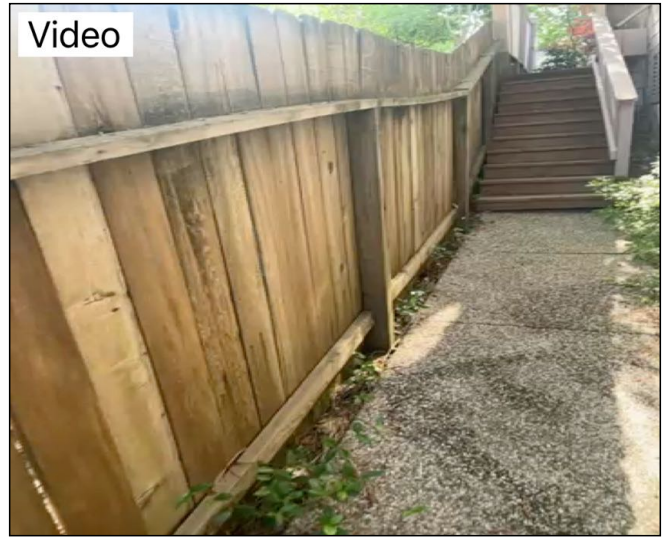
16. Fence Condition

- In the inspectors opinion the fence is near the end of its useful life due to visual signs of wood rot and a considerable amount of movement when testing its rigidity.

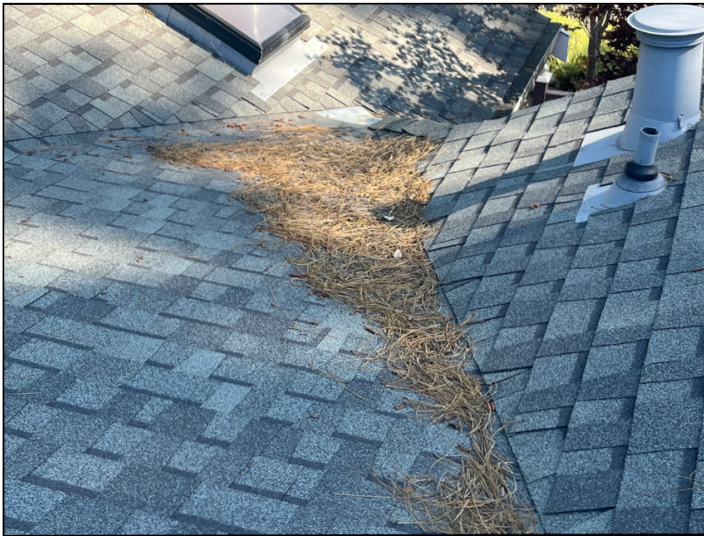
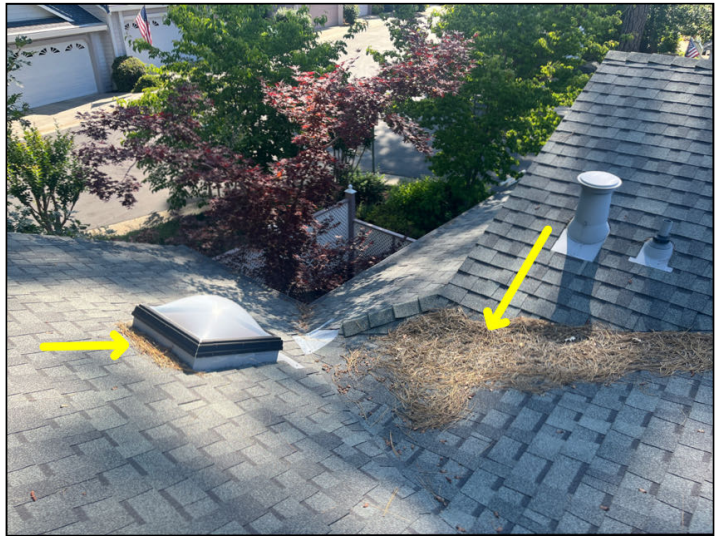
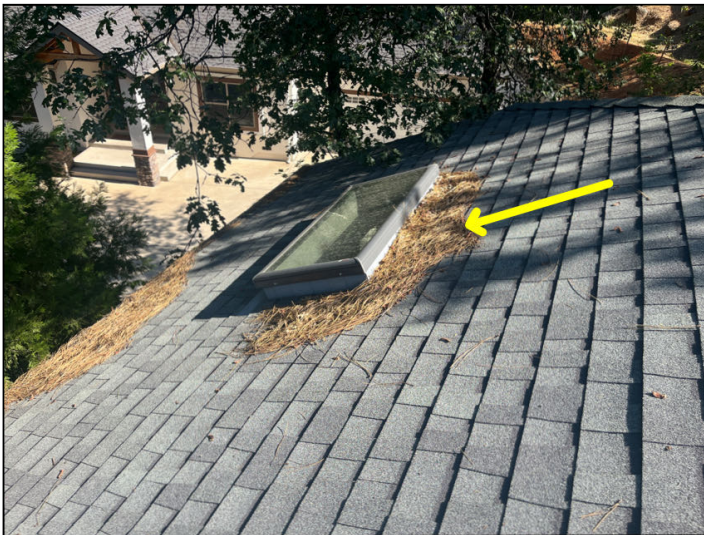
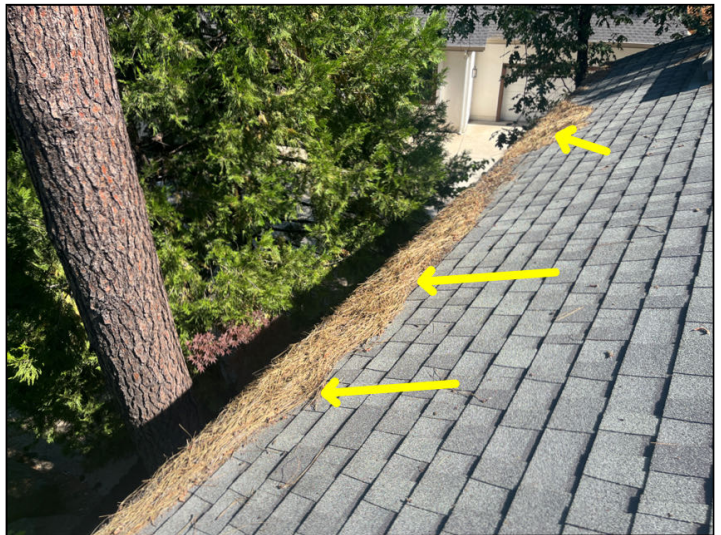
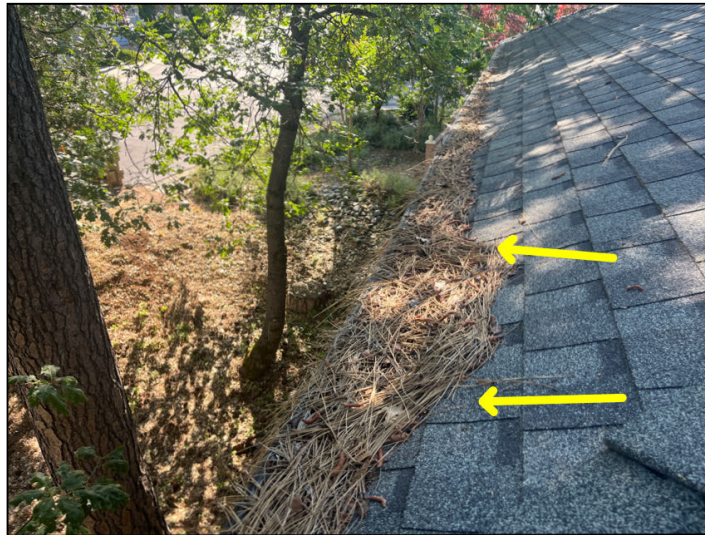
1. Roof Condition

- No safety, functional, or structural concerns noted at the time of inspection.
- **Clean roof in these areas as significant amounts of organic debris is evident.**

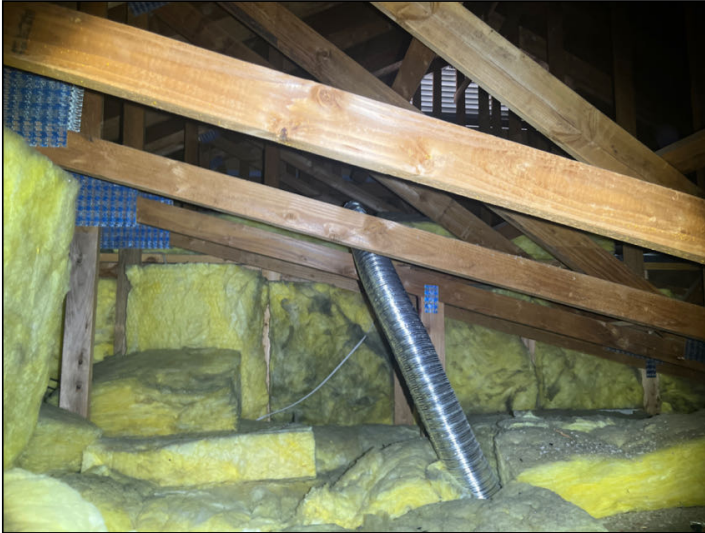
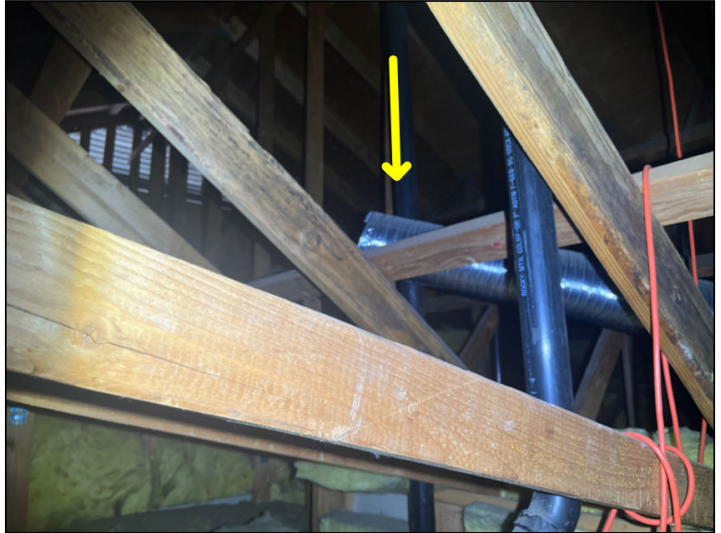
- **ABS** plumbing vents
- All the plumbing vent piping extends to the exterior of the home using adequate materials and maintains a proper seal at the roof. However, two of the ducks have fallen down from their roof penetration and are venting into the attic space. Recommend pushing these back up to the roof penetration to prevent unwanted moisture from the attic. However, they're still functional in the condition they are in.

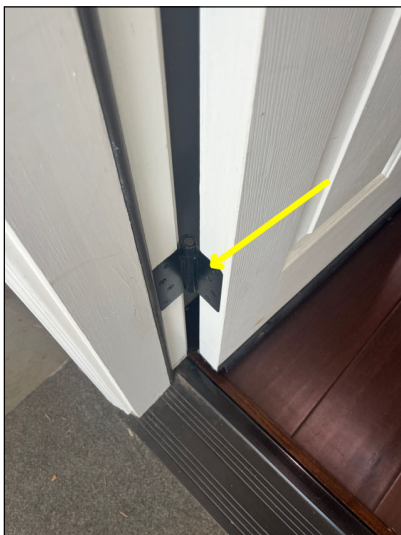
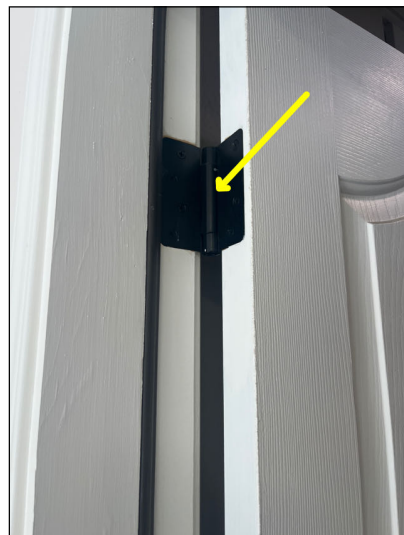
- **Garage-house door does not close automatically. This is to act as a fire stop, and keeps exhaust fumes out. I recommend adjusting the auto closing hinge to this door.**

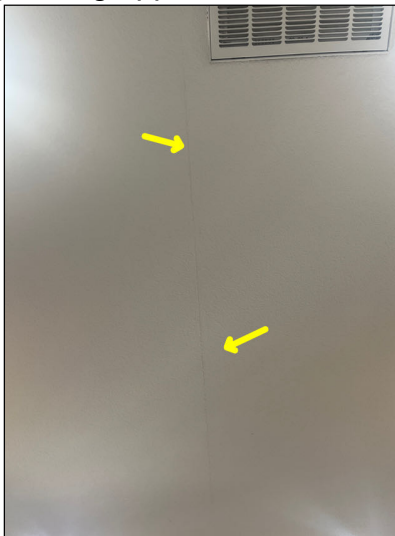
9. Ceiling Condition

- All areas of the ceiling appeared to be in a serviceable condition.
- Small cracking in the wall finish is noted. This is probably caused by the joint compound (spackle) drying too quickly during application.

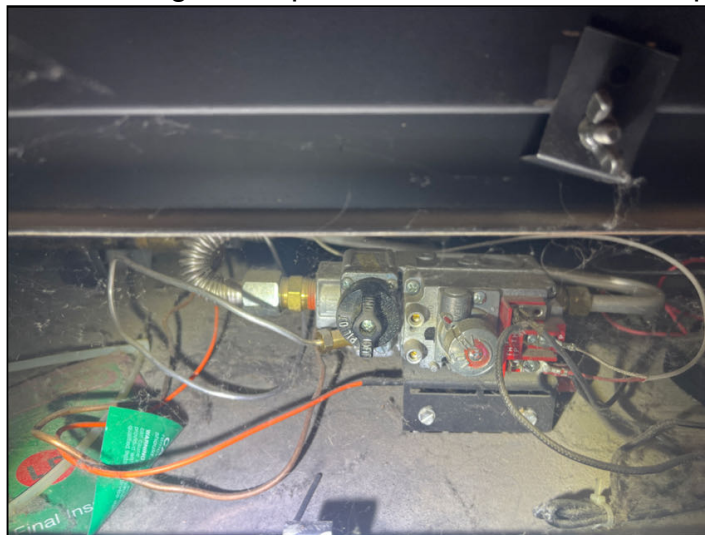
- Have a gas fireplace professional service/evaluate fireplace before operating. Pilot light was in the off position during the inspection. However, this unit appears to be functional.

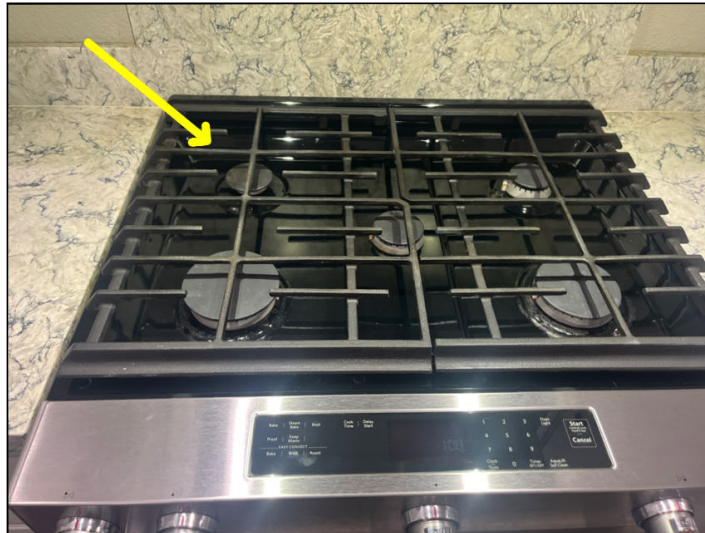
7. Cook top condition

- 4 or the 5 burners were operational and functioned as intended during the inspection. The back left burner would not ignite. It's possible the gas orifice under the top plate is clogged and just needs to be cleared.

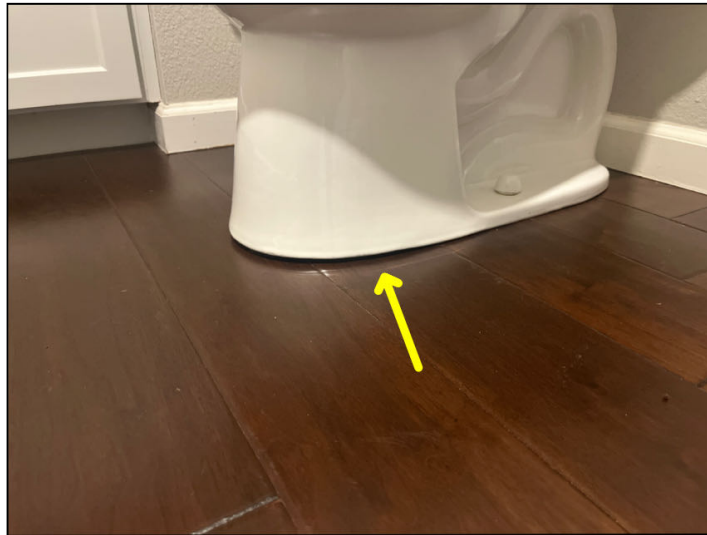
- Operated when tested. No deficiencies noted.
- The toilet in this bathroom needs a bead of caulk to prevent moisture from going under the toilet.

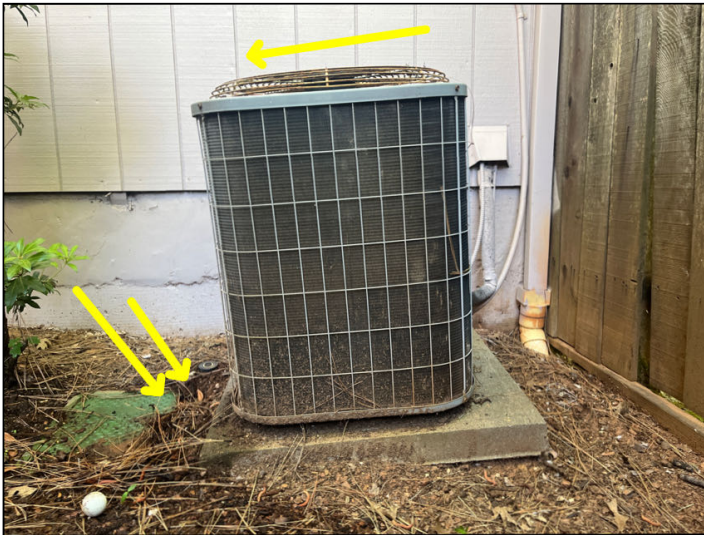
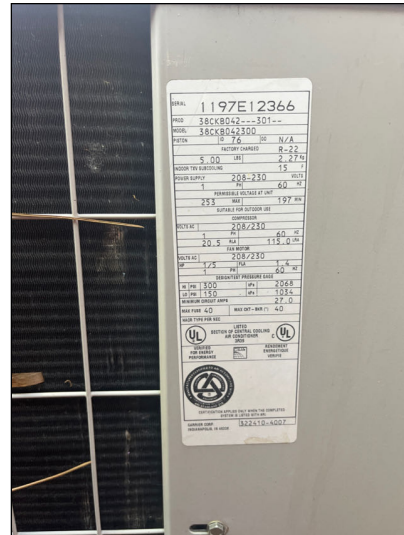
8. AC Compress Condition

- AC compressor appeared functional at the time of inspection. Routine maintenance and cleaning will increase the longevity of this unit.
- Exterior unit not level. This can affect system performance. I would recommend having the base/ concrete pad re-leveled to prevent performance issues to the AC compressor itself.
