# Home Inspection Report

5420 Cheyenne Dr, Kelseyville , CA 95451

Monday October 5, 2020

Dustin Wallace Home Inspections & Construction  
16496 Main St.  
Lower Lake, CA 95457  
(707) 293-6307  
dustinjameswallace1985@gmail.com

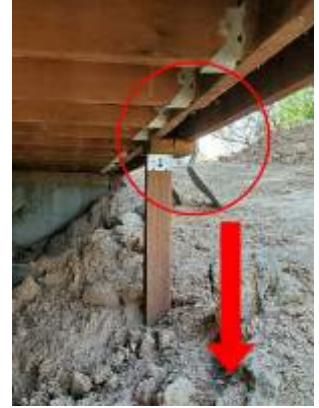
This added 2x6 block on rim was added due to settlement of slope off the deck. This is a temporary fix I would recommend where arrow is dig another footing and install another 4x4 post and lateral brace tie into the rim attached to house or the ending joist closest to the rim of the house.

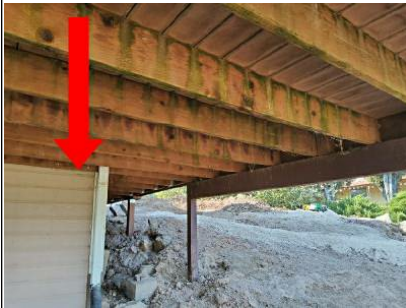
arrow shows where lateral bracing can be installed for future issues with settlement of deck.

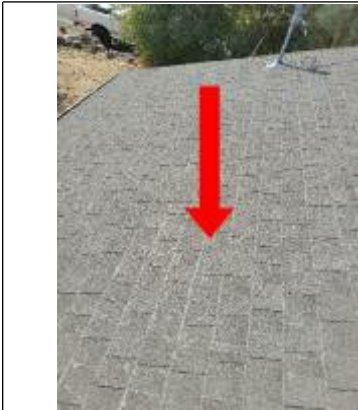
Garage portion showing sun damage of roof

**Comments** I have mentioned in the beginning of the report of the condition of the roof over the garage. Since the garage is not a "living area" I would be less concerned of adding another layer of roofing. Luckily this house is 13 years old, a second layer of composition roofing can be installed directly over up to the ridge. The ridge would have to be pulled off and replaced but the shade side of the house is in fine condition. I believe the back portion the back master bedroom has about five years left.

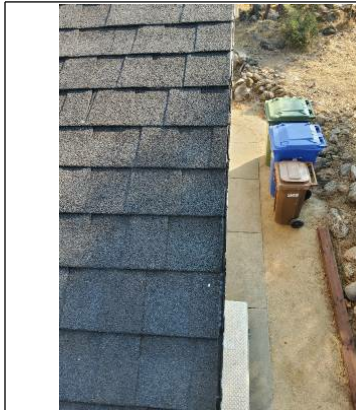
The only issue I had with how the roofing was the lack of overlap over the flashing / fascia. "Rule of Thumb" is a quoted term which means its ment to go past the tip of your thumb past the flashing / fascia. This is very minimal to worry about when the next layer eventually is installed I would recommend it but there is also not soffit underlayment underneath the "jacks" and "tails"

1 inch overhang lap

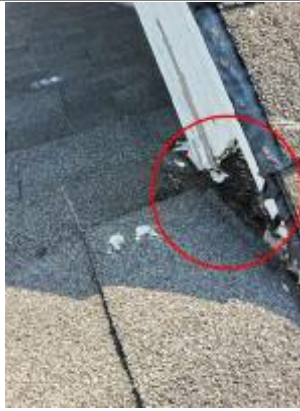
I would recommend pulling up a piece of the shingle carefully and installing a piece of flashing between the gable and the edge of that shingle.

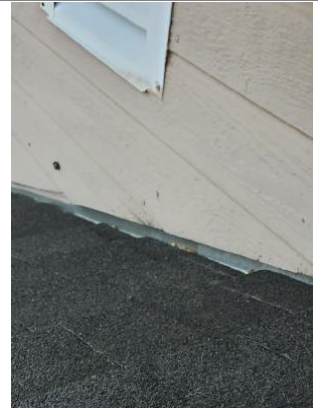
Proper way to flash underneath the lap siding

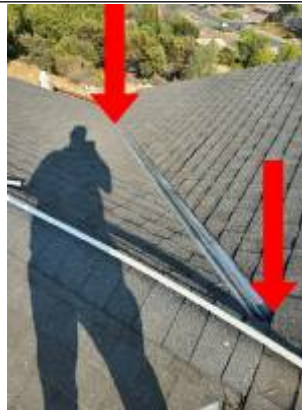
PVC Sprinklers are not to be of concerned as no damage has been observed on the roof even if they have been ran for "Potential Fire"

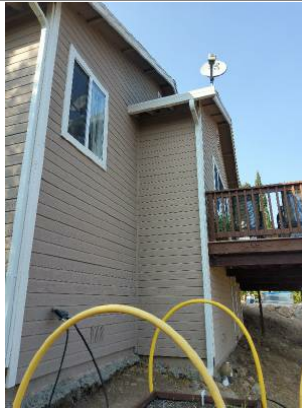
I wish i took a better picture up close of the quality trim job but its on video. the butt joints on the lap siding is what i took notice. You always want to leave a little gap most chalk for expansion / contraction however he flashed it at each three boards for expansion and contraction movements very smart. no worry of leaks and also allows the boards to breath and not buckle.

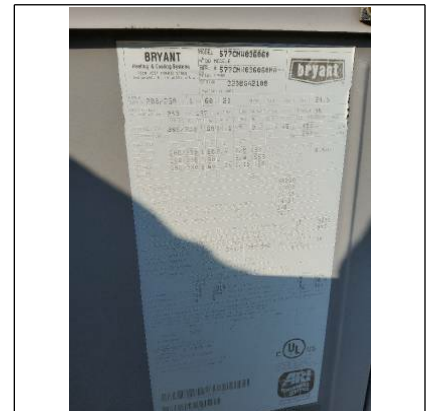
there is flashing so there is no way of condensation getting into the unit, but would recommend extending pvc with cuppling and running a 90 turn on side of unit

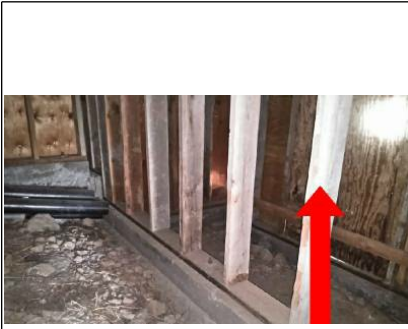
These were once used as the foundation forms of the house there is nothing wrong with doing this as there is so much structural support beyond what a post and pier would provide.
