# Home Inspection Report

1112 5th St, Lakeport , CA 95453

Tuesday May 3, 2022

Dustin Wallace General Contractor Home Inspections  
16496 Main St.  
Lower Lake, CA 95457  
(707) 293-6307  
dustinjameswallace1985@gmail.com

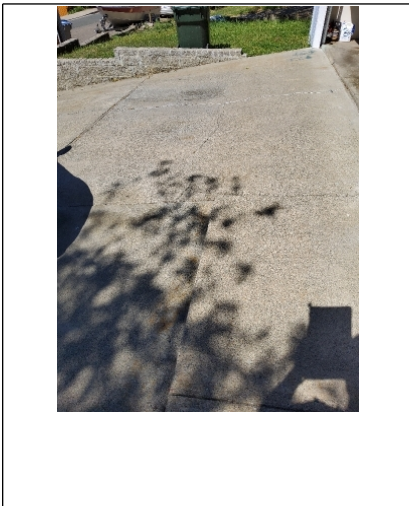
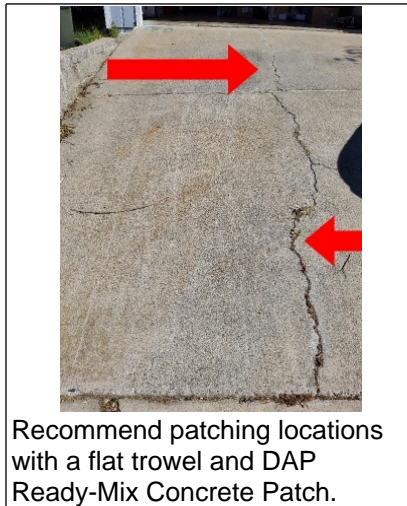
☐ Satisfactory ☒ Marginal ☐ Poor ☐ Settling Cracks ☐ Typical cracks ☐ Pitched towards home  
☐ Trip hazard ☒ Fill cracks and seal

Recommend patching locations  
with a flat trowel and DAP  
Ready-Mix Concrete Patch.

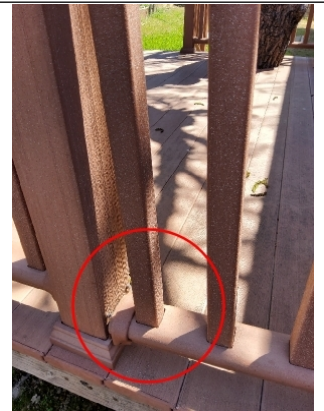
Composite railing is loose and should be properly fastened to the post.

Composite railings from Trex have always had issues especially during this time. This is one of the first generations of composite and have since improved significantly. The problem with composite is its easy for screws to strip and split the composite without an ease of repair.

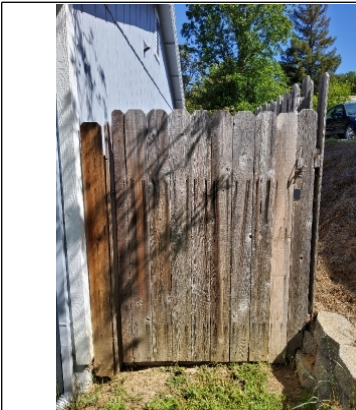
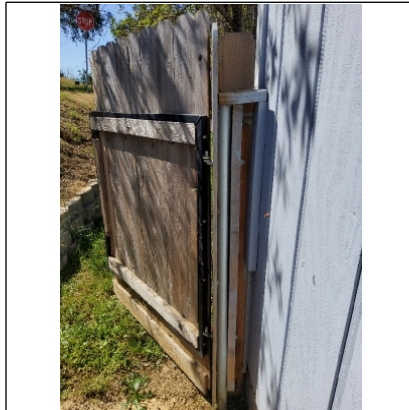
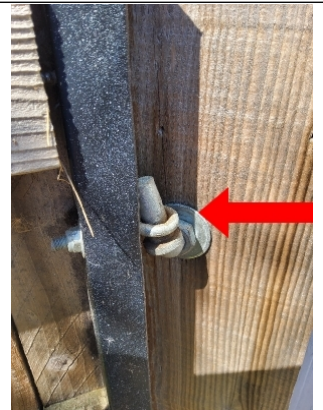
Loose gate hinge. Will have to plumb up straight and tighten nut on other side.

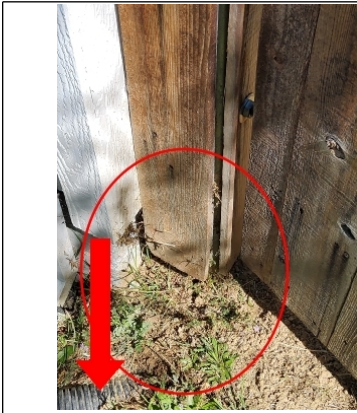
Post and footing has loosened. Recommend additional post mortar mix 60 Lb Quikcrete applied around the base of the post. May have to rerout drain tile (arrow) Make sure to use a 4' level and temporarily brace post prior to digging out old footing.

Recommend replacing rusted gate latch

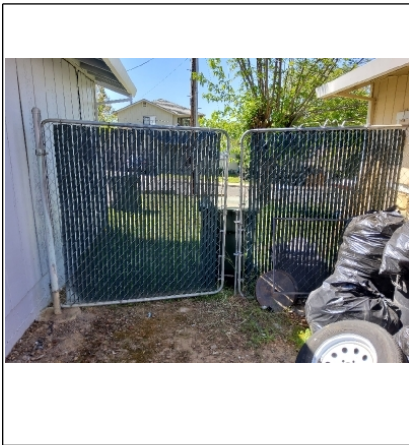
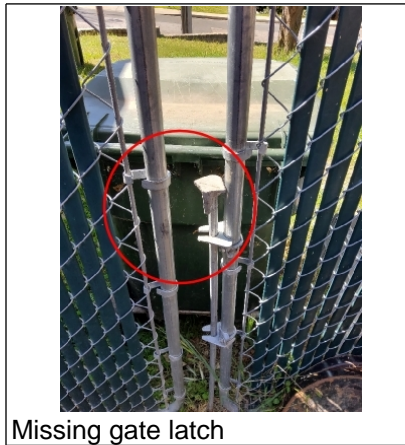
Missing gate latch

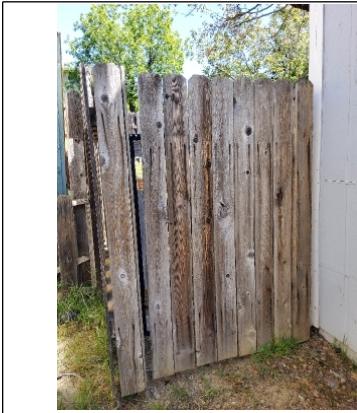
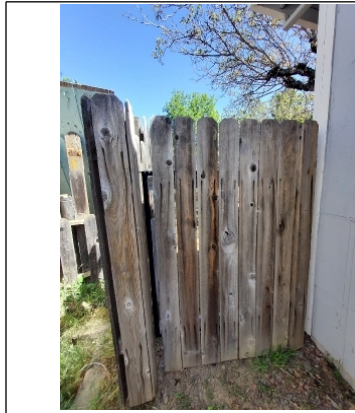
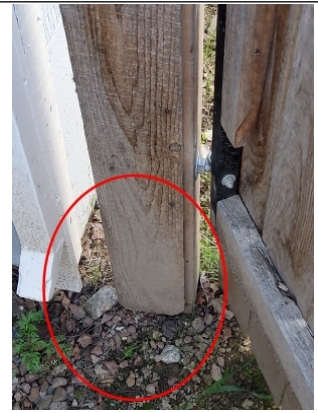
Post and footing has loosened. Recommend additional post mortar mix 60 Lb Quikcrete applied around the base of the post. Make sure to use a 4' level and temporarily brace post prior to digging out old footing.

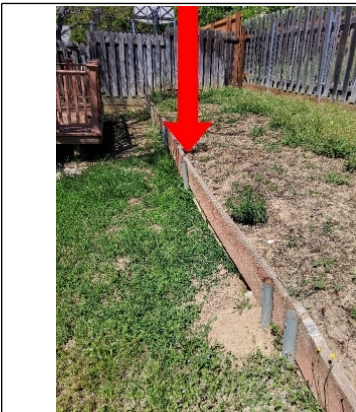
This is a landscaping retaining wall and poses no threat to the home perimeter or deck if fails. If a new retaining wall is desired it does not need to be engineered as it is less than 4' high.

Disconnected pressure treated plank members recommend fastening addition 2x8 treated in front of it.

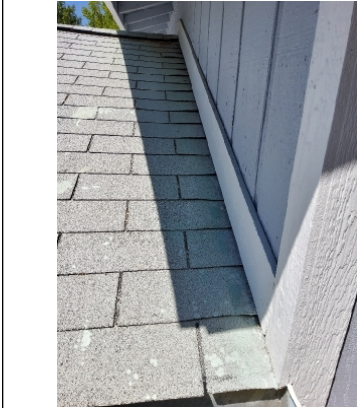
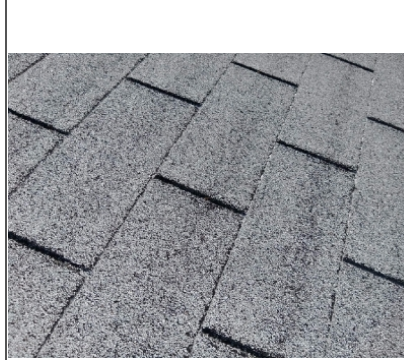
Fiberglass is showing around the base of the shingles. Expect to replace the roof in 5-7 years.

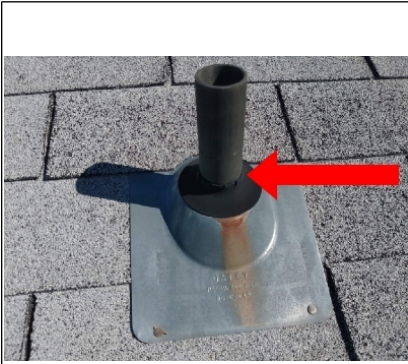
Storm collar needs to be replaced.

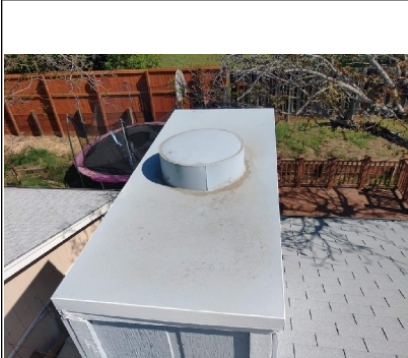
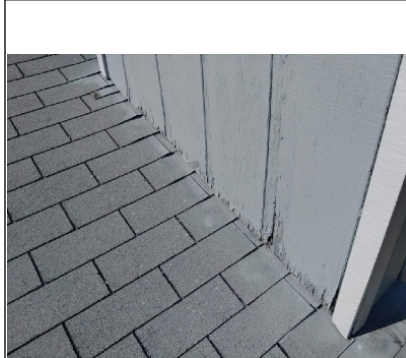
Siding is showing some damage at the base. Recommend installing 1x4 trim member 1" off the flashing. (Reference: Roof: flashing)

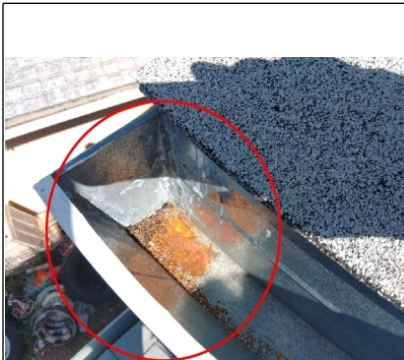
Rust is evident.

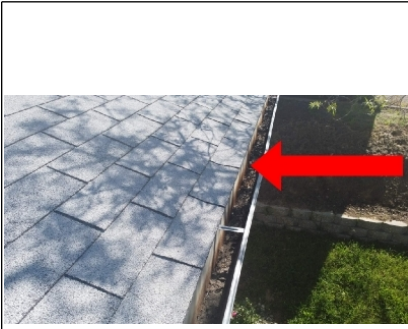
Rust is evident.

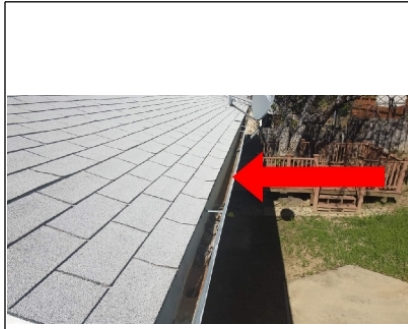
Rust is evident.

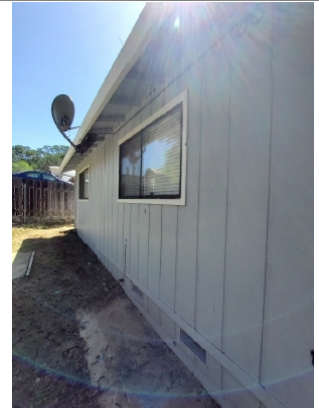
**Left Side Frame Members:** The left portion of the house both the cripple wall and frame members are out of plumb ("level"). I did not see any concerns with the perimeter foundation wall at this location and I believe that the cripple wall members were out of plumb at the initial construction phase after installing the mudsill. I do not believe this is from

movement as there is no evidence to show concerns of movement with the perimeter wall structure like vertical, piercing or horizontal cracks. What happened was the builder never plumb lined that left side of the wall and the frame members got out of plumb when applying to bottom plate member above the subfloor. I do not believe this is of concern that is worth addressing. That section did have replaced T1-11 siding as the width also is less then 8' between both sections and has a different grain and appearance. In the end, I do not find this to be worth addressing as the cost will be significant and the reward will be unnoticed.

Left side of house is reference location for 4' level plumb check.

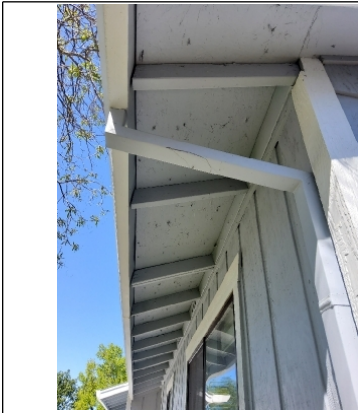
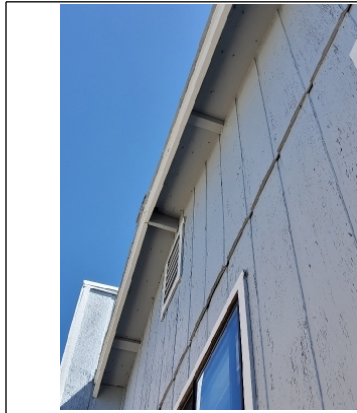
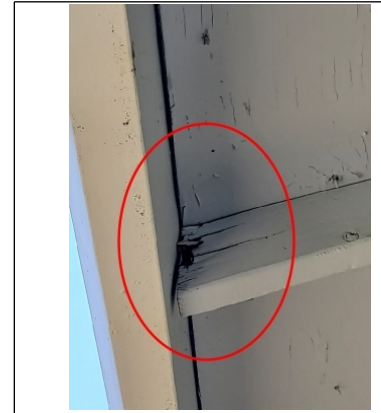
Moisture damage truss tail.

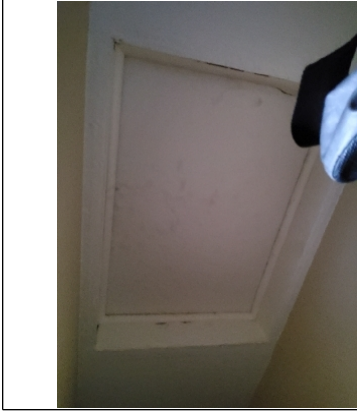
Thermal gun shows 96.1 Degrees on ceiling insulation.

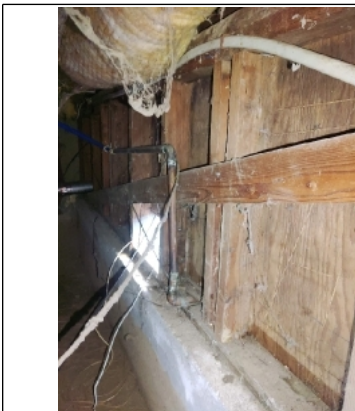
Level is placed on the left side of the home with regards to the cripple wall to confirm it is out of level.

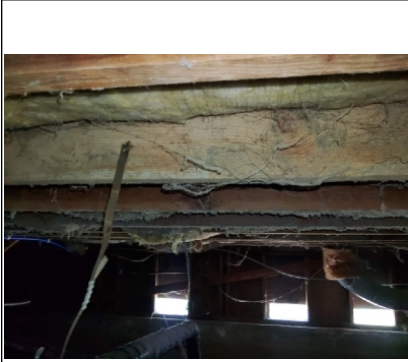
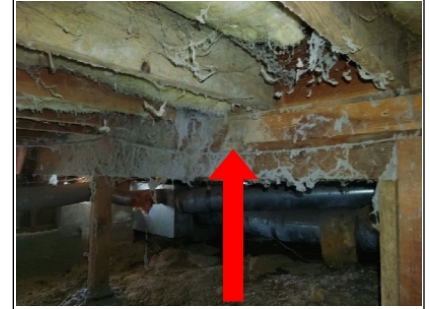
As mentioned the ducting needs to be further examined and tested for leaks by licensed HVAC contractor.

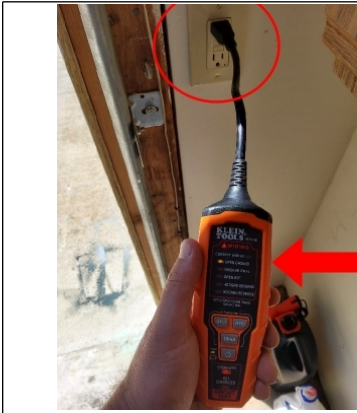
Electrical outlet shows open ground. It is a GFCI and will not produce an electrical shock but should be repaired.

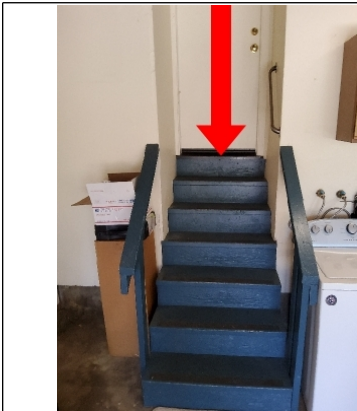
Missing 36" landing at door level. This was not required in 1980 and just cannot be fixed. Installing a landing will take room away from car to park in the garage and your head would hit the wall. The roof line also cannot be changed. Leave as is nothing can be done.
