# Home Inspection Report

5330 Lakeshore Blvd #16, Lakeport, CA 95453

Tuesday August 15, 2023

3233

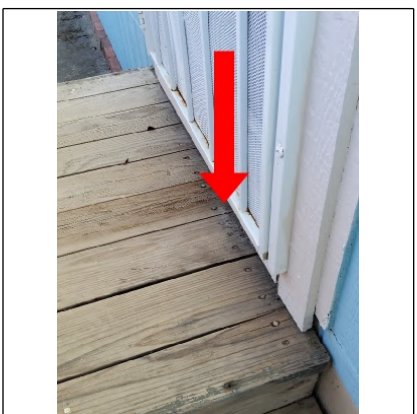
Joist span should not exceed 2' on center when 1-1/2" wood tread members are used.

Recommend removing loose nails and installing a new joist member with 2x6 Simpson Strong-Tie hangers and replace nails with 4" exterior screws.

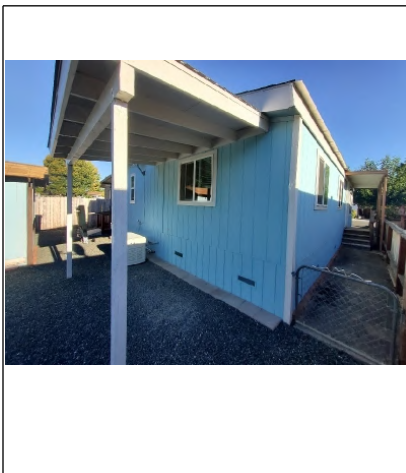
Slight warping and moisture damage is evident on siding.

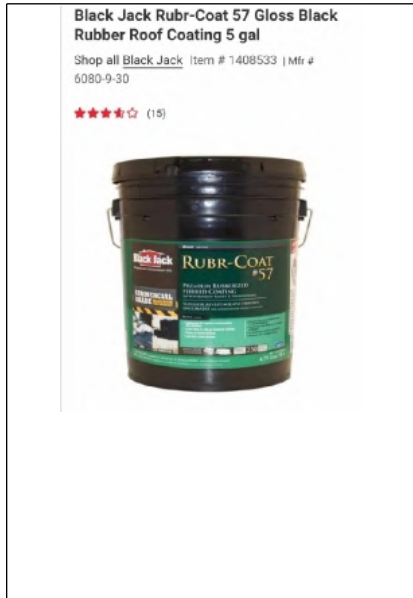
Henry's roof sealant was applied for flashing. This would have to be reapplied every 3-years I would recommend resealing it with a much better product like Black Jack Rubr-Coat.

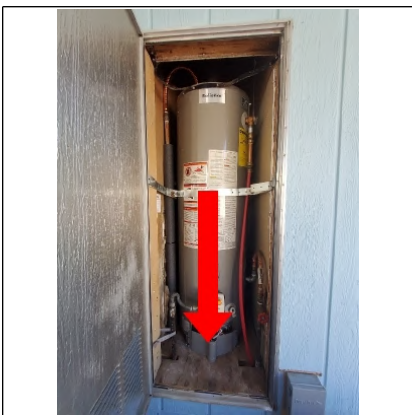
Water heater is not technically in a living area but as at the same floor level as the home. This is not required but I would recommend a drain pan be installed below the water heater with a drain line being stubbed to the exterior.

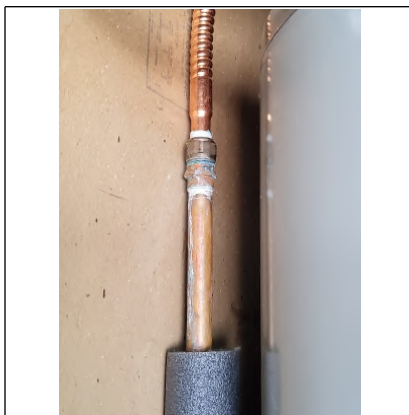
Slight oxidation and corrosion is evident.

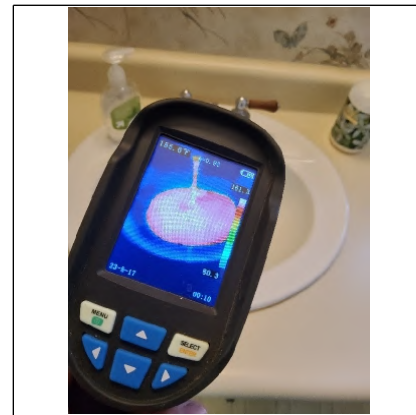
Thermal Imager shows water temperature is 155.6 Degrees F I would suggest reducing the temperature of the water heater. The standard temperature range is 115 Degrees F to 120 Degrees F.

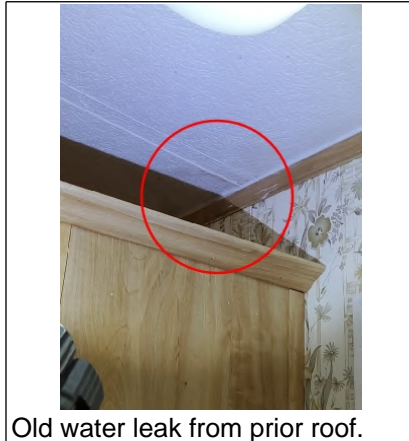
Old water leak from prior roof.

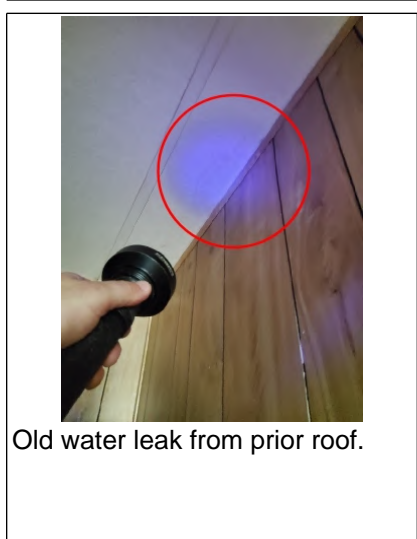
Old water leak from prior roof.

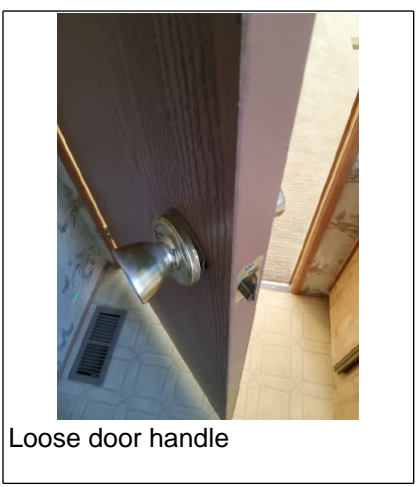
Loose door handle

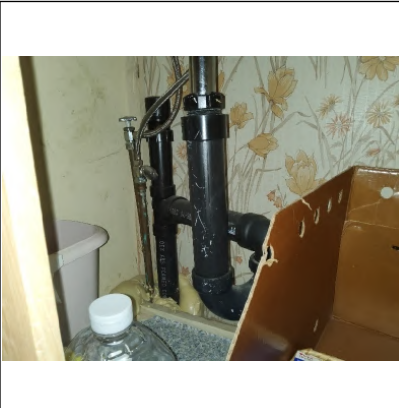
Disconnected drain stop

Recommend using WD40 to ease the operation of the shower door.
