Home Inspection Report

4280 Lakeshore Blvd, Lakeport, CA 95453

Saturday September 9, 2023

Manufactured Home Roof

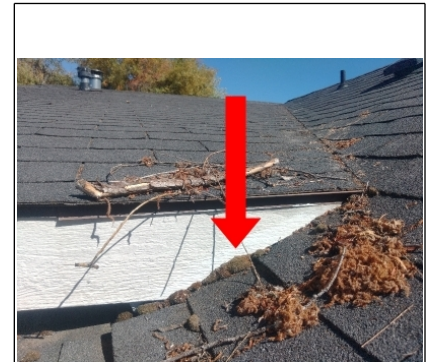
Fascia should not be sitting directly on roof shingles without being flashed underneath the fascia member. Recommend removing the "Lichens" and apply a thick bead of sealant on the fascia member and shingles.

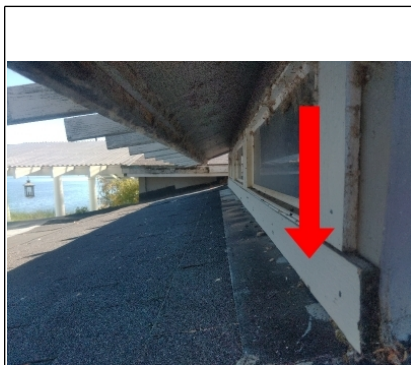
when replacing the roof I would recommend replacing the galvanized flashing and moisture damaged trim member. (This is fine for this winter)

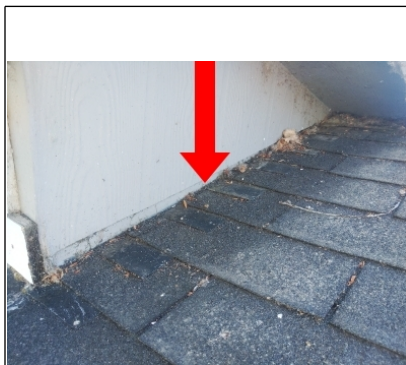
Step flashing is fine for winter

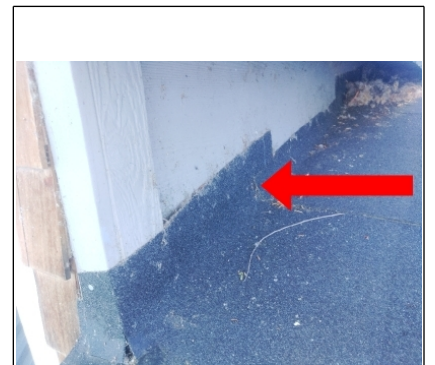
This is incorrect application and must be addressed before winter. Recommend removing existing roll asphalt and have the shingles underneath and properly evaluated. After, recommend installing galvanized step flashing and install a 1x4 primed trim member across the newly installed flashing 1" of clearance from the roofing and chalk above the 1x4".

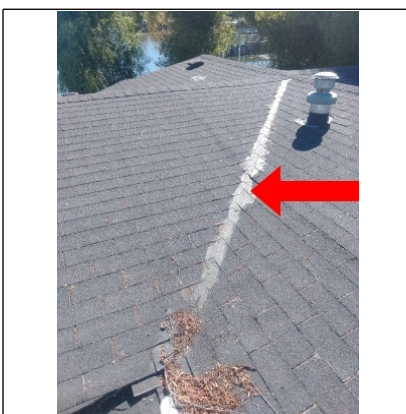
Roof sealant was applied on valley location and for this winter should be resealed with a better sealant product

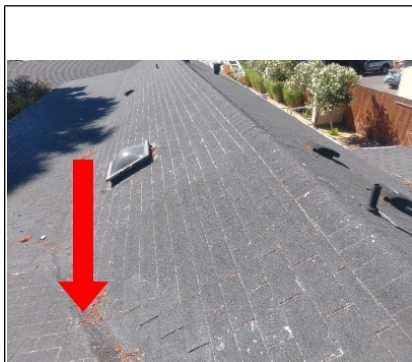
Shingles were replaced. However the valley is not properly flashed and is only for only a temporary repair. Correct application would have been to remove the shingles on the otherside of the valley so they could overlap or weave.

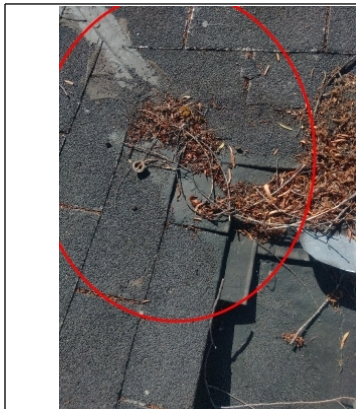
Exposed nail holes are evident on shingles. This area should be properly nailed off and apply sealant again going down the valley. This is a roof leak location.

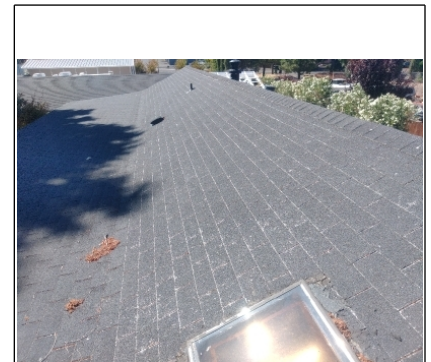
The roof does need to be replaced but can get through this winter if properly patched.

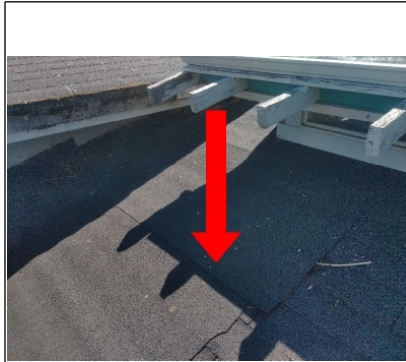
Two layers of roofing should not be installed on manufactured homes. Recommending having the roll asphalt removed and properly repaired by a Licensed C39 Roofing Contractor or Licensed General B Contractor.

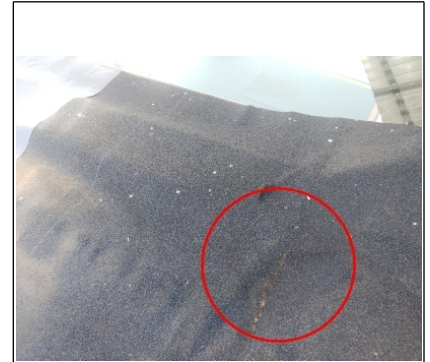
This is not a correct application of roll asphalt and must be removed and properly done before this winter. This location will have standing water and ponding.

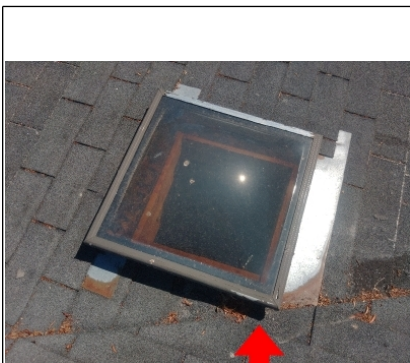
This area can be a concern with water intrusion underneath the flashing at the valley location.

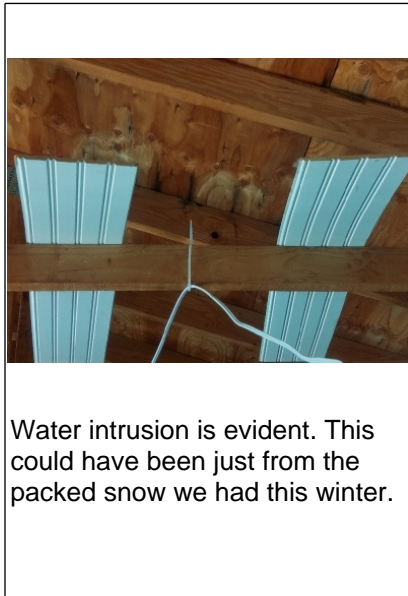
Water intrusion is evident. This could have been just from the packed snow we had this winter.

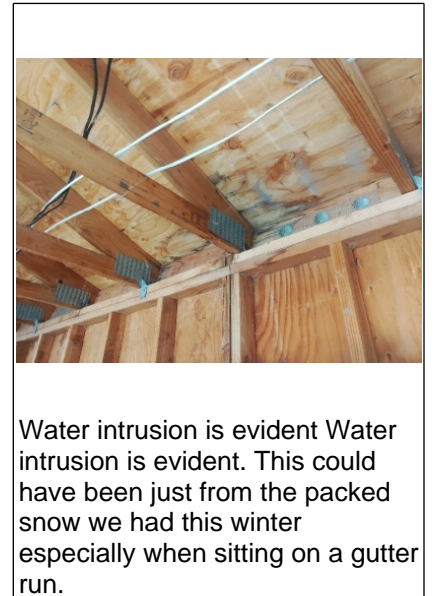
Water intrusion is evident. Water intrusion is evident. This could have been just from the packed snow we had this winter especially when sitting on a gutter run.
