# Home Inspection Report

2865 Nectorine Way, Clearlake Oaks, CA 95423

Monday August 10, 2020

143

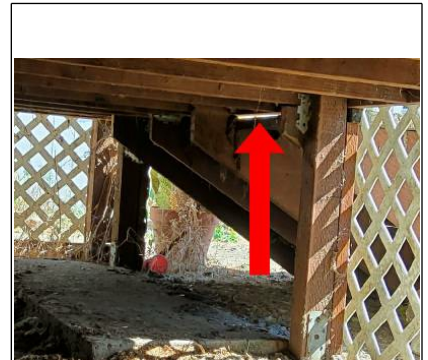
Missing riser for stairs needed for support of treads.

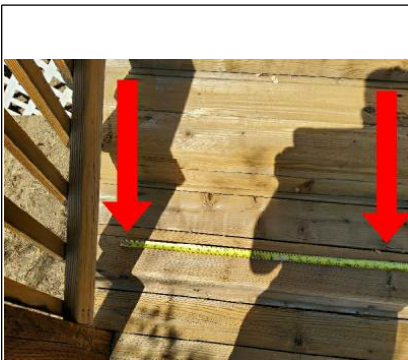
Span is 30 inches minimum requirement 24 inches for wood.

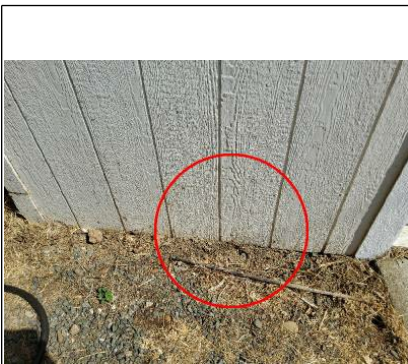
Improper clearance minimum six inches from contact.

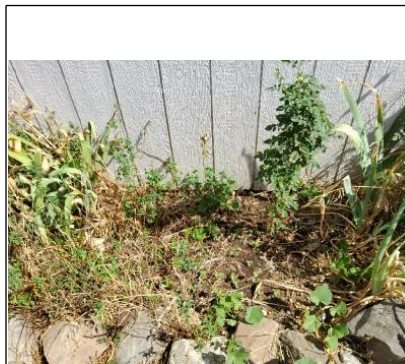
Minimum six inch clearance needed.

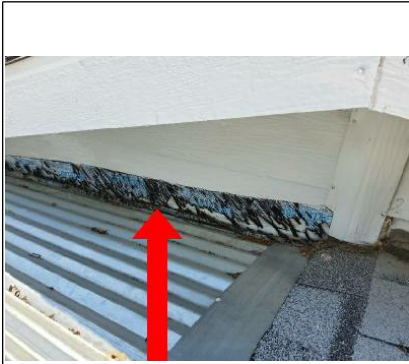
Possible leak issue. Not properly installed flashing.

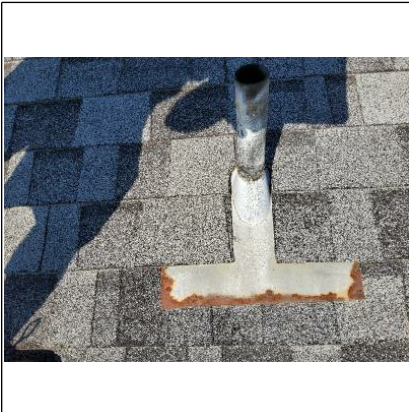
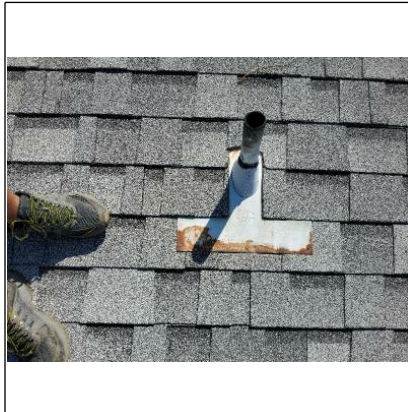
**Comments** Galvanized roof jacks rusting need to be replaced.

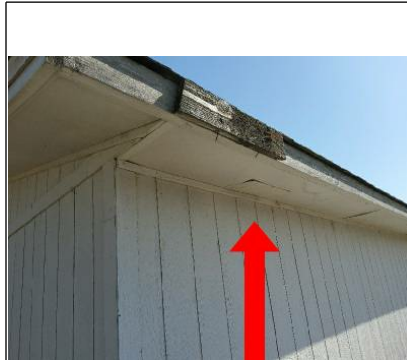
Water damage of possible roof leak. Both outbuilding and house need gutters.

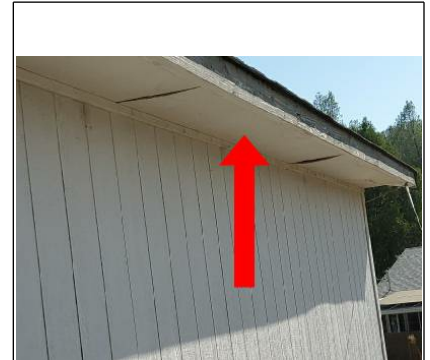
Rotted soffit. Water damage has been evident.

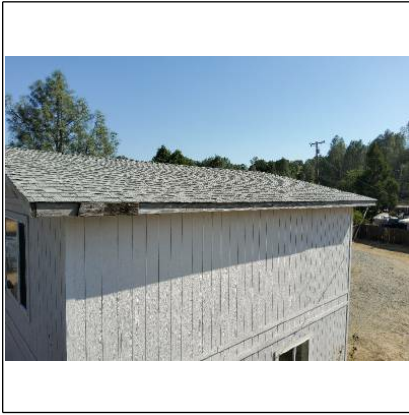
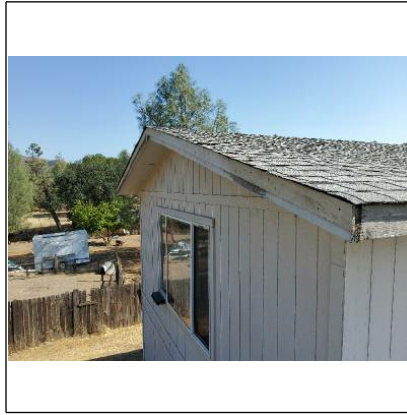
**Comments** Fascia rotted/damaged, recommend repair

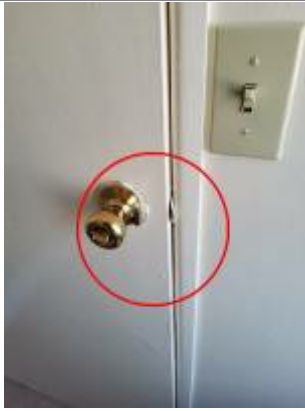
Door does not close properly.  
Recommend a three inch screw  
through the door jamb through  
the trimmer for ease of access.
