# Home Inspection Report

8242 Point Dr, Kelseyville , CA 95451

Monday January 25, 2021

4445

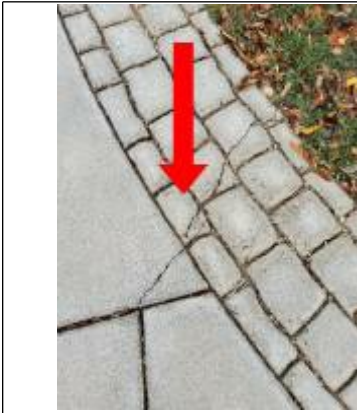
Non-Piercing Settling Crack

Standard settling crack did not pierce through less than 1/4 of inch wide.

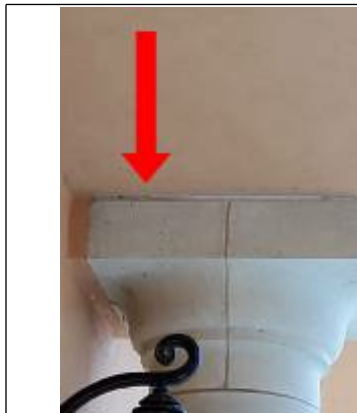
(Right Column) Crack can be regouted

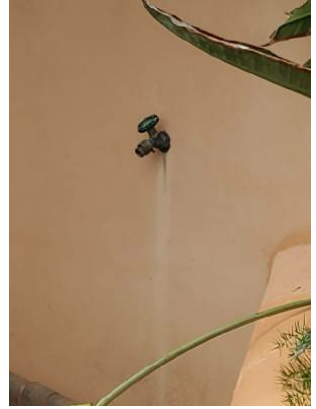
Replace Hose Bib its Leaking  
(location between right porch and garage )

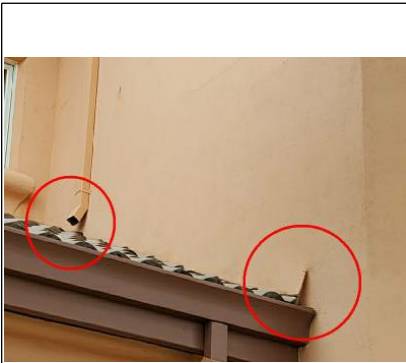
Properly flashed no evidence of any stucco cracks this is important to note this because this is a common area where you would see cracks especially with the close proximity to the 2nd level downspout.

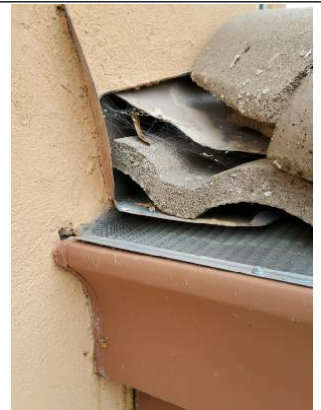
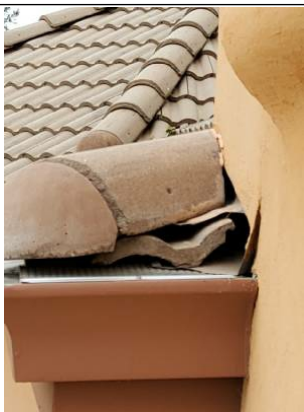
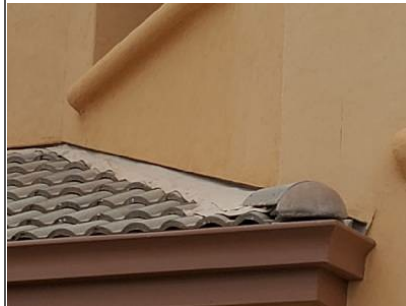
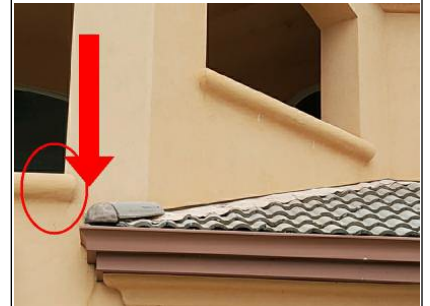
Valley above right porch needs to be flashed. This is exposed wood.

Recommend another 22 L-Flashing Aluminum like the other that's there to collect the water that protrudes down the bottom sill (Circle)

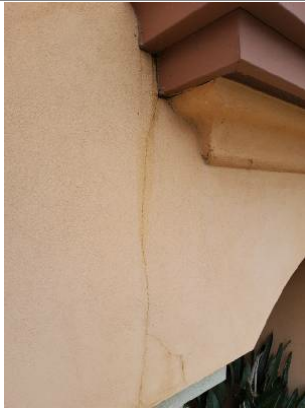
This is referenced to previous slide with regards to flashing

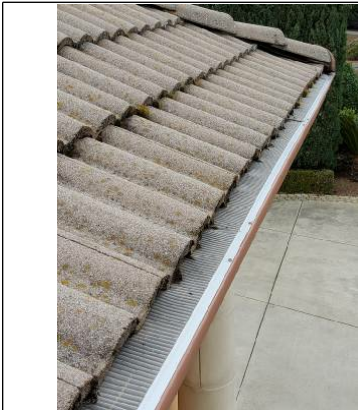
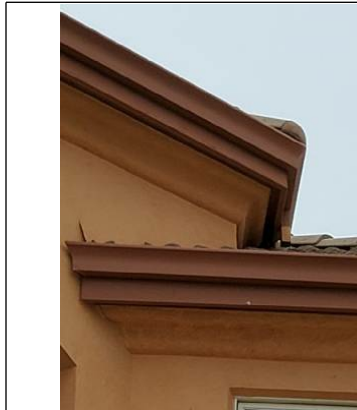
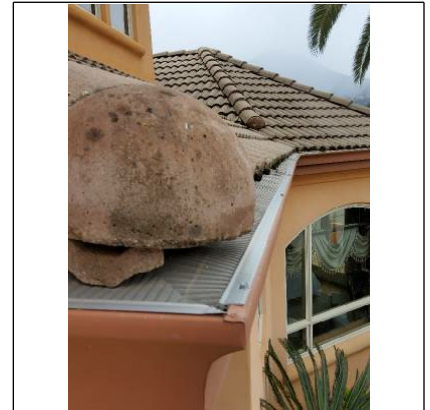
Missing Bracket for downspout  
and can be refasted to gutter

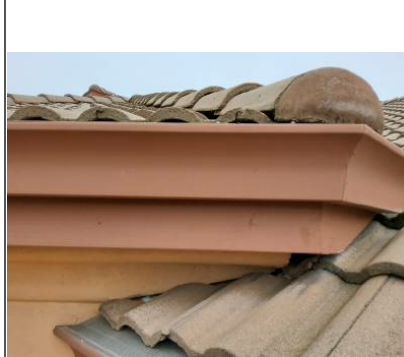
This is the only fascia 2x6 that's not completely flush together, this is very minor but can be fixed by clamping together and running a counter screw from back side after predrill (arrow)

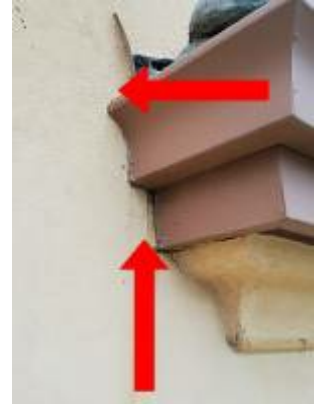
This has been referenced in Roof Portion with regards to Flashing (Location Entry Right Side). Water protruded behind the fascia the flashing could have extended a little past, but like mentioning before (Left Arrow) another angle step flashing could be installed and the Fascia could be replaced on corner if needed.

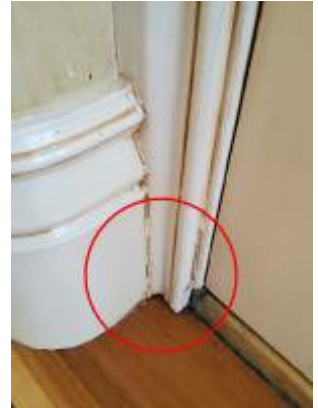
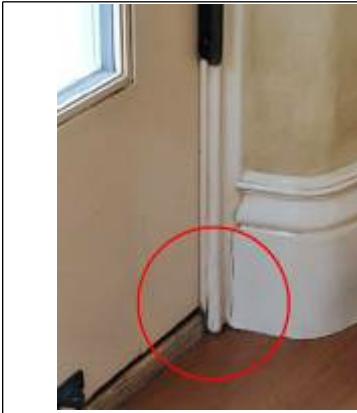
Moisture damaged areas on trim, casing and bottom wood interior sill. This would be expected on this side of the house based on outside elements of back patio of home.

Both sides of trim of the door can be replaced with new bottom sill installed. I have contacted my cabinet guy with regards to possibly making a custom bottom sill for this door.

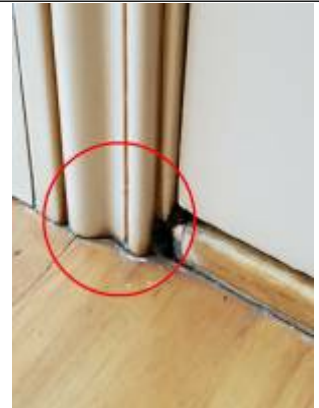
Moisture damaged areas on trim, casing and bottom wood interior sill. This would be expected on this side of the house based on outside elements of back patio of home.
