Home Inspection Report

20462 Powder Horn Dr., Hidden Valley Lake, CA 95467

Tuesday June 23, 2020

Dustin J. Wallace Construction and Home Inspections
16496 Main St.
Lower Lake, CA 95457
(707) 293-6307
dustinjameswallace1985@gmail.com

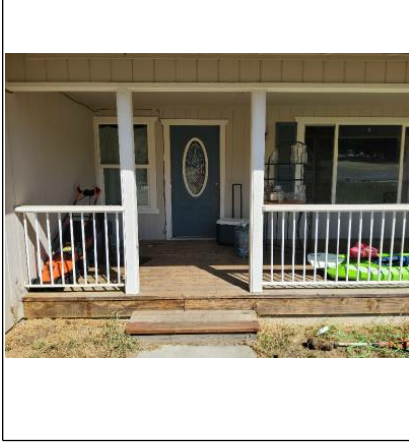
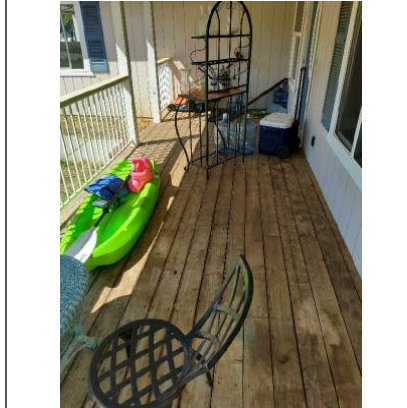
Nails need to be sunk.

Comments Recommend painting or treating the wood on deck/porch

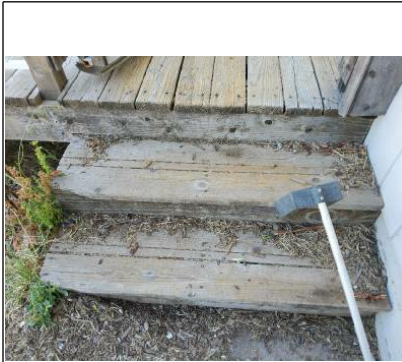
Wood damage on steps all nails need to be sunk

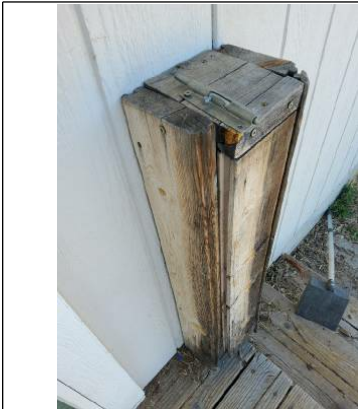
Not properly built. should be the side that is hinged. Lags can be ran to the stud behind siding,

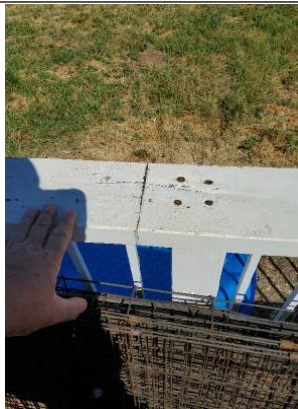
Loose should be reattached with lags from rim into 4x4 refer to next photo

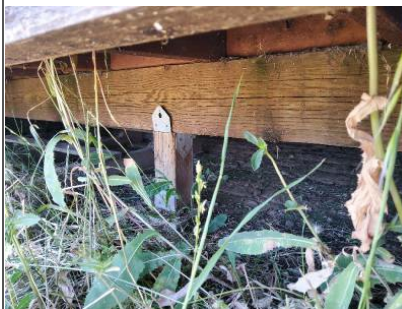
not properly nailed to girder. needs 1 1/4 tekko nails

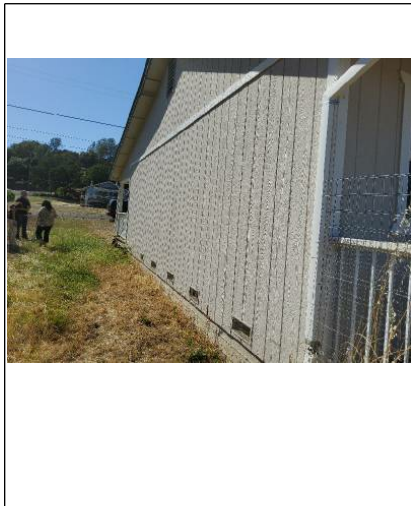
Siding below six inches. must have minimum six inches of clearance of ground.

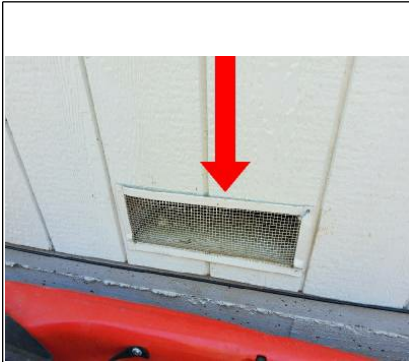
Broken bent vent

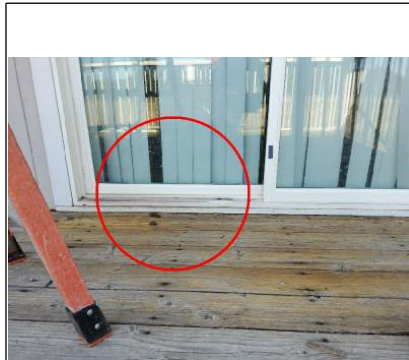
Some damage on bottom sill. also need to rechalk around the trim on inside butting the frame of slider.

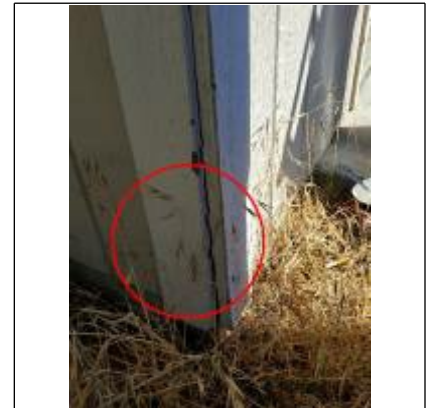
Rot damage, needs to be replaced

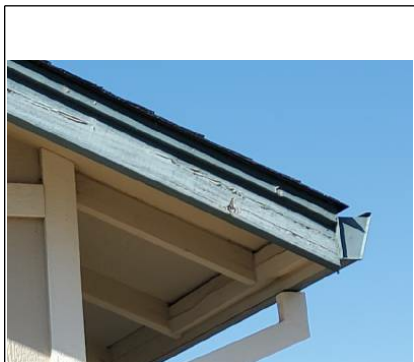
Wood damage on the sun side of fascia

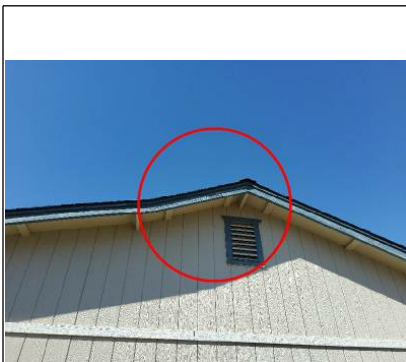
Top Fascia piece needs to be replaced

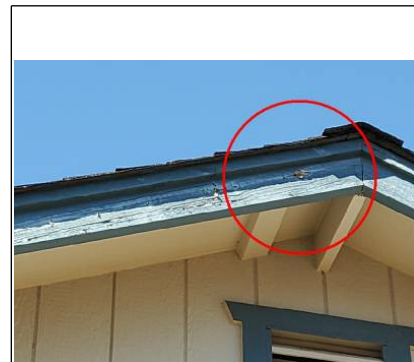
Wood damage from sun needs to be replaced

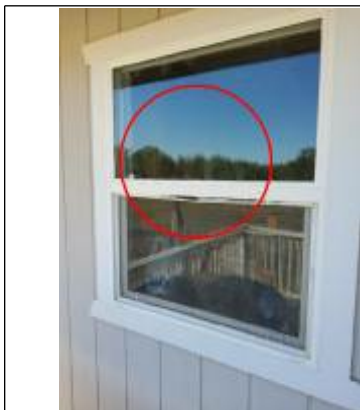
Screen damage

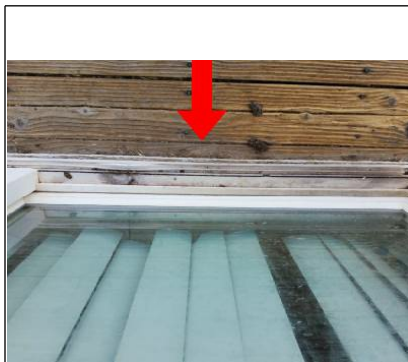
Bottom sill damage on back patio door

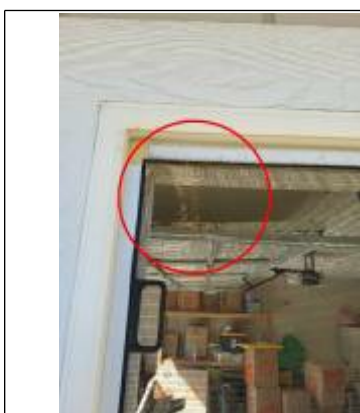
Broken Screen

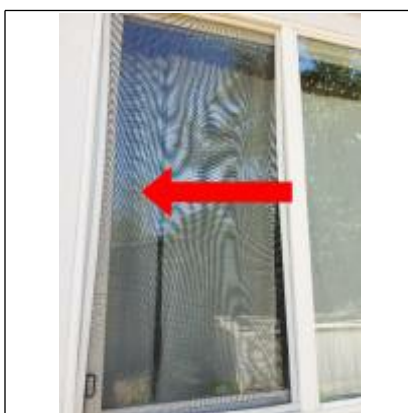
Bent screen

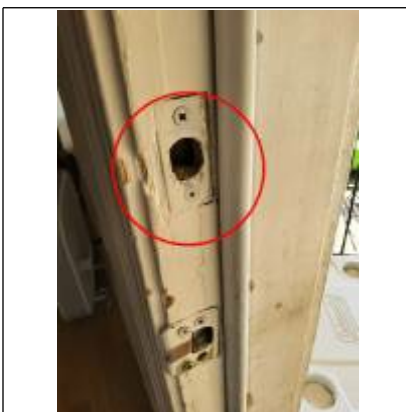
Not properly installed as door has issue closing

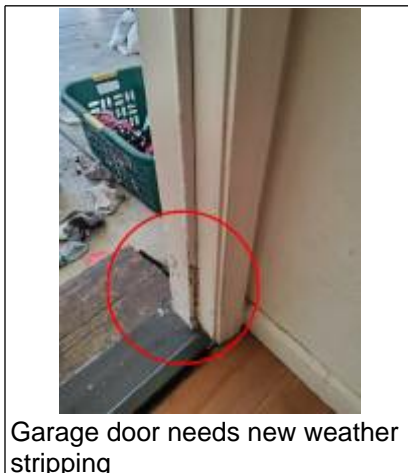
Garage door needs new weather stripping

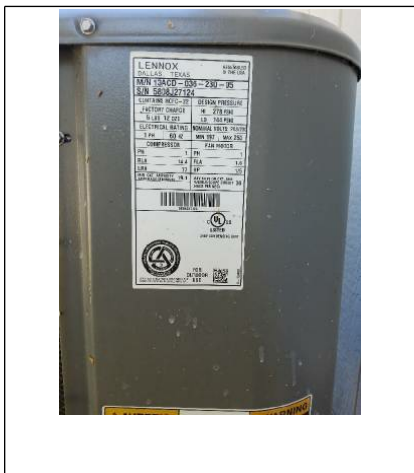
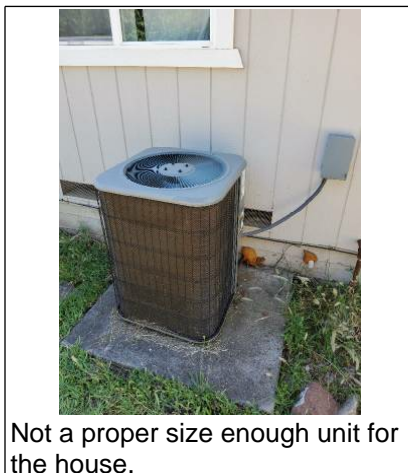
Condition Satisfactory Marginal **Poor** Cabinet/housing rusted

Comments Too small of unit for home

Not a proper size enough unit for the house.

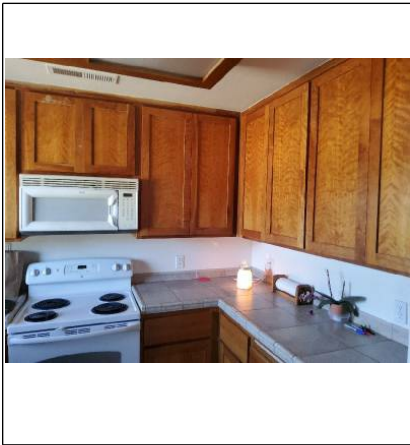
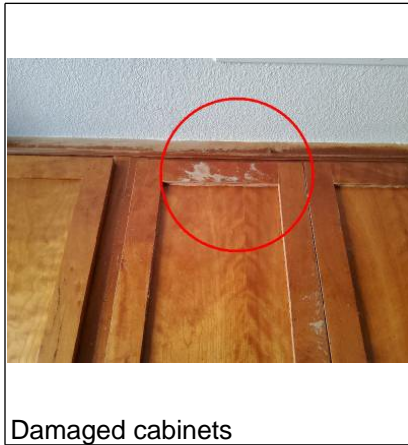
Comments Cabinet doors damaged recommend repair

Damaged cabinets

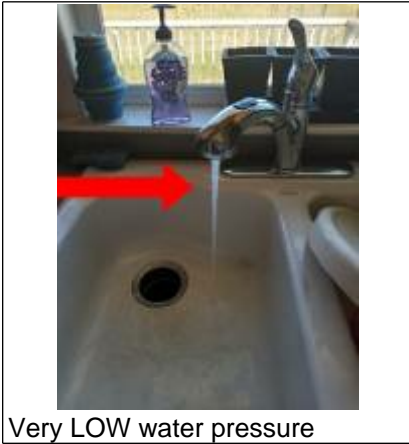
Very LOW water pressure

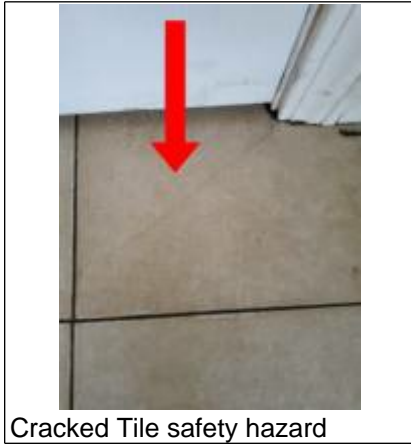
Cracked Tile safety hazard

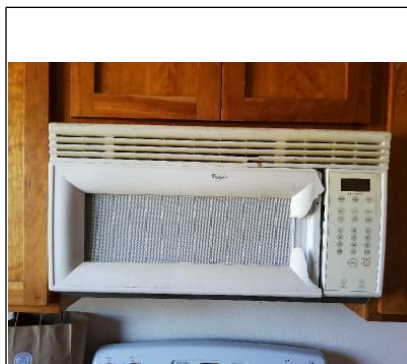
Must replace microwave.
Unacceptable

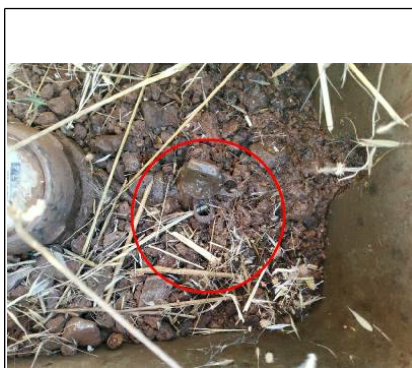
Leak has been found

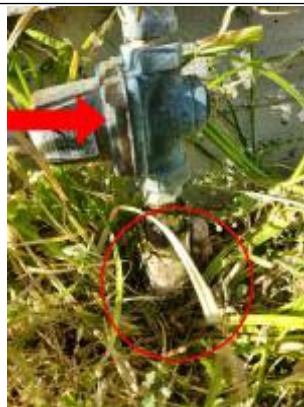
slow leak is also noticed at the connection. Furthermore, recommend replacing water pressure reducer as corrosion is shown this is the source of the issue with low water pressure in the house.

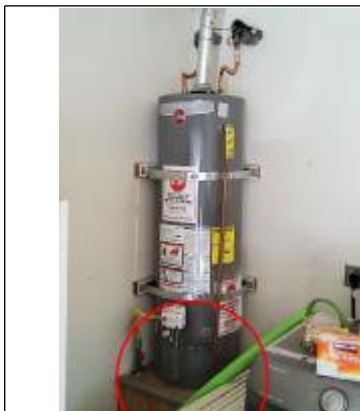
No over flow pan. This is an electrical hazard

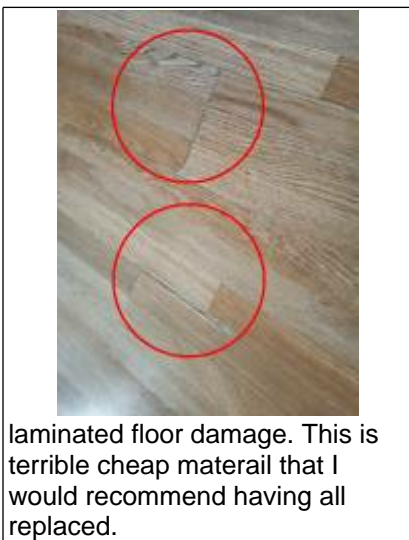
laminated floor damage. This is terrible cheap material that I would recommend having all replaced.

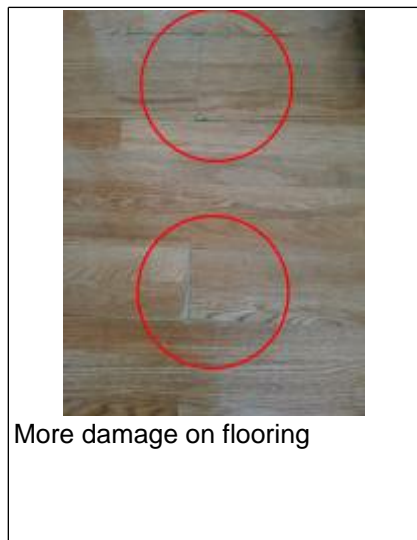
More damage on flooring

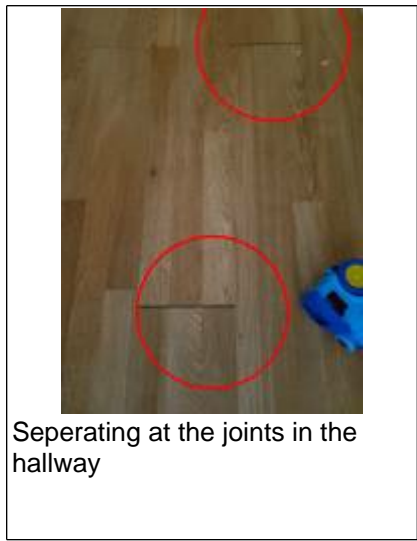
Seperating at the joints in the hallway

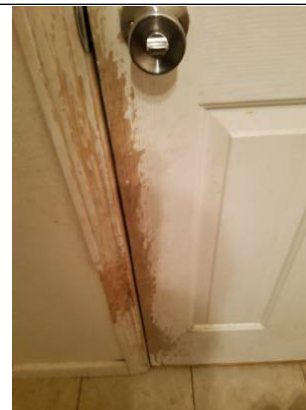
Door needs to be replaced damaged. Trim needs to be replaced as well.

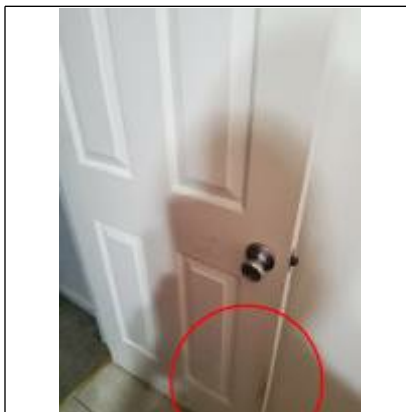
Damage on door

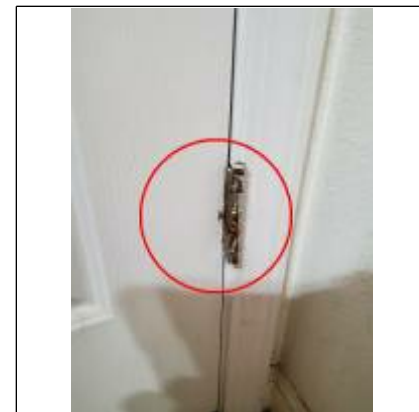
Rust on hinges in bathroom need to be replaced

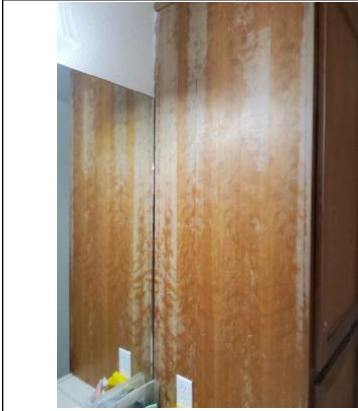
Cabinet is worn

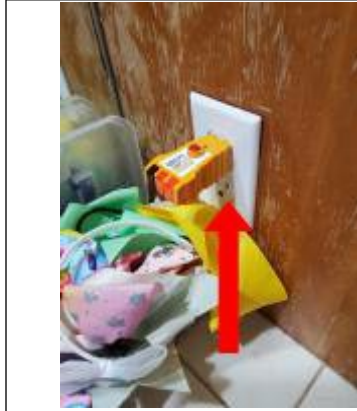
Not proper GFCI in Master Bathroom

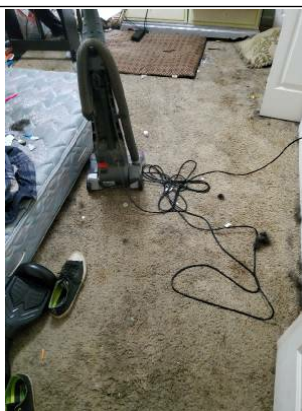
Carpet damage needs to be replaced

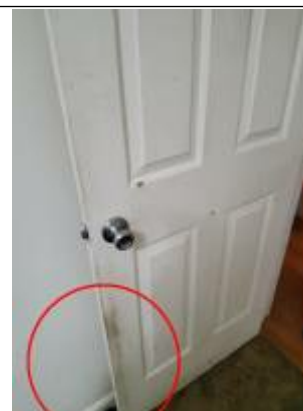
Door damage
