**DUSTIN WALLACE**  
Home Inspections  
& Construction

## Home Inspection Report

706 Ketch Court, Clearlake Oaks, CA 95423

Saturday October 10, 2020

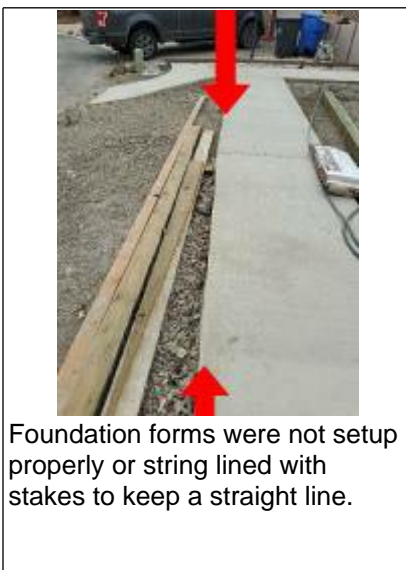
Foundation forms were not setup properly or string lined with stakes to keep a straight line.

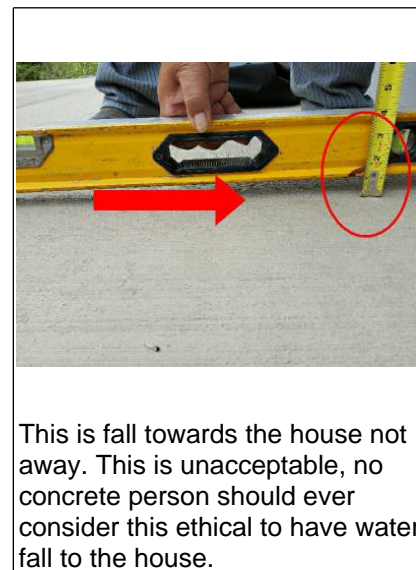
This is fall towards the house not away. This is unacceptable, no concrete person should ever consider this ethical to have water fall to the house.

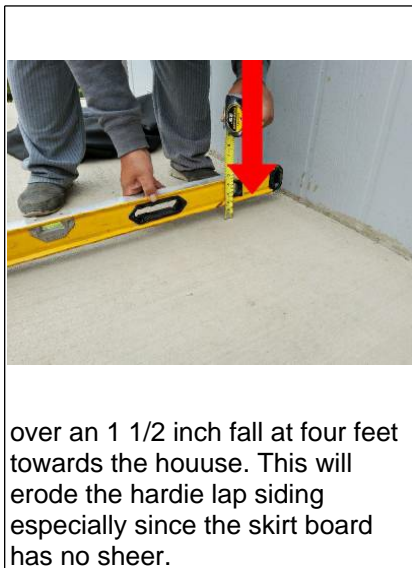
over an 1 1/2 inch fall at four feet towards the houuse. This will erode the hardie lap siding especially since the skirt board has no sheer.

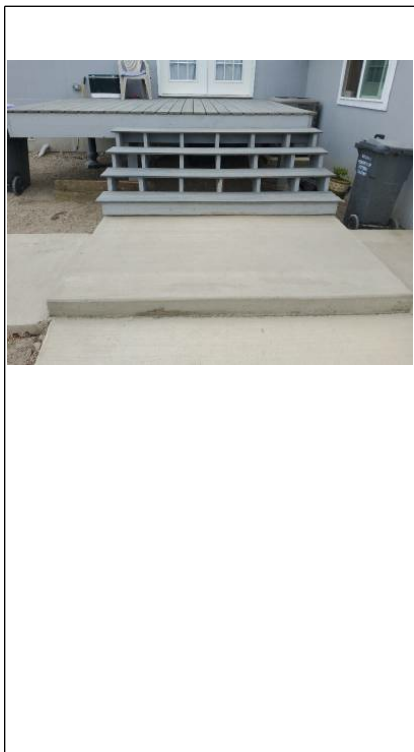
The contractor had no thought process when it came to installing a railing on this porch, or where to put the posts with the illegal location of this HVAC unit. If he was following the wrong way of doing posts on the back deck then he would have no room for the posts and rail. The proper way to do this is explained in the Railing portion of the report.

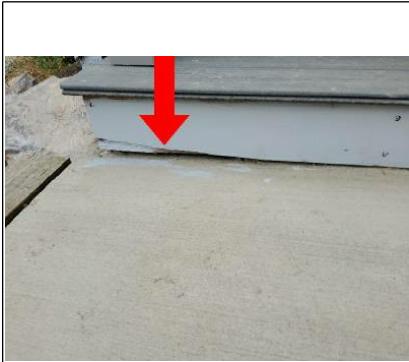
needs to be replaced

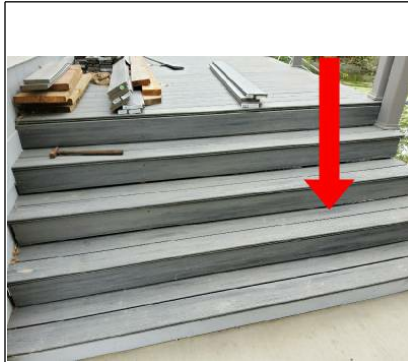
Same goes for this back deck. Deck treads need to be taken off and more stair stringers need to be installed for a 16 on center spacing.

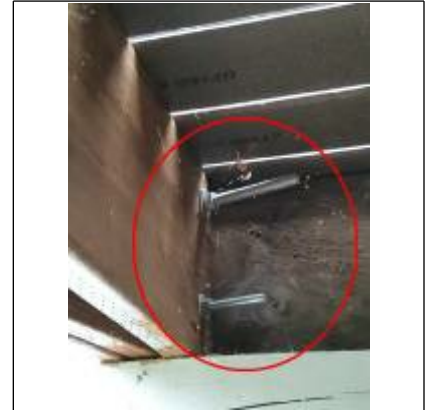
inside of the rim showing the nut and washer.

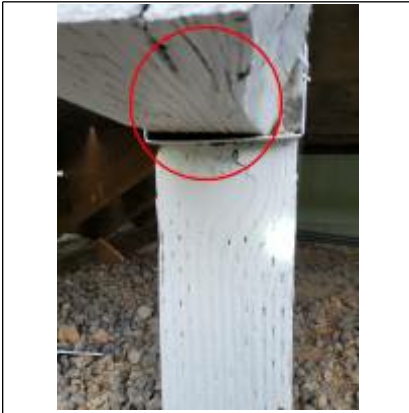
girder is not sitting directly on post mounting hardware / strong tie

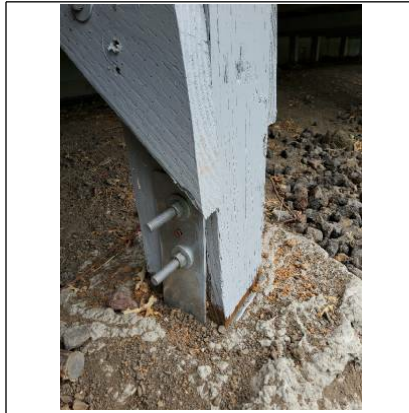
Again this needs to be lags not bolt and washers.

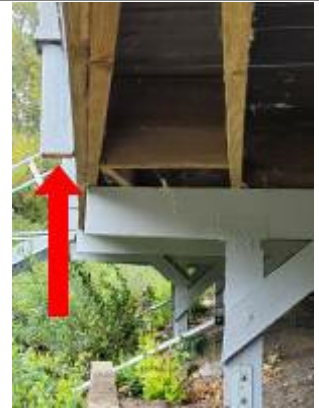
arrow refers to posts with no support. I would at this point recommend running another rim on other side of 4x4 and run deck planning long way opposite as installed now and it would better tie in posts and the appeal will look more finished as well.

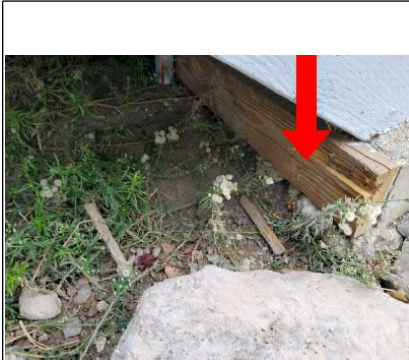
needs to be removed.

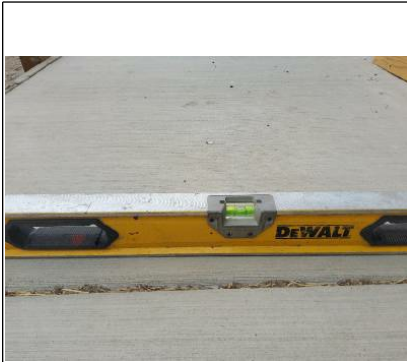
Not proper fall in front of crawl hole.

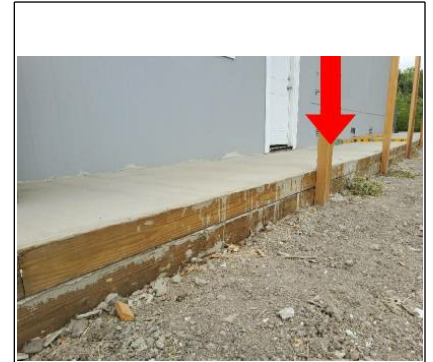
These foundation forms should be pulled as the general claimed he left them there for fencing? so he would go horizontal with the planking? This does not make any sense. the 2x4 horizontal piece would have been in between the posts so there is no point. Also this looks terrible! u can see this from the road.

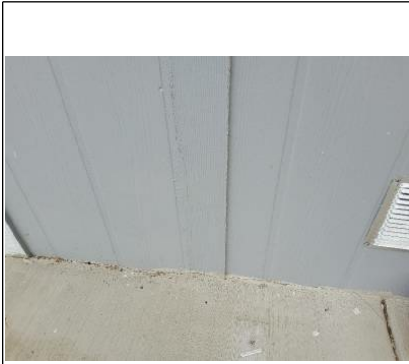
Concrete is poured over the siding! that is unacceptable

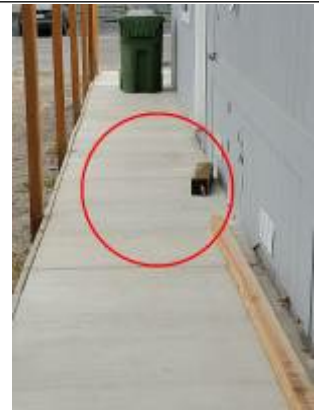
This is guaranteed to be a puddle area where water will just sit.

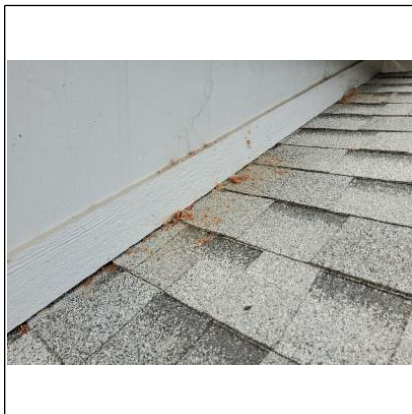
**Comments** Flashing should have been tucked under siding on the gable end. What he did is very common for people who reroof a house. However was the unit nailed off, before garage was attached being a manufactured home? Then he would have no choice then to do it this way with the 1x4.

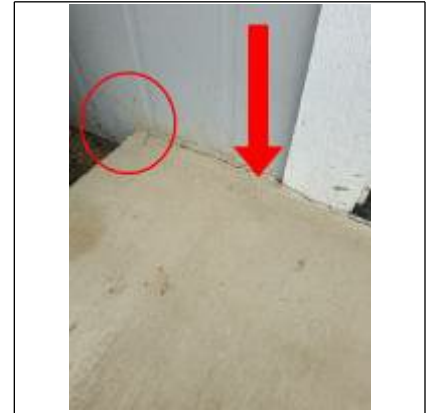
Refer to circle on this one... that its 4 inches atleast of concrete up against the hardie plank with no added support behind the siding!

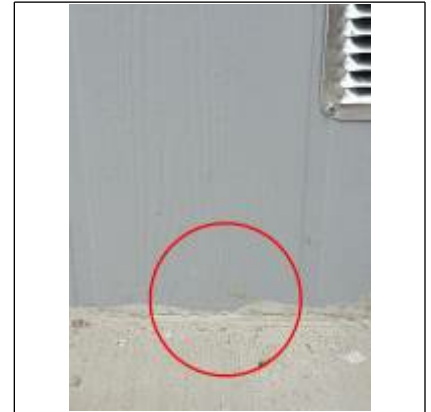
Concrete butting the siding this is a terrible HACK JOB!

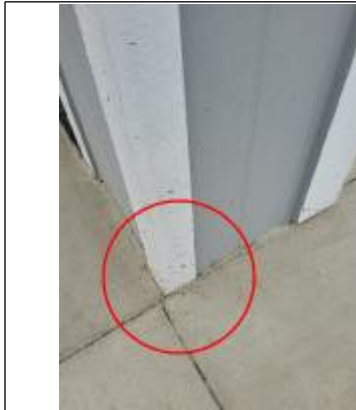
Wood trim should not be touching concrete this will rot.

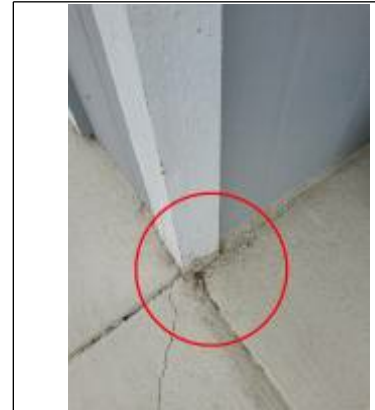
Wood trim is imbedded in the concrete, unacceptable!

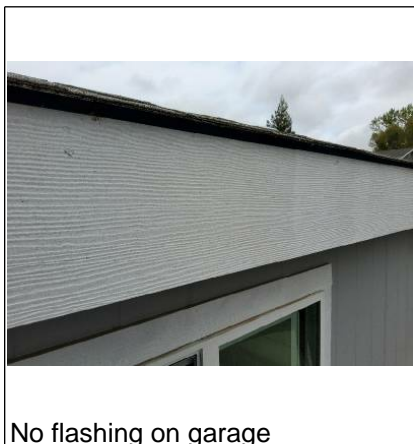
No flashing on the garage.

No flashing on garage

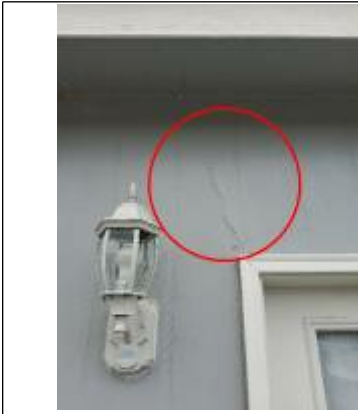
This is a cracked hardie plank that should have been replaced with a new sheet instead it was chalked and patched this will only look worse in the coming years.

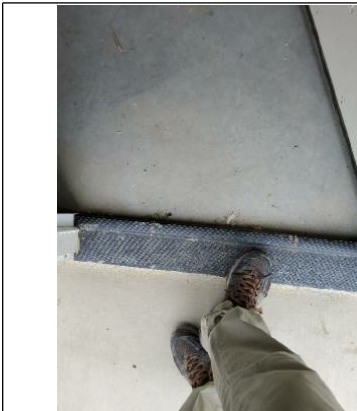
Missing tapcom on middle of sill. should predrill in concrete, use some solder and tighten sill to concrete slab. These two units were poured at the same time. This is not how you build a garage as there is no perimeter wall on this garage.

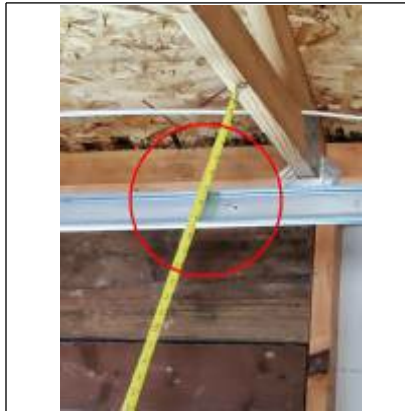
**Comments** the hardware for the garage is completely unacceptable. There is a 3.5 inch difference in height from one end to the other that would tweak the garage door. Refer to tape measure to see height difference between both sides.

Right side 7 inches from truss to top of garage door track.

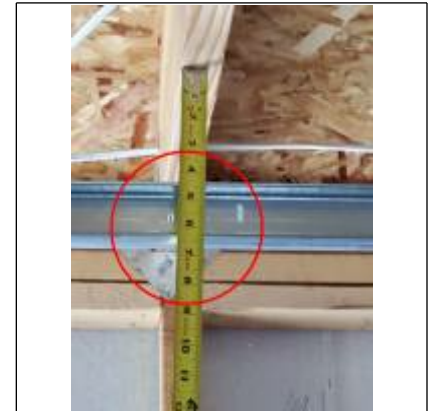
Left side 4.5 inches from truss to top of garage door track.

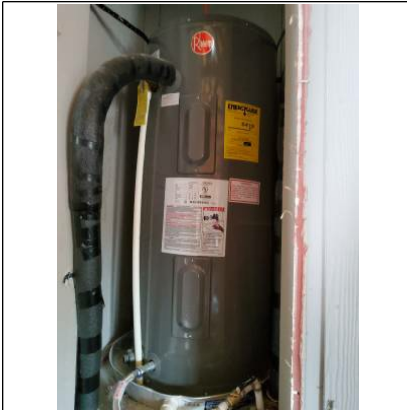
Missing earthquake straps.

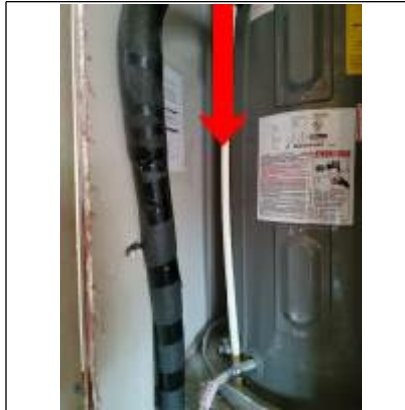
Relief valve is suppose to be copper.

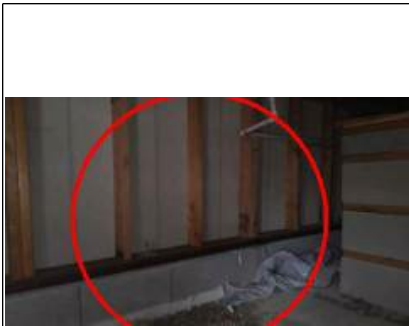
No sheerwall or vapor barrier on skirt board of unit.

**Comments** There is no vapor barrier between the Hardie and the framing of the perimeter foundation. There should be sheer and vapor barrier then hardie siding

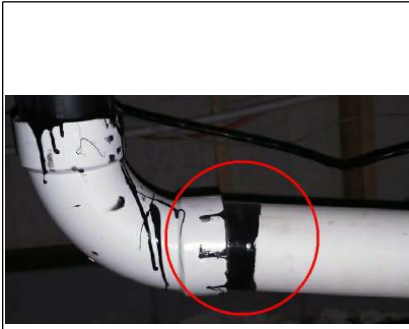
This is not securly attached as a leak or blow out is bound to happen.

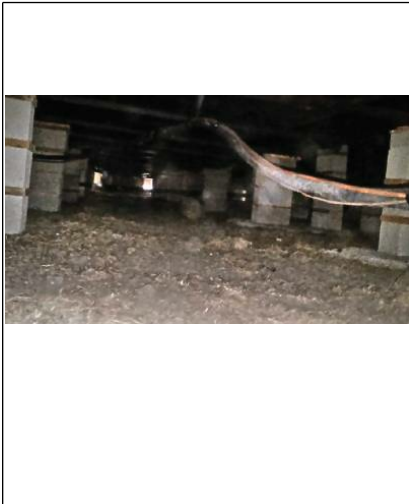
Duct tape and metal strap holding ducting not a correct way to install ducting.

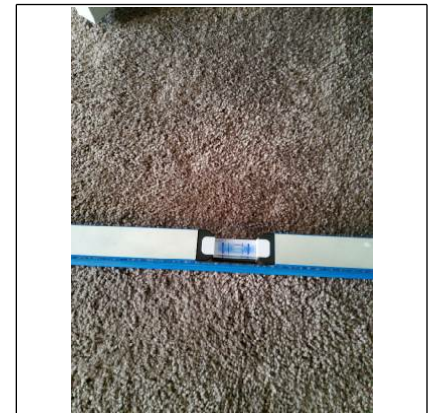
There is a huge dip where the two connected units meet as the level shows.
