Home Inspection Report

Vednesday August 4, 2021

Dustin Wallace General Contractor Home Inspections
16496 Main St.
Lower Lake, CA 95457
(707) 293-6307
dustinjameswallace1985@gmail.com

3232

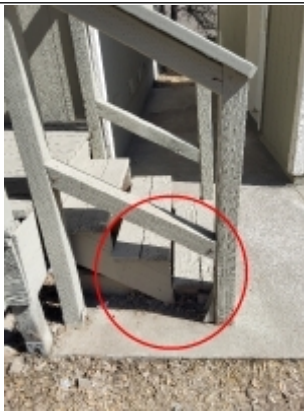
Staircase needs to be replaced as stair stringers have lost structural integrity and is not properly repaired.

Replace stringers not proper application

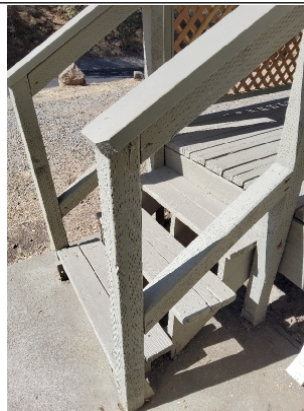
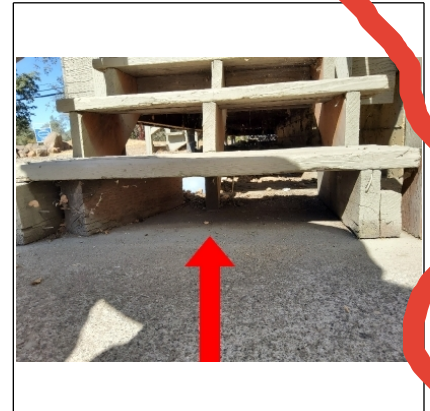
Missing Center Stair Stringer.
 With 1 1/2" wood tread members no more then 2ft on center can be applied.

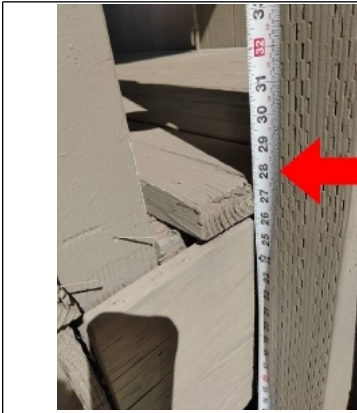
Less then 30 inches from tread to ground level does not require railing or 4" ballusters

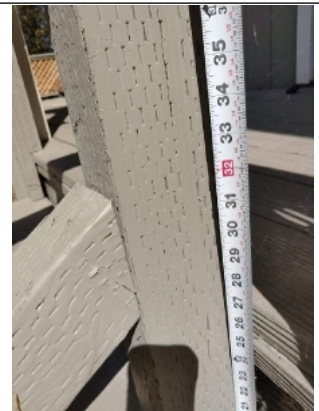
Less then 30 inches from tread to ground level does not require railing or 4" ballusters

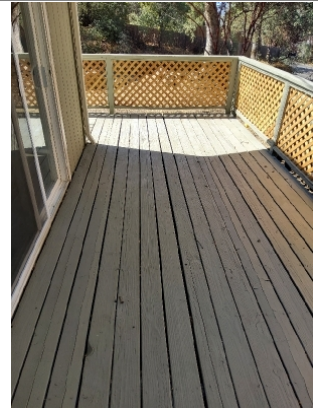
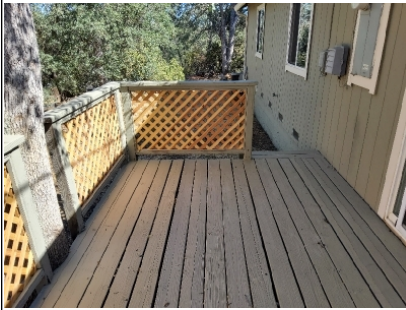
Not properly fastened column.
However, being Less then 30
inches from tread to ground level
does not require railing, column
or 4" ballusters

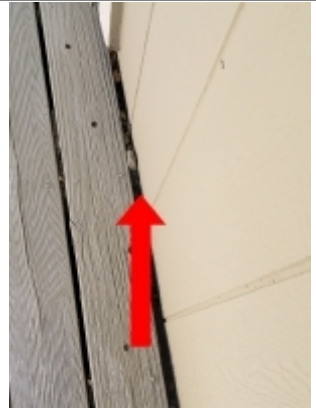
Builder should have installed flashing. Ledger Boards and joist members are pressure treated which is a positive. When replacing the plank members recommend flashing the ledger members and install a 2x4 trim member.

Refasten plank member on joist member with exterior deck screws.

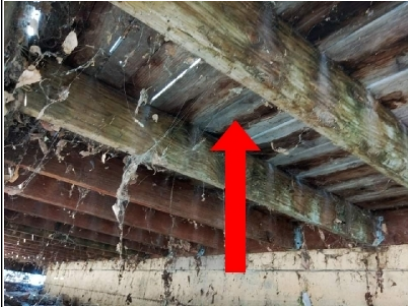
Slight Moisture Damage
underneath planking members.

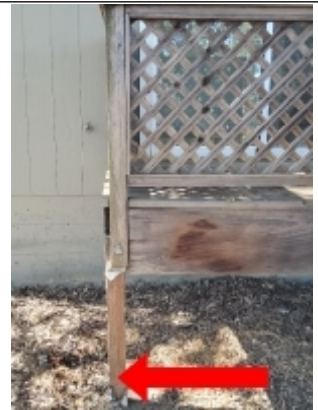
Not properly plumb. Recommend releveling column.

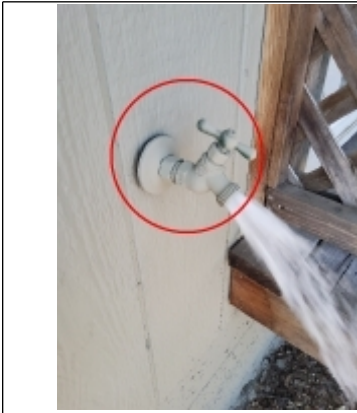
Loose Hose Bib

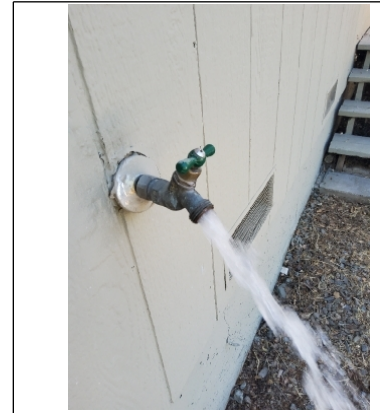
Loose Hose Bib

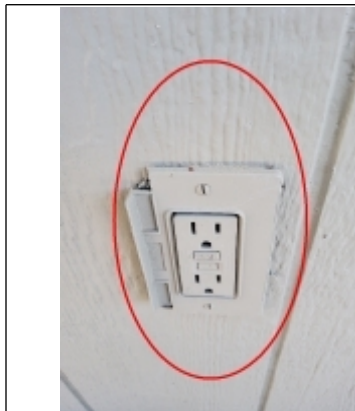
Gfci won't reset
Missing Electrical Cover

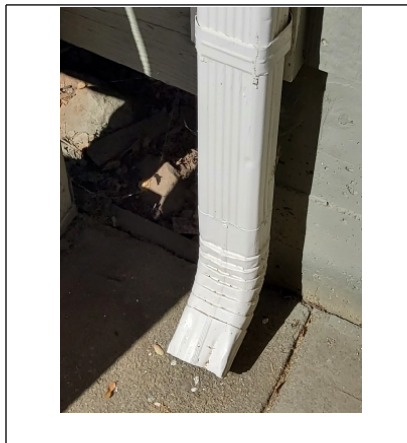
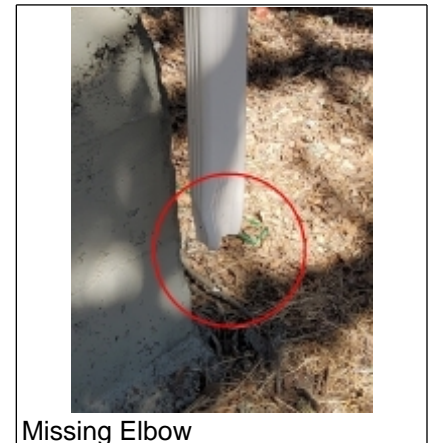
Missing Elbow

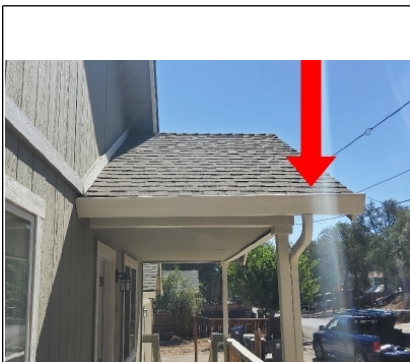
Not properly pitched. Gutter needs to be pitched to downspout.

Reference to previous picture. Loose Attachment needs to be properly pitched to downspout.

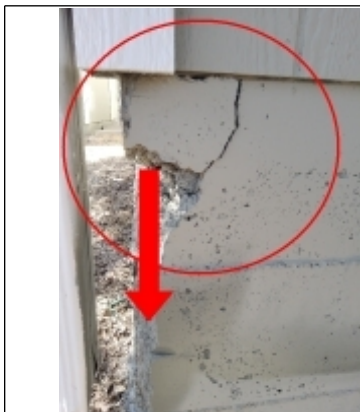
There is one foundation concern with regards to this home located at the corner. (Refer to "Report Section: Exterior") with regards to pictures. This area does have to be addressed as directly below the mudsill theres a missing portion of the concrete perimeter wall (Back of Home) and another portion (Right of Home, when facing from front side) is detached from the perimeter wall. In order for this location to be fixed foundation forms will have to be used. Drilling through the existing foundation will also have to be applied, tying in new number 4 rebar at the corner will have to be applied and concrete epoxi injections would be needed.

Repair is needed this was referenced in summary.

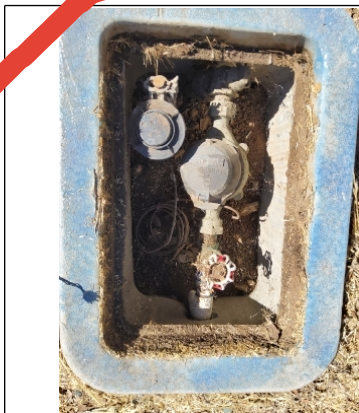
Slight leak at PVC

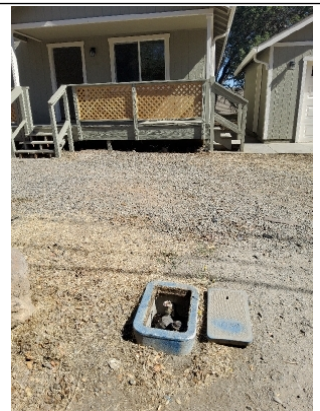
Slight leak on PVC Connection

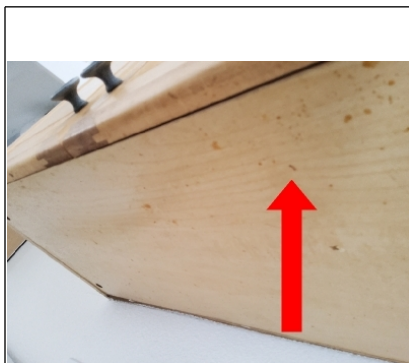
Grease stains

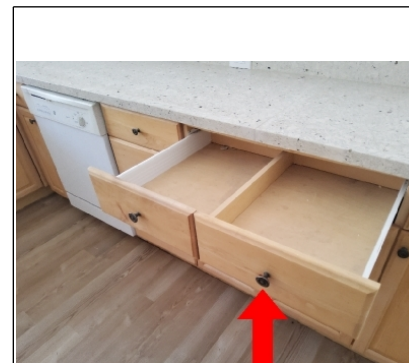
Loose knob

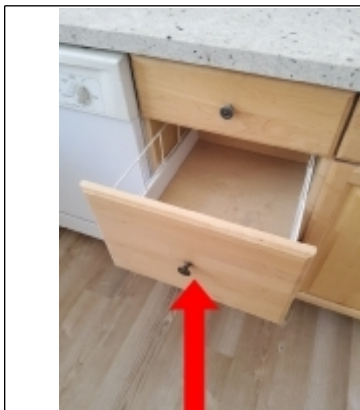
Loose knob

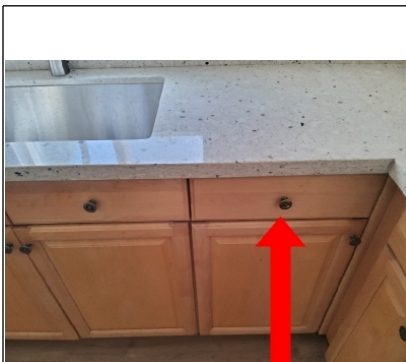
Loose knob

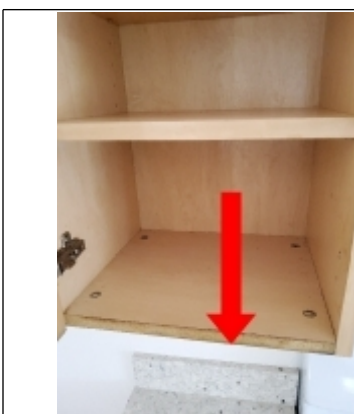
Missing cover

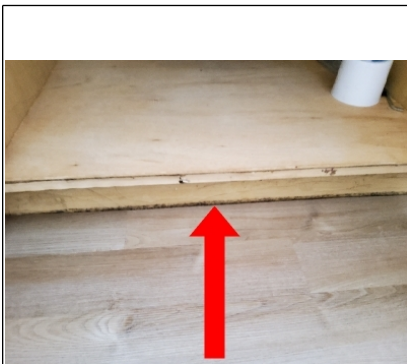
Missing Toe Kick

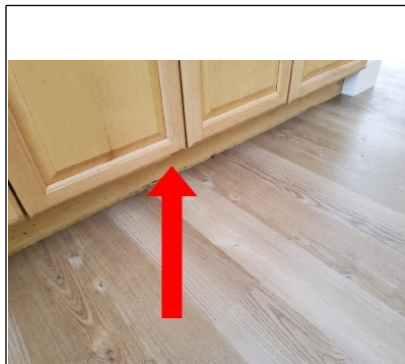
Missing Toe Kick

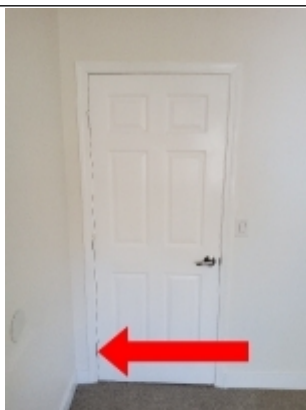
Door rubbing (Refer to Next picture for solution)

Replace existing screw center of hinge. Predrill and match the head at local lumber store, install a 3" screw after predrilling, this will tighten the jamb to the trimmer.

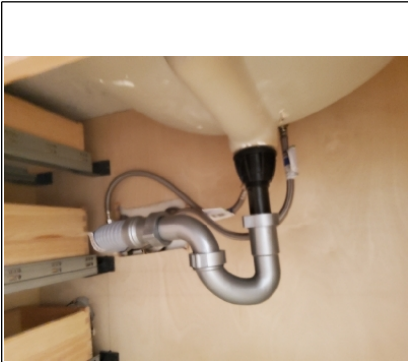
Missing Trim member

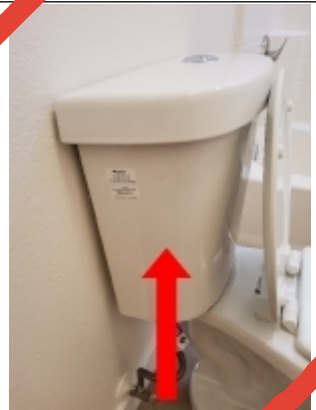
Loose Toilet Tank

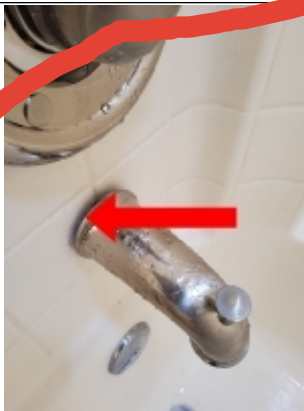
Loose bathtub Spout

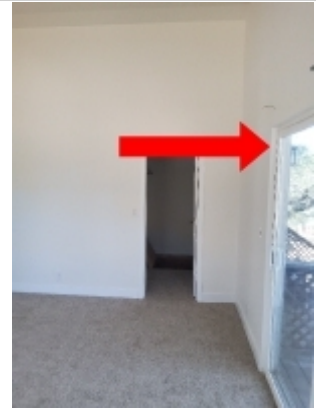
Texture and Overspray is noted in various locations on the window frames and slider.

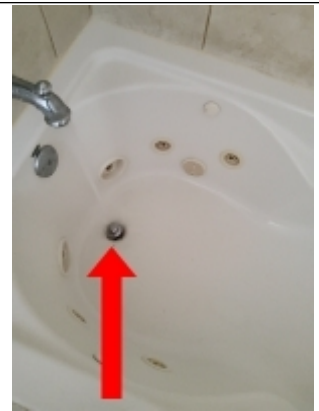
Slow drain

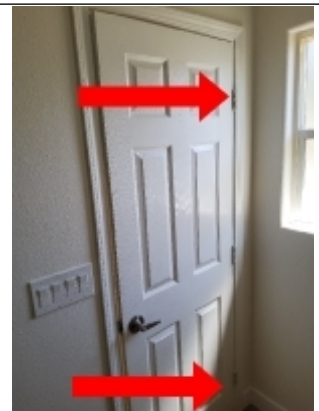
Door rubbing Jamb (Refer to Next slide for solutions)

Replace existing center screw just one in each jamb. Predrill and match the head at local lumber store, install a 3" screw after predrilling, this will tighten the jamb to the trimmer.

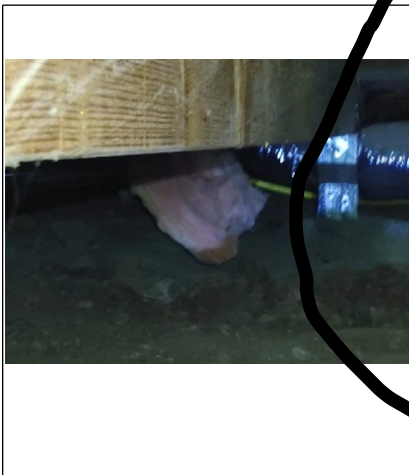
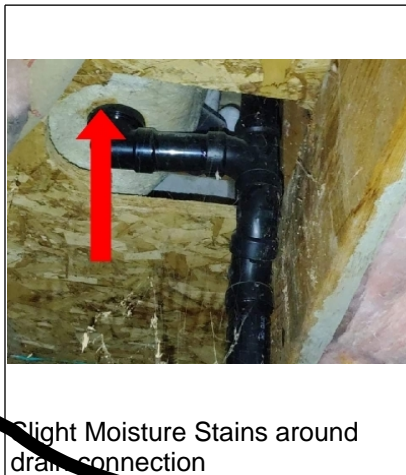
Slight Moisture Stains around drain connection

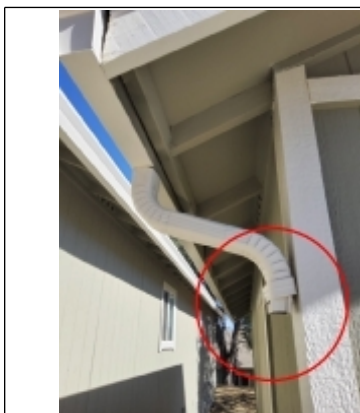
Missing Downspout

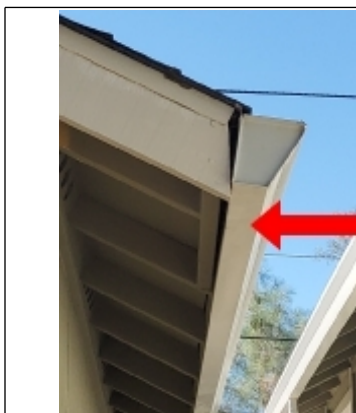
Loose Attachment

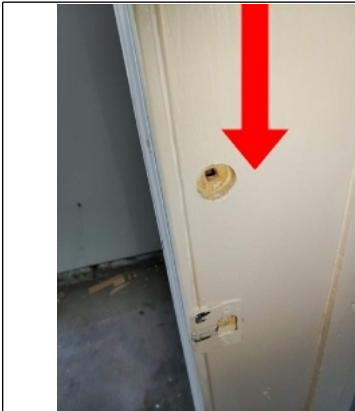
Missing Jamb Stop and Weatherstripping

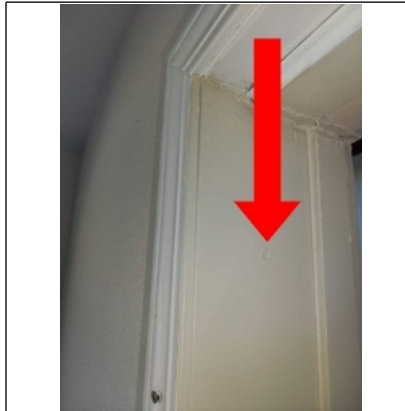
Missing Jamb Stop
