Home Inspection Report

11925 Widgeon Way, Clearlake Oaks , CA 95423

Wednesday May 18, 2022

Dustin Wallace General Contractor Home Inspections
16496 Main St.
Lower Lake, CA 95457
(707) 293-6307
dustinjameswallace1985@gmail.com

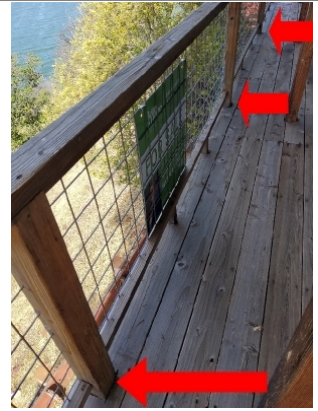
Loose posts. Recommend installing Simpson Strong-Tie L galvanized steel angle strap. (Refer to next slide for item)

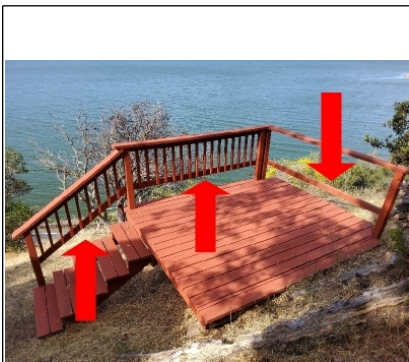
Recommend additional frame members 1. Down Arrow: balusters should be installed with no more 4" space opening 2. (Up Arrows) No more then 4" space opening required. Recommend installing 2x6 pressure treated wood members.

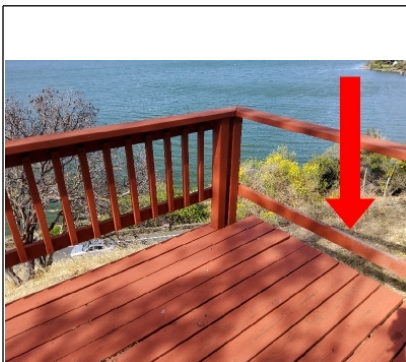
Per Residential Building Code R312.1.1 a railing is required as tread to dirt level exceeds 30 .

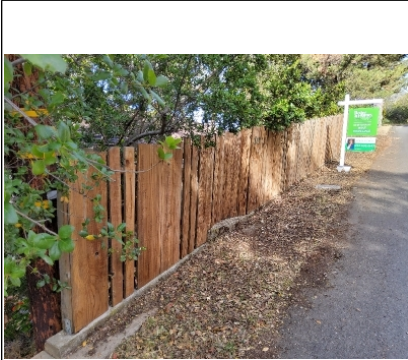
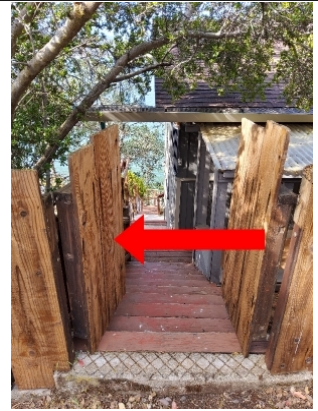
Recommend changing gate to an outswing because there is no 36" wide landing and could be considered a safety concern. Having the gate swing the other way will be safer.

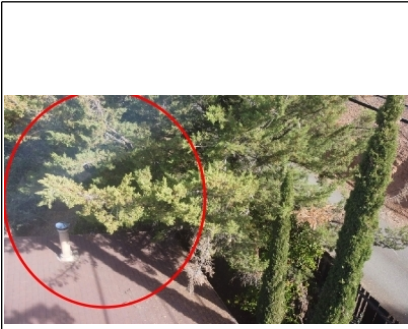
Recommend trimming back tree branches especially over the chimney chase.

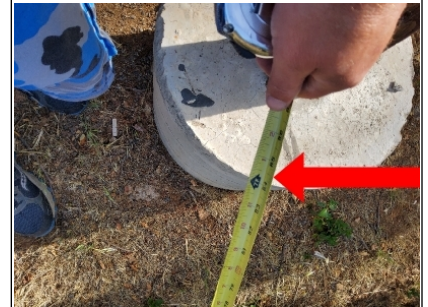
Significant concerns are evident on this retaining wall. A new retaining wall is needed as there is significant concern that erosion from the possible failure of this retaining wall will compromise the footings of the deck columns and possible house itself. This also needs to be engineered as it exceeds 4' height (1' below grade, which will need to be more than 1' based on the given slope.)

Most concerning area of retaining wall is 7' from the last pier cylinder.

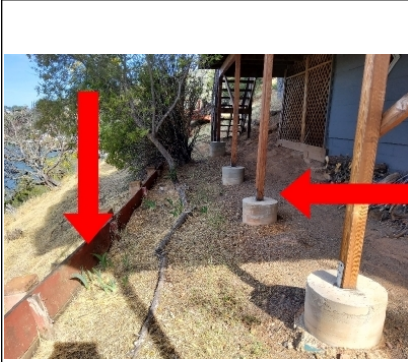
Retaining wall needs to be replaced as the pier cylinders for the 4x4 columns are in close relation to the retaining wall.

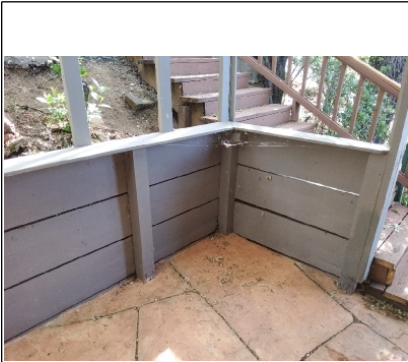
Moisture damage is evident on bottom of wood member. Recommend installing additional 2x8 pressure treated wood member and tie in existing 4x4 member.

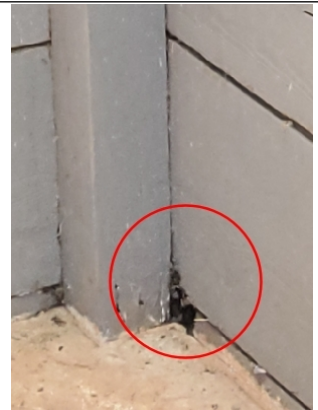
Moisture damage is evident on bottom of wood member. Recommend installing additional 2x8 pressure

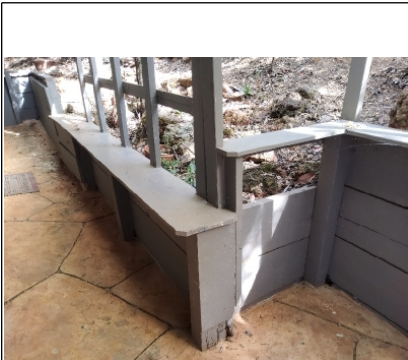
Recommend applying additional plank members on existing retaining wall. Additional columns that are red headed through simpson column hardware would help with additional support.

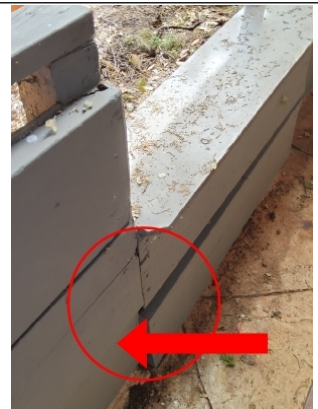
Double up bottom plank member with additional pressure treated 2x8 member and run past the existing to tie at arrow location. Use galvanized lags 1/2"

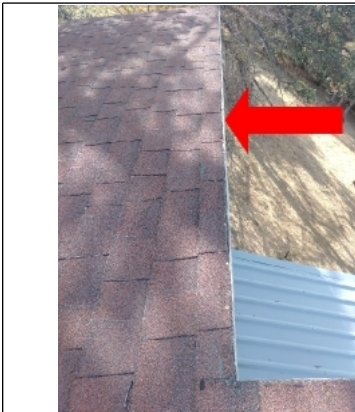
Missing Flashing. Recommend installing new galvanized L-Flashing over roof shingles.

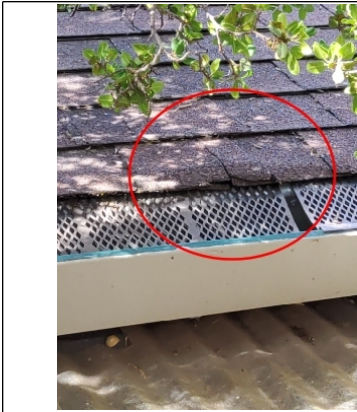
Damaged Shingles

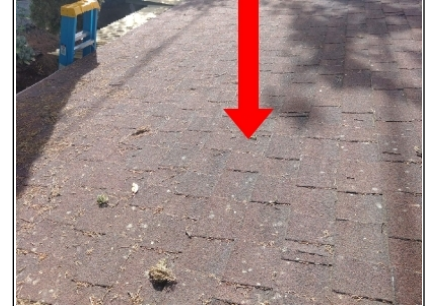
Damaged shingles

Based on the present conditions of the roof I estimate that the roof will need to be replaced within the next 3-5 years.

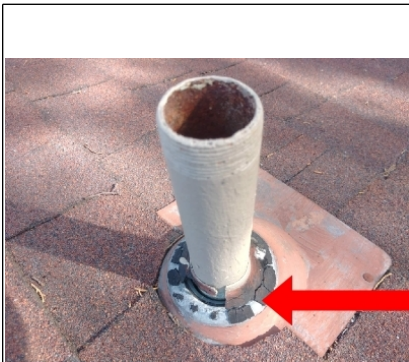
Replace storm collar

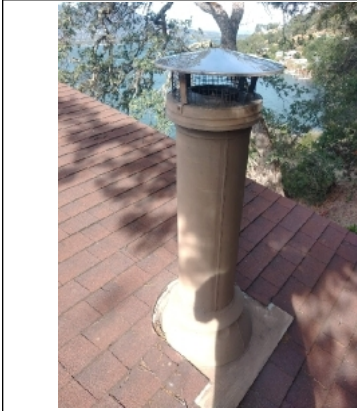
Rain cap / Spark arrestor is loose.
Recommend having properly fastened.

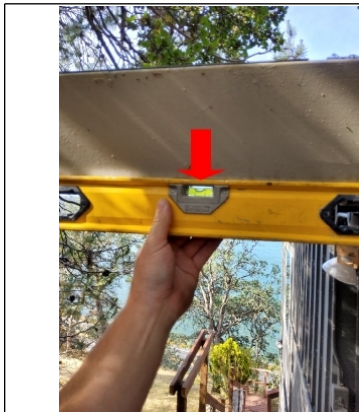
Gutter is improperly sloped to downspout. (Arrow points to the center of the bubble that shows improper pitch to downspout)

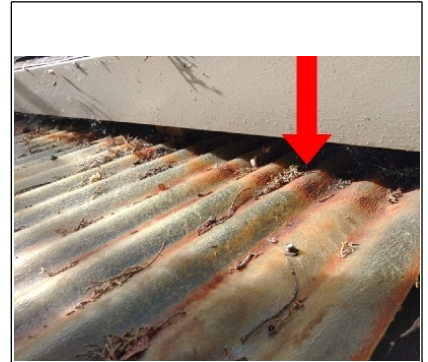
Gutters are leaking which explains the rust on porch cover.

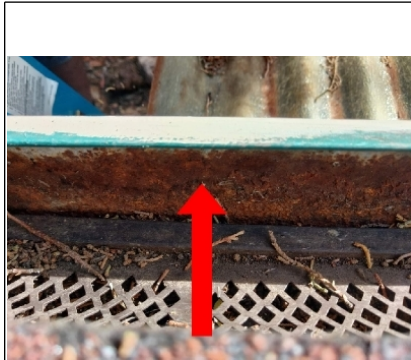
Significant rust is evident on gutters. Recommend having all gutters replaced.

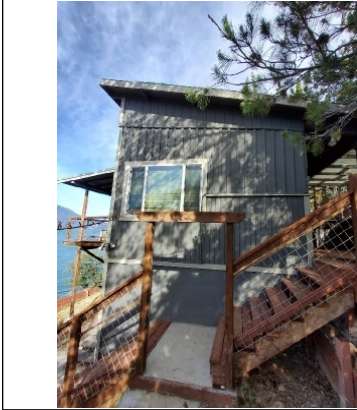
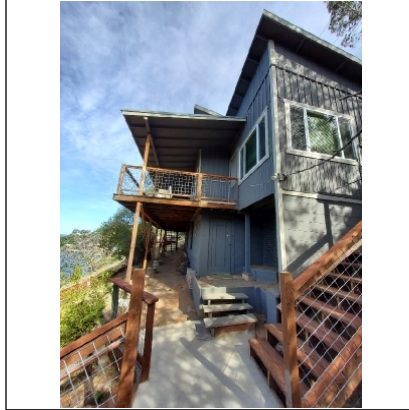
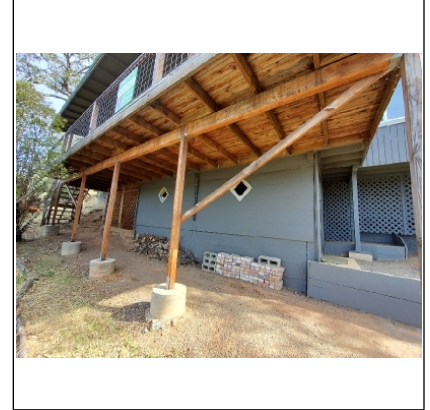
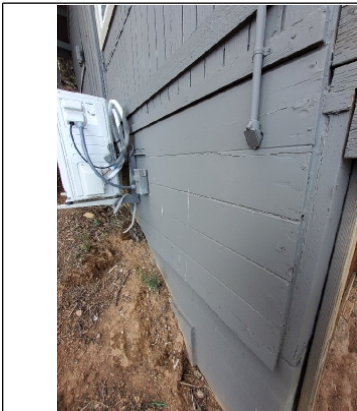
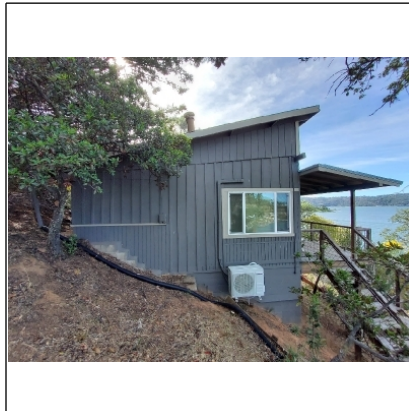
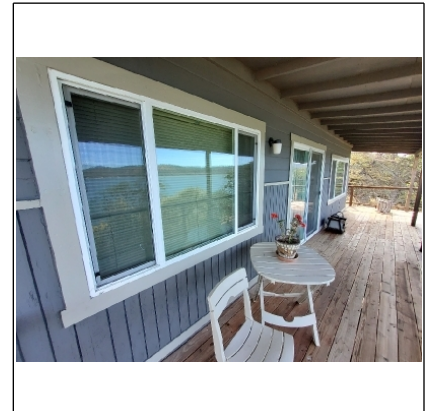
Sun damage is evident on the siding. Recommend having sanded and repainted.

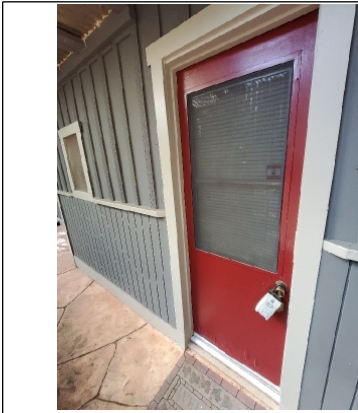
Damaged door slab. Recommend having exterior door replaced.

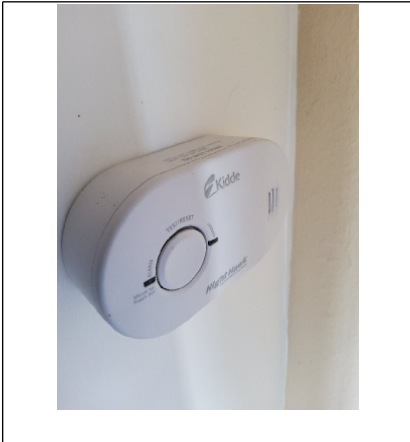
Replace batteries

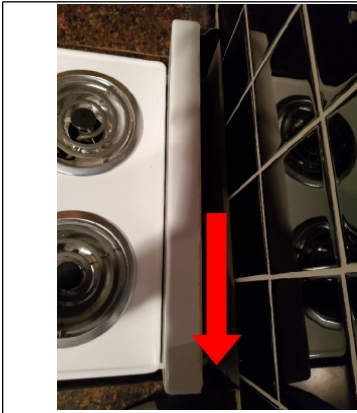
Missing anti tip bracket

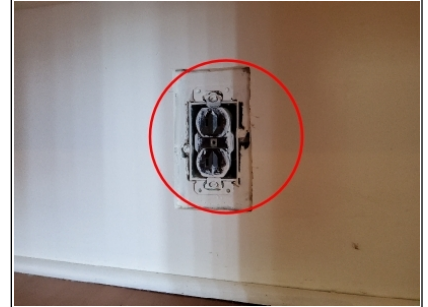
Open Ground Electrical

Recommend replacing 2-prong electrical outlet with GFCI. Won't be grounded but will eliminate chances of electrical shock.

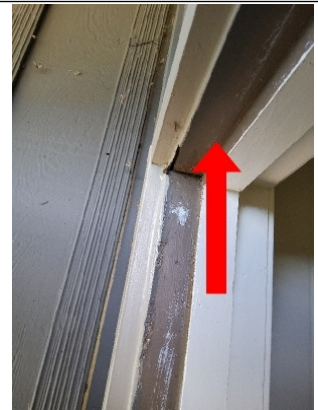
Install weatherstripping

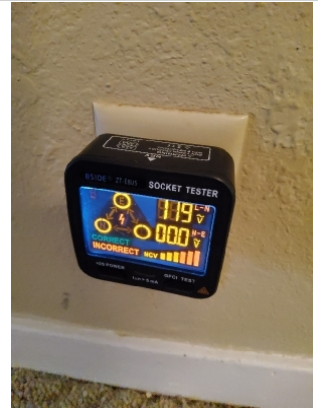
Open ground electrical outlet

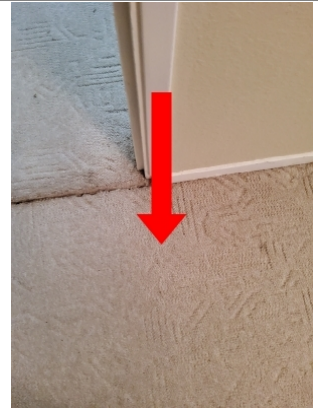
Loose subfloor. Only way to refasten to joist member is removing carpet. Don't address unless you plan on removing carpet.

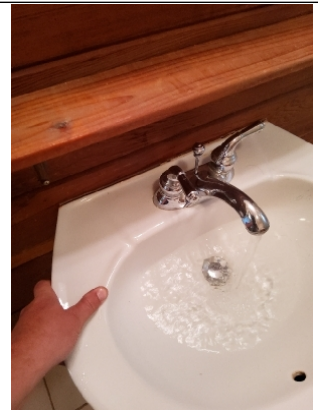
Loose vanity

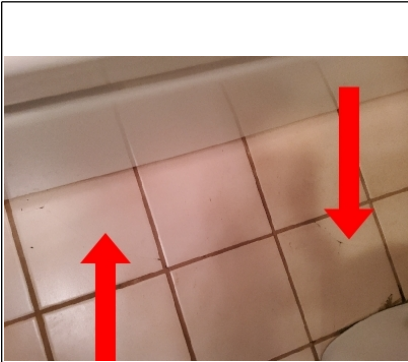
Slightly cracked tiles

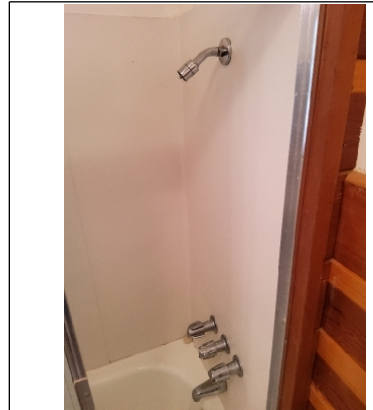
Replace diverter valve

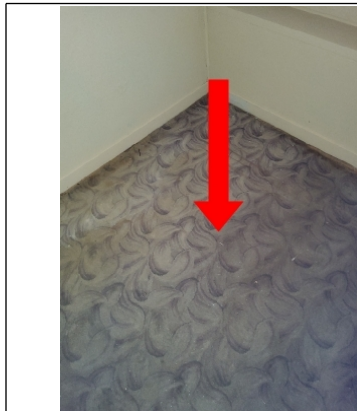
Possible rotted subfloor

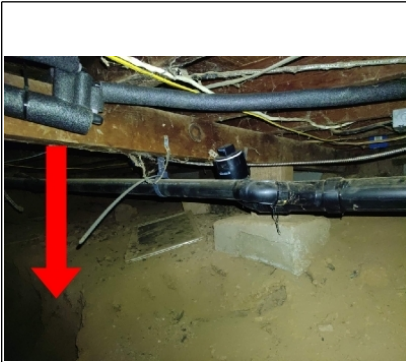
Recommend addition 6x6 pressure treated column and footing installed. After installing lateral brace on each side of 6x6 to girder member.

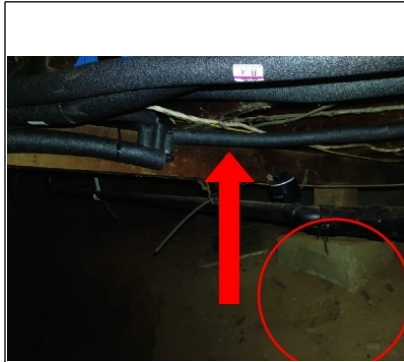
When inspecting the crawl space I noticed a significantly crowned girder member (in relation to the dip living room, refer to "Report Section: Living Room") with regards to the exact location. I believe there was undermining below the column that supports the girder member in the crawl space and lateral bracing will be needed along with more concrete footing around existing. I also would recommend additional pressure treated 6x6 post installed with minimum 2' footing (preferably 3') on the noted location of the girder member. The dip in the living room will be something to get use to but addressing and adding more support to that girder member will significantly reduce unwanted settling. There are joist members that were cut out and blocked that are suppose to span to perimeter wall I would recommend having minimum 6x6 posts with 2' footing installed directly below the area of concern. Refer to "Report Section: Crawl Space" for more details.

Concerned that erosion is reasoning for significant dip in floor (living room location) (arrow points below living room)

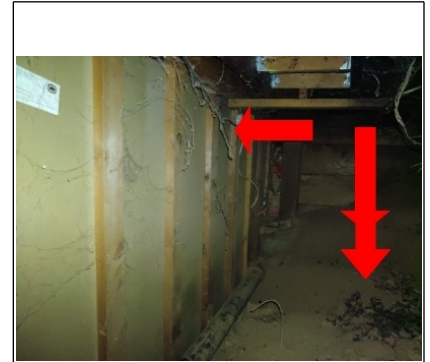
Location for both footings recommend installing below flat 2x4 plate member. Recommend also installing addition 2x4 stud below the flat 2x4 member on the wall (Left arrow)

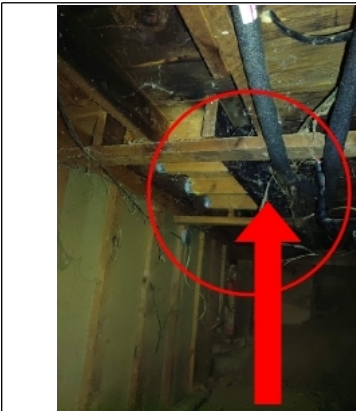
Recommend two 4x6 girder member applied below flat 2x4 with two 4x4 pressure treated posts installed with 2' footing. There appears to have fire damage on joist member and repairs were done but correctly.

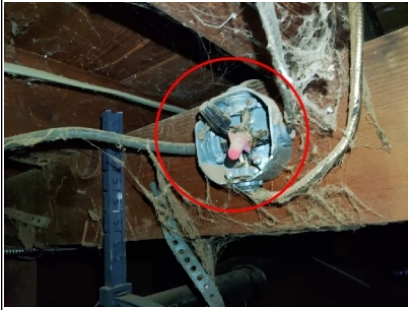
Electrical box is missing junction box covers. Recommend having electrical box properly covered.
