Home Inspection Report

13823 Lemon Ln, Clearlake Oaks, CA 95423

Sunday August 29, 2021

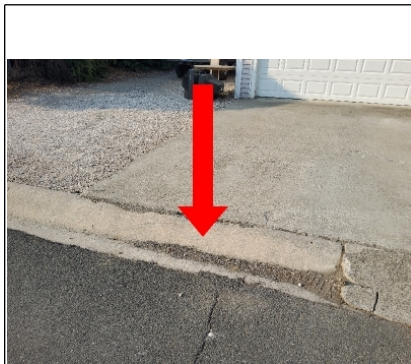
Recommend attaching platform.
Refer to next slide as noted on
neighbors driveway.

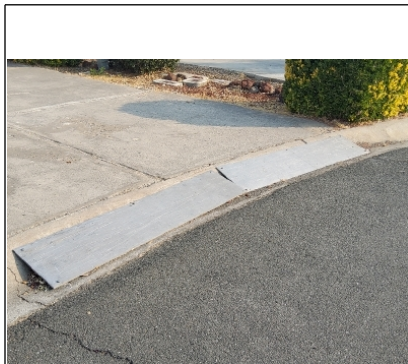
this is referenced to prior slide

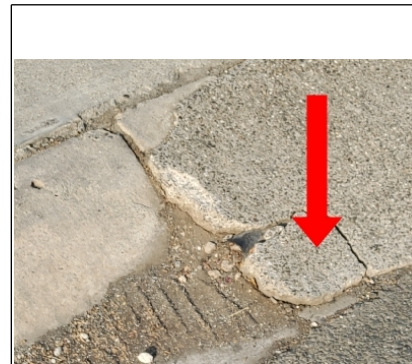
Clear out debris in abs pipe and
recommend patch work on
disconnect concrete.

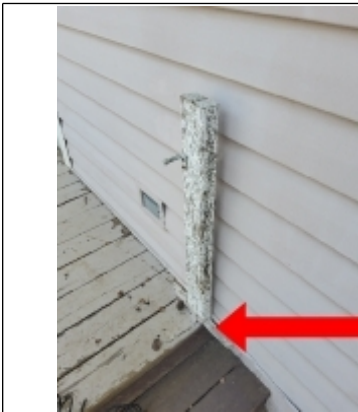
Scope camera was used to check conditions throughout the deck.

For now before removing deck. Change out bottom bracket and replace with straight galvanized bracket to tie in rim board.

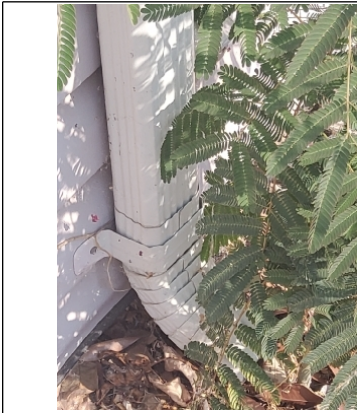
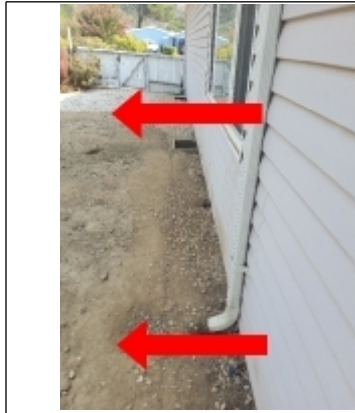
Loose gutter

I will recommend extension. Dig a trench with proper fall away from the house and use corrugated pipe with the holes down.

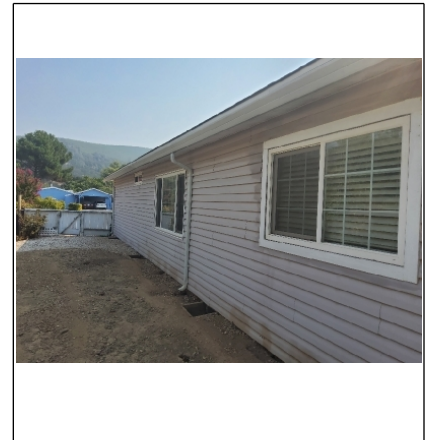
Some noted damage

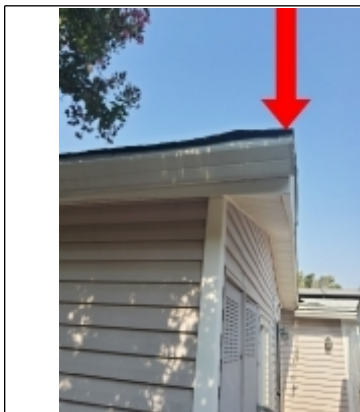
There is a slight dip on the overhang. I did test this and found no structural concerns.

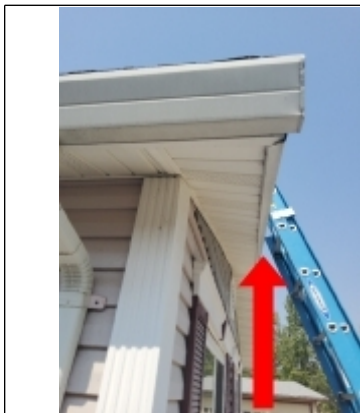
There is a slight dip on the overhang. I did test this and found no structural concerns.

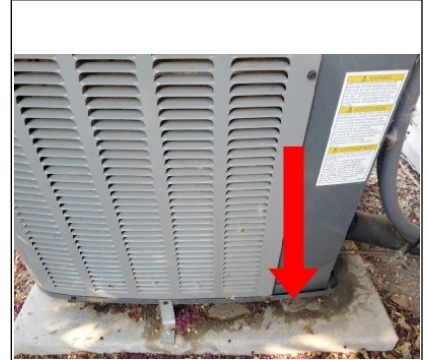
Perfectly normal this is defrost.
The hotter the exterior tempature
the most defrost will be evident
this is a new unit that is less then
4 years old.

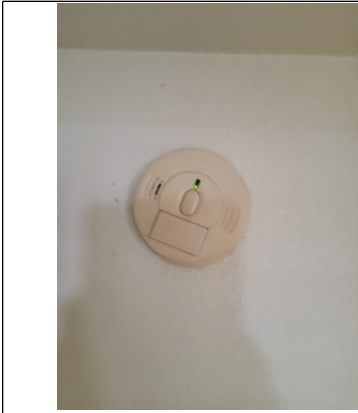
Operable (Location in Hallway)

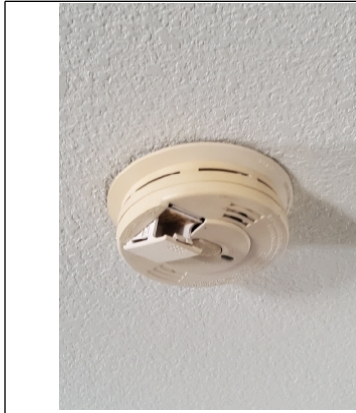
Bedroom 1 (Missing Battery)

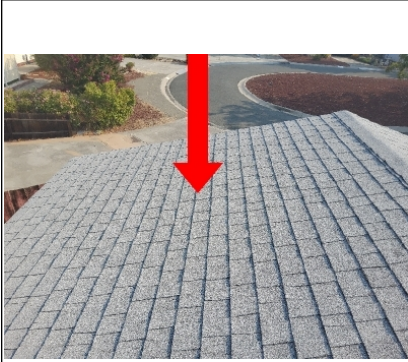
Slight delamination on sheathing. This most likely was like this from Day 1 in the factory where the manufactured home was assembled. I would leave it there are no evidence of leaks

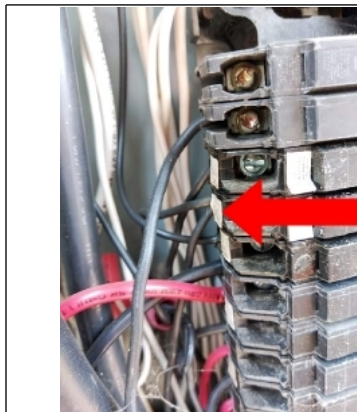
Double tapped wire. Recommend either pigtailing or replacing the 15 amp breaker with a tandem breaker.

1. Recommend replacing 15amp breaker that is double tapped with a tandem breaker or breaker designed for two wires.

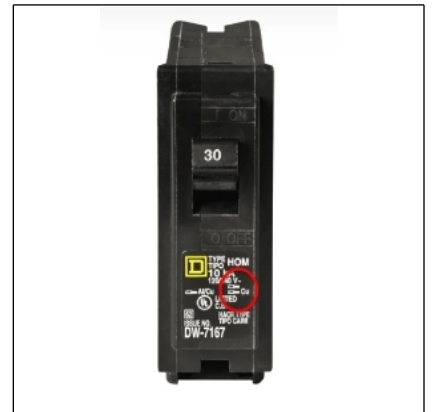
Unable to find the proper label on breaker. This is the label that is designed for double wiring on a single breaker.

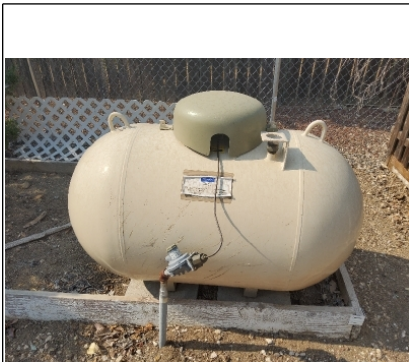
Comments Shut-off is at the tank. There does not need to be a shut-off at the house when the tank is in line of sight and in close proximity.

Recommend finding out if the tank is leased or owned and make sure to be "On the Route with propane supplier"

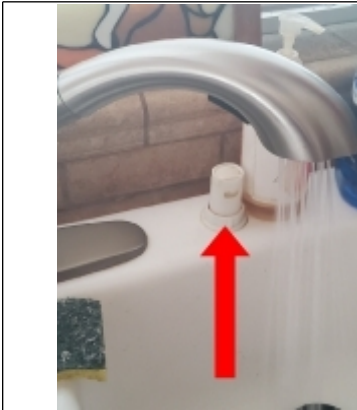
Missing Dishwasher Air Gap Cover

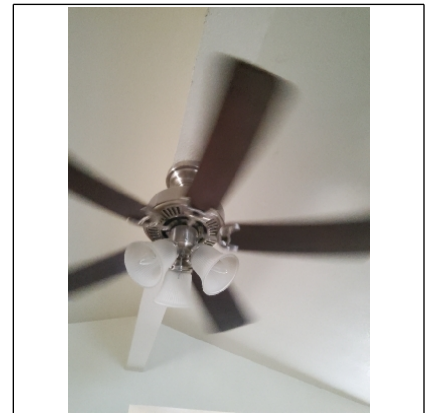
Ceiling fan needs to be repaired or replaced

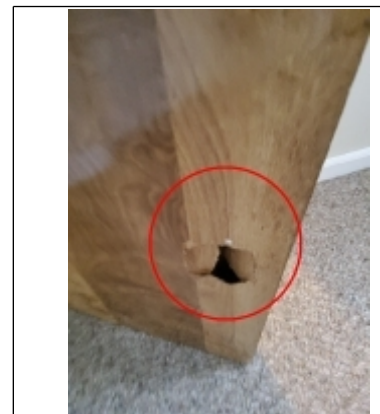
Damaged Slab
