Home Inspection Report

19064 Coyle Springs Rd , Hidden Valley Lake, CA 95467

Sunday August 6, 2023

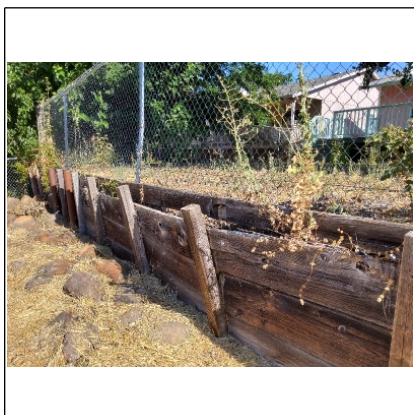
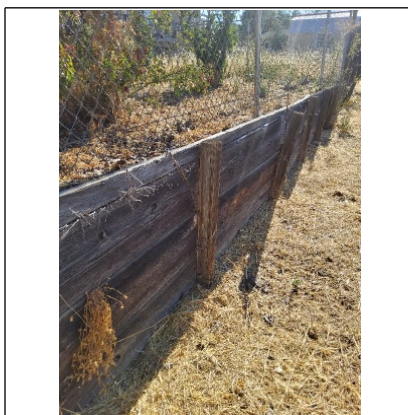
Comments *Retaining wall is not on the property based on the property line location however it is compromised. This retaining wall belongs to the home that is behind this retaining wall.*

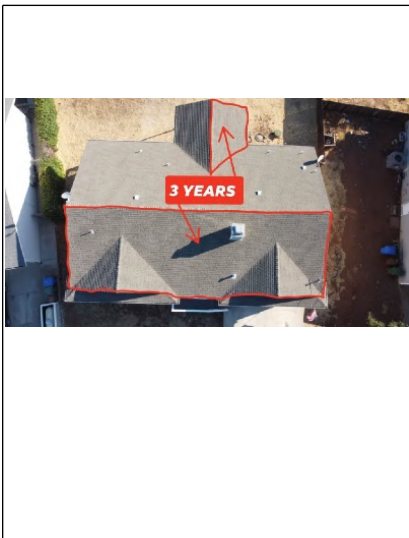
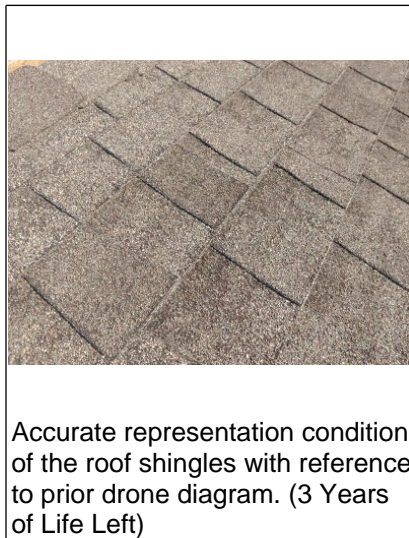
Accurate representation condition of the roof shingles with reference to prior drone diagram. (3 Years of Life Left)

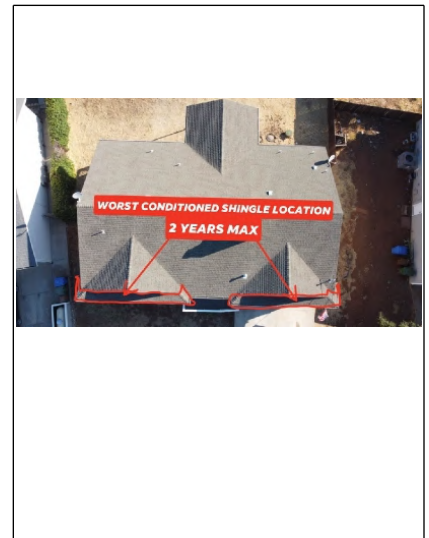
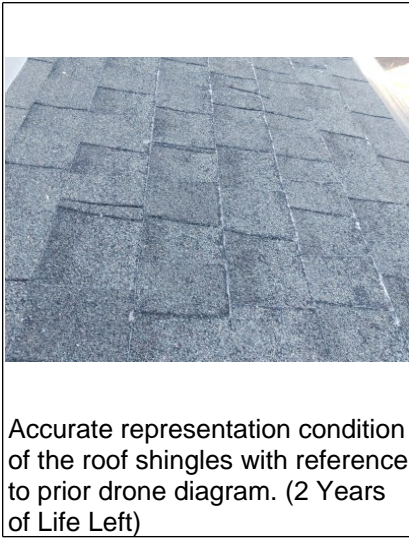
Accurate representation condition of the roof shingles with reference to prior drone diagram. (2 Years of Life Left)

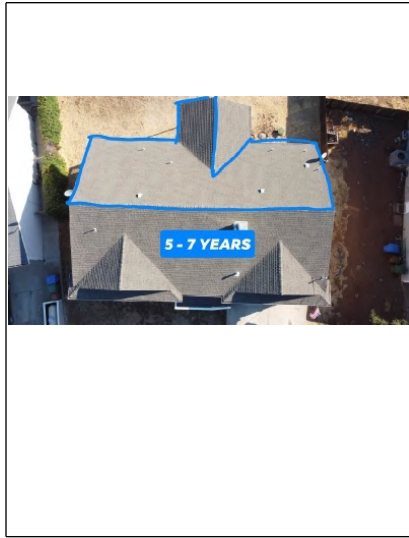
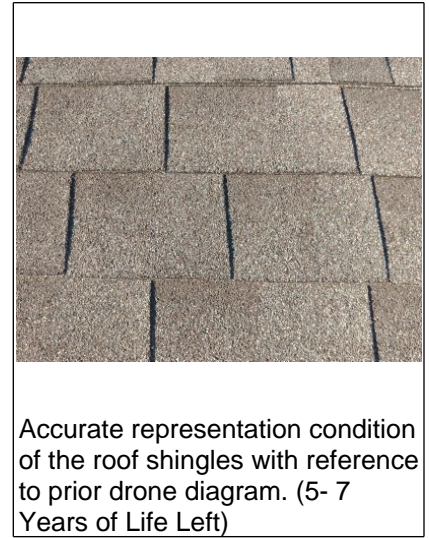
Accurate representation condition of the roof shingles with reference to prior drone diagram. (5- 7 Years of Life Left)

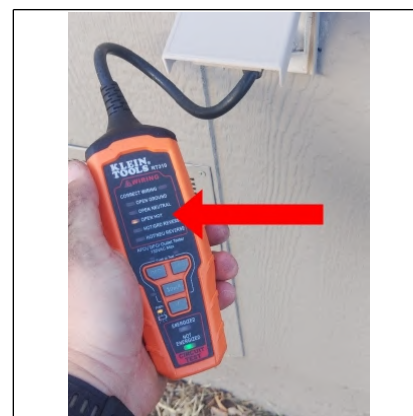
GFCI is inoperable. Recommend having replaced by a Licensed Electrician.

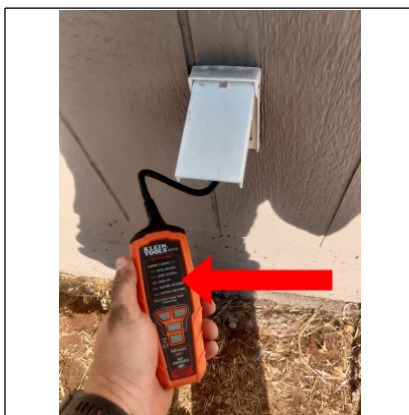
1. GFCI is inoperable. Recommend having replaced by a Licensed Electrician.

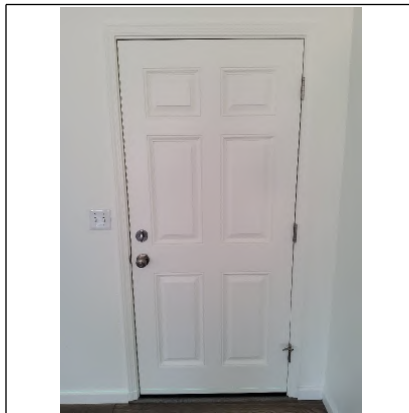
Very often with homes there are little movements or the builder does not adjust strike plates. In this case there is a small lip or flange that bends that stops the door wiggling when closed properly. There are three types of strike plates: 1. No flange, 2. Closed Flange, 3. Open Flange which can be adjusted with a flat screwdriver. Closed flanges require removing the strike plate and adjusting it with pliers to bend correctly. When strike plates with no flange are present recommend replacing them with strike plates that have an open flange.

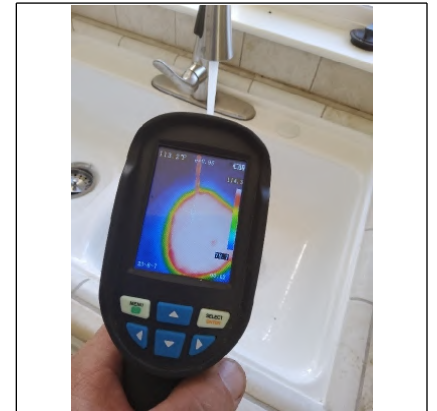
Thermal Imager shows hot water is present through faucet.

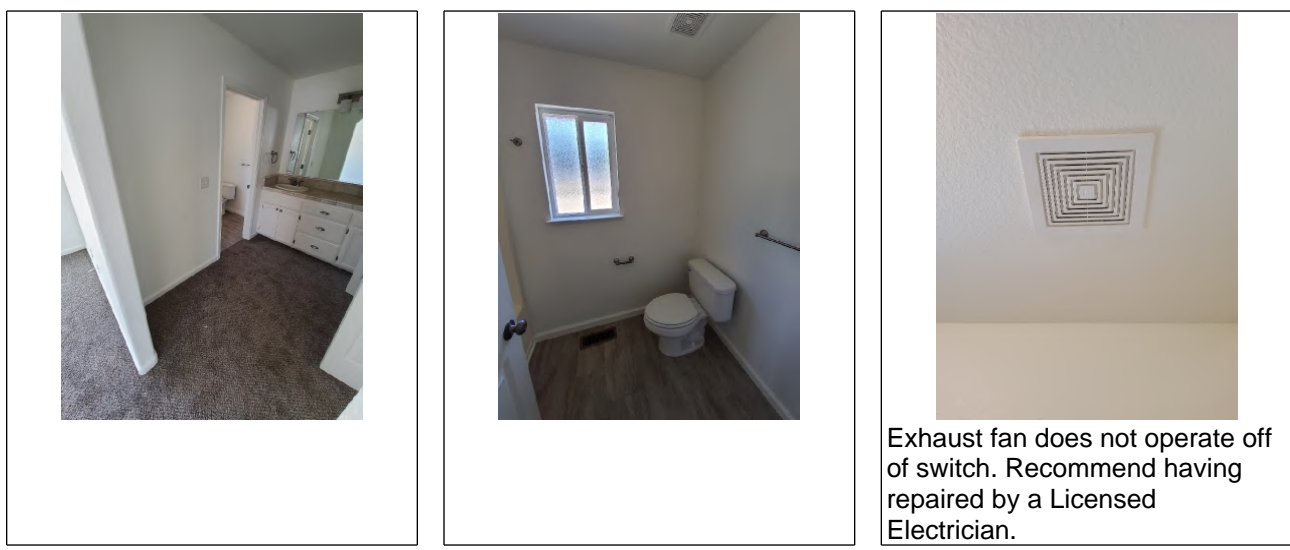
Exhaust fan does not operate off of switch. Recommend having repaired by a Licensed Electrician.
