Home Inspection Report

3911 Villa Ave, Clearlake , CA 95422

Saturday September 19, 2020

Dustin Wallace Home Inspections & Construction
16496 Main St.
Lower Lake, CA 95457
(707) 293-6307
dustinjameswallace1985@gmail.com

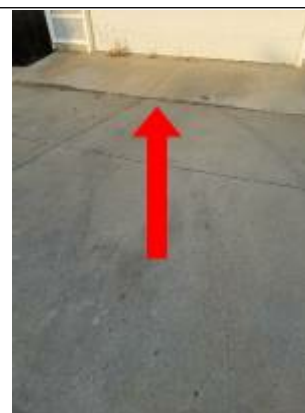
I could not notice is there was proper drainage in front of the garage door but should not be a major concern as the slope degree is not to vertical to cause any water to get into the garage.

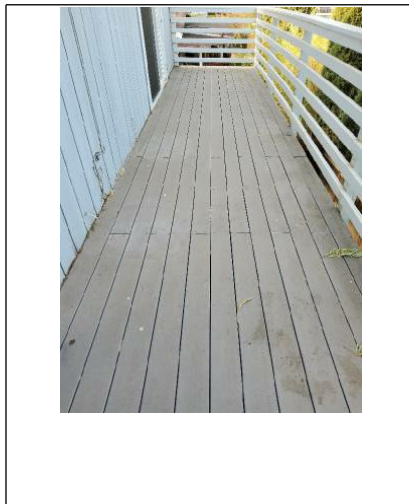
The only issue I have is if that for composite "Trex" planks the joist spacing must be 16 inches and not 24 inches therefore if potential sagging is shown more joist support must be installed.

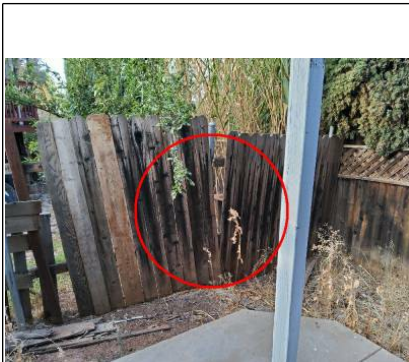
Fence needs to be fixed possible damage from neighbor dog.

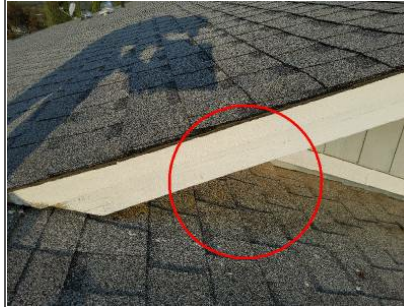
This is a very common incident where the girder of garage and gable meet and with no sun you see moisture buildup and that creates green stain on shingles just apply the same formula on the moss on this and it should start clearing up in a few weeks.

I would recommend putting "Wet-and-Forget" Moss killer on the section of the house that has moss buildup I have myself used a flat screwdriver and knife and carefully picked off the moss so it doesn't grow back especially since we are approaching colder months.

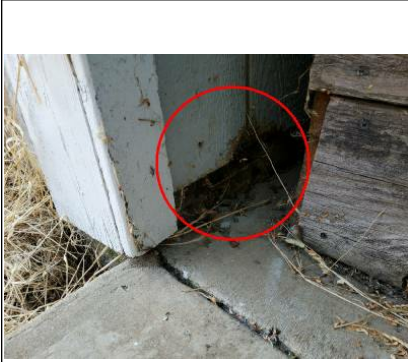
Siding can be replaced however this is below the top of the rim so there is nothing in the house that is being damaged just something to monitor.

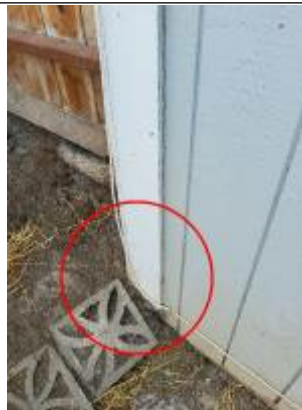
Comments Trim had some deterioration recommend repair and painting

Wood to dirt contact this cause the trim side to rot.

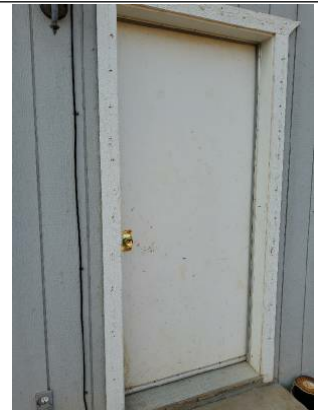
The door going to unit 2 below needs new "thicker" weather stripping. The door is beginning to warp.

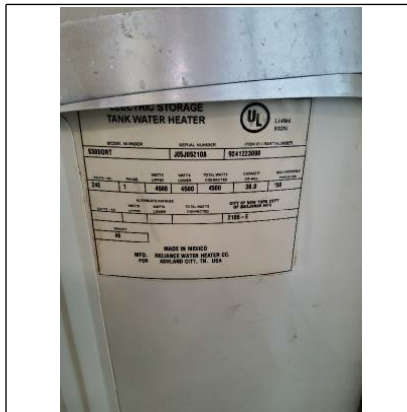
Condition ☐ Satisfactory ☒ Marginal ☐ Poor

Comments Recommend replacing with new hot water heater. I would upgrade to a Rheem 50 gallon and have my plumber put it in.

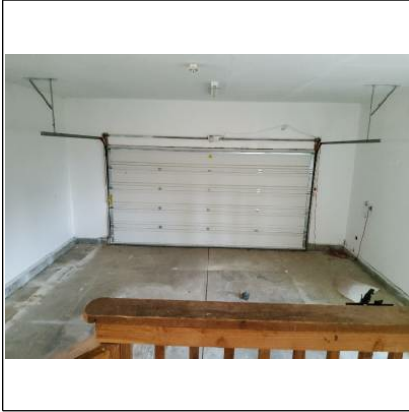
Garage door des not have any overhead. I have recommended in the beginning of the report my garage door guy to install an overhead operator.

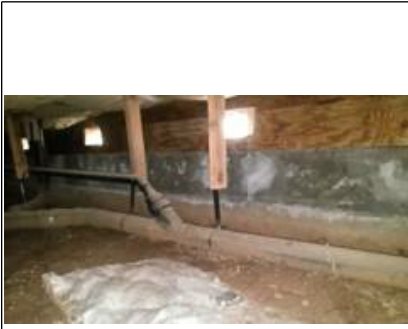
Proper fall noted (1/4" per 1') on
ABS waste lines

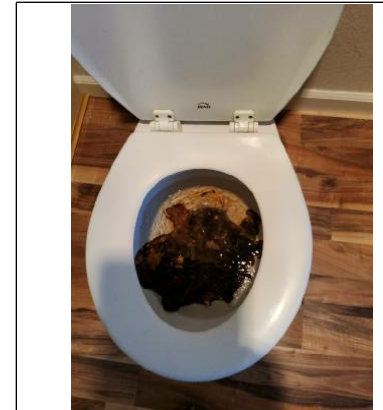
Replace toilet non-operable

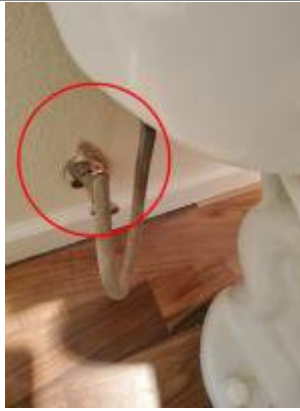
I shut off the valve so the toilet
wouldnt keep running.

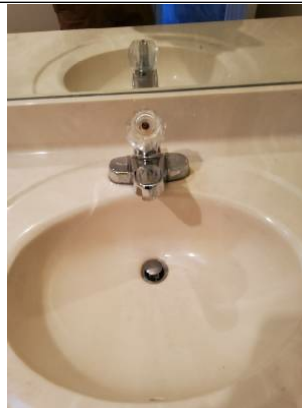
I have adjusted flex lines underneath to be turned on and still no water. Recommend when having hot water heater replaced have plumber check this out. Could be clogged o ring

Comments Recommend replacing the flex lines. Replacing the toilet.

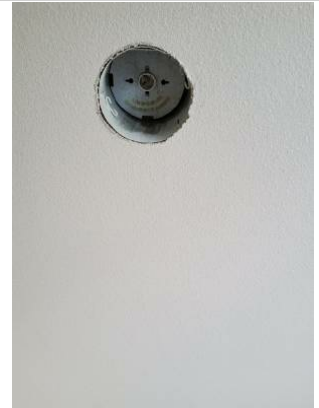
Missing light fixtures in two openings.

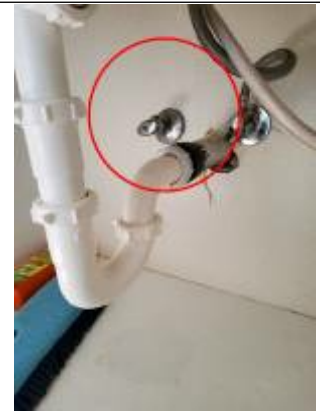
Disconnected flex line
recommended adding new flex
line to sink

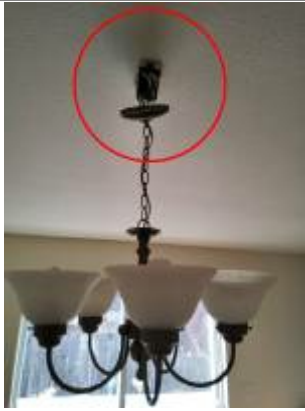
Dining light needs to be reattached and adjusted.
