Home Inspection Report

2255 Will O View Circle, Lakeport, CA 95453

Wednesday August 30, 2023

This inspection is a Certified Roof Inspection from Dustin Wallace General Contractor Home Inspections CSLB#1052482. Home Inspectors are NOT licensed for Roof Certifications unless they also carry either a C39 Roofing Contractors License or a General B Contractors License. In these roof inspections the roof conditions (as well as the material used) are examined as well as flashing, plumbing vents, storm collars, the examination of gutter conditions (if present), the degree of water run off in the subterranean area (if crawl space is present) and most importantly structural (conditions of rafters, truss members, header beams, etc) if an attic is present then thermal readings are calculated to do determine if extra ventilation is needed. PLEASE REFER TO "REPORT SECTION" FOR A COMPLETE DIAGRAM BREAKDOWN WITH REGARDS TO THIS ROOF INSPECTION.

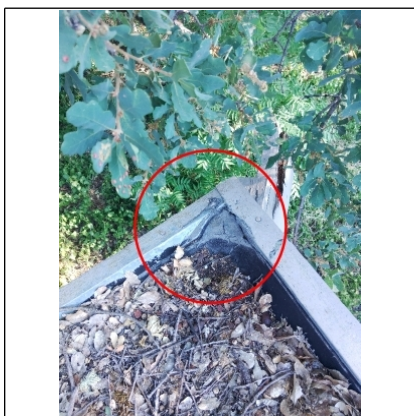
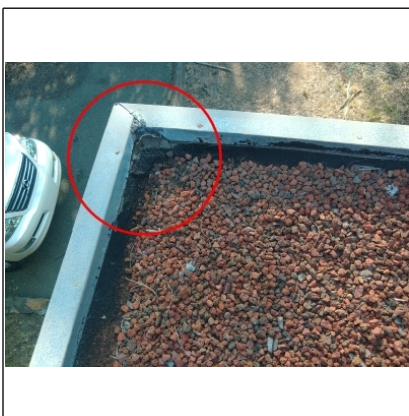
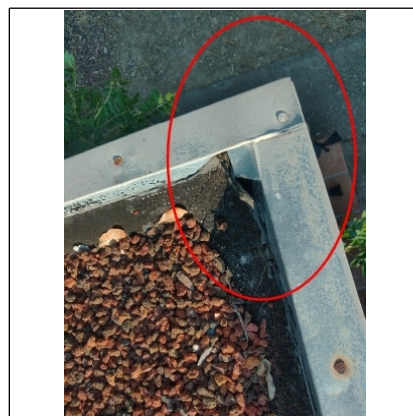
Comments **1. The most common locations where water will intrude as well as locations that require the most attention are each corner of the roof. These locations should be resealed as evidence shows water has intruded causing damage on the fascia members and through the planking.**

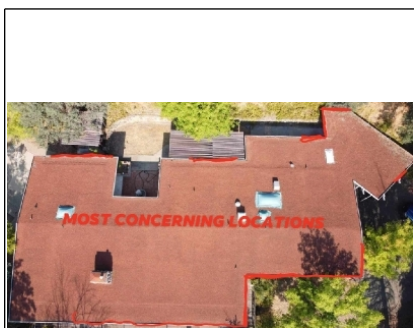
These locations that are in red are the most concerning locations with regards to water intrusion, moisture damage and improper pitch and flashing.

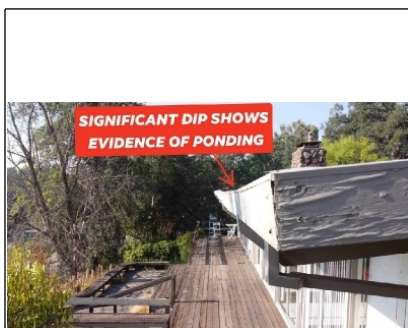
This is a significant dip on the overhang where the tongue and groove planking shows moisture staining and disconnection. This area has had an issue with ponding and does not have proper pitch to the downspout.

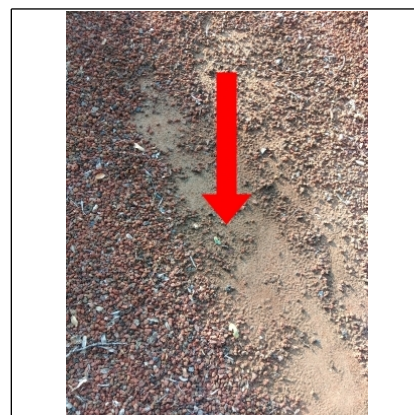
Missing gravel is evident at this location. Recommend additional gravel be applied at noted location.

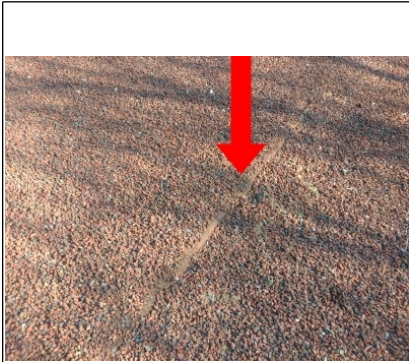
Missing gravel is evident at this location. Recommend additional gravel be applied at noted location.

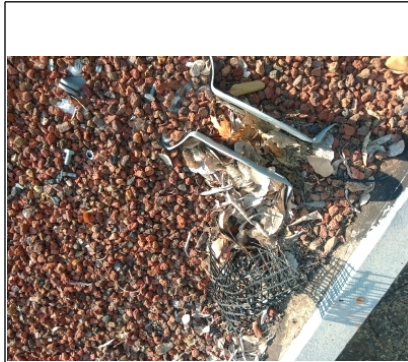
Recommend removing all hardware "screws" from the roof covering from prior satellite dish installation.

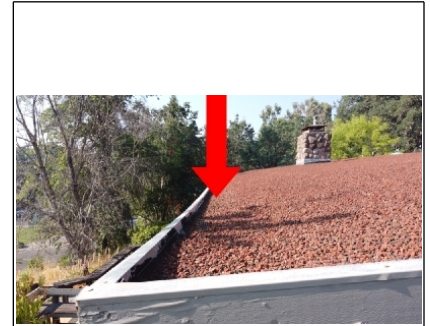
Ponding location is prior to the scupper drain location.

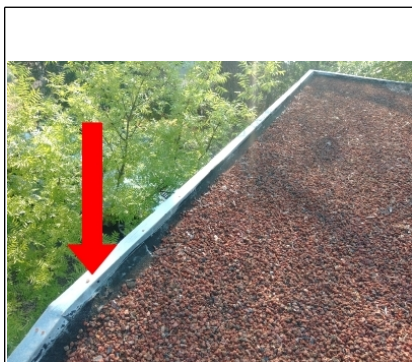
Rusted nails have allowed water to intrude through the fascia.

1. Recommend after replacing all moisture damaged fascia members replace all nails on the flashing and refastening the existing galvanized flashing with hex head screws that provide a proper rubber washer and a dab polyurethane sealant.

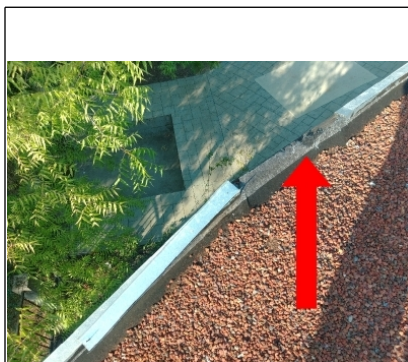
Missing flashing

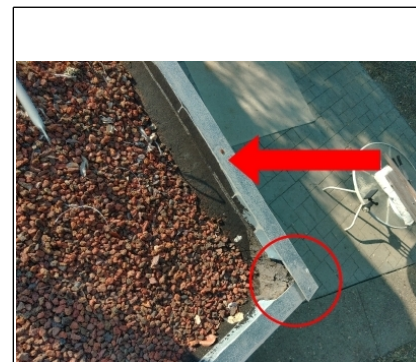
Rusted nails have allowed water to intrude through the fascia.

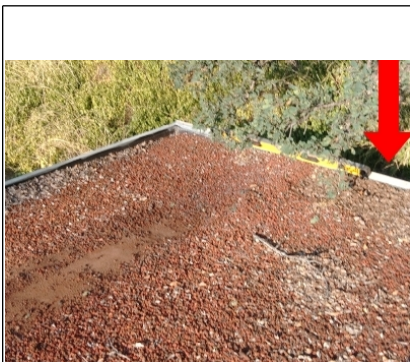
4' level is placed on the edge to show there is an improper pitch to the existing scupper drain.

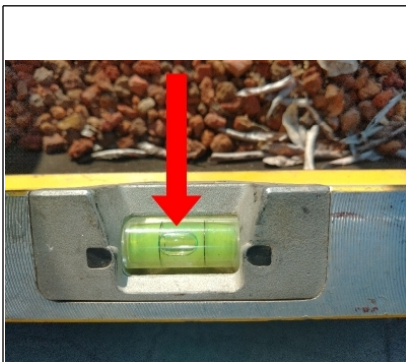
Arrow points to center of bubble with reference to prior slide.

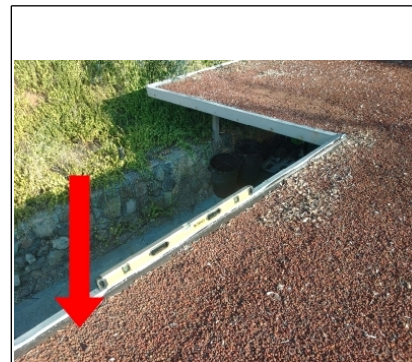
4' level is placed on the edge to show there is an improper pitch to the existing scupper drain.

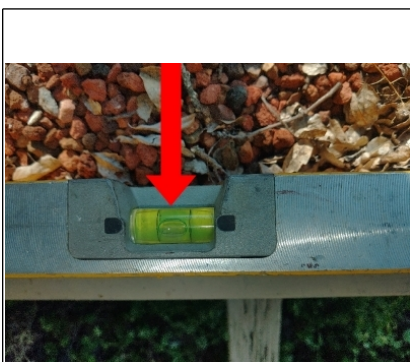
Arrow points to center of bubble with reference to prior slide.

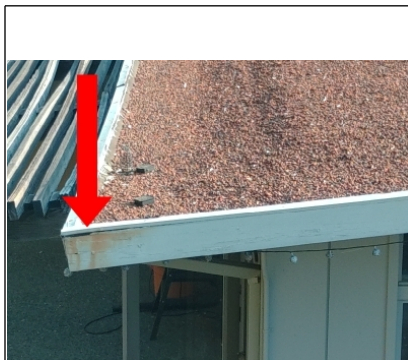
Moisture damage is evident on fascia from excessive ponding. This also could be in relation to the downspout needed to be cleaned.

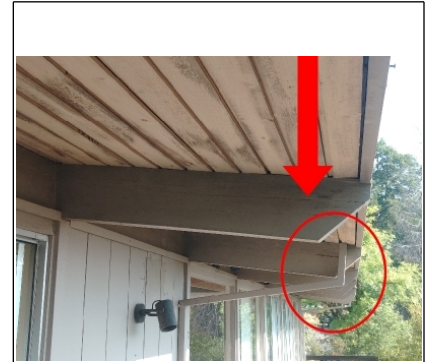
Moisture stains are evident on fascia from moisture intrusion through the tongue and groove planking.

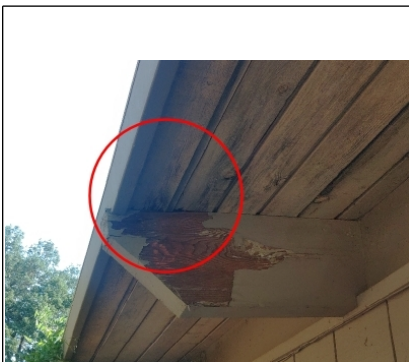
Moisture stains are evident on fascia from moisture intrusion through the tongue and groove planking.

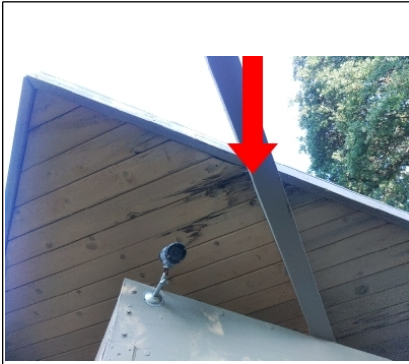
1. Water intrusion is evident between the connections (male and female) of the tongue and groove planking. This is from excessive ponding where water has seeped through slowly from both the combination of a lack of proper pitch to the scupper drains and downspouts as well as through the fascia members from lack of proper flashing. These are active moisture stains that may have accelerated because of the massive winter we have had. The dips in the planking also could have gradually got worse and then at the front of the home where the most sun exposure could have possibly warped the planking underneath. Regardless, there is a correlation between the most evident moisture staining on the planking and the most concerning roof locations up top that show a history of water intrusion.

Active leak

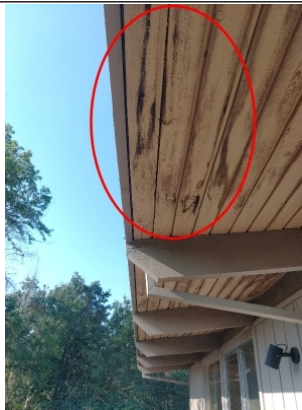
Stains are from water intrusion between the grooves of the planking.

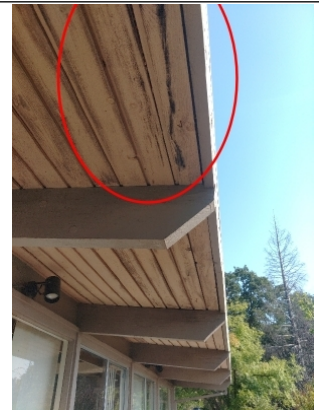
Stains are from water intrusion between the grooves of the planking.

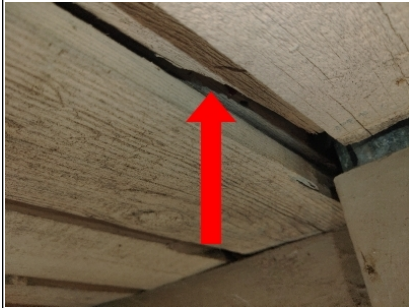
Another concern is that after this long winter and now this summer these exposed T and G planking members have shrunk. These are 1-1/2" wide T and G planks.

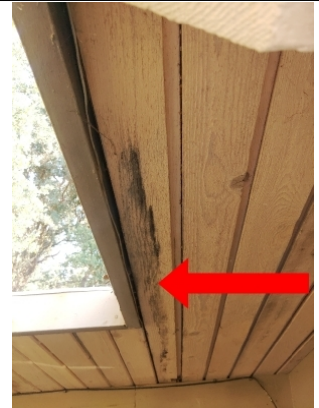
Moisture stains from active ponding location.

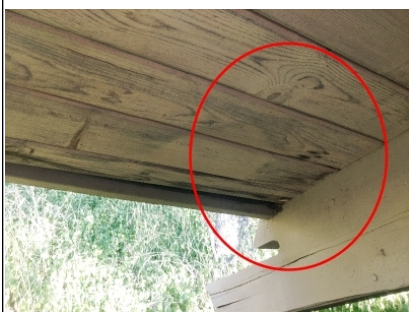
Active leak

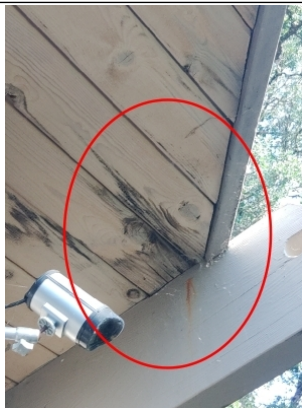
Active leak

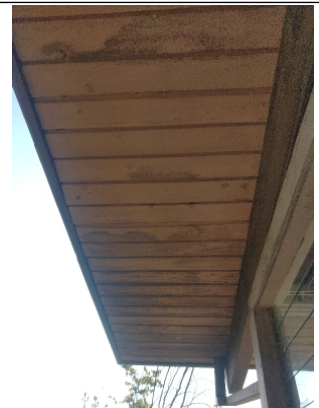
Significant bowing is evident on the T and G planking at the front portion of the overhang.
