# Home Inspection Report

16289 Ponderosa Dr., Cobb, CA 95426

Saturday February 29, 2020

Dustin J. Wallace Construction and Home Inspections  
16496 Main St.  
Lower Lake, CA 95457  
(707) 293-6307  
dustinjameswallace1985@gmail.com

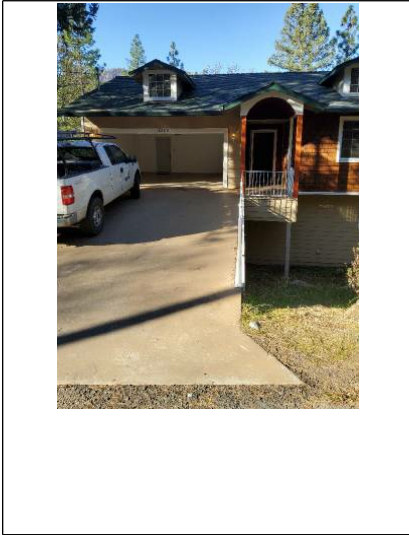
steps must be added and a landing

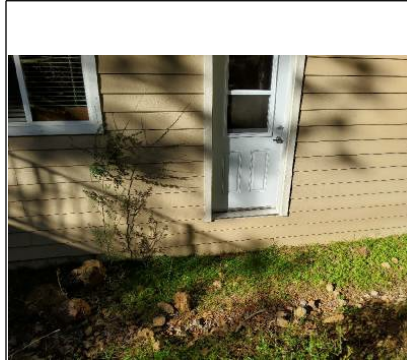
siding must be 6 inches from ground level. Any areas that siding is closer then six inches must be fixed.

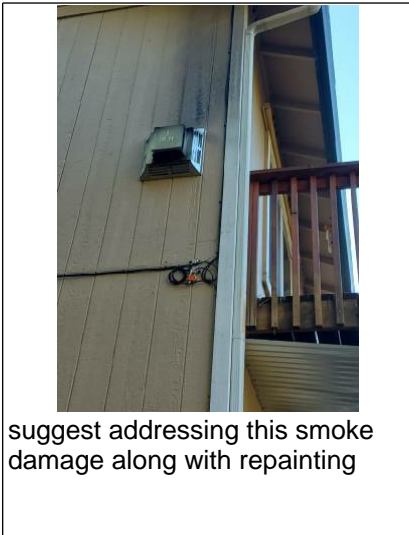
suggest addressing this smoke damage along with repainting

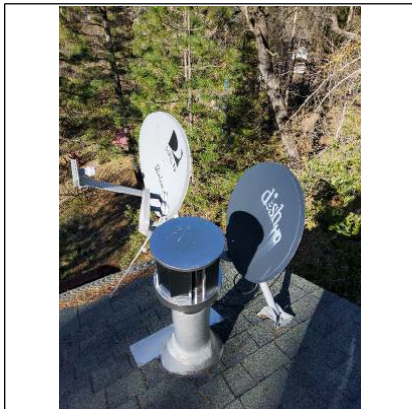
**Comments** Recommend antennas moved

Suggest contacting Satellite provider and moving these to a different location.

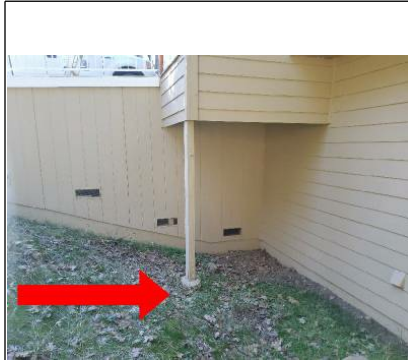
No Possible Drain Tile?  
recommend a diversion away  
from the foundation of the house

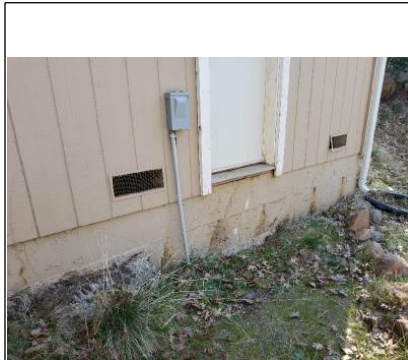
Steps are needed for access

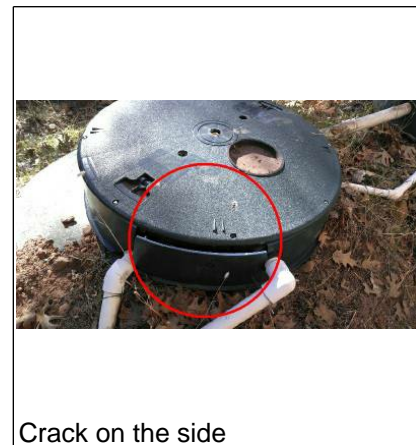
Crack on the side

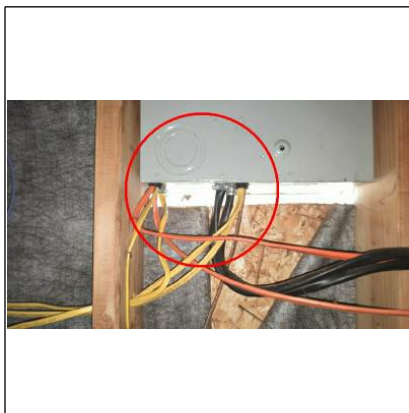
**Comments** The Main Panel box must be sealed from outside elements. From the crawl space view clearly you can see daylight through the top and bottom of the panel box. Recommend proper trim and chalking

this is open light behind the panel box in the crawl space this needs to be addressed

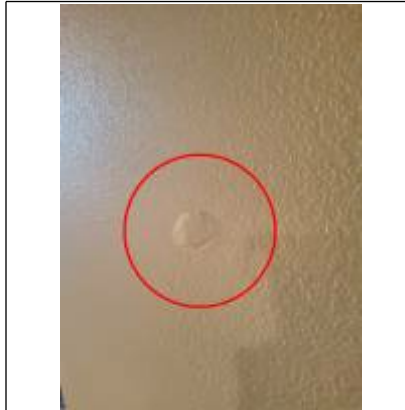
Drywall Damage

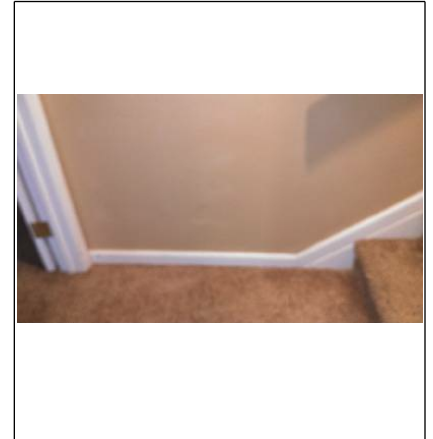
Door Stopper makes it hard to open. Possibly do to new carpet being installed.

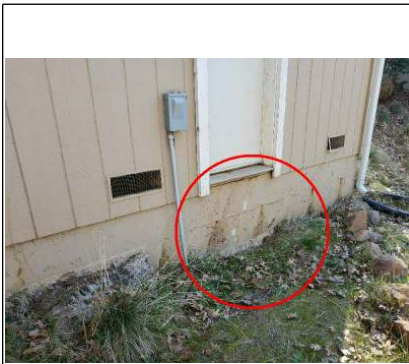
**Comments** There needs to be steps installed to get better access underneath the house. Clear Safety Issue

Need steps and landing pad

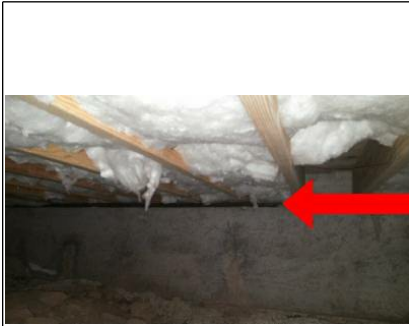
This is the beginning of the foundation. The foundation is out of square as the next photo will show how the joist was shimmed up with OSB which is not a structural support for this.

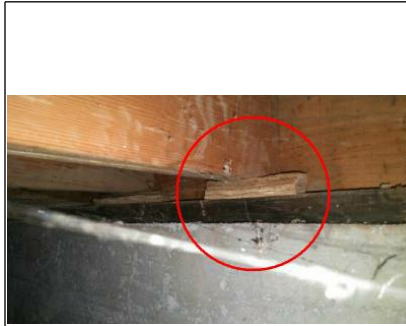
This is a shim holding up the joist off the mudsill. Clear structural issue. Suggest a ripped piece of wood to along the entire width of the mudsill to give proper structural support. This is at the other end of the foundation wall with support being from 2x4 blocks.

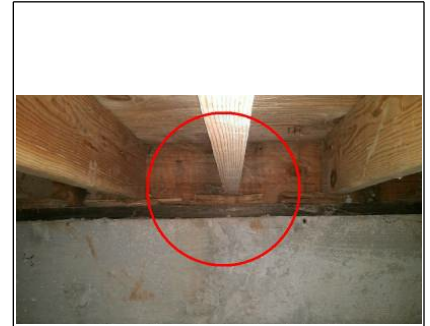
Double OSB shimmed with a painters shim between the joist and mudsill. As a licensed Contractor this completely unacceptable.

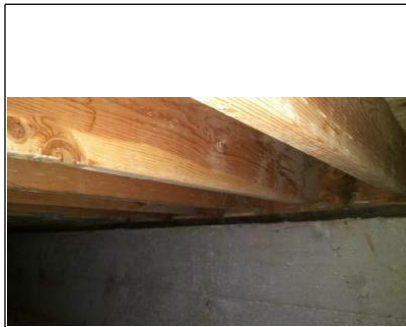
the foundation at the complete span on lowest level is an inch out of level. With note 2x OSB at half inch at a quarter of the span of the home.

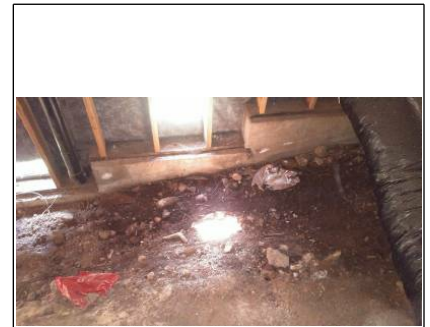
This is the bottom of the house where you can see water moisture. There has not been any rain in a month. This is a serious issue

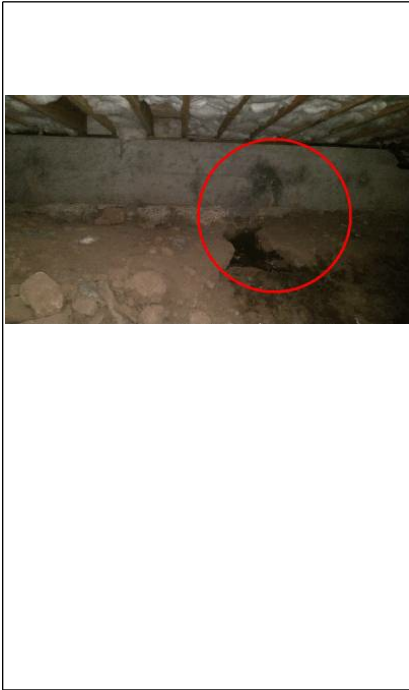
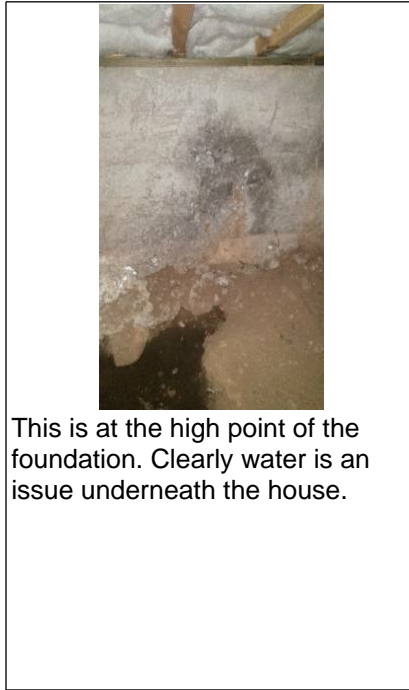
This is at the high point of the foundation. Clearly water is an issue underneath the house.

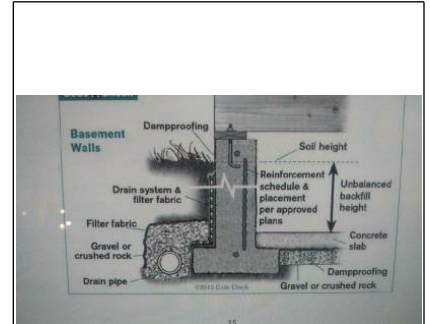
Code Check for Proper Draining

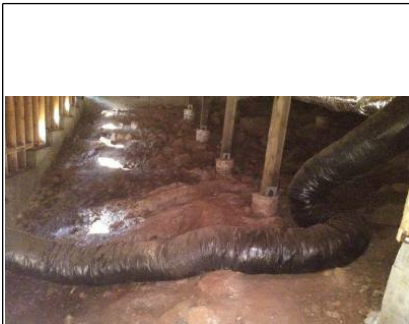
This should not be touching the ground. Duct work must always be off the ground. This is referred as handyman installing not from the builder.

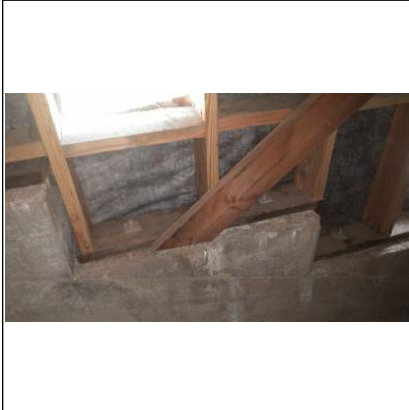
**Comments** Cross braces used to plum line have not been removed. Recommend cutting a quarter inch off so the untreated wood does not have direct contact with the concrete

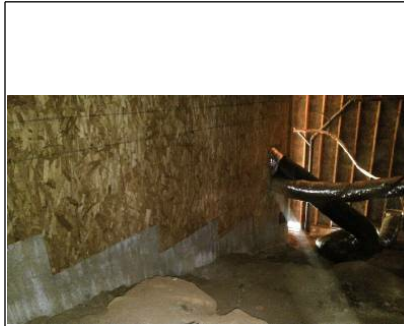
Sheerwall is noted to having direct contact with concrete. Recommend Copper Green to help preserve wood.

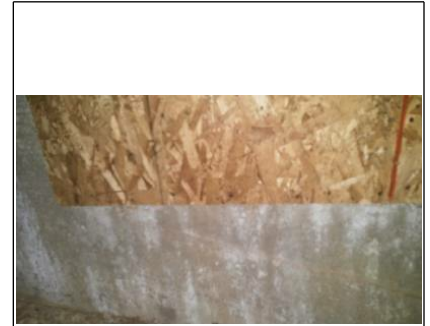
OSB sheerwall direct contact with concrete recommend treating contact area with Copper Green or cut out the exposed part by saw

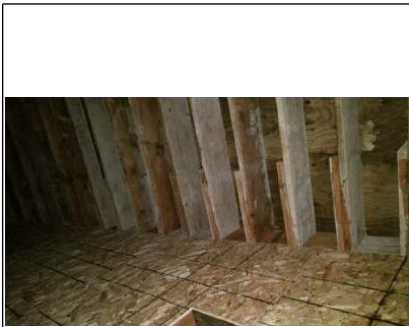
These joists were reused after being used as foundation forms. They should be treated as concrete will dry out the wood for structural support.

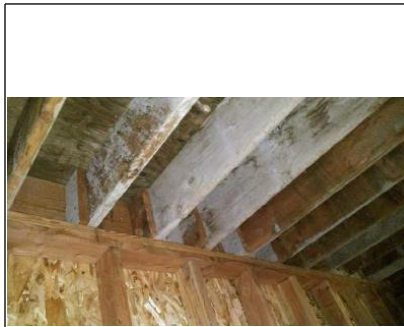
Joist should be treated due to reuse from concrete forms. This is an unacceptable practice as a way to cut corners. This is reused lumber. These joists should be treated with copper green.

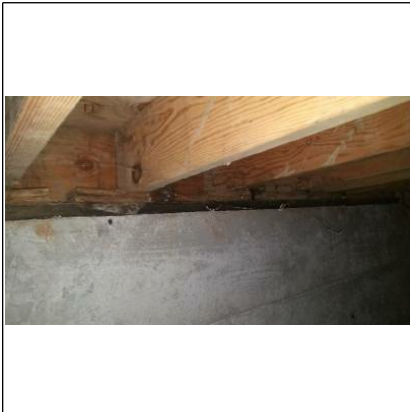
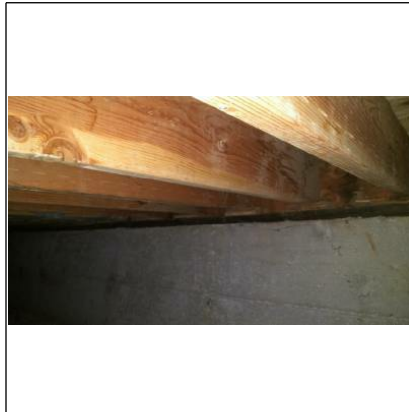
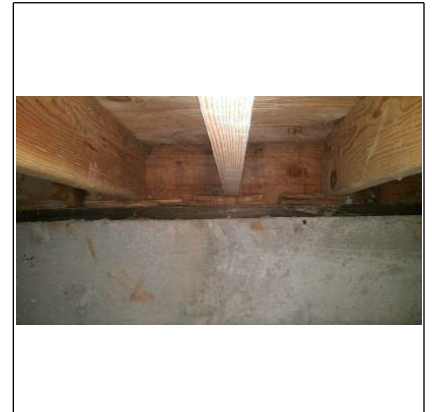
**Comments** Insulation missing underneath in areas that are below conditioned areas. All areas that are considered to be below a conditioned area must have insulation. The insulation that has been inspected is in good condition.
