Home Inspection Report

18279 Hidden Valley Road, Hidden Valley Lake , CA 95467

Monday August 14, 2023

Dustin Wallace General Contractor Home Inspections
16496 Main St.
Lower Lake, CA 95457
(707) 293-6307
dustinjameswallace1985@gmail.com

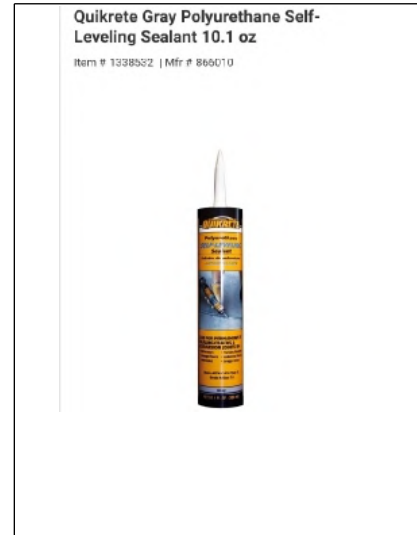
Tripping hazard

Recommend filling crack with gray polyurethane self leveling concrete crack sealant. (Comes in a caulking tube)

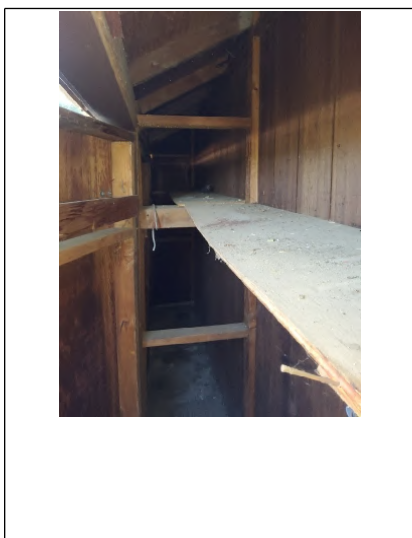
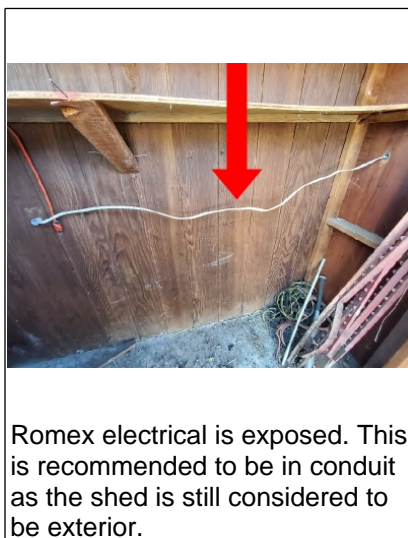
Romex electrical is exposed. This is recommended to be in conduit as the shed is still considered to be exterior.

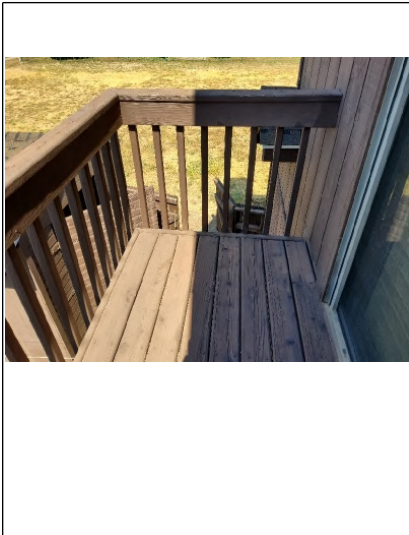
Plank members are loose. Recommend removing existing nails and refastening with 4" exterior screws.

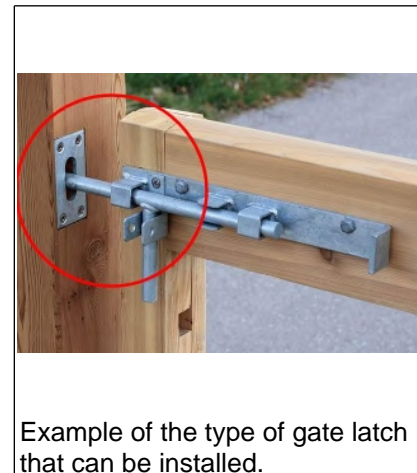
Gate is missing a latch

Example of the type of gate latch that can be installed.

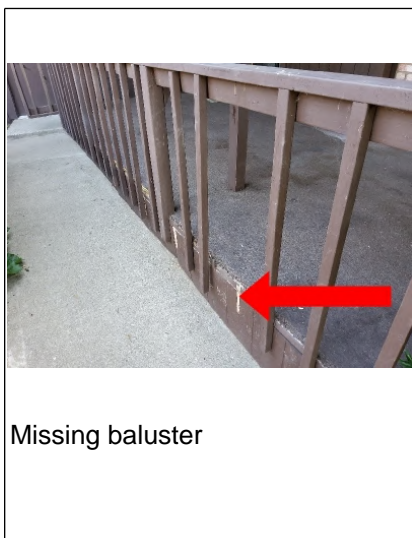
Missing baluster

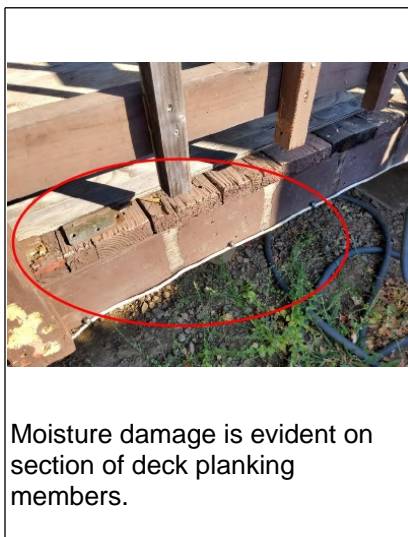
Moisture damage is evident on section of deck planking members.

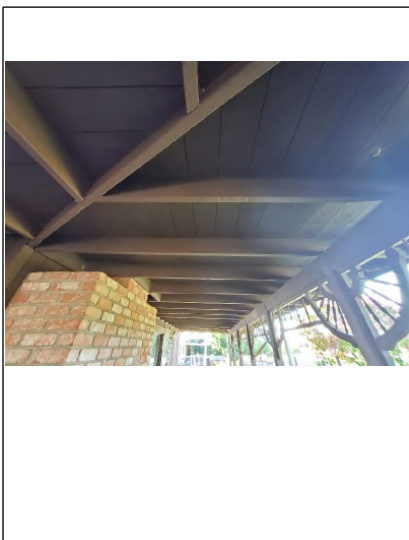
This is not of structural concern do not touch. This is T and G planking and the bottom female lip is just slightly damaged.

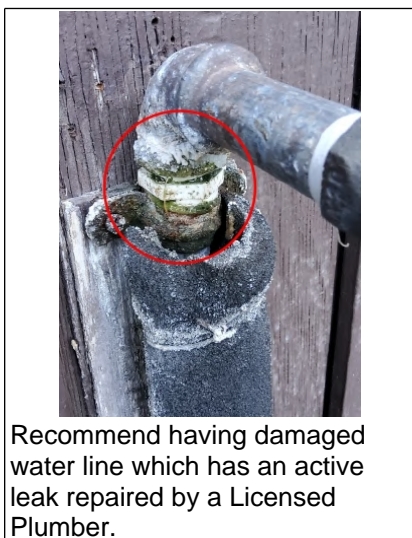
Recommend having damaged water line which has an active leak repaired by a Licensed Plumber.

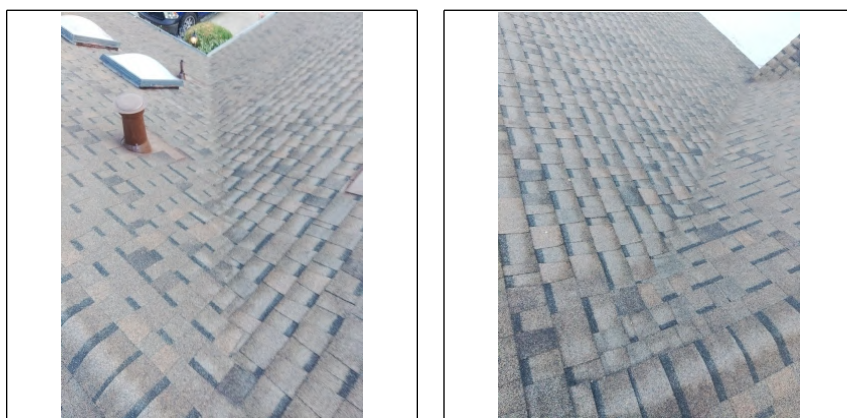
Comments *This is known as a weave design or others call a California Weave which is a much better way to roof a valley when doing a closed valley practice. This method is the best of the two styles while the other is known as a Closed Cut. With regards to protection from water protrusion through the seams between the roof sheathing. The other method is not a weave method. On this the roofers run a full starter down the valley and then snap a line and cut the shingles which only leaves one point protection from water protrusion through the sheathing. This way provides not only two layers of protection as a starter roll is used as well in the valley but with the weave has significant overlap that is not seen by the naked eye.*

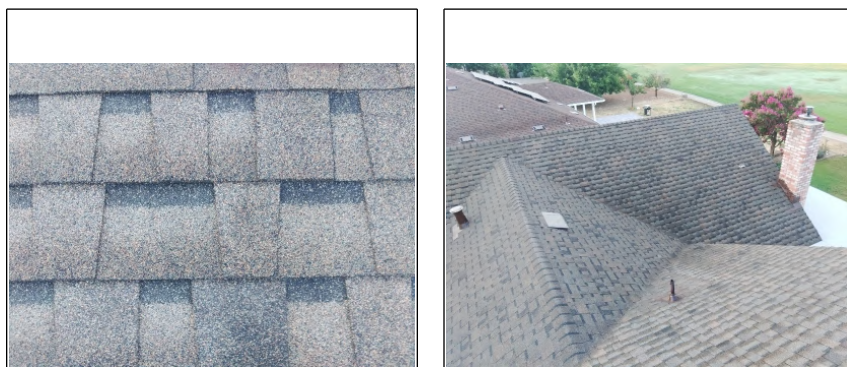
This is an accurate representation of the conditions of the roof shingles which are of satisfactory condition.

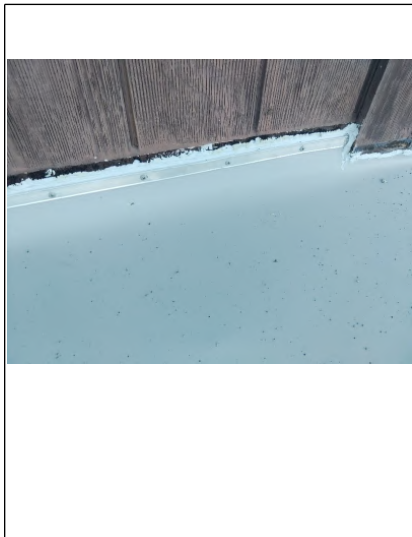
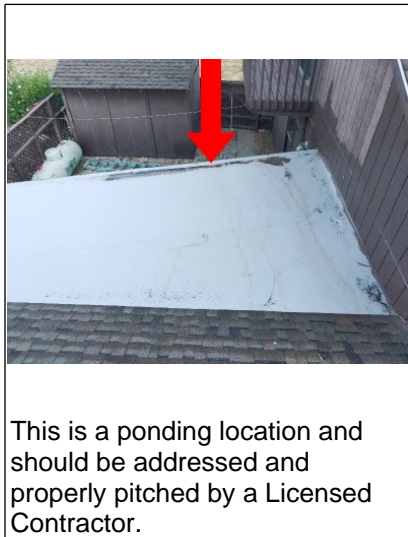
Comments **1. The ponding location that is noted in the pictures should be repaired by a Licensed General B Contractor or Licensed C39 Roofing Contractor.**

This is a ponding location and should be addressed and properly pitched by a Licensed Contractor.

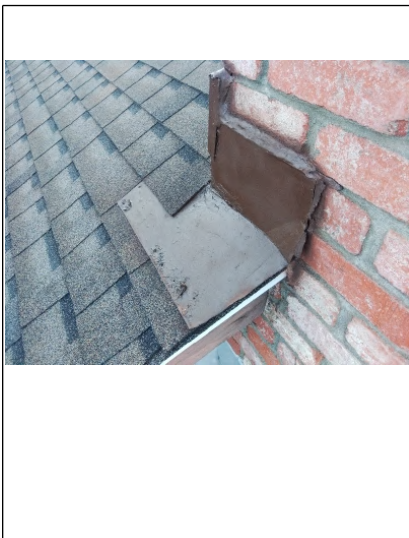
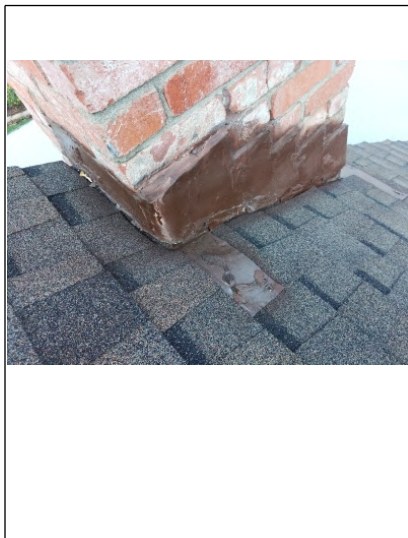
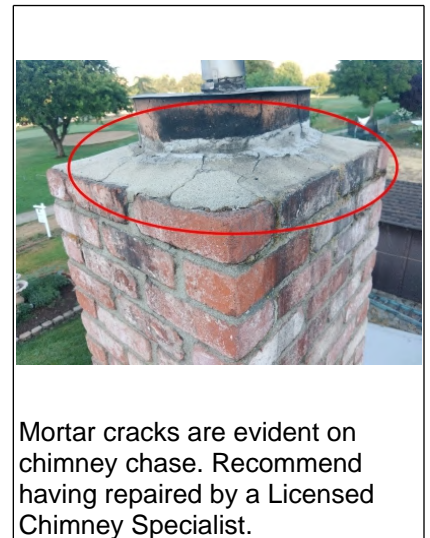
Comments **1. Mortar cracks are evident on chimney chase. Recommend having repaired by a Licensed Chimney Specialist.**

Mortar cracks are evident on chimney chase. Recommend having repaired by a Licensed Chimney Specialist.

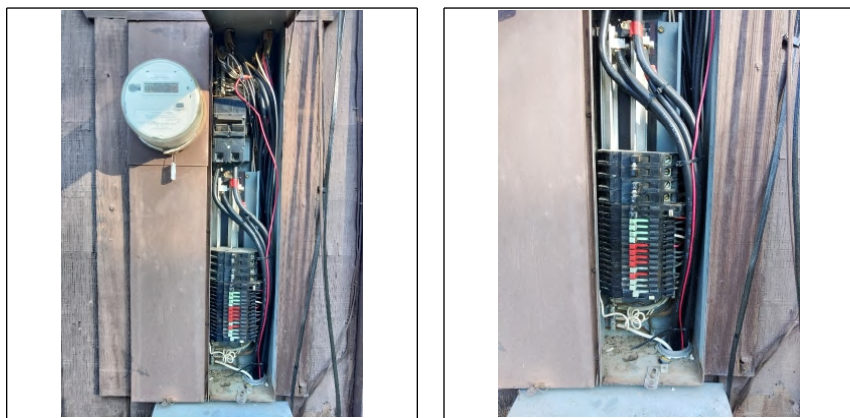
Comments 1. The main panel box is a Sylvania brand. Zinsco and Sylvania are one in the same as in 1973 Sylvania bought out Zinsco. The two major issues that the panel box s do have is the material used to construct the panels and breakers. I only take note of a major concern when I see burn or melting areas in the panel box or corrosion at the breakers. The breakers are also known to not trip as they are known to allow far more amperage than allowed. 25% of all Zinsco / Sylvania panel boxes are known to fail where the normal rate is 1% to 4% on other panel boxes. The plastics on the breakers are also an issue; the plastics often break down causing the breaker to still be energized when it appears to be off.

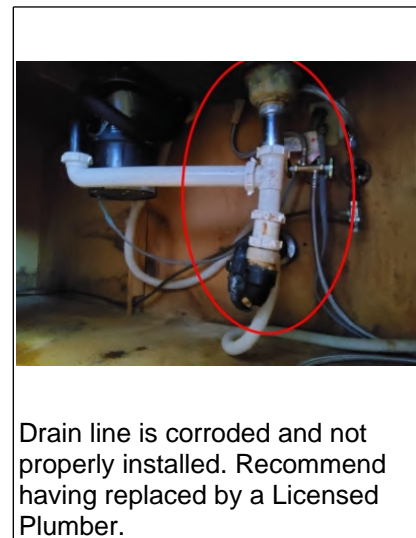
Comments **1. Drain line is corroded and not properly installed. Recommend having replaced by a Licensed Plumber.**

Drain line is corroded and not properly installed. Recommend having replaced by a Licensed Plumber.

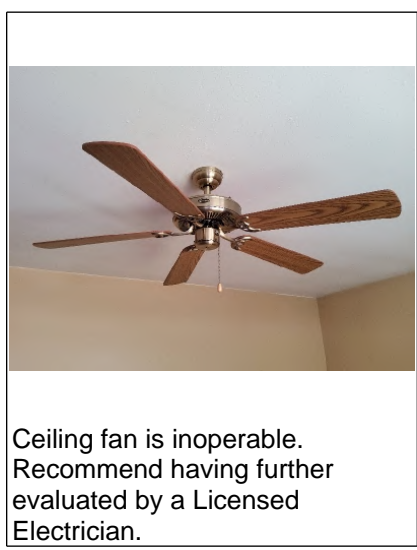
Comments 1. Ceiling fan is inoperable. Recommend having further evaluated by a Licensed Electrician.

Ceiling fan is inoperable. Recommend having further evaluated by a Licensed Electrician.

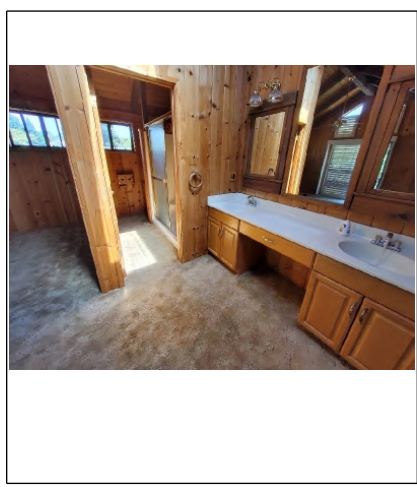
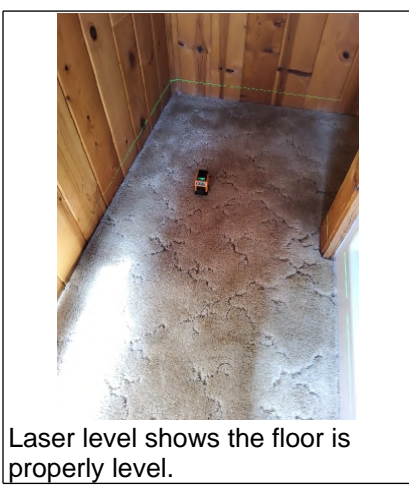
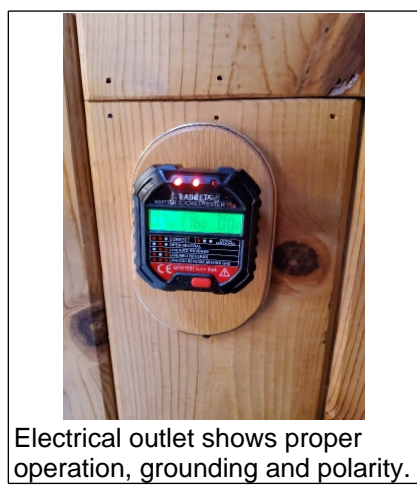
- Comments**
1. Sink drain line is not straight. Recommend having repaired by a Licensed Plumber.
 2. Toilet is loose at the base. Recommend having properly fastened to the floor from a Licensed Plumber.
 3. Recommend having aerator replace on faucet by a Licensed Plumber.

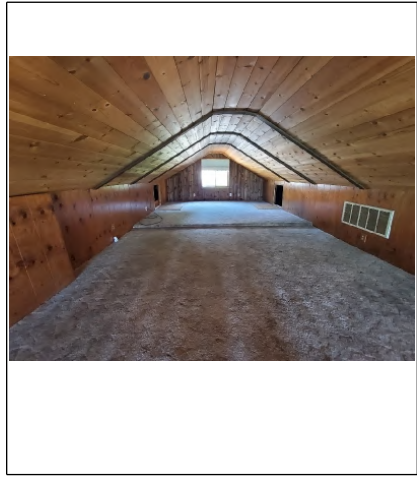
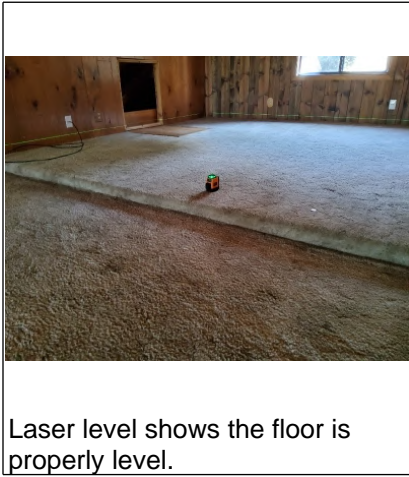
Comments 1. **Noted Electrical Outlets are inoperable. Recommend having further evaluated and repaired by a Licensed Electrician.**
