Home Inspection Report

18961 Coyle Springs Rd., Hidden Valley Lake, CA 95467

Wednesday January 25, 2023

This inspection is a Certified Roof Inspection from Dustin Wallace General Contractor Home Inspections CSLB#1052482. Home Inspectors are NOT licensed for Roof Certifications unless they also carry either a C39 Roofing Contractors License or a General B Contractors License. In these roof inspections the roof conditions (as well as the material used) are examined as well as flashing, plumbing vents, storm collars, the examination of gutter conditions (if present), the degree of water run off in the subterranean area (if crawl space is present) and most importantly structural (conditions of rafters, truss members, header beams, etc) if an attic is present then thermal readings are calculated to do determine if extra ventilation is needed. PLEASE REFER TO "REPORT SECTION" FOR A COMPLETE DIAGRAM BREAKDOWN WITH REGARDS TO THIS ROOF INSPECTION.

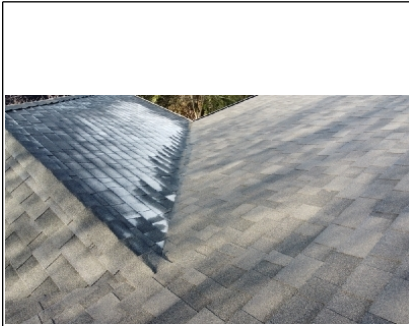
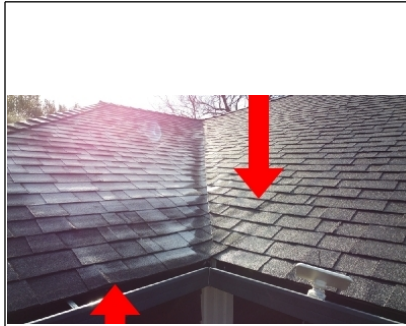
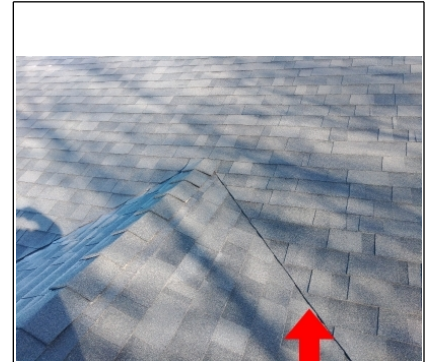
Comments The concern I have with the moisture staining and possible leak is at the the rear valley location. I am concerned whether the proper membrane was installed as again these stains do not appear to be from the prior roof, but again there is only one section of roof sheathing that really shows of structural concern or delamination. Therefore, the possible repair if needed is not a significant ordeal or cost. However, the concern I do have if which I do believe these are new stains are whether the valleys were properly flashed as closed cut valleys (which this is) is not always the best practical method but it does allow repairs to be done much easier then if there was a California Weave. As stated prior, I am concerned that the underlayment or starter roll did not go passed far enough up the hip from the valley causing water to seep through during extreme weather conditions.

Various shingles do appear to be having waves which is common. This is also relevant to the exterior temperatures being below 40 degrees during the inspection.

The concern I have is whether the roof shingles underneath span pass far enough to avoid water intrusion during significant storms. A section should be opened up to see the extent and what should be done. This is only a visual inspection and nothing has been opened up to confirm the extent. (This section is in relation to attic location that was referenced twice on December 5th 2022 and January 18th, 2023.)

A better application to do a valley is either a galvanized open valley or a California Weave. The weave is a much better way to roof a valley when doing a closed valley practice. This method is the best of the two styles while the other is known as a Closed Cut. With regards to protection from water protrusion through the seams between the roof sheathing. The other method is not a weave method. On this the roofers run a full starter down the valley and then snap a line and cut the shingles which only leaves one point protection from water protrusion through the sheathing. This way provides not only two layers of protection as a starter roll is used as well in the valley but with the weave has significant overlap that is not seen by the naked eye.

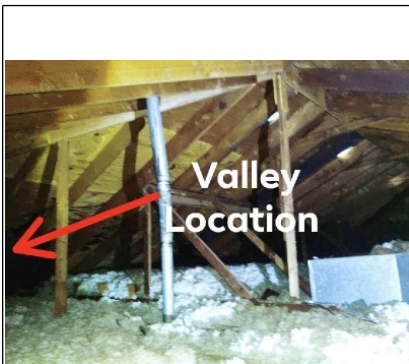
This is the attic view from the valley location.

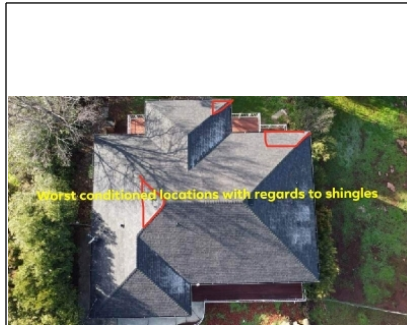
This diagram is in reference to noted locations that are considered the worst conditioned shingles. These locations should be addressed within 3-5 years based on the condition of the shingles themselves. This does not reflect the entire roof coverage.

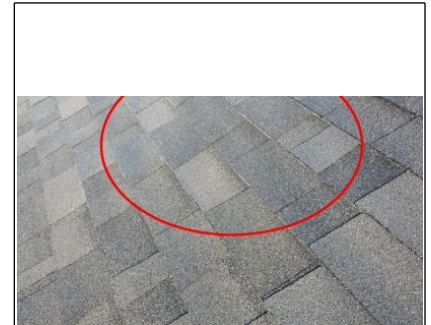
Location shows fiberglass lining around the base of the shingles.

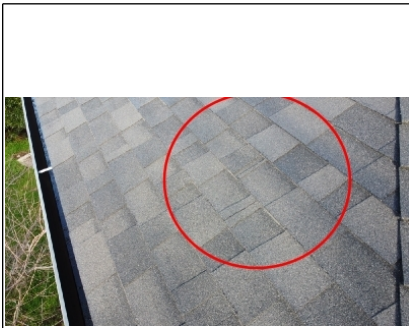
Location shows fiberglass lining around the base of the shingles.

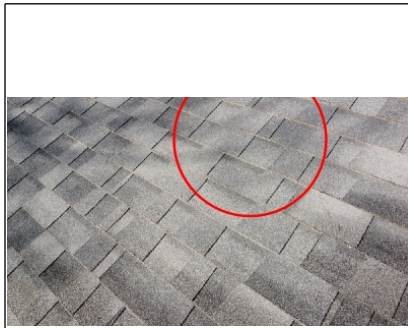
Location shows fiberglass lining around the base of the shingles.

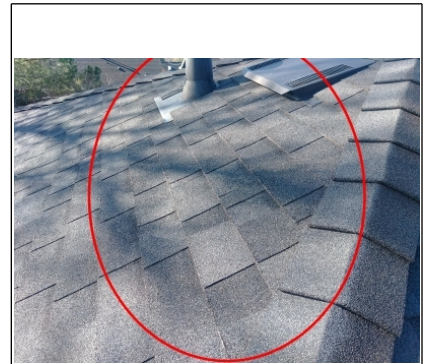
Location shows fiberglass lining around the base of the shingles.

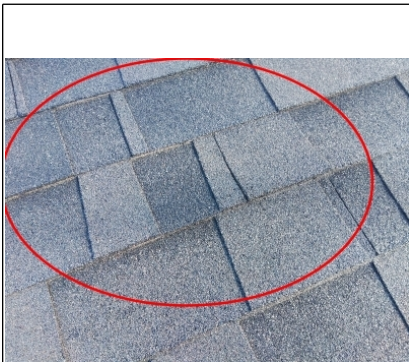
Location shows fiberglass lining around the base of the shingles.

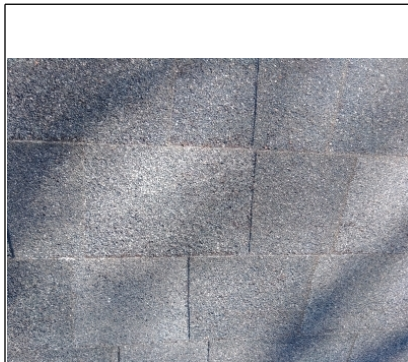
Upclose location with reference to conditions of shingles. (This only reflects the worst location and does reflect all the shingle conditions.)

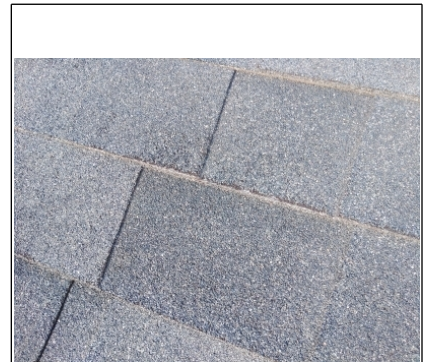
Upclose location with reference to conditions of shingles. (This only reflects the worst location and does reflect all the shingle conditions.)

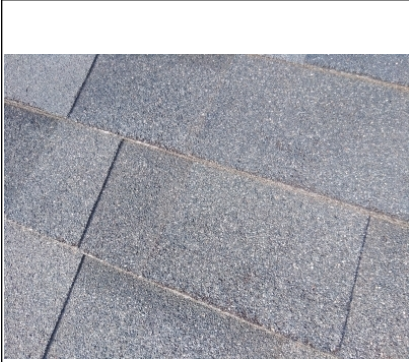
Upclose location with reference to conditions of shingles. (This only reflects the worst location and does not reflect all the shingle conditions.)

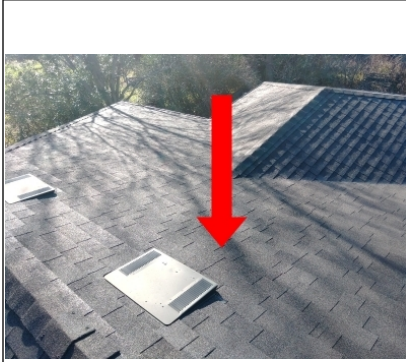
The largest concern with regards to roof conditions appears to be at the the valley location on the california hip that covers the rear deck. When walking the roof, I only felt one location that had possibly delaminated sheathing as it had a "bounce" and was in the area of concern (Refer to "Report Section: Roof"). Since no nail holes appear to be present I believe that water may have gotten passed the roof sheathing that is underneath the upper shingles and there possibly is not a proper underlayment with regards to protecting water from seeping into the sheathing itself. The extent is unknown until the section is opened up for further review. I believe being that it is a valley location with a good pitch there would not be extended noticeable damage on the loose insulation as there is no standing water causing a large amount of water droplets. With regards to the other water stains that are evident on the rafters without physically testing them I cannot determine the age but from the appearance themselves they do appear to be recent.

There is concerns with delaminated roof sheathing at this section.

I have contacted Lucerne Roofing with regards to this and have submitted this report to Lucerne Roofing for a deeper evaluation and possible roof repair bid. This is only a roof inspection and based on the conditions and concerns I would recommend a repair bid if needed be provided by Lucerne Roofing. I recommend them coming back out and reexamining the attic again after these pictures have been taken and further evaluating the areas of concern to provide a proper bid or repairs if needed.

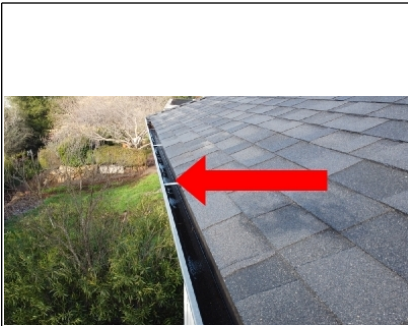
Standing water is evident. Most likely the gutter is clogged at the downspout location.

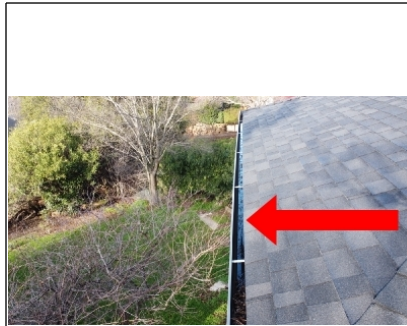
Standing water is evident. Most likely the gutter is clogged at the downspout location.

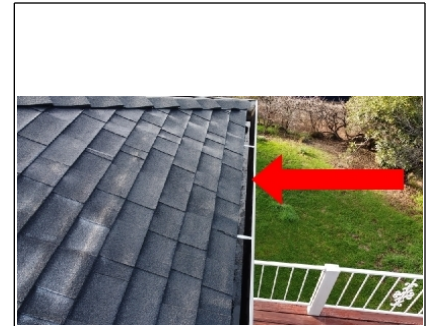
Standing water is evident. Most likely the gutter is clogged at the downspout location.

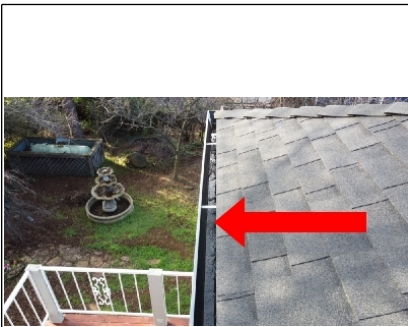
Standing water is evident. Most likely the gutter is clogged at the downspout location.

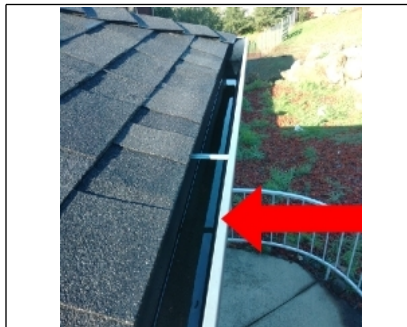
Standing water is evident. Most likely the gutter is clogged at the downspout location.

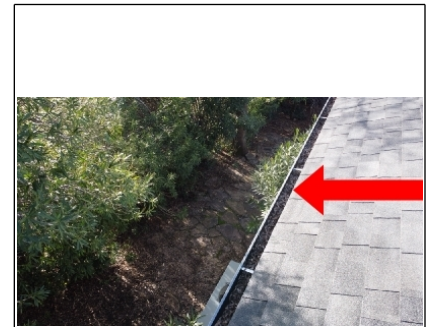
Excessive amounts of leaves are evident in gutter run. Recommend having gutters cleaned and possibly installing gutter covers at this location.

This gutter cover is a good option for that gutter run EasyOn Gutter Guard 24'

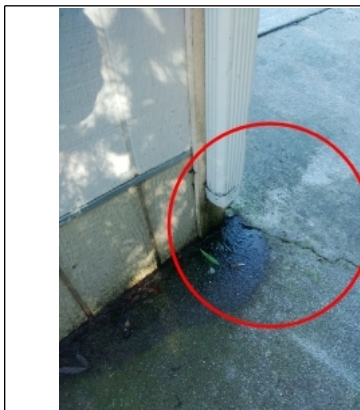
Crack on slab is from excessive water run off from lack of a proper elbow or drain extension.

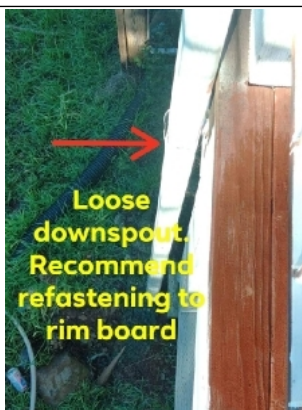
Loose downspout.
Recommend refastening to rim board

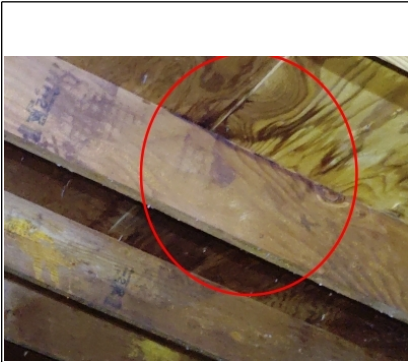
Moisture stains are evident from possible active leak.

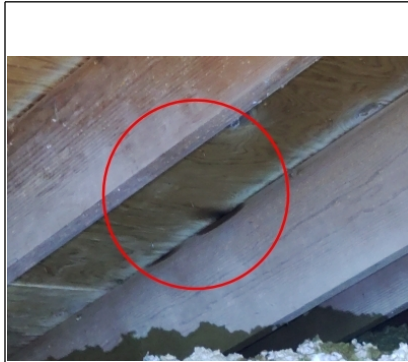
Moisture stains are evident from possible active leak.

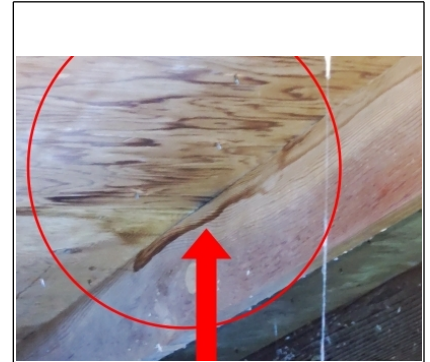
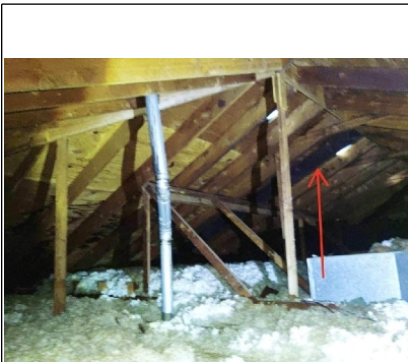
This location is of concern with delamination. Excessive moisture stains are evident on rafter and the arrowed location (referenced in the roof section) is of concern with delamination.

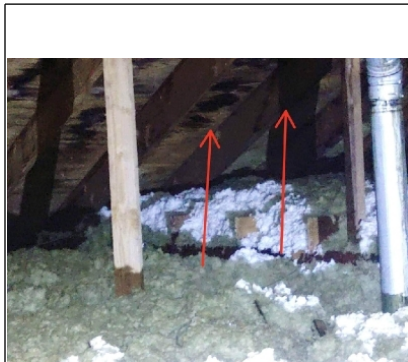
Arrows points to more locations of concern. (Again, at this location, when walking the roof the sheathing was not delaminated) only one small section of sheathing appeared to be delaminated.
