# Home Inspection Report

9472 Yaquima Drive, Kelseyville, CA 95451

Wednesday July 22, 2020

Dustin J. Wallace Construction and Home Inspections  
16496 Main St.  
Lower Lake, CA 95457  
(707) 293-6307  
dustinjameswallace1985@gmail.com

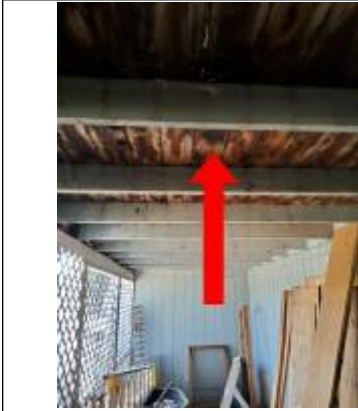
missing joist hanger nails.

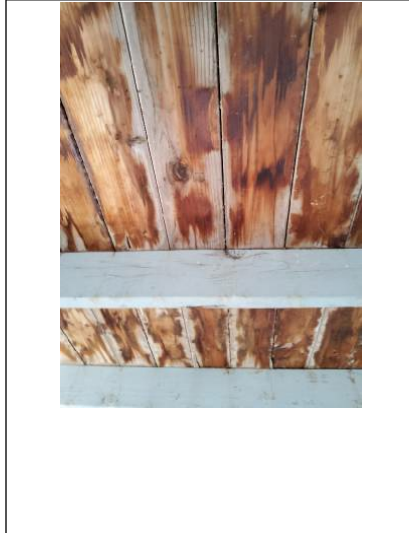
Moisture damage. However being a covered porch this is not a major concern as the deck still has kept its structural integrity.

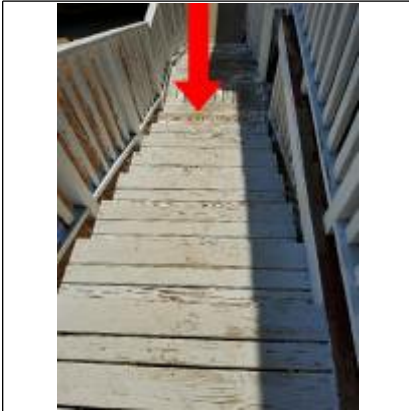
this step is a trip hazard needs to be refastened.

Steps need to be resanded and repainted. Contact Xavier a professional painter for a bid 707-320-8876

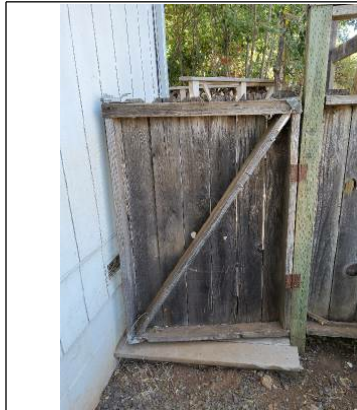
Not properly closing due hardware, installation and age.

Replace hinges (Rusted))

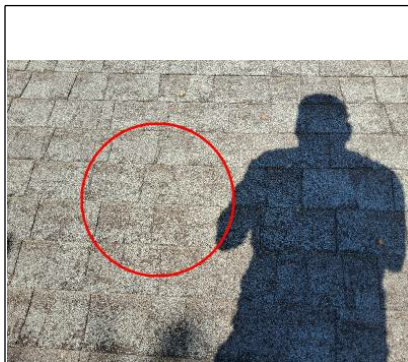
Two Layers of roofing

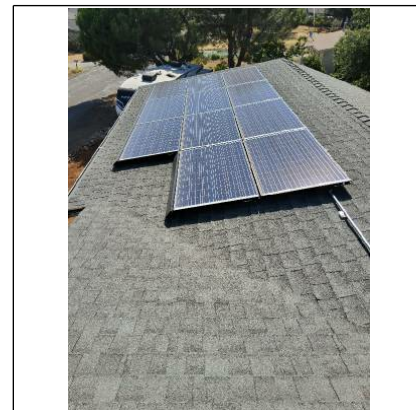
This is the sun facing dimensional roofing second layer that was installed over the 3 Tab roofing. This is the end of its life cycle and must be torn out and replaced.

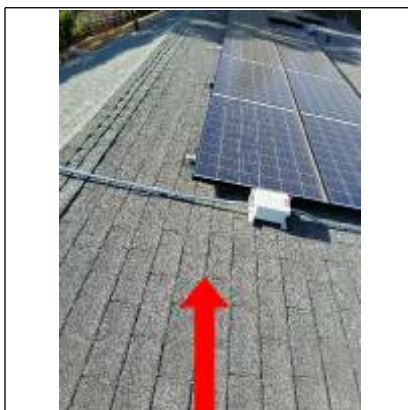
Two layers of roofing dimensional over 3 tab.

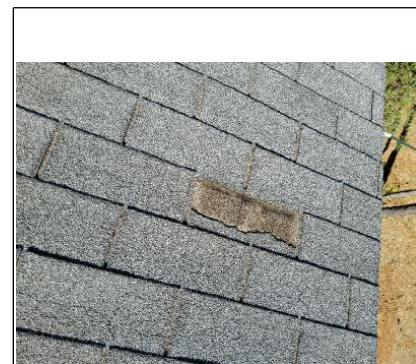
Roof needs to be replaced. In order for roofing to be replaced panels would have to be taken down. This 3 tab roofing life expectancy has been over for years.

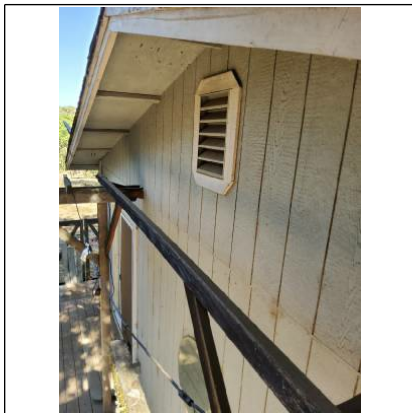
**Comments** Would require a controlled conditioned fan in the gable to operate for more proper air circulation.

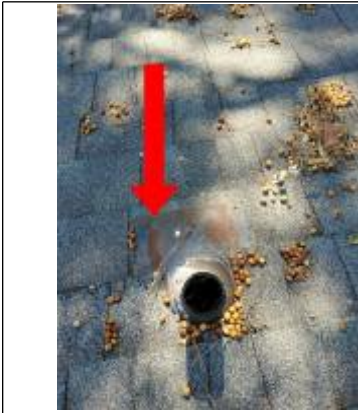
Again, rusted nails since nails are not to be used on exposed roof jacks. use a roofing tar over the nails to avoid future leaks.

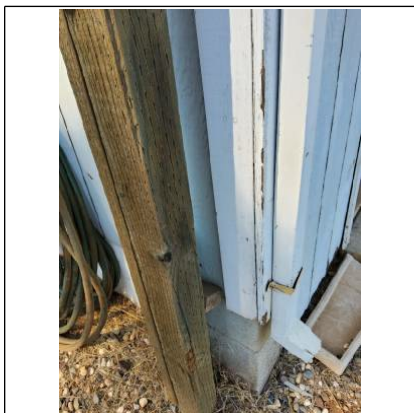
**Comments** Trim had some deterioration recommend repair and painting

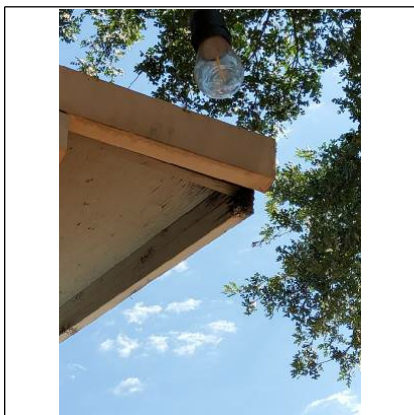
Facia needs to be repainted

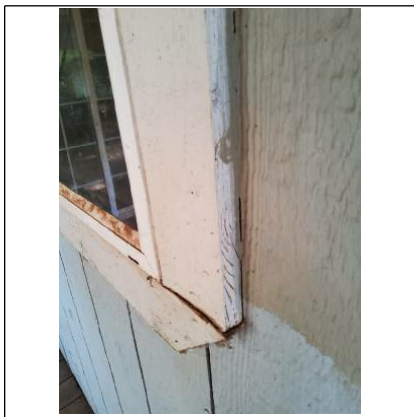
Most notable area of needed chalking

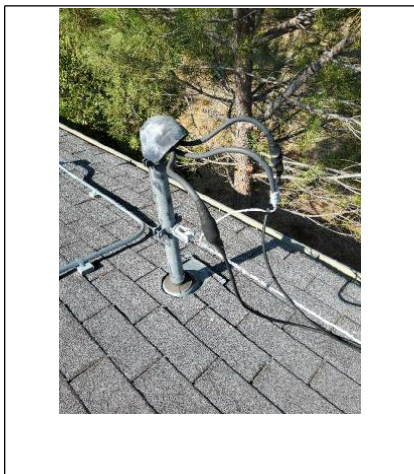
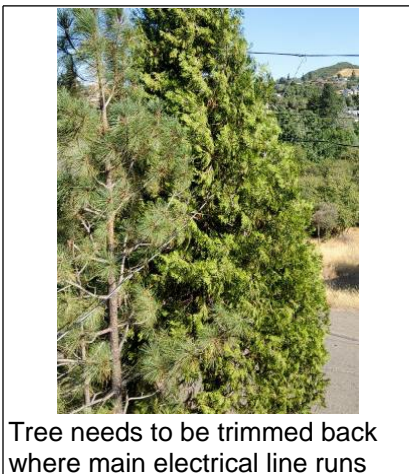
Tree needs to be trimmed back where main electrical line runs

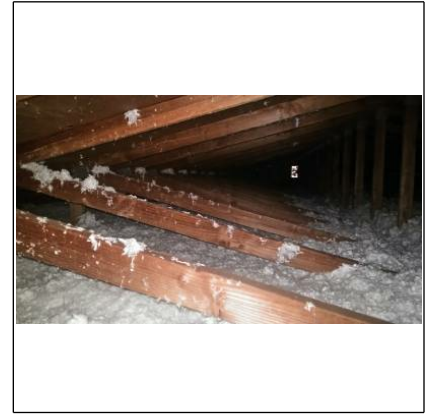
- Comments** Ventilation was marginal recommend additional ventilation be added  
Recommend adding a humidistat to the power vent.

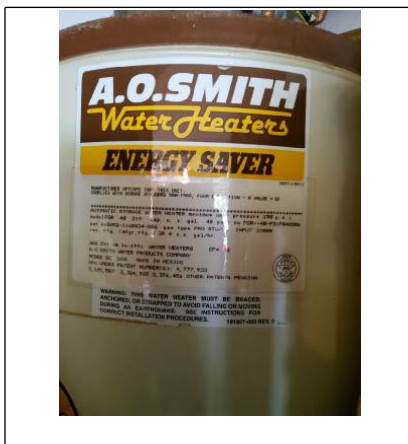
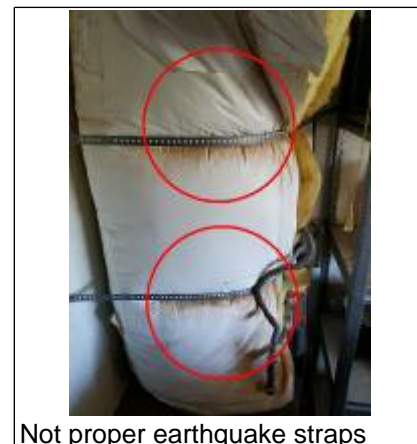
Comments Concerned this hot water heater is ending its life cycle.

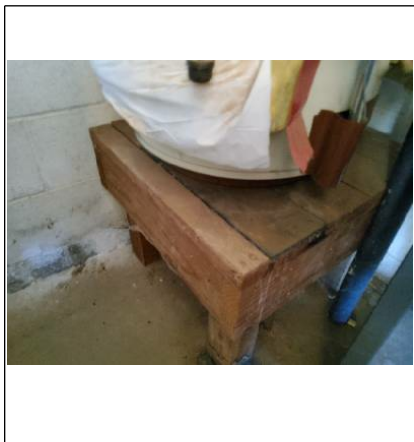
Not proper earthquake straps

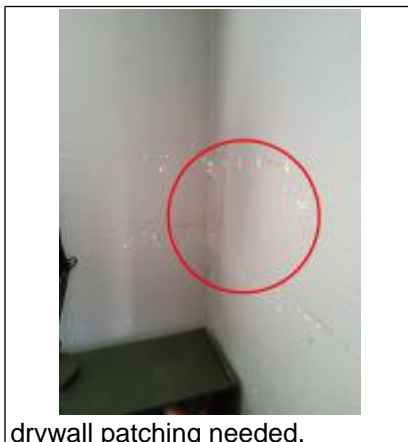
drywall patching needed.
