# Home Inspection Report

10698 North Slope Drive, Kelseyville, CA 95451

Thursday September 14, 2023

7776

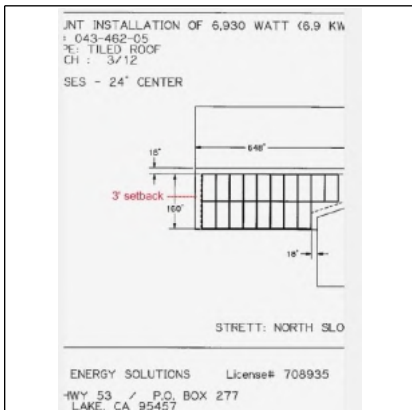
This is the set of plans that show a diagram of 3' setback

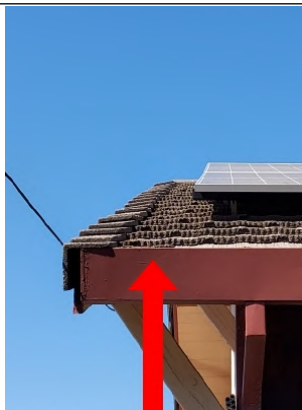
Clearly the solar panels do not have a 3' setback.

The first reason why the solar panels must be moved is for proper fire clearance in case there is a fire on the roof. The location of the solar panels could also be a concern if this home does get on the California Fair Plan, which is high-risk fire insurance. I would recommend having the fire marshal evaluate the location of the solar panels to determine if the locations of the solar panels are considered a fire hazard given that they do not provide proper clearance of a minimum of 3'.

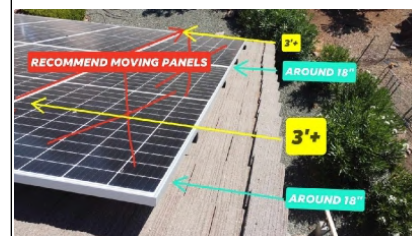
This is a diagram that shows the estimated clearance of the solar panels during the inspection and the need to move the last row of the solar panels.

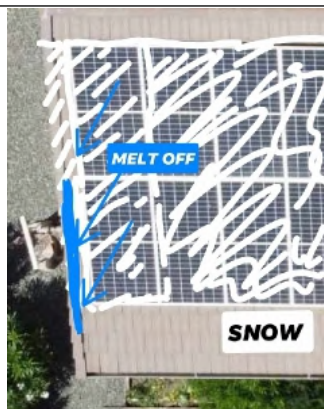
The second reason why the solar panels must be moved is that the overhang that has tongue and groove already was dipping because of the excessive weight (corbels were most likely installed later) from the concrete tiles on the roof. Combining that with water runoff from two rows of solar panels has and will continue to seep through the tongue and groove overhang, causing additional water damage to the already dry-rotted sections of the overhang. This winter also did not go well with the solar panels, especially after having 1' of snow on top of them. There is enough evidence to show that the snow that was sitting on top of the solar panels did slowly seep through the roof tiles and the tongue and groove planking on the overhang. If the solar panels were installed 3' from the edge like originally shown on the approved set of plans, then the water damage would not have been as significant because the snow would have melted within the roof sheathing location.

This is a diagram showing where the snow melt on the solar panels would have seeped through which is where the damage is on the overhang. (Of course all of the concrete tile roof was covered in snow)

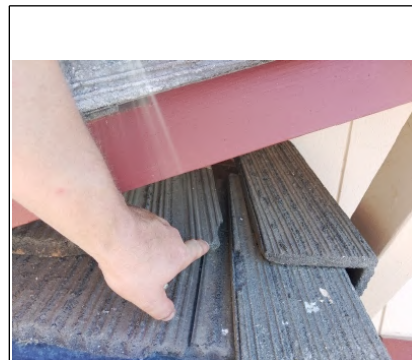
This concrete tile is loose. I would recommend having repaired by a Licensed Roofing Contractor.

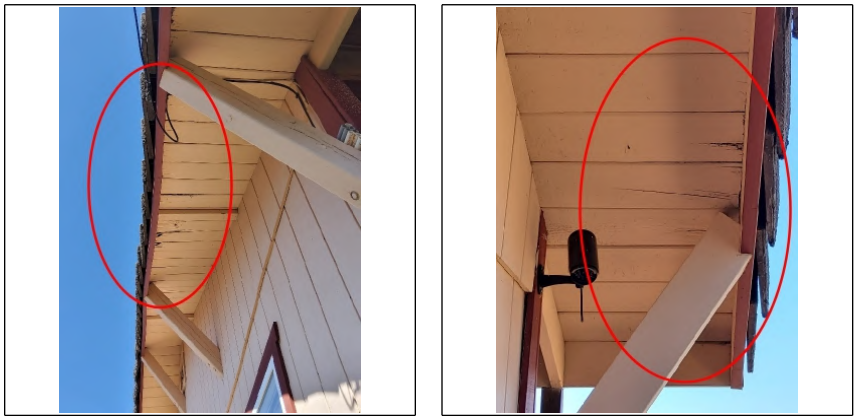
**Comments** As stated in the summary the tongue and groove overhang is damaged at these locations from both the dip in the overhang as well as contribution from the solar panels that are 18" from the edge of the roof.
