# Home Inspection Report

15208 Harbor Lane, Clearlake, CA 95422

Monday August 21, 2023

3233

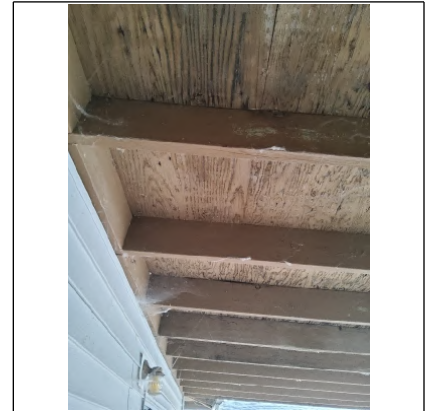
**Comments** **1. Recommend replacing moisture damaged sheathing. This should be handled when removing all of the existing 3-tab shingles and applying the correct material roll asphalt based on the roof pitch. The reason for the moisture damage and staining is that the water seeps through the shingles.**

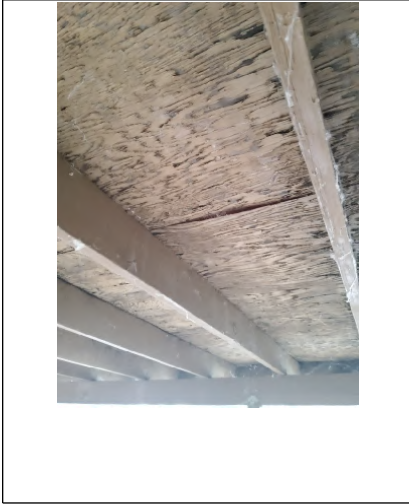
Reference location for prior slide of worst condition sheathing location.

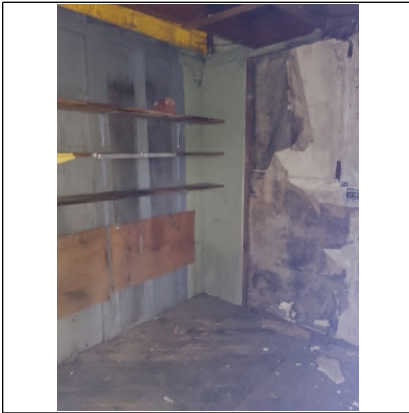
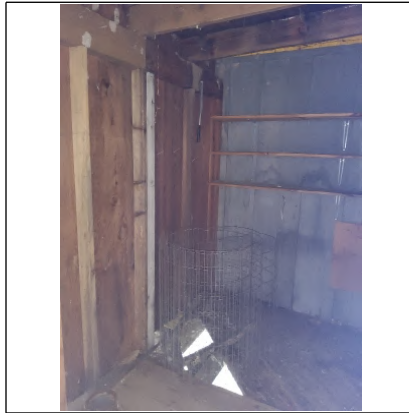
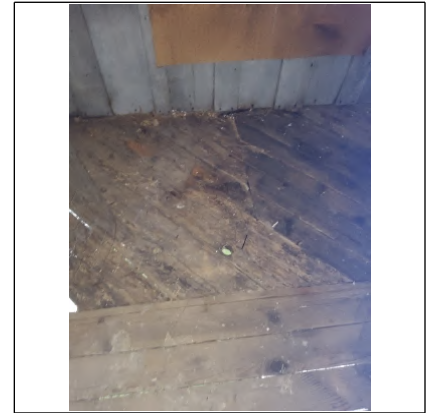
**Comments** 1. Recommend removing and replacing all moisture damaged wood members.

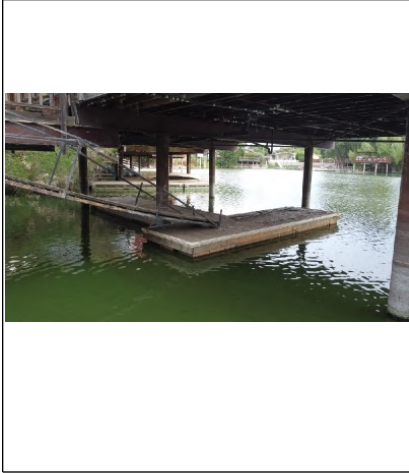
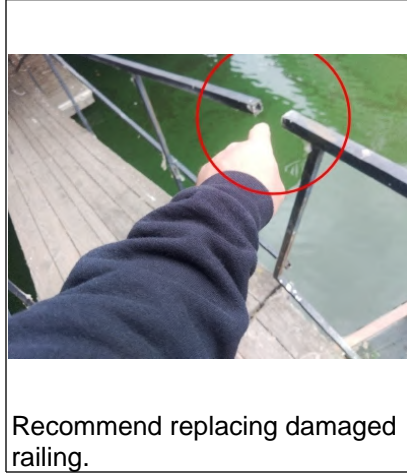
**Comments**    **1. Recommend replacing noted damaged railing.**

Recommend replacing damaged railing.

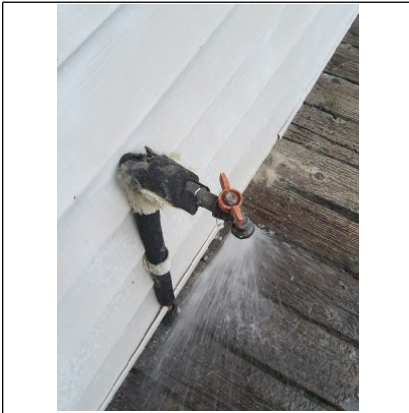
**1. Recommend replacing leaking hose bib.**

Recommend replacing leaking hose bib

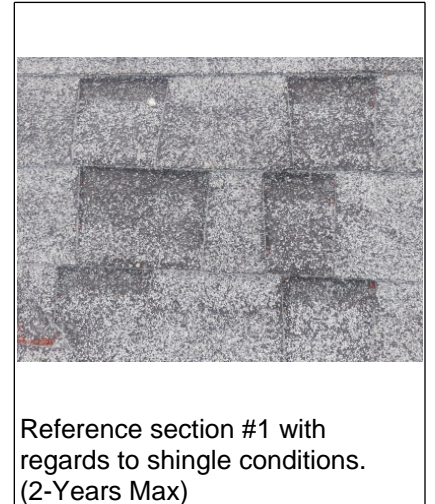
Reference section #1 with regards to shingle conditions. (2-Years Max)

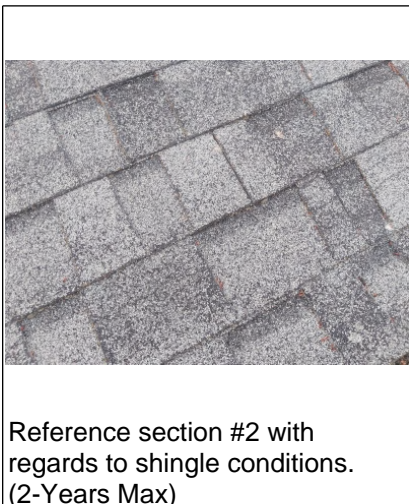
Reference section #2 with regards to shingle conditions. (2-Years Max)

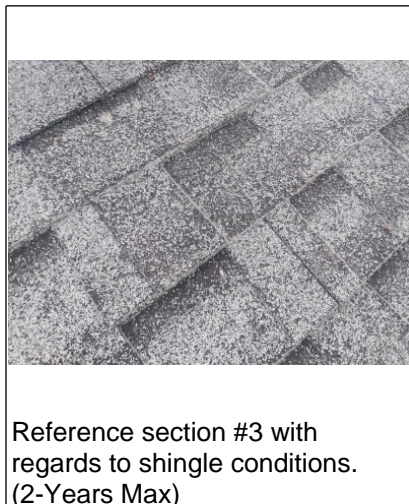
Reference section #3 with regards to shingle conditions. (2-Years Max)

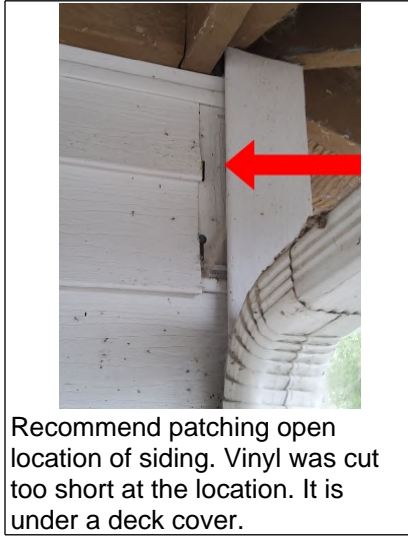
Recommend patching open location of siding. Vinyl was cut too short at the location. It is under a deck cover.

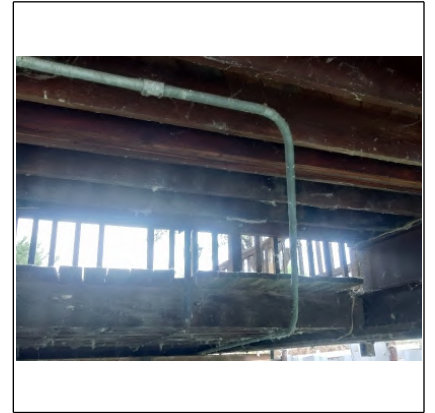
Electrical outlet has no proper grounding. Recommend further evaluation and replacement by a Licensed Electrician.

Recommend replacing electrical outlet with a GFCI and installing an exterior cover.

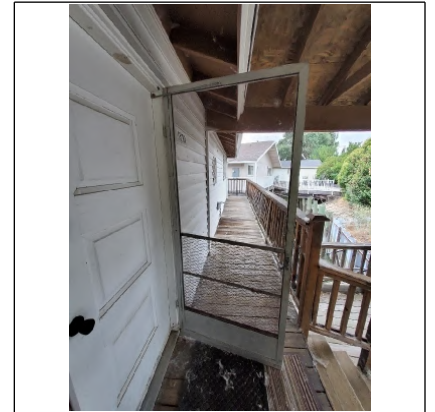
Damaged screen door.

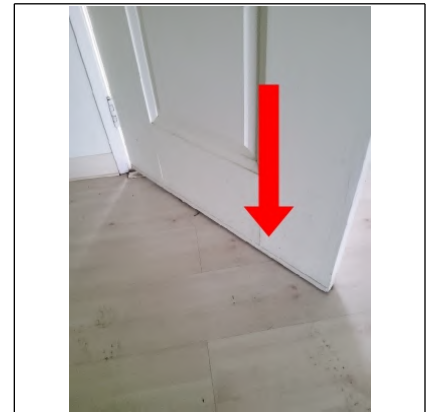
Loose handle

Recommend replacing door sweep to ease the operation of the exterior door.

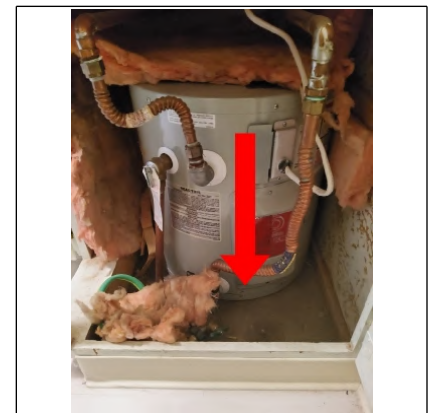
Water heater is missing seismic straps.

Water heater is in a living area and should have a drain pan. Recommend having a drain pan installed and a drain line stubbed to the exterior wall in the underfloor location. (Or in this situation the floor)

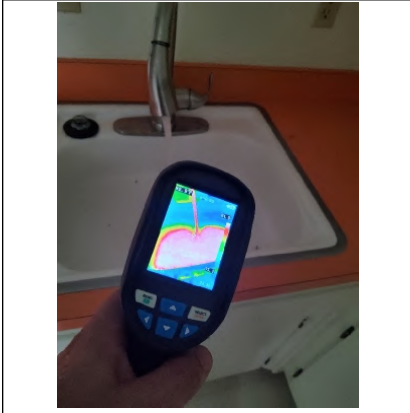
Thermal Imager shows 82 Degrees F on faucet which shows the water heater is operating but there could be an issue with the heating element.

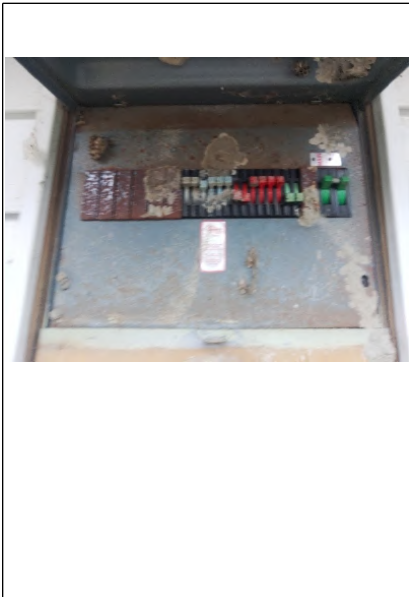
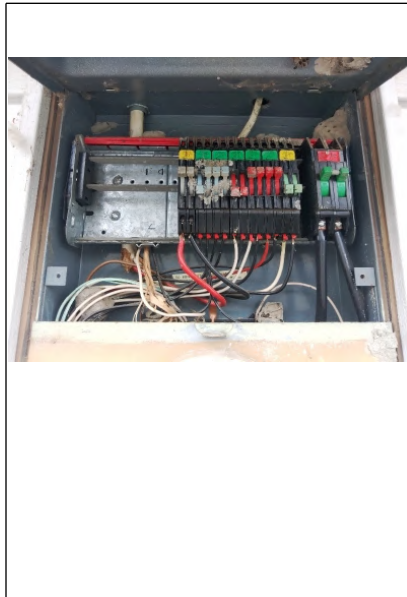
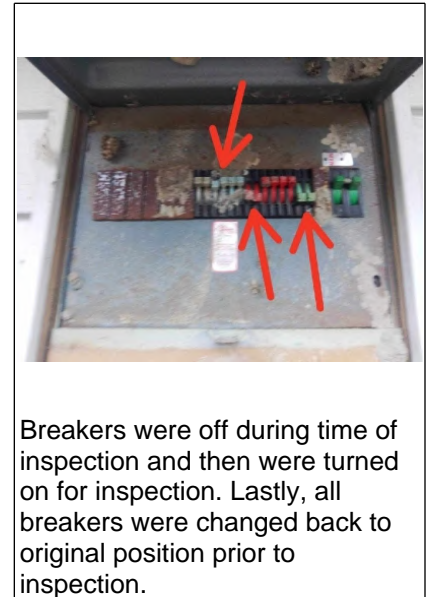
**Comments** **1. Recommend having Zinsco panel box replaced by a Licensed Electrician. The two major issues that the panel box s do have is the material used to construct the panels and breakers. I only take note of a major concern when I see burn or melting areas in the panel box or corrosion at the breakers. The breakers are also known to not trip as they are known to allow far more amperage than allowed. 25% of all Zinsco / Sylvania panel boxes are known to fail where the normal rate is 1% to 4% on other panel boxes. The plastics on the breakers are also an issue; the plastics often break down causing the breaker to still be energized when it appears to be off.**

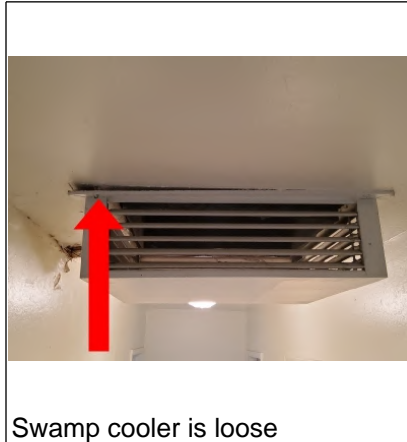
Swamp cooler is loose

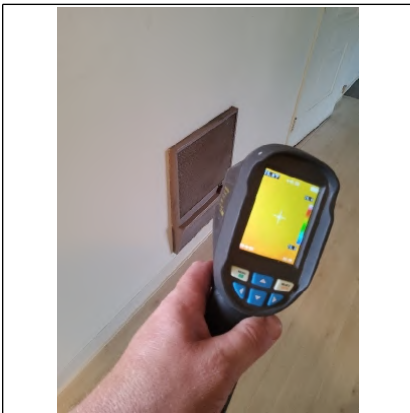
Comments **1. Thermal Imager shows wall heater is inoperable when testing.**

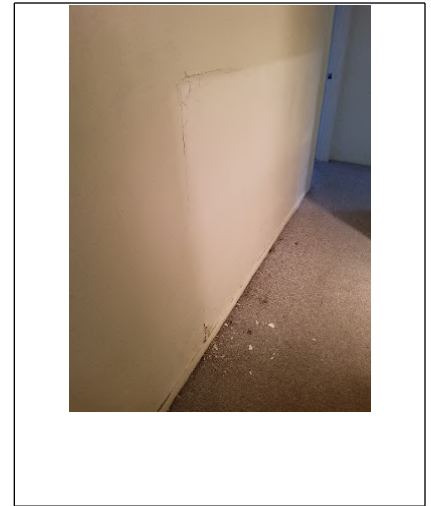
Damage is evident on drywall. Recommend having damaged drywall replaced and patched.
