“Full” Reserve Study

Sun Country Maintenance Association Cle Elum, WA

Report #: 27561-0

Date Prepared: September 24, 2015

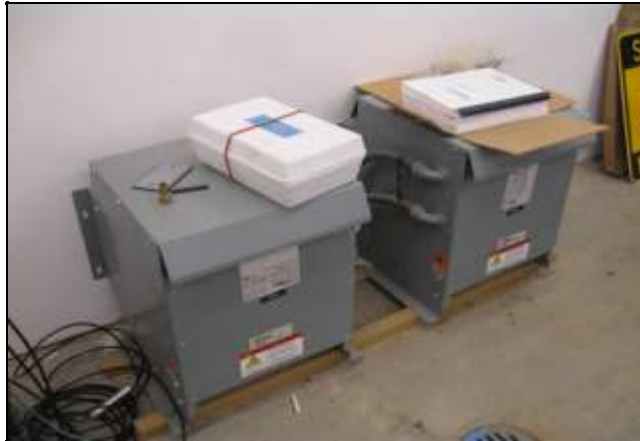
Comp # : 825 Transformers - Replace Quantity: (2) 480 Volt
 Location : Pump station interior
 Funded? : No Useful life not predictable, repair/replace as needed out of operating budget
 History : Installed in 2011
 Evaluation : Assumed to be performing as designed, no problems reported.

These types of transformers, especially when not exposed to outside elements, have an extended life expectancy. Based on expected long life and lower cost (~ \$2,000/each), reserve funding is not recommended for this component.

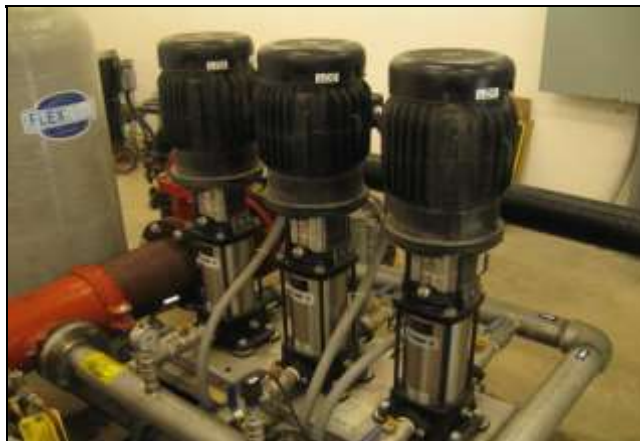
Comp # : 830 Pumps - Replace Quantity: (3) 5hp Grundfos pumps
 Location : Pump station interior
 Funded? : Yes
 History : Installed in 2011
 Evaluation : Main pressure pumps are reportedly functioning as designed.

These pumps will eventually wear out and require regular cycles of replacement at roughly the time frame indicated below. Monitor closely and adjust as needed in future reserve study updates.
