Case Report – Outlet Pigtailes Creep Damage Assessment

This case report summarizes the condition assessment performed on outlet pigtailes at a reformer unit. The work was conducted by SOIL Ingeniería Ltda. as part of a broader evaluation of the reformer's operational condition, specifically to assess the effects of creep damage on Alloy 800HT outlet pigtailes. Data was collected through dimensional measurements, visual inspections, and review of metallographic replica results.

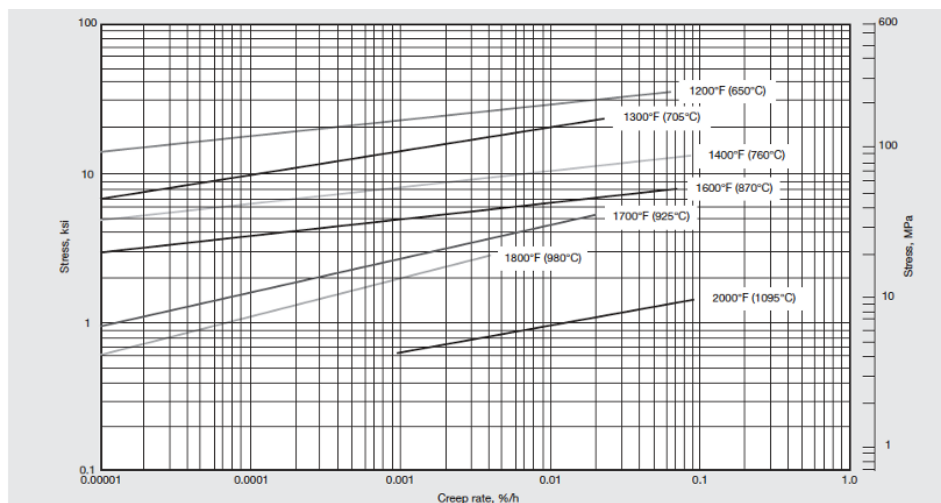
OD measurements were taken on selected pigtailes where insulation was removed for inspection. These measurements were compared to nominal values and plotted against creep rate curves for Alloy 800HT. The plots indicated that some pigtailes have been operating at higher-than-design temperatures, resulting in elevated creep rates.

Figure 1: Reference chart or dataset visualization (Special Alloys)

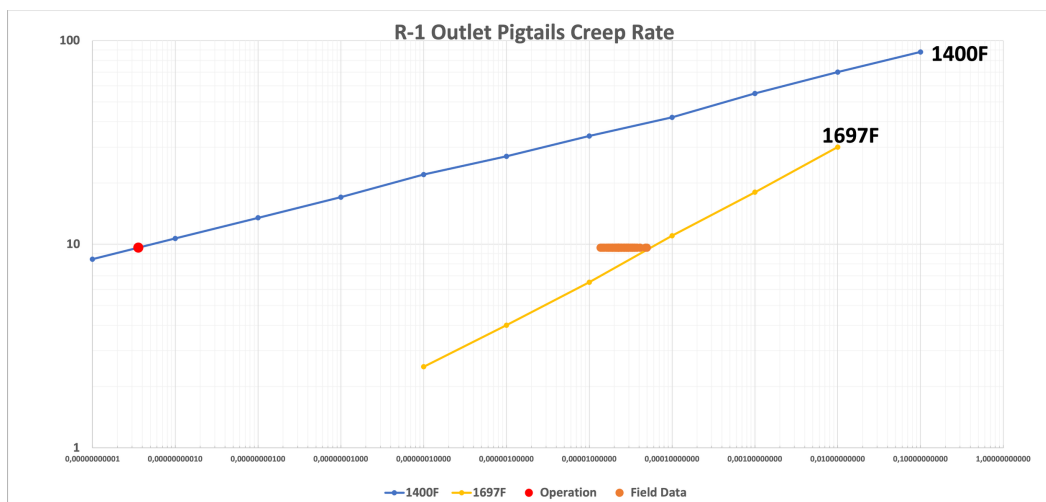
Figure 2: Real Creep of pigtail as measured. Note 1400F is the operation set point

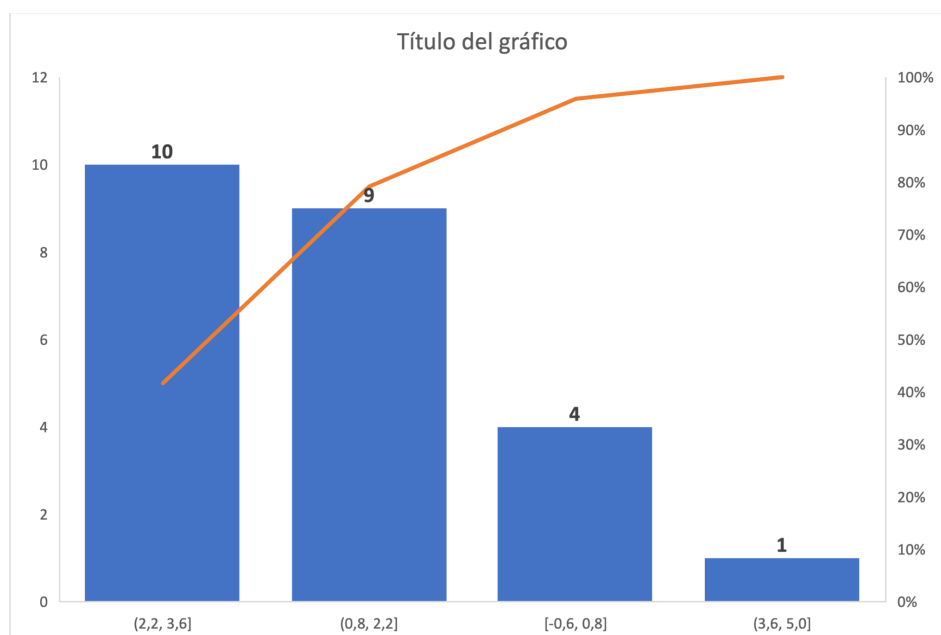
Figure 3: % of expansion from Nominal Diameter.

The OD expansion measurements suggest localized overheating in certain reformer zones. Visual inspection of catalyst tubes and pigtailes confirms high-temperature operation episodes like start-ups. Replica results showed sensitization, which is expected at service temperatures and does not directly indicate creep damage. The presence of sigma phase could contribute to crack propagation but is not the primary cause of creep-related failure.

- 5.1. Remove and destructively examine at least one pigtail to correlate OD expansion with metallurgical condition.
- 5.2. Establish a baseline OD measurement for all replacement pigtailes.
- 5.3. Perform a reformer-wide OD mapping to identify hotter zones and manage operational risk.
- 5.4. Evaluate the installation of Tube Growth Monitoring (TGM) systems for real-time assessment of thermal growth and hotspot detection.
- 5.5. Send removed samples to an accredited laboratory for detailed metallurgical evaluation.

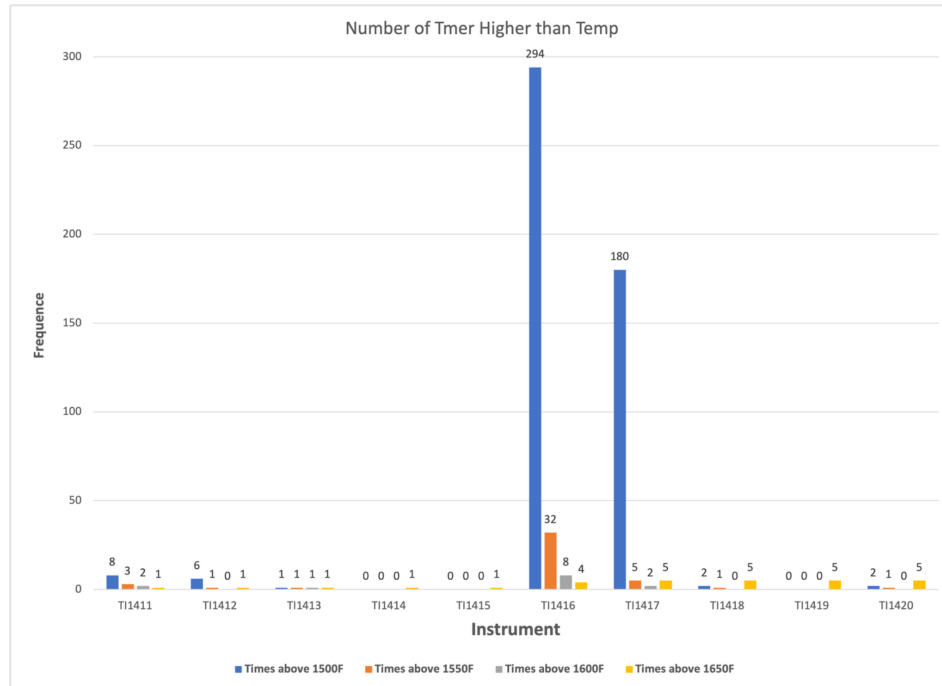
Figure 4: Times that the temperature were above the max allowable.

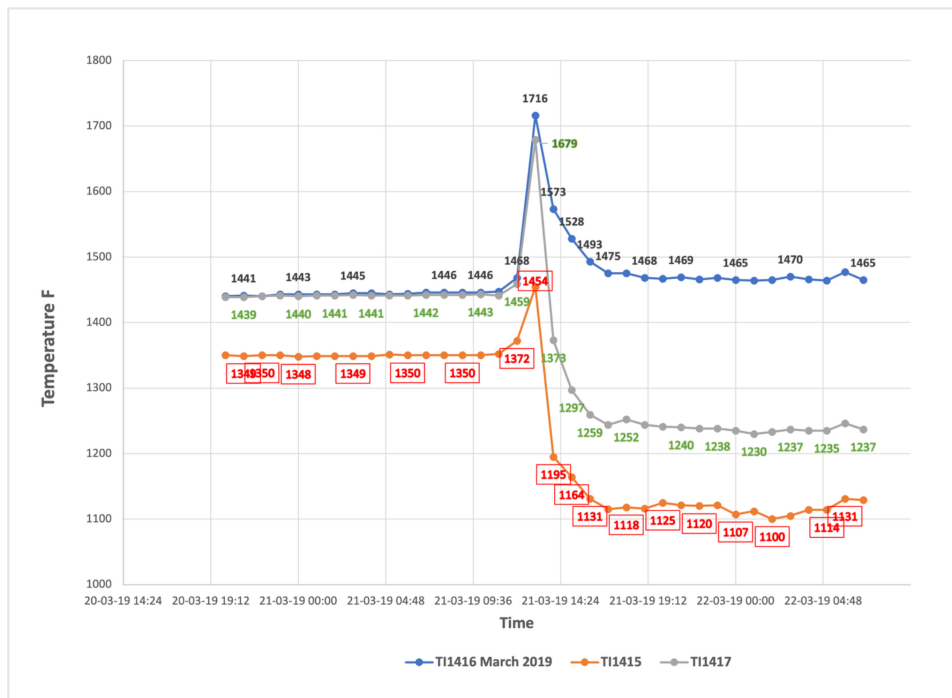
Figure 5: Temperature spike on March 2019.

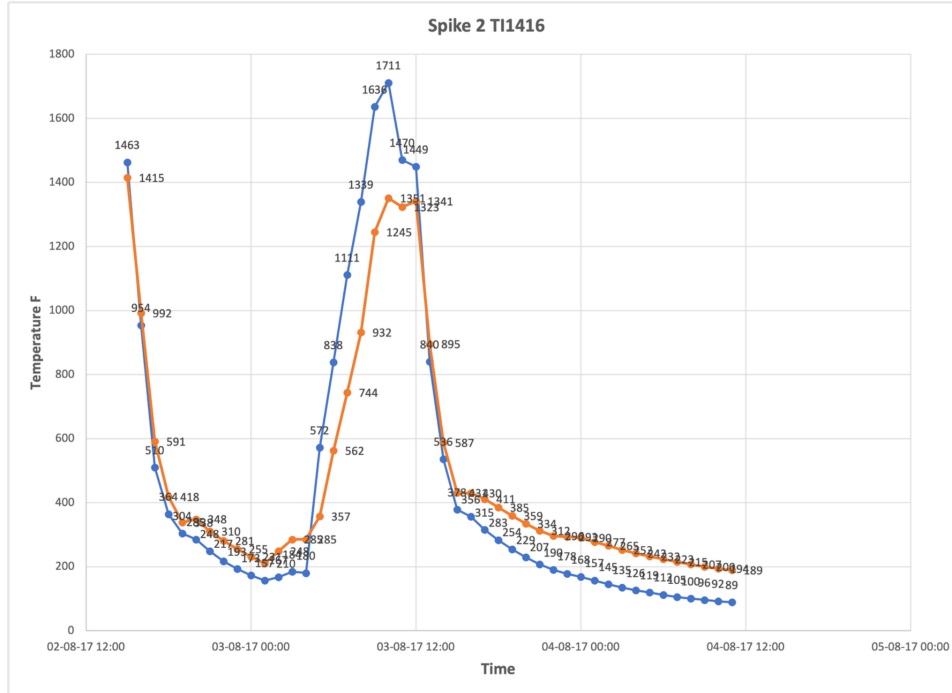
Figure 6: Temperature spike on August 2017.

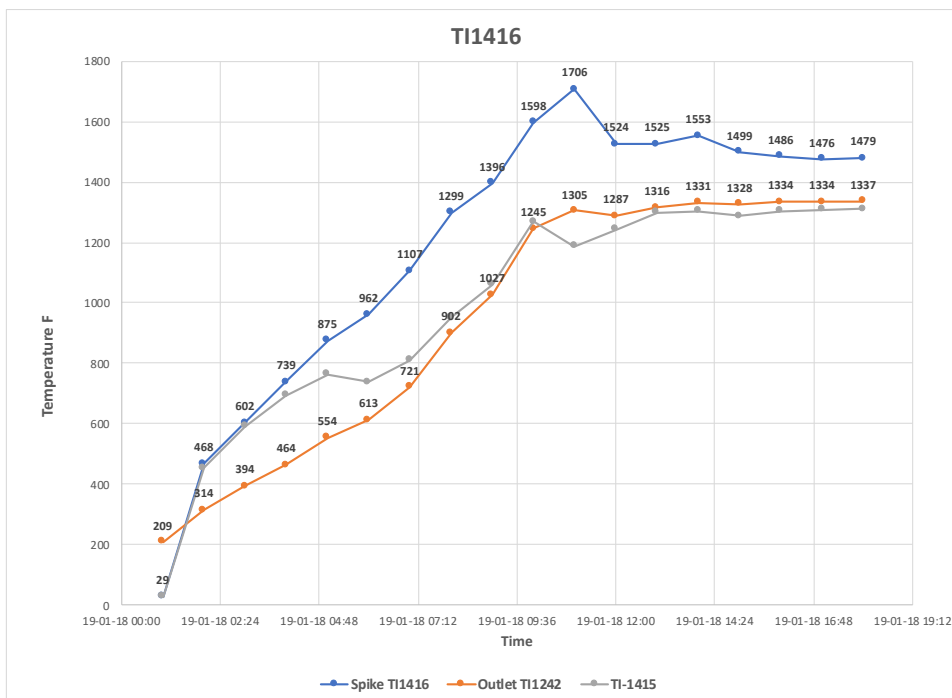
Figure 7: Temperature spike on January 2018.
