<b>Steam reformer – Eddy Current Report</b> <b>Reliability Analysis</b>	<b>Report: RPT-002</b> <b>Revision: 0</b> <b>Date: April 6<sup>th</sup>, 2025</b> <b>By: O.Olatte</b>
--	--	--

This report details a reliability analysis to the reformer status based on Eddy current inspection results report to the catalyst tubes installed in the Reformer US-01-103-R-0100, located at VertGTL plant in Lake Charles, LA. As an additional antecedent, is considered a report based on a LOTIS inspection report from 2004, issued by LENA (Linde) in 2013 as preparation to the reformer inspection and works made in 2014.

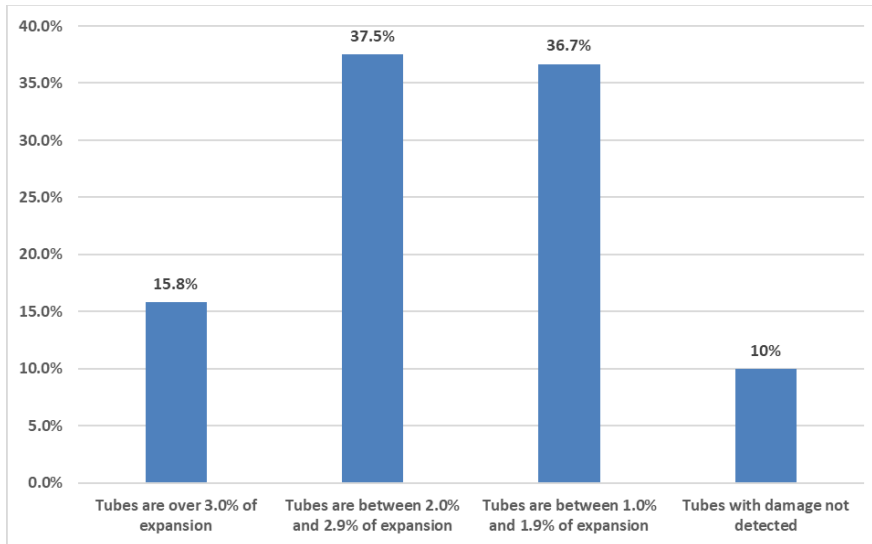
It can be observed that the great part of the tubes today are in the range between 1.0% y 2.9% with a distribution quite normal. See figure below.

This reveals that there is a great number of tubes that are progressing to 3% and above expansion. It can be seen that the tubes over 3% tend to be greater than those with no damage detected, insinuating a growing tendency of these tubes. This transition depends on temperature, time and transients in service. This applies despite the number of tubes removed and replaced.

As presented on the Pareto chart, the tubes 3% or above in diameter expansion have to be replaced to avoid an unexpected and expensive reformer shutdown.

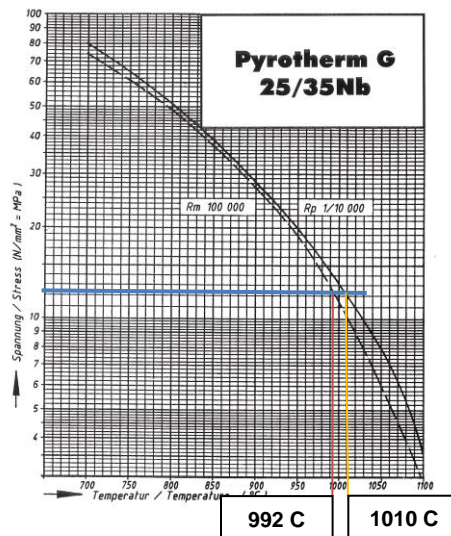
**Note:** at the design stress the Pose Maree material fits the 100,000 hrs (min) and plus rupture life. At the design pressure the allowable temperature for 100,000 hrs is about 992 C. Design temperature is 971C. The service life designed of 135,000 is credible.

The problem detected here is not one about design is a malfunction of the arch burners system. Causes have to be investigated in order to find a solution.

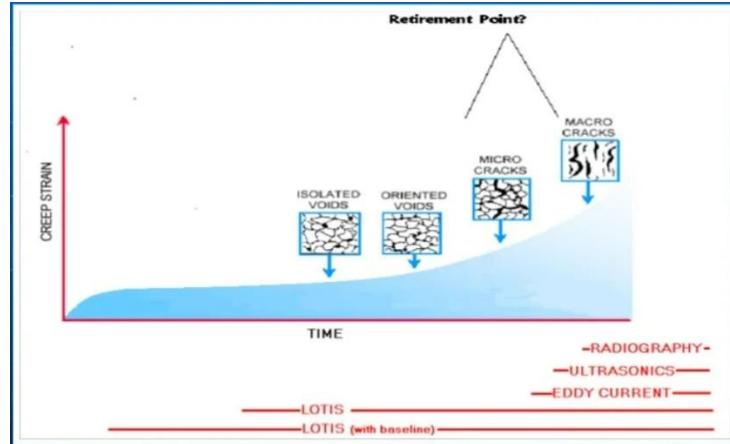
- 4.5 It is relevant to point out that the Eddy Current respond, obviously, to the sensitivity of the technology, hence, a tube showing no defects, not necessarily is free of creep damage. This may be the case of row A tubes which present a number of tubes with “no defects”. The following figure presents the sensitivity comparison between some NDE technologies in the creep damage detection of creep damage.
