## RELIABILITY REPORT

Title: Reliability Study on a Reformer

Author: SOIL Ingeniería

Steam Methane Reformer (MW Kellogg)

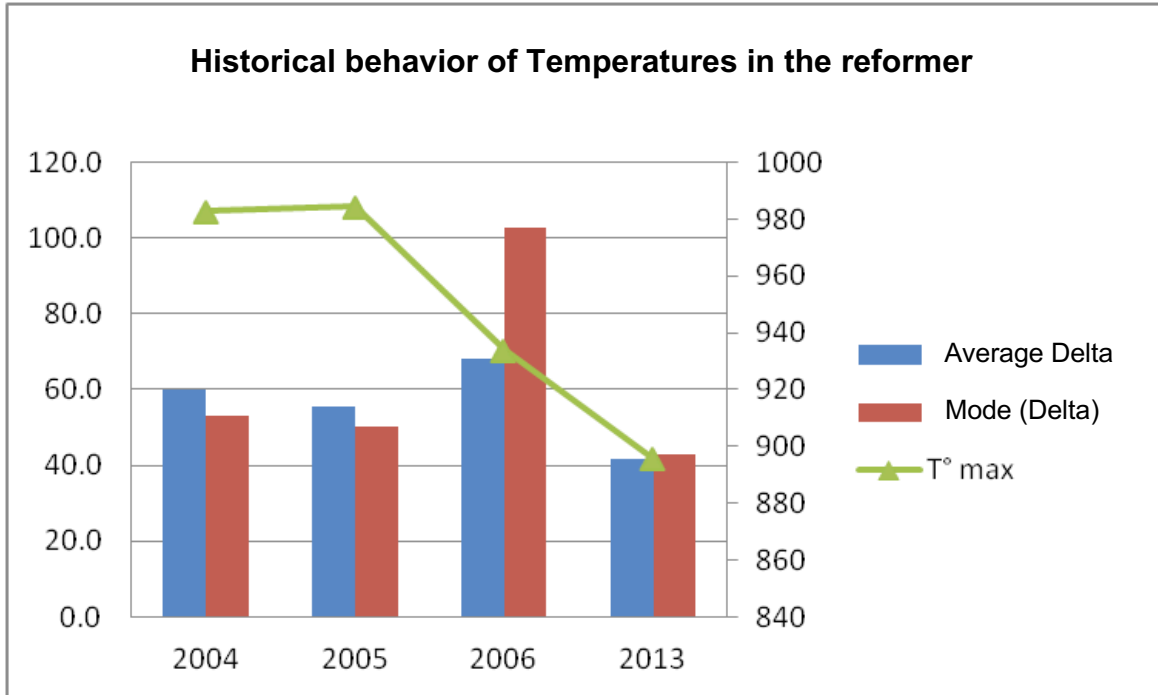
Analysis of 2004–2006 operation (FER near 100%) shows high temperature “upsets,” significant temperature deltas, and oscillations. In 2006, deltas  $\geq 100^{\circ}\text{C}$  were frequent. Maximum temperatures in all three years reviewed could cause premature manifold failure, especially with oscillations.

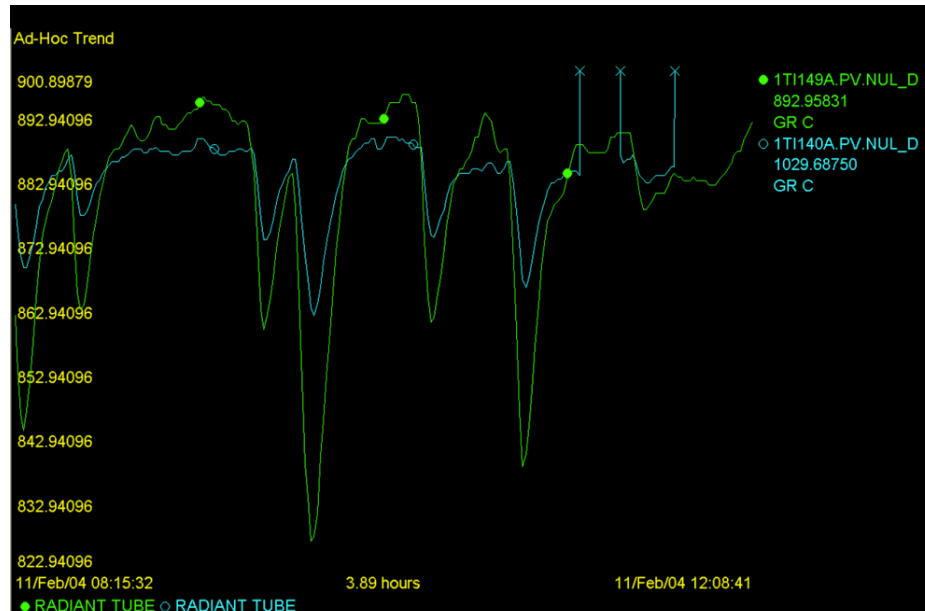
Examples from 2004 and 2006 showed extremely high cooling rates (568.3°C/hr and 573.5°C/hr).

Manifold 12, 2004. 568.3 °C/hr

- Balance air distribution to arc burners to lower South-side temperatures.
- Make local air adjustments to arc burners as needed.
- Keep manifold operation within established alarms; avoid exceeding them.
- If temperature control is insufficient, consider shutting down some burners during low-load operation.
- Monitor temperature change rates, keeping them below 50°C/hr.

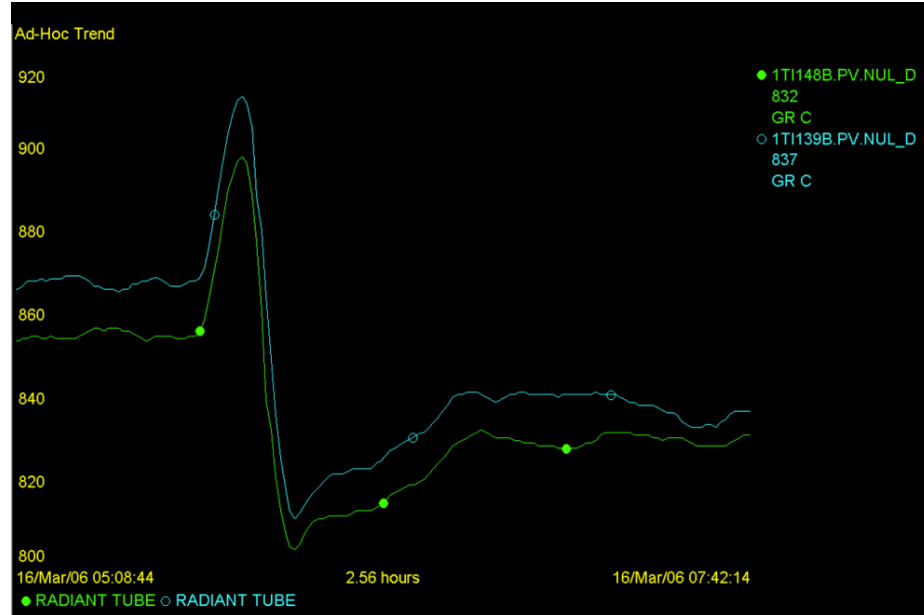
- Manifold 13, 573.5°C/hr. 101°C en 10:34 min

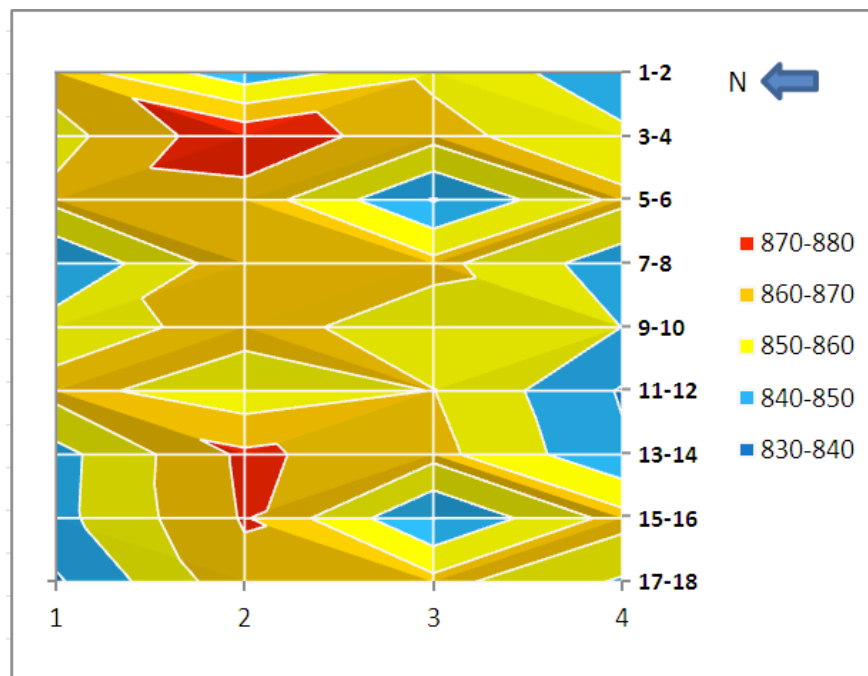
Lower load operation is less severe, but damage is cumulative. Current air imbalance affects manifolds 3, 17, 13, and 15 most. Manifold 13's 2006 repair was partial; remaining sections were exposed to earlier severe conditions. Furnace temperatures have reached 895.5°C (max) and averaged 875.5°C, with some exceeding TSI alarm limits. Heating/cooling rates above the 50°C/hr criterion have also occurred.

As a result, an uneven temperature distribution can be seen, with the greatest impact on manifolds 3, 17, 13, and 15. The distribution for November 22, 2013 is shown as an example:

In conjunction with Production personnel, an adjustment was made to the burners associated with rows 3 and 17, increasing the air flow, thereby achieving a temperature reduction to an acceptable level.

I-20, I-22, I-24 row 3

A-21, B-25, B-26 row 17

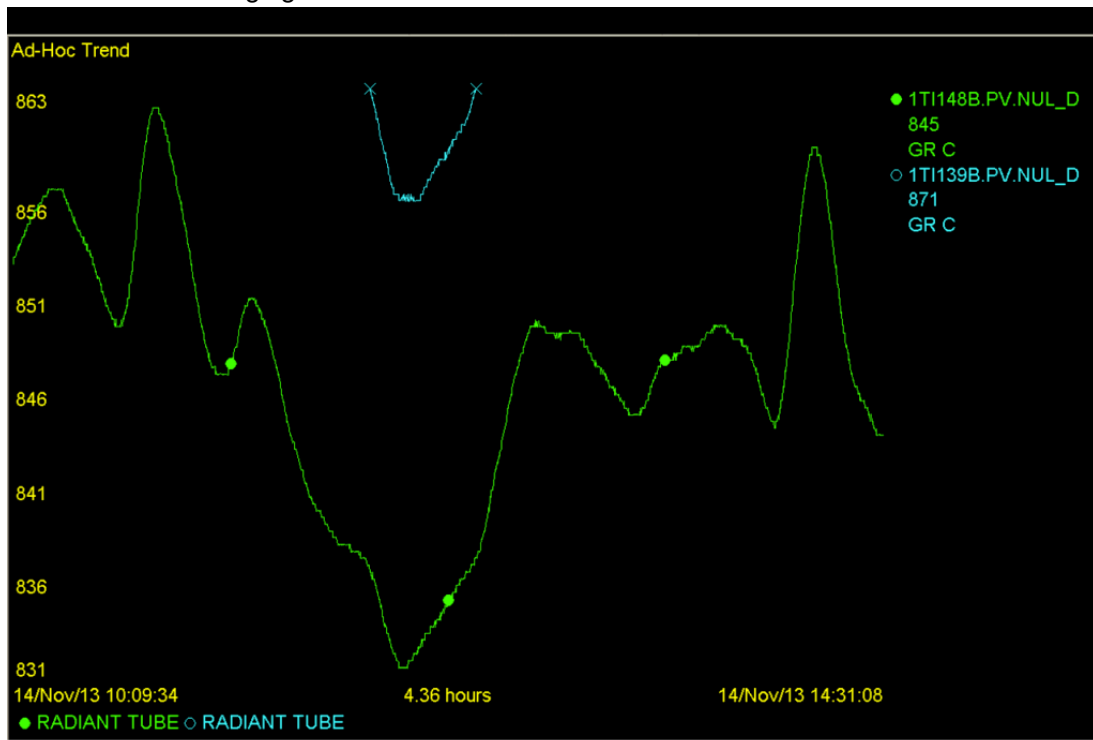
Regarding heating and cooling rates, there have also been cases where these have exceeded the 50°C/hr threshold. This can be seen in the following figures:

70 °C/hr

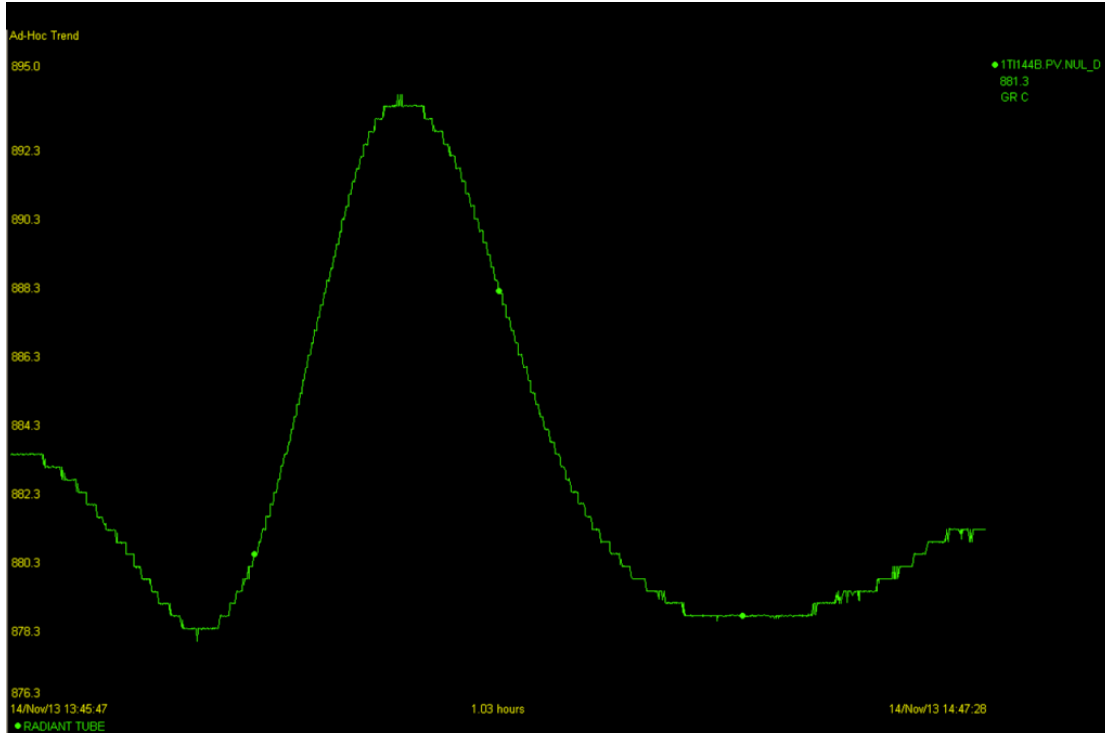
Temperature increases above 890°C with heating rates of 118.4°C/hr have been detected, with high potential to cause material damage.

118.4 °C/hr

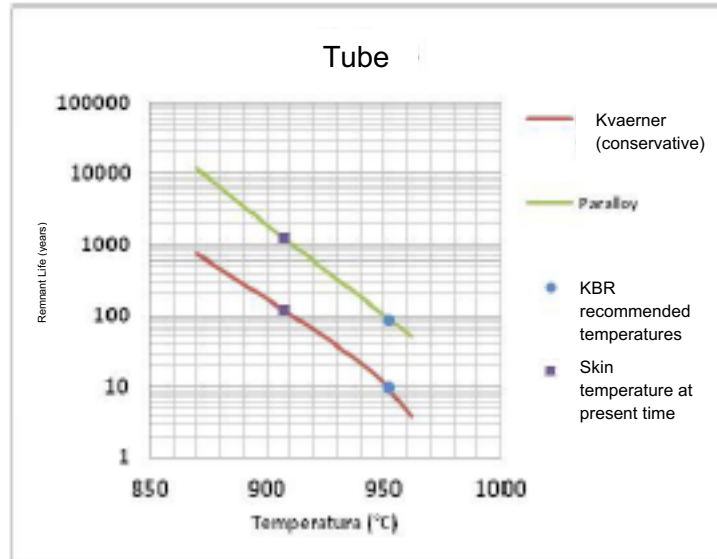
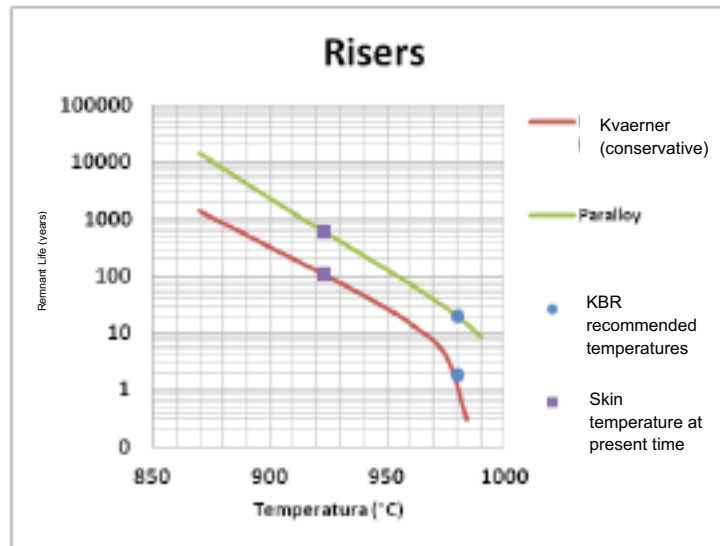
While they are subject to the same variations and operating conditions as the arc burners, these parts are made of a different material that is more resistant to creep and has a more ductile aging behavior and less loss of strength. The operating temperatures measured with a pyrometer show that these are far from the maximum allowable temperatures, as shown in the following figures:

Although these are theoretical curves, it can be seen that the operating temperatures are far from causing significant damage to the materials. However, care must be taken to avoid high temperatures, as these also affect the remaining life of the material.
