| | <b>Field Assessment Report</b><br><b>Steam Methane Reformer</b><br><b>US-01-101-R-0100</b> | <b>Date: 03/17/2025</b><br><b>Inspector: O. Olatte</b><br><b>Page 1 of 14</b> |

| <b>Scope of the assessment:</b> | | | | | | | External Visual Inspection in as found condition | | | | | | |

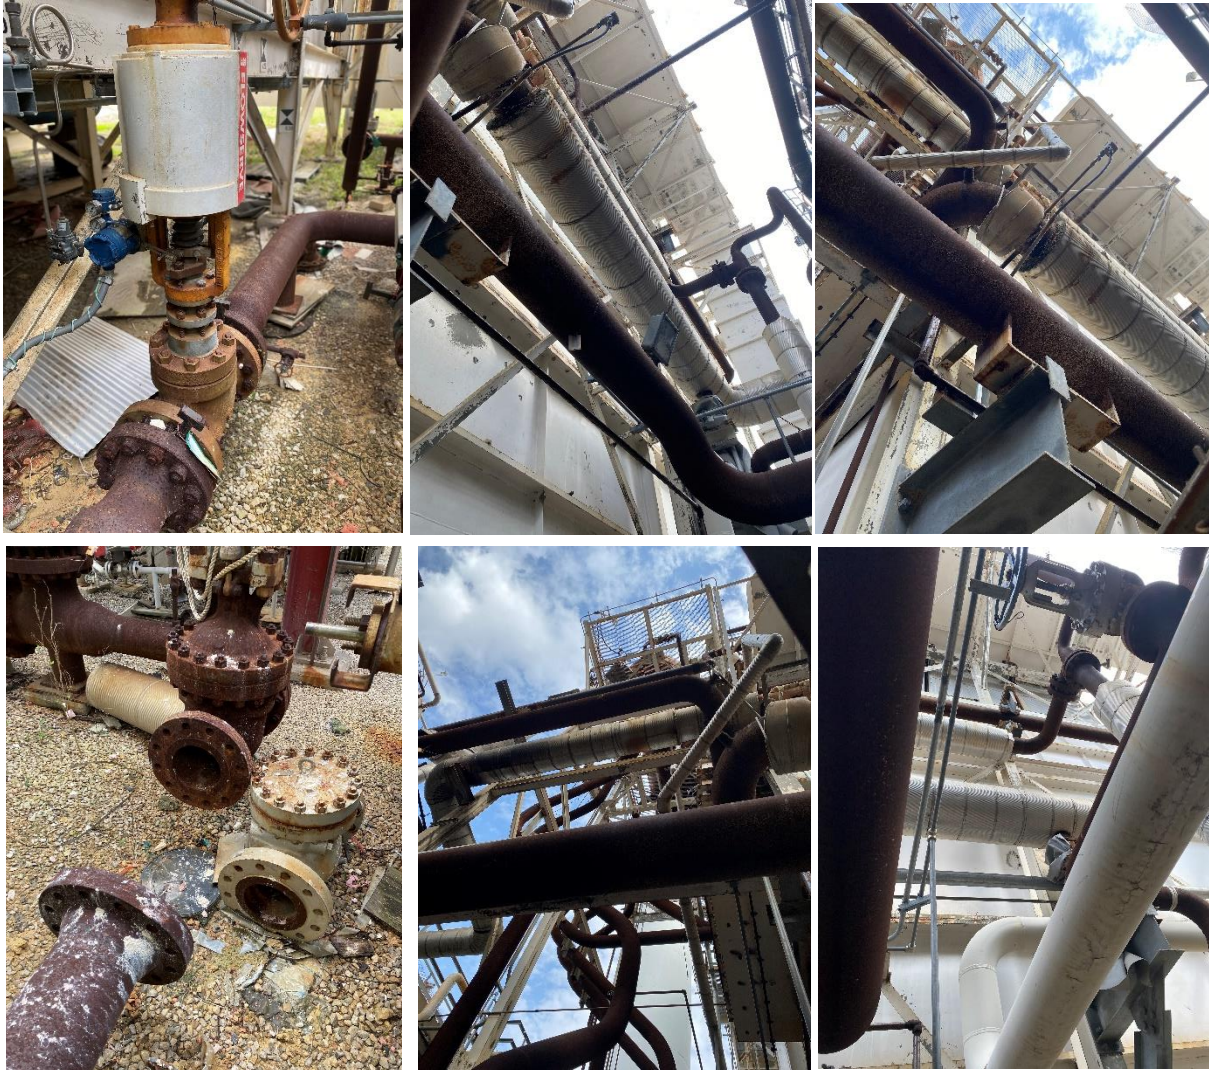
**Mixed Feed Inlet Pipe:**

- Modules panel walls with paint worn out.
- Corrosion in flanges in joints between panels.
- Insulation jacketing debris, likely from the ID Fan in trapped in some structures.
- The roof plate of transition ducts is with paint worn out. No evident signs of corrosion or mechanical damage.
- Mixed feed piping shows insulation lost and corroded.
- Internal inspection of pipeline 104-PRS-02760-8"-6CJ1S01-HC-X" accessing through the space left by check valve C506CJ500 removed, show material corrosion.
- Mixed feed inlet pipe presents areas with no insulation and corroded.
- Mixed feed coil outlet pipe shows insulation in good condition but it is suspected of CUI.
